TECH TRENDS

*The Applied Technologies
Newsletter for Superfund
Removals & Remedial
Actions & RCRA Corrective
Action*

"Snow Cap" Used for Sediment Remediation

DOE Comparison of Landfill Cover Designs

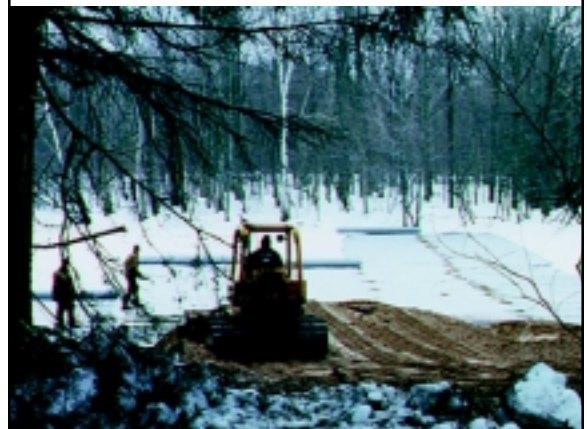
Figure 1. Spreading Geotextile over Frozen Lake

geotextile and sand blanket over the impacted area, and a second layer of geotextile and rock "islands." The geotextile keeps sediment from migrating into the sand, and sand from migrating into the rock "islands" that serve as a spawning habitat. Snowmobiles were used to pack the snow and increase the ice thickness from 6 to 24 inches, thus providing support for heavy, wheeled construction equipment. By constructing the cap on top of the frozen lake, the creation of a "mud wall" (typically formed when water capping begins at a shoreline and pushes the cap materials outward over the sediment) was avoided. The formation of such mud walls commonly re-suspends contaminated sediment and prevents adequate contaminant containment. Installation of the cap on top of the frozen lake also allows the geotextile to be spread during a longer time frame, overlapped uniformly, inspected prior to covering, and placed without sediment disturbance (Figure 1).
