Development of a Long-term Sampling Network to Monitor Restoration Success in the Southwest Coastal Everglades: Vegetation, Hydrology, and Sediments

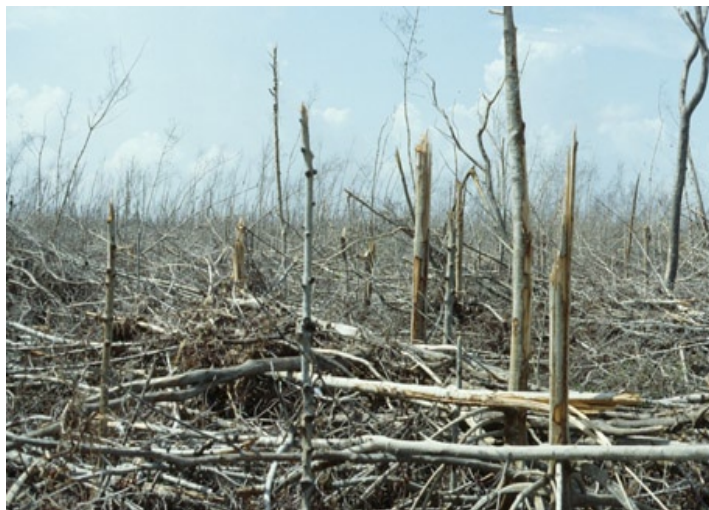
Figure 1. What is left of a mangrove forest that was crossed by the eye wall of Hurricane Andrew. The photo was taken in Biscayne National Park in September 1992, three weeks after the storm.

Hurricane Andrew, a Category 5 storm, crossed the southern Florida peninsula on the morning of August 24, 1992 (Fig. 1). Following the storm, the National Park Service conducted an environmental damage assessment to gauge the storm's impacts on the natural resources of south Florida Park Service holdings (Pimm et al., 1994). Although hurricanes have impacted Park Service lands such as the Everglades in the past (Houston and Powell, 2003), no systematic, permanent sampling scheme has been established to monitor long-term recovery (or lack thereof) following disturbance.

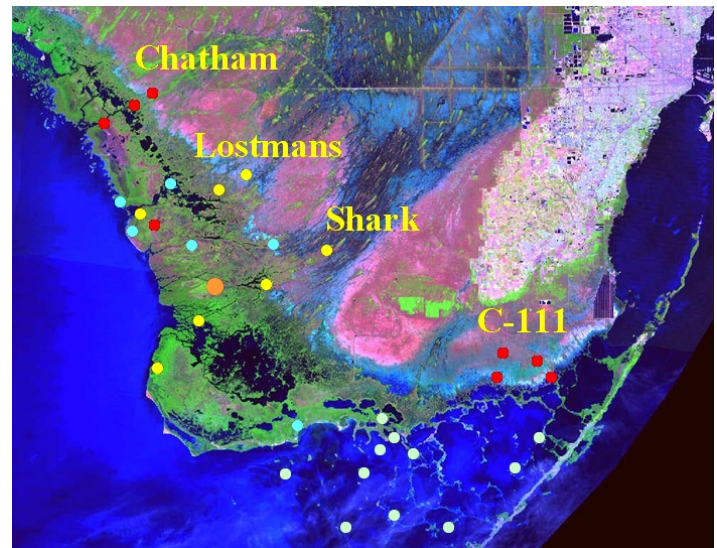
Figure 2. Location of sampling sites in Everglades National Park. **RED** dots = surface and groundwater stage and conductivity; **YELLOW** dots = surface and groundwater stage and conductivity, permanent vegetation plots, and sediment elevation sampling; light **GREEN** dots = sediment porewater piezometers and permanent vegetation plots; light **BLUE** dots = permanent vegetation plots; large **TAN** dot = location of the mangrove marsh ecotone boardwalk, with surface and groundwater wells, sediment porewater piezometers, and permanent vegetation plots.

In October 1992, vegetation monitoring plots were established in heavily damaged areas of mangrove forest on the southwest coast of the Everglades, along the Lostmans and Broad Rivers (Smith et al., 1994, see Fig. 2). As the permanent plot network was being established, funding was awarded for

the South Florida Global Climate Change project (SOFL-GCC). This led to the establishment of a network of hydrological monitoring stations (Anderson and Smith, 2004). Finally, sediment elevation tables (SETs) were installed at many locations. SETs provide the means to measure very small changes (2 mm) in the sediment surface elevation accurately over time (Cahoon et al., 2002). We also set up marker horizons to measure accretion of sediment at each site (Smith and Cahoon, 2003). Sampling sites were located along three transects extending from upstream freshwater wetlands to downstream saltwater wetlands along the Shark, Lostmans and Chatham Rivers in Everglades National Park (Fig. 2).

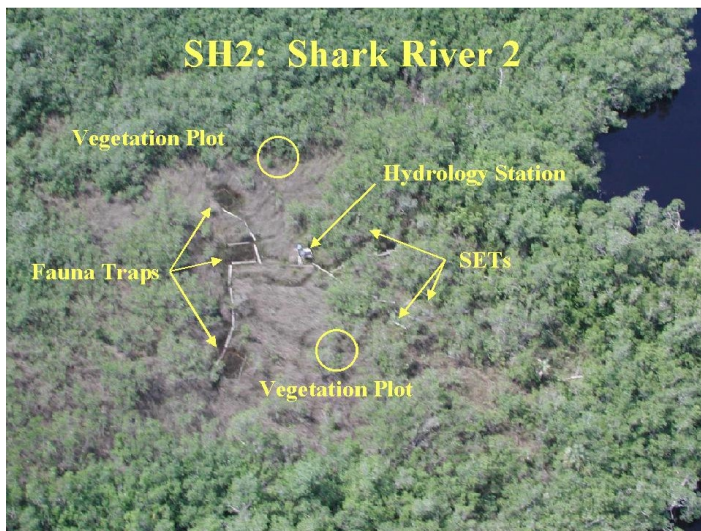
Figure 3. Oblique aerial photograph of a representative study site layout with vegetation plots, hydrology station, and sediment elevation tables (SETs). The greenish color is mangrove forest and the grayish color is black needle-rush marsh. Estuarine fauna is also sampled at this site.

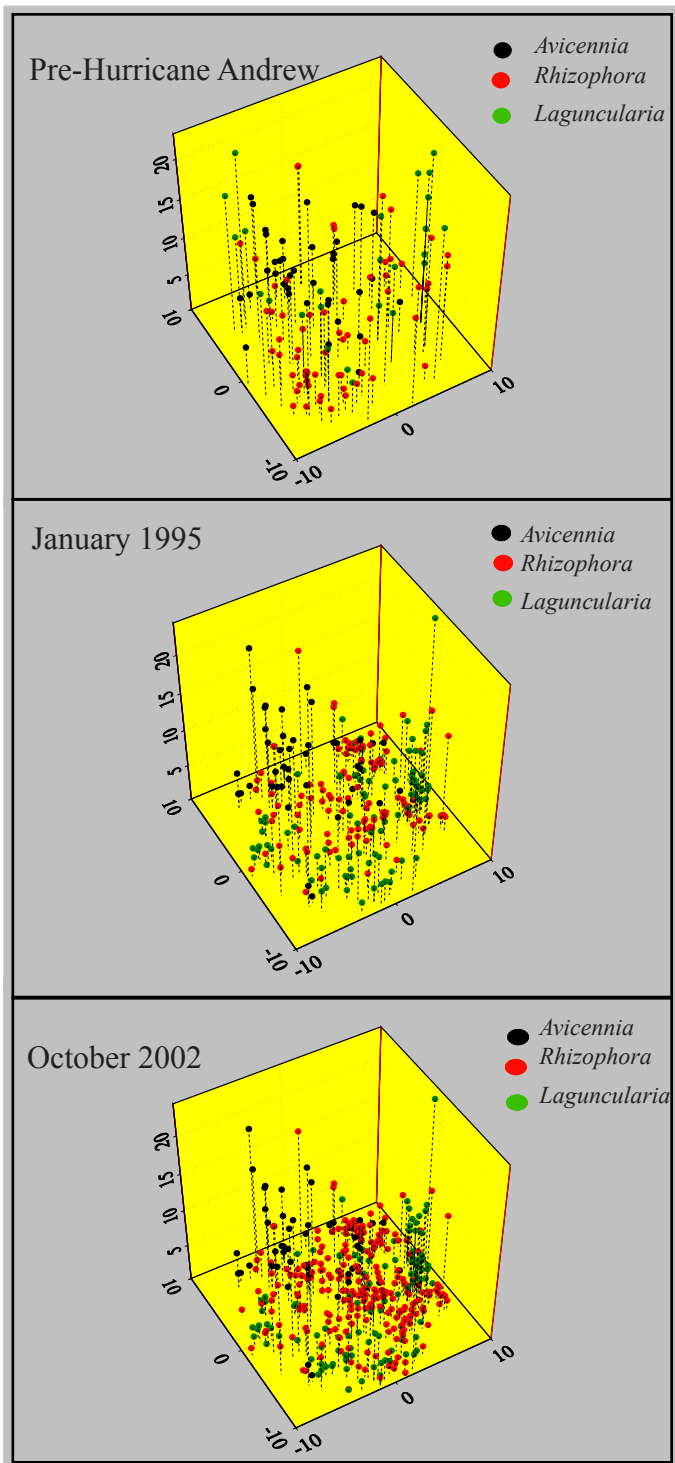
Figure 4. Results from three surveys at the Lostmans Ranger Station plot are shown. The X and Y axes are arbitrary, with 0,0 representing the center of the 10m radius plot. The vertical axis shows stem diameter at breast height, in cm. The top figure depicts the plot as it appeared prior to Hurricane Andrew (based on a “reconstruction” from the initial sampling in October 1992). The middle panel shows the situation in January 1995. Recruitment is well underway and consists of an even mix of *Rhizophora* and *Laguncularia*. The bottom figure shows the status in October 2002, 10 years after the hurricane. *Rhizophora* now dominates the pool of recruits.

The trajectory of vegetation change, growth, mortality, and recruitment has been highly variable among plots. Indeed, most plots have followed unique patterns. The only overall pattern was the increase in stem density observed in all plots (Fig. 4). The species that dominated recruitment varied, sometimes being *Rhizophora mangle* (red mangrove), often *Laguncularia racemosa* (white mangrove), but never *Avicennia germinans* (black mangrove). The rate of stem-density increase has varied among plots by over two orders of magnitude. Individuals are continuing to recruit into the population at many sites.

Mortality is occurring at all sites. Sources of tree mortality include continuing demise from damage initially caused by Hurricane Andrew, trees being killed by falling debris, lightning, wind-throw during winter cold fronts, freeze, fire, and several less intense tropical cyclones since Andrew such as Hurricanes Georges, Harvey, Irene, and Mitch. Trees in the smaller-size classes are beginning to perish due to suppression (that is, being overtopped and heavily shaded by larger neighbors, see Fig. 4).

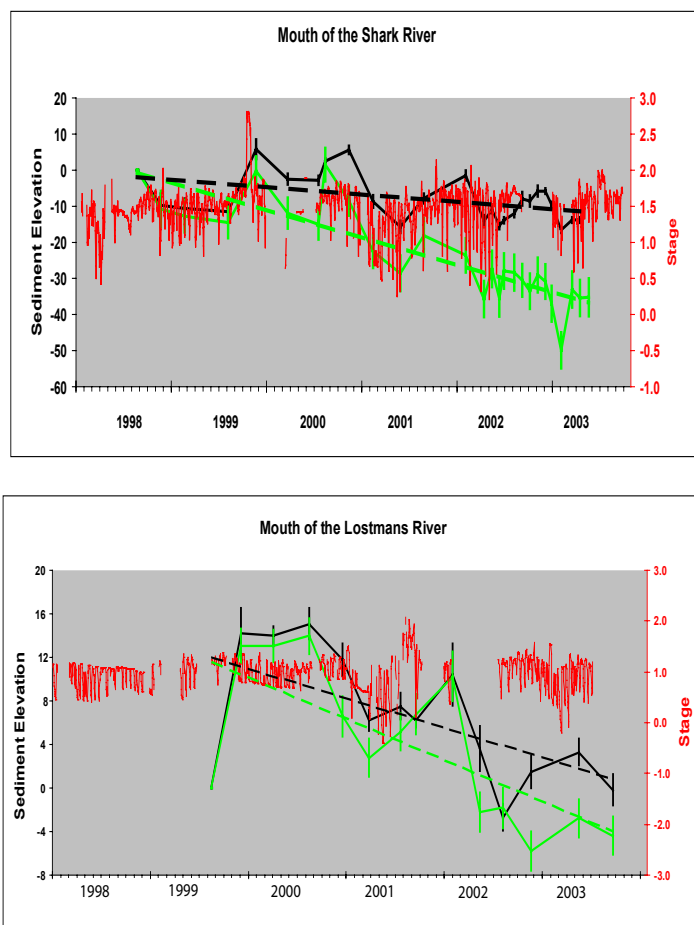
Figure 5. Surface-water hydrology (red) and sediment-elevation dynamics at two river-mouth locations in Everglades National Park. The black lines show sediment surface elevation over time (solid with error bars, ± 1 SE) and the linear trend in elevation (dashed). The green lines show sediment elevation minus accretion (solid with error bars) and the linear trend (dashed).

surface. In the lower Lostmans River, an area highly impacted by the storm, sediment elevation has been decreasing for at least five years (Fig. 5). The forests at the mouth of the Shark River, an area not impacted by Hurricane Andrew, are remaining at constant elevation (Fig. 5). Visual inspection of the data indicates that surface-water dynamics do not seem to be related to sediment-elevation changes.
