The Columbia River at Risk

Prepared by the Oregon Department of Energy

Revised, July 2006

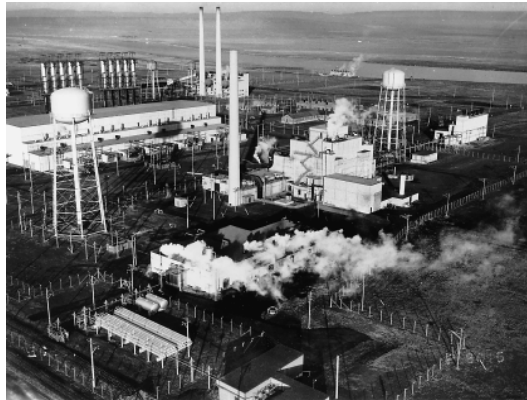
Hanford Production Reactor

In early 1943, during the height of World War II, the U.S. government selected a remote area of southeastern Washington state as the location to manufacture plutonium for a nuclear bomb. Plutonium is produced when uranium fuel rods are irradiated in a nuclear reactor. The nuclear reactions produce heat and new elements, including plutonium. Eventually, nine nuclear production reactors were built along the banks of the Columbia River at Hanford. Hanford's first nuclear reactor began operation in September 1944.

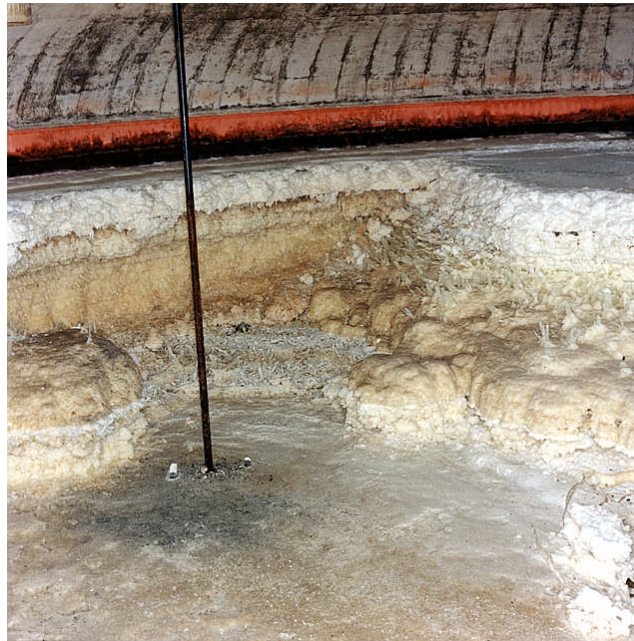
Inside a Hanford Waste Tank

Hanford's single shell tanks are cylindrical reinforced concrete structures with inner carbon steel liners just one-quarter to three-eighths of an inch thick. The domes of the tanks are made of concrete and do not include a steel liner. The smallest tanks are about 26 feet deep and 20 feet in diameter. The largest tanks are about 45 feet deep and 75 feet across.

The double shell tanks have two steel liners (with a single liner in the dome) and are reinforced by a concrete shell. All the tanks are covered with about 10 feet of soil and gravel.
