Appendix A

Example VAHBS Hospitals

Medical Center A VAHBS Data Sheet

SUPPLEMENT TO RESEARCH STUDY REPORT VA HOSPITAL BUILDING SYSTEM

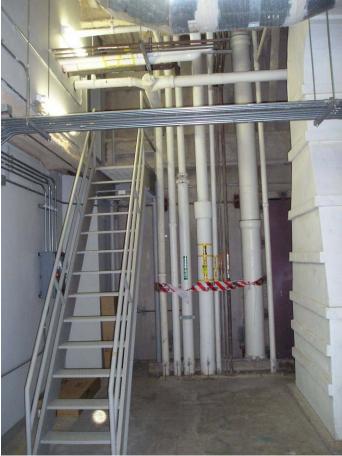
Photo A-1 Service Bay Showing industrial stair for access to interstitial service zone

Note plumbing risers and stacks in background.

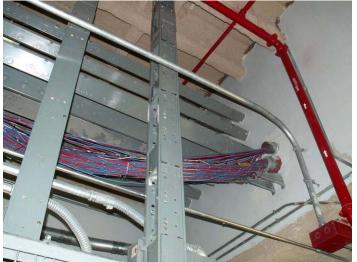
Photo A-2 Service Bay Side showing electrical penetrations of 1-hour wall to interstitial service zone

Note non-compliant telephone/data cabling installed outside of wire-ways.

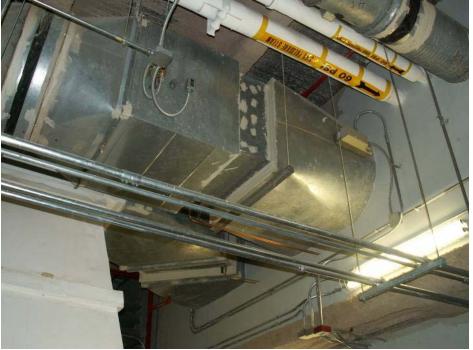
Photo A-3 Service Bay Side showing duct penetrations of 1-hour wall to interstitial service zone

Fire dampers are not required at duct penetrations.

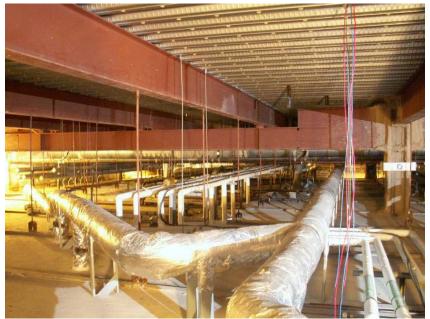
Photo A-5 Interstitial Service Zone Showing typical distribution subzones and channels

Note dropped girder in S-2 subzone.

Note non-compliant telephone/data cabling.

Note branch ducts supported from platform.

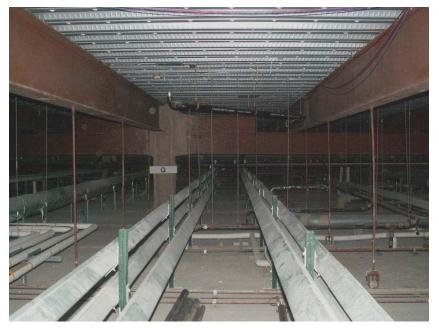
Photo A-6 Interstitial Service Zone Showing Electrical channel in Subzone S-4

S-2 subzone. Note dropped girder in background.

S-4 subzone. Hanger rods are visible at both sides of channel for electrical wire-ways.

Channel for HVAC is to left.

Note HVAC piping (insulated) and plumbing are crossing at right angles in S-5 subzone below.

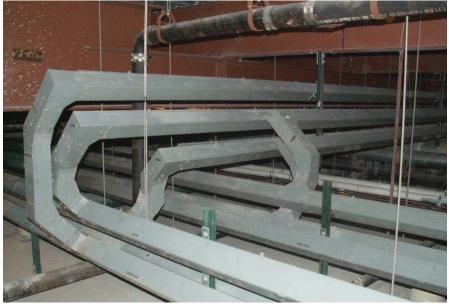
Photo A-7 Showing transition of Electrical Wireways from mains to laterals at S-3 to S-4 subzones

Note piping in S-2 subzone.

Note S-3 mains are supported from structure above; S-4 laterals are supported from interstitial platform (purlins not visible in photo).

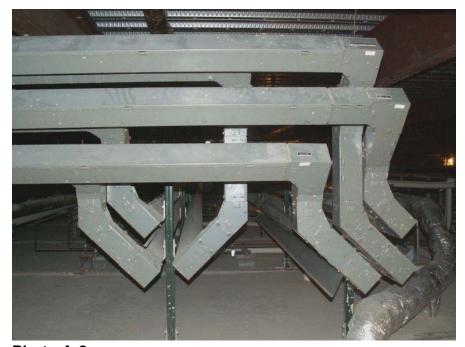
Photo A-8 Showing transition of Electrical Wireways from mains to laterals at S-3 to S-4 subzones

Note specially fabricated transitions.

Note strut "christmas trees" supporting wireway from platform.

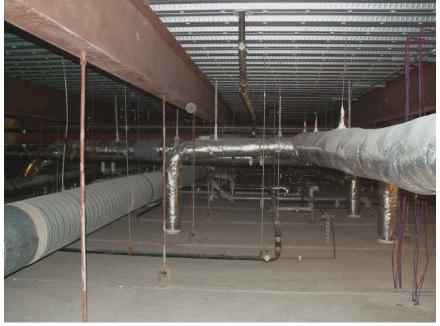
Photo A-9 Interstitial Service Zone Showing remodel work

Note branch duct, sanitary piping and tele/data cabling installed outside designated channels. Low concentration of services in this area still allows access for maintenance or modifications.

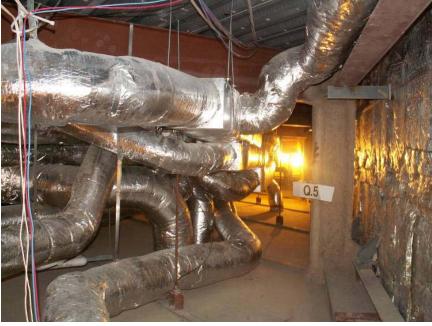
Photo A-10 Interstitial Service Zone Showing remodel work

Note haphazard modifications to HVAC and telecommunications systems. There are numerous violations of established channels for services and access aisle.

Installation has compromised ability to maintain systems in this area as well as future adaptability. This page intentionally left blank.

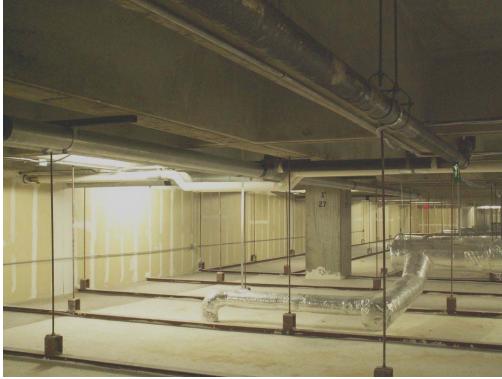
Photo B-1 Interstitial Service Zone Near end of main runs

Note cast-inplace concrete structure and piping offsets from S-2 subzone.

Note hanger rods for interstitial platform system; tops of purlins are visible above gypsum concrete deck.

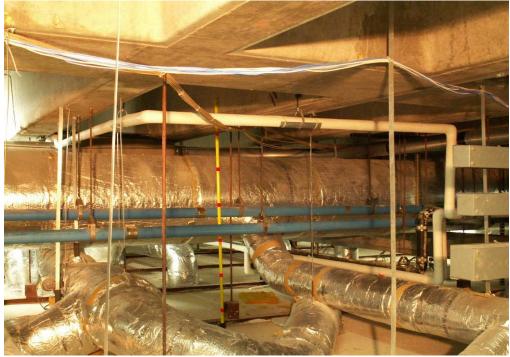
Photo B-2 Interstitial Service Zone Showing HVAC mains in S-3 subzone and branch ducts in S-4 subzone

Note noncompliant tele/data cabling.

Ends of electrical mains in S-3 subzone can be seen in foreground at right side of photo.

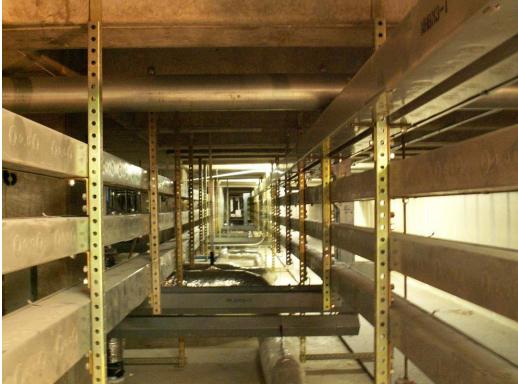
Photo B-3 Showing wireways in S-3 and S-4 subzones

Note branch ducts in background in S-4 and S-5 subzones.

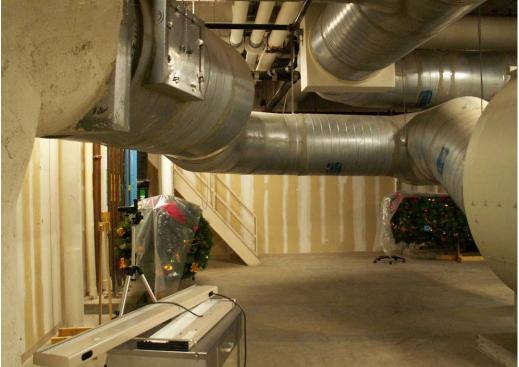
Photo B-5 Service Bay Showing crossovers of ducts and piping

Note industrial stair for access to interstitial service zone in background.

Crossovers occur in Service Bay, <u>not</u> interstitial service zone.

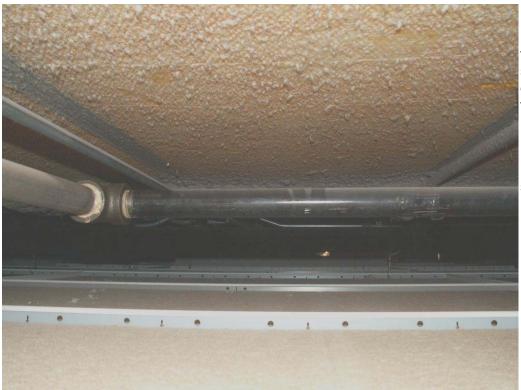
Photo B-7 Subzone S-7 Above suspended lay-in ceiling system

Note fiberglass formboard and sub-purlins for gypsum platform deck.

Fire sprinkler piping is run in subzone S-7.

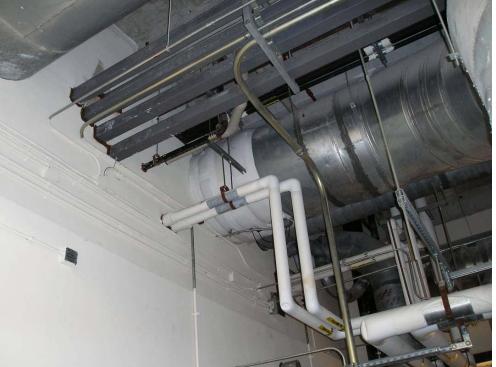
Photo C-1 Service Bay Side showing penetrations of 1-hour wall to interstitial service zone

Fire dampers are not required at duct penetrations.

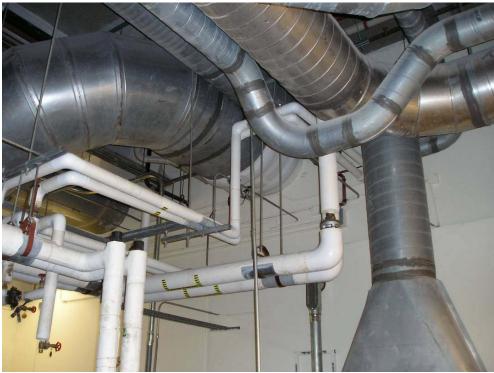
Photo C-2 Service Bay Side showing duct penetrations of 1-hour wall to interstitial service zone.

Note duct and piping crossovers occur in service bay, <u>not</u> in interstitial service zone.

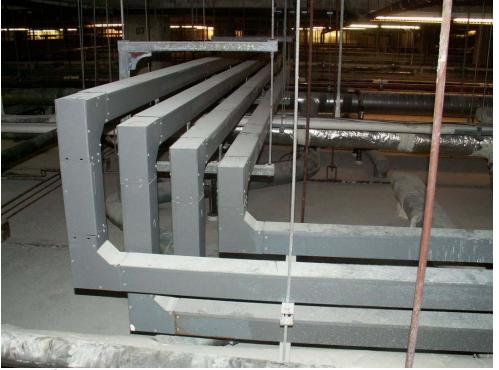
Photo C-3

Note HVAC branches crossing under wireway mains in S-4 channel in background.

Note plumbing in S-5 subzone at far left side of photo.

Electrical transition from mains in S-3 subzone to branches in S-4 subzone.

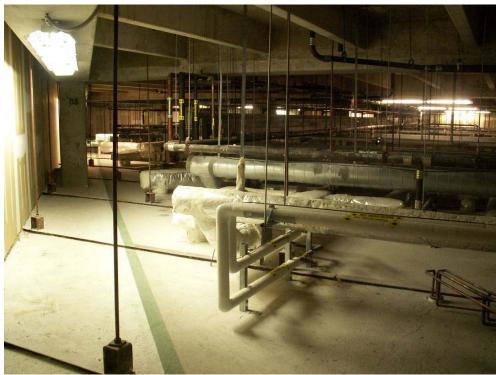
Photo C-4 Interstitial Service Zone Showing typical perimeter access aisle (note stripe on deck)

Note transition of piping from S-2 to S-3 subzones in background.

Note fluorescent fixture lack wire guards.

Note hanger rods and purlins for platform deck system.

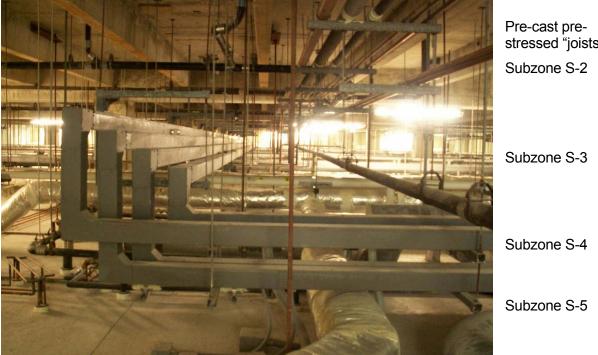
Photo C-5 Interstitial Service Zone Showing typical distribution

stressed "joists"

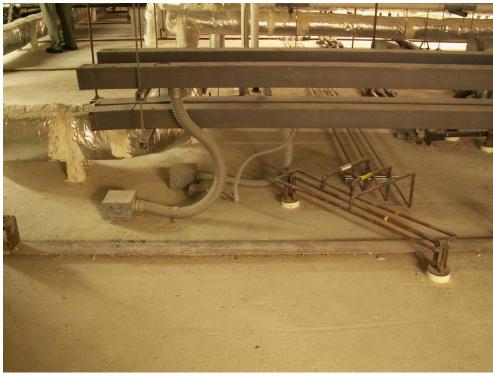
Photo C-6 Transitions from S-4 to S-5 subzones

S-4 subzone w/ HVAC & Electrical channels

Note flex conduit at transitions from wireway in S-4 through S-5 subzone.

Medical gas and plumbing in S-5 subzone.

Note exposed top of purlin for interstitial deck.

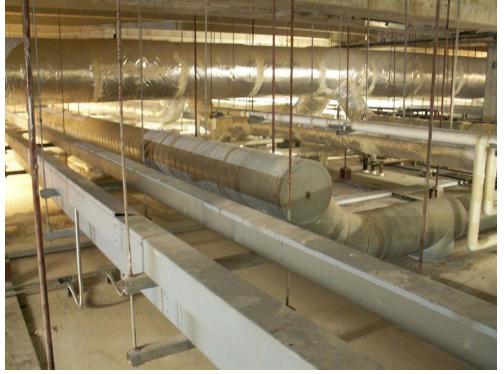
Photo C-7 Showing Electrical and HVAC channels in S-4 subzone crossing under HVAC main in S-3 subzone

S-3 subzone

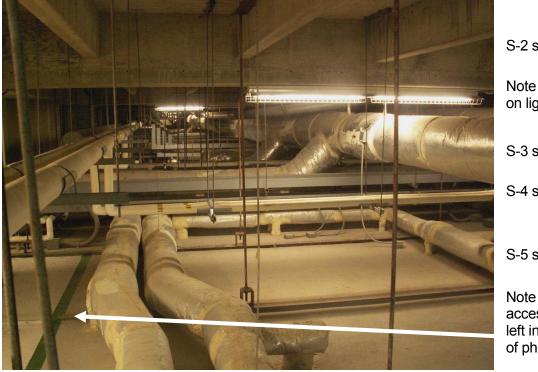
S-2 subzone

Note wire guard on light fixture.

S-3 subzone

S-4 subzone

S-5 subzone
