Potential Environmental Impacts of Quarrying Stone in Karst— A Literature Review

U.S. Geological Survey
Open-File Report OF-01-0484

By William H. Langer

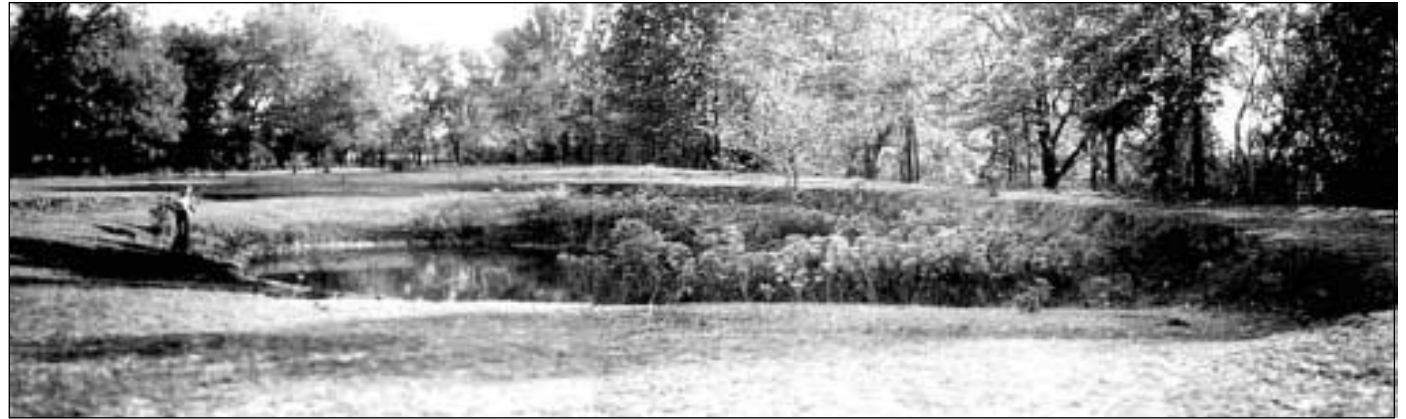
Figure 3. Shallow sinkhole typical of karst terrain in Cherokee County, Kansas. (USGS photographic library - Pierce # 339, 340.)

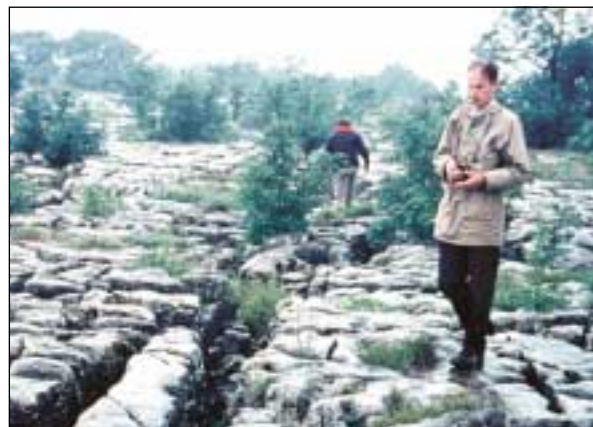
Figure 6-a (right). Limestone surface in karst area with no soil cover.

Figure 6-b (far right, top and bottom). Removal of overburden has exposed the furrowed and pitted surface of carbonate rock. (Photograph courtesy of Keith Bennett, Williams Earth Sciences, Inc.)

Unusual bedrock surfaces may be created as the carbonate rock is dissolved (fig. 6a and 6b). In temperate climates, some of the surfaces resemble abstract sculptures or contain pointed columns called pinnacles. A residual soil forms over the bedrock because there are minerals within limestone that are not affected by carbonic acid. As the process of dissolution continues, these insoluble minerals collect on top of the bedrock surface as clayey residual material. Some residual material is carried by water into openings in bedrock where they clog the openings. Other material, such as stream alluvium, may overly the clay. Depending on the climate, topography, and type of parent bedrock, soil on the bedrock surface can be non-existent or greater than 50 m thick.

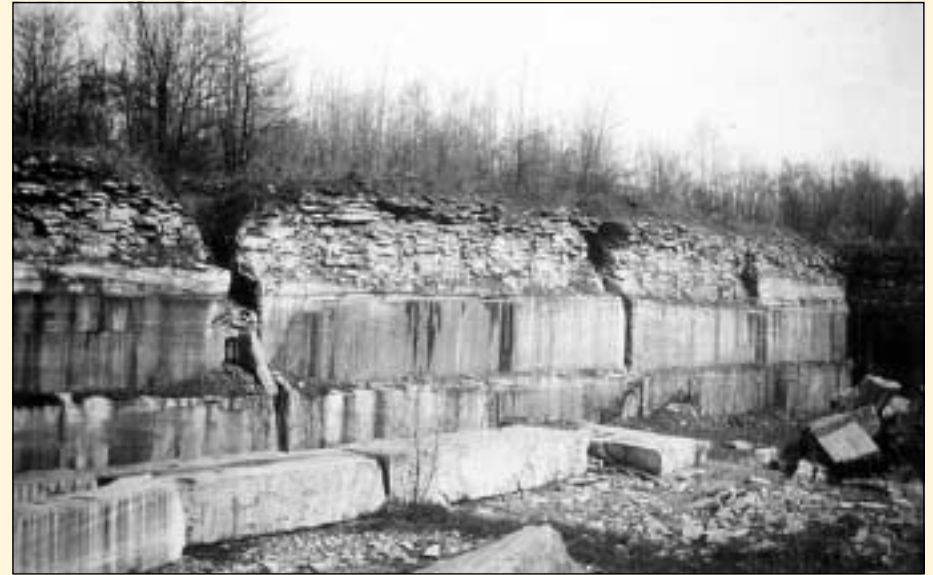
Figure 7. Working face of dimension stone limestone quarry in Lawrence County, Indiana, showing smooth surfaces from which large blocks have been removed. (*USGS photographic library – Burchard #556.*)

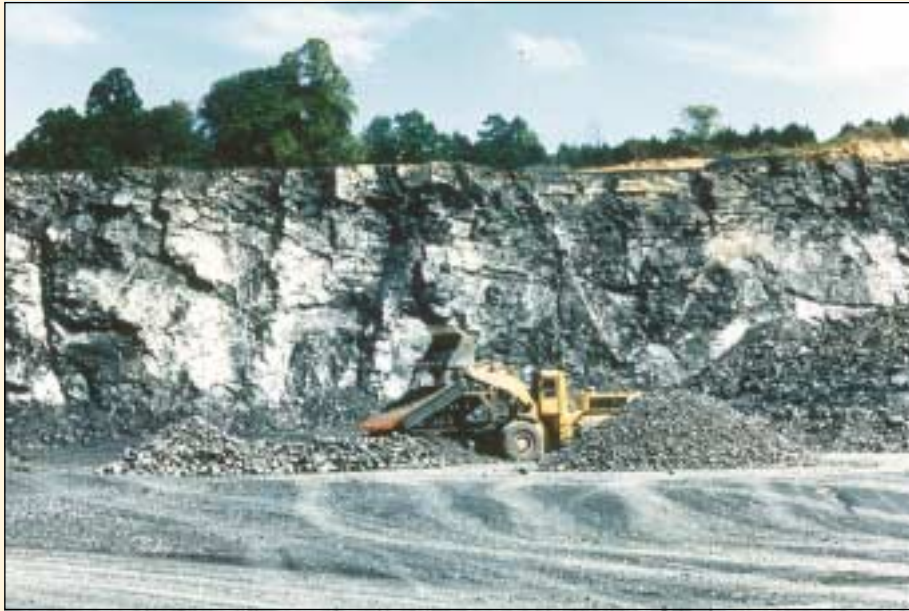
Figure 8. Working face of crushed stone operation showing rubble created by blasting. (Photograph courtesy Luck Stone.)

The general objective of crushed stone quarrying is to produce relatively small pieces of rock that are suitable for crushing into gravel-sized particles (fig. 8). To produce crushed stone, the rock is first drilled and blasted. Blasting commonly breaks the rock into pieces suitable for crushing. When the blasted material is dry, it can be extracted by using conventional earth-moving equipment, such as bulldozers, front loaders, track hoes, and scraper graders. Rock quarries that do not penetrate the water table, or where discharge from the water table naturally drains from the quarry, is offset by evaporation, or is otherwise insignificant, commonly are mined dry.

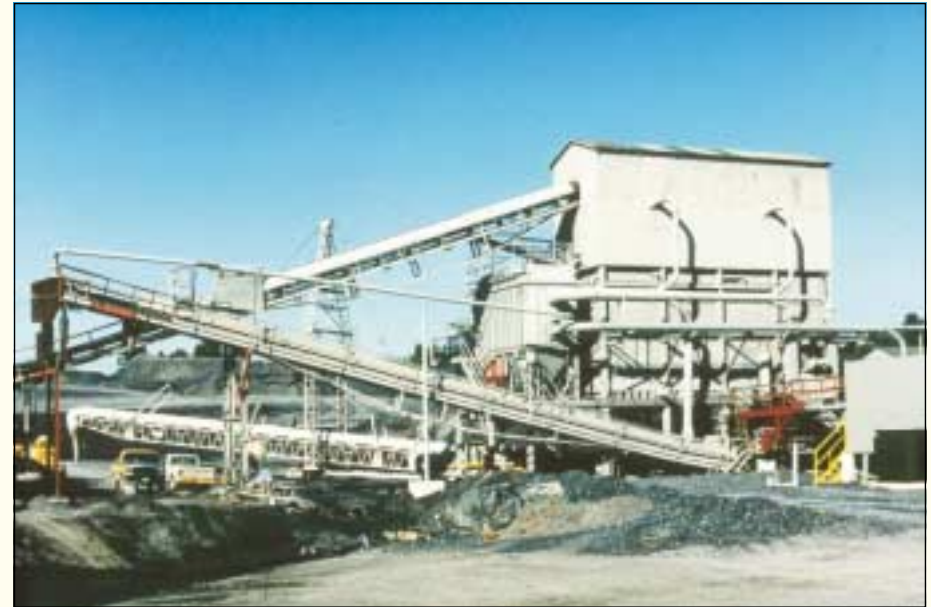
Figure 13. Noisy equipment can be located away from populated areas and can be enclosed in sound-deadening structures. (Photograph courtesy Luck Stone.)

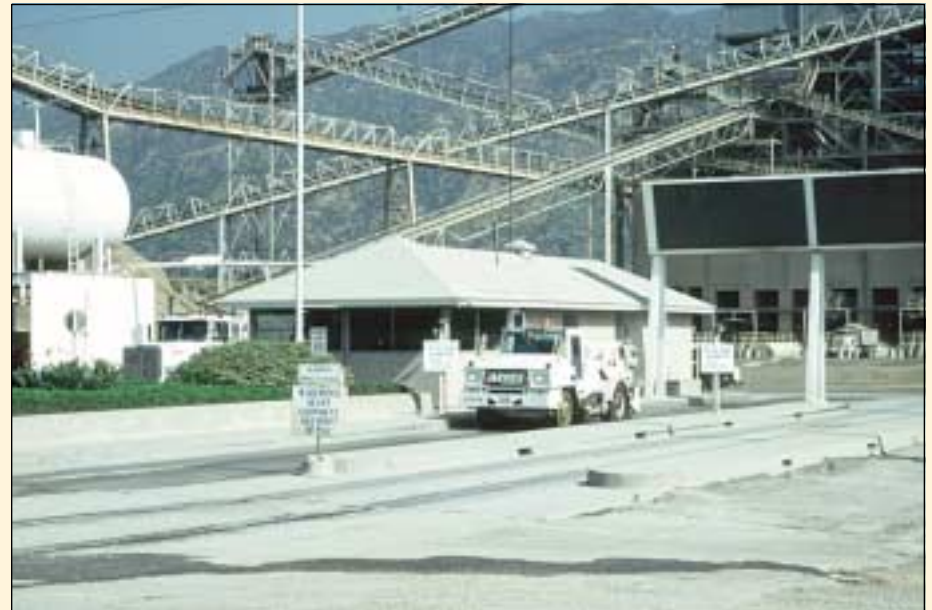
Figure 14. Dust control techniques include the use of water trucks and sweepers on haul.

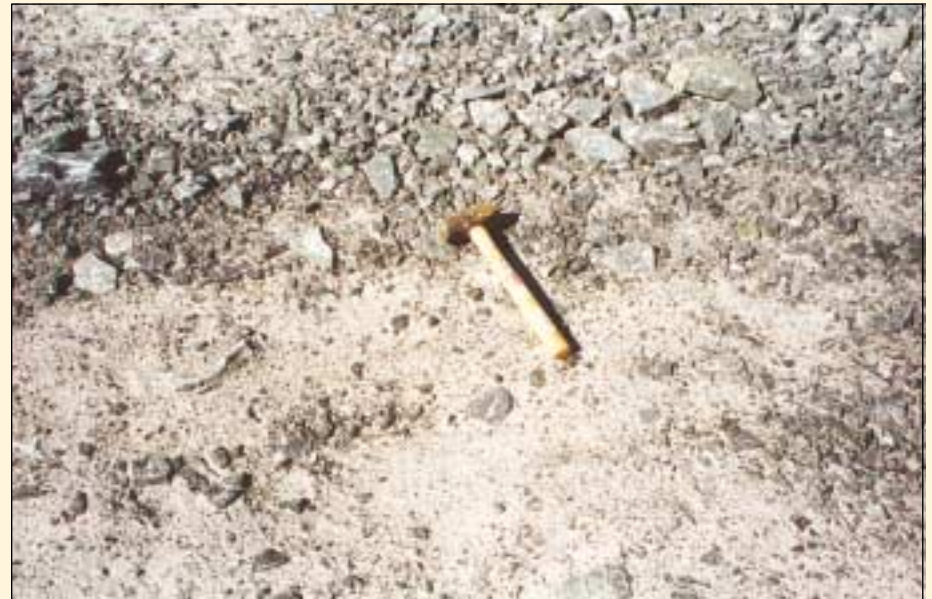
Figure 15 (right). Dust on quarry floors can clog pores in the ground, thus altering ground-water recharge.

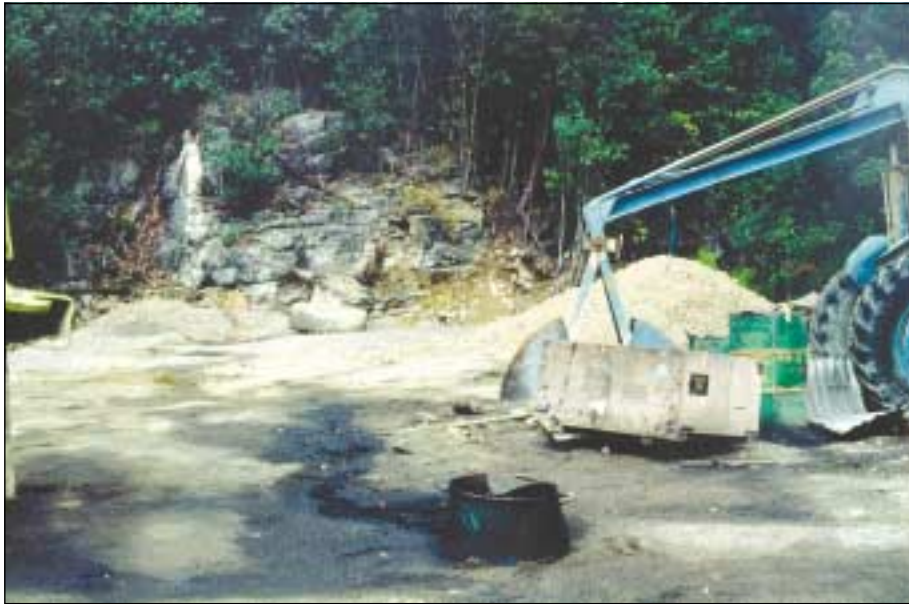
Figure 17a. Fuel oil spills can rapidly contaminate karst aquifers. (Photograph courtesy Elerly Hamilton-Smith.)

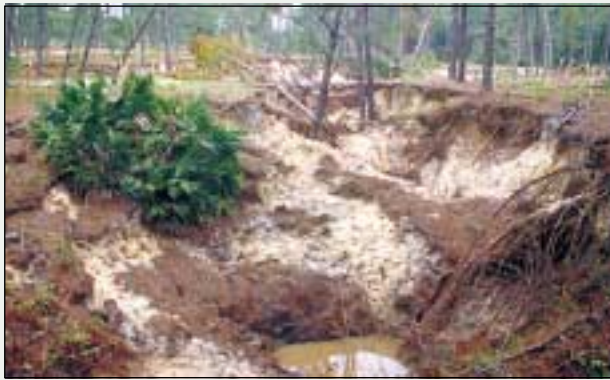
Figure 19. Human-induced sinkholes formed during the development of an irrigation well affected a 20-acre area and ranged in size from less than 1 foot to more than 150 feet in diameter. (Photograph courtesy Ann Tihansky, USGS.)

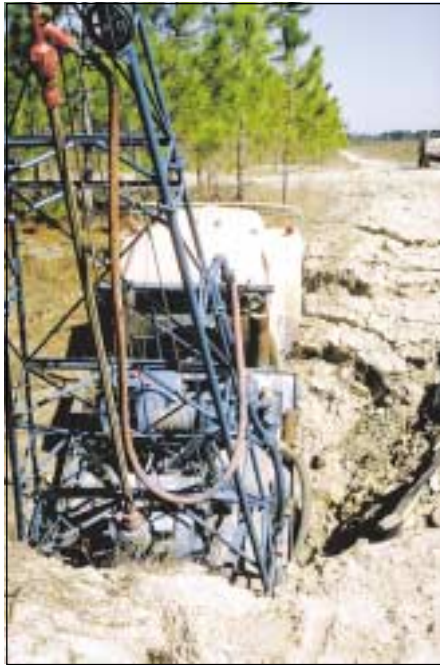
Figure 22. "A giant sink hole opened up on Thursday, September 19 [1975] at a drilling site near Tampa, Florida and swallowed up a well-drilling rig, a water truck, and a trailer loaded with pipe all valued at \$100,000. The well being drilled was down 200 ft when the ground began to give way to what turned out to be a limestone cavern. Within 10 minutes all the equipment was buried way out of sight in a crater measuring 300 ft deep, and 300 ft wide. Fortunately, the drilling crew had time to scramble to safety and no one was hurt." -from National Water Well Association newsletter. (Photograph courtesy Tom Scott.)
