## Emergency Watershed Protection Program

### *An EWP Success Story*

### **Minnesota's Long Tom Dam Rebuilt**

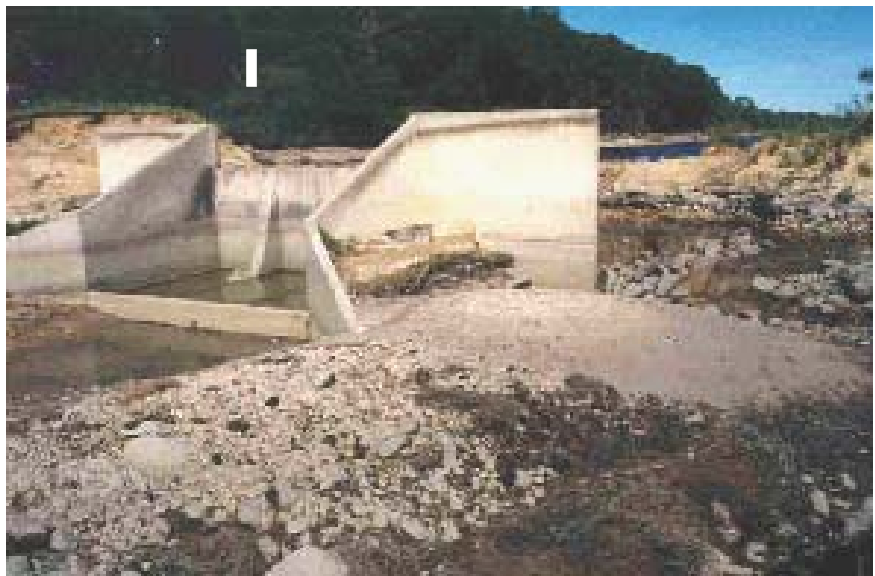
The earthen embankment has a concrete drop structure with a ten-foot drop. The runoff from the snowmelt in 1997 and the spring rains breached the earth embankments on either side of the concrete drop structure, leaving the structure in place, as shown in the photo above.

The NRCS Emergency Watershed Protection (EWP) program can only repair a site to the condition that existed prior to the natural disaster. However, when the site was evaluated by the NRCS and the Minnesota Department of Natural Resources (DNR), which is responsible for dam safety in the state, it was determined that restoring the site to its prior condition did not meet current dam safety standards.

A cooperative effort was launched to both repair the structure and to improve it to meet current criteria. Funding to repair the dam came from the EWP and funds to improve it to meet current criteria came from state dam safety funds. The reconstructed earth face was covered with precast concrete blocks, cabled together to provide overtopping protection. In 2001, further rains caused outflows from Long Tom similar to what was experienced in 1997. The NRCS staff was pleased to report that the structure handled the large discharges without damage.
