US Army Corps
of Engineers
Waterways Experiment
Station

Technical Note ZMR-3-11

Use of Removable Intake Screens to Reduce Maintenance Problems Associated with Zebra Mussels

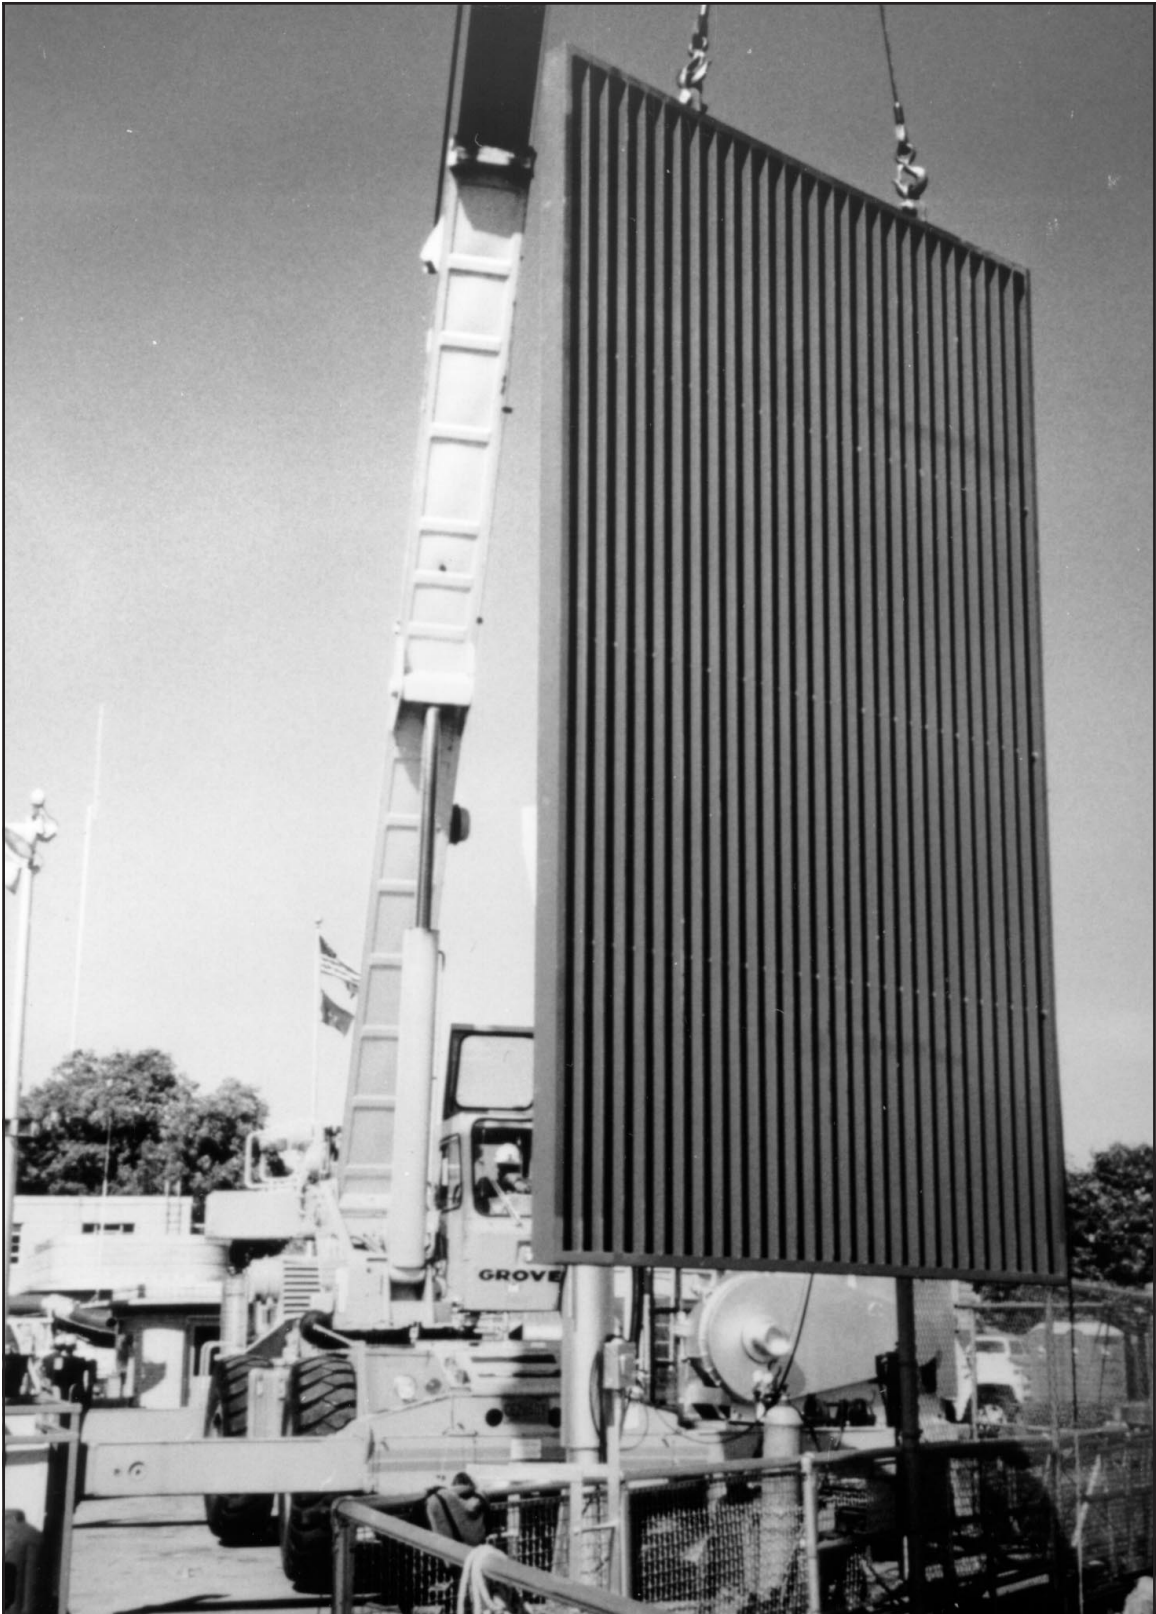
Figure 1. Removable screen

Design of the removable screen In October 1992, Cheatham Lock on the Cumberland River was dewatered as part of normal maintenance. Eight fixed screens, which were in need of replacement, were removed. The Nashville District supervised the construction of fixed frames and removable screens to replace the original screens (Figure 1). The frames were permanently mounted in the culvert by divers. The screens were set in grooves in the frame.

The screens were designed so that they can be easily removed for cleaning or minor repairs. If the screens become infested with zebra mussels, they will be removed and cleaned manually.
