# Benton Foothills Watershed Analysis Area

Marys Peak Resource Area  
Salem District, Bureau of Land Management  
1717 Fabry Road  
Salem, OR 97306  
503-375-5646

September 1997

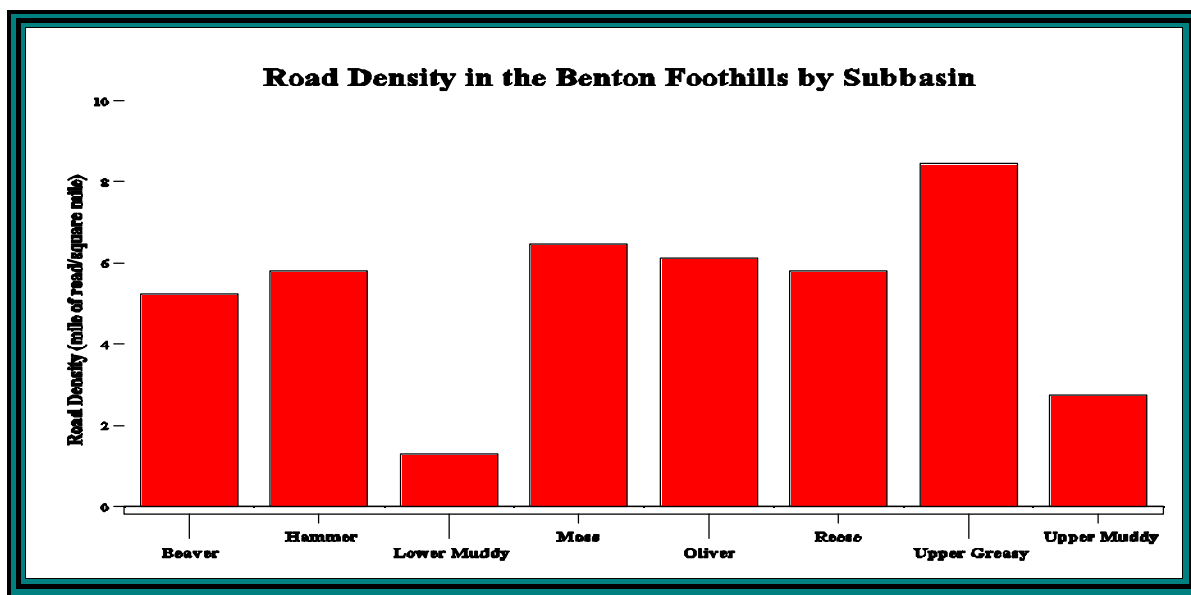
**Figure 2. Road Densities in the Analysis Area**

by Moss Creek with 6.5 mile/square mile (Figure 2) (includes road system, overgrown roads, and OHV trails). Seventy percent of total road mileage exists in the four sub-basins with the greatest concentration of forest management: Beaver Creek, Hammer Creek, Oliver Creek, and Reese Creek with 122, 92, 97, and 57 miles of road respectively. Thirty-four miles of road (1% of total road length) are currently located within riparian zones (based on interim riparian widths). Fifty percent of these (16.9 miles) are in Beaver Creek sub-basin.

An average of 3.5 mile/square mile of road exists on the BLM lands within the analysis area. The Aquatic Conservation Strategy requires that these roads be closely evaluated for their impact on aquatic functioning and considered for closure/decommissioning (see Transportation section). Approximately 0.5 mile of road is currently located on moderate to high risk landslide terrain in the Upper Muddy Creek. These sections of road on BLM have been inventoried and evaluated as candidates for closure/decommissioning (see Transportation section).

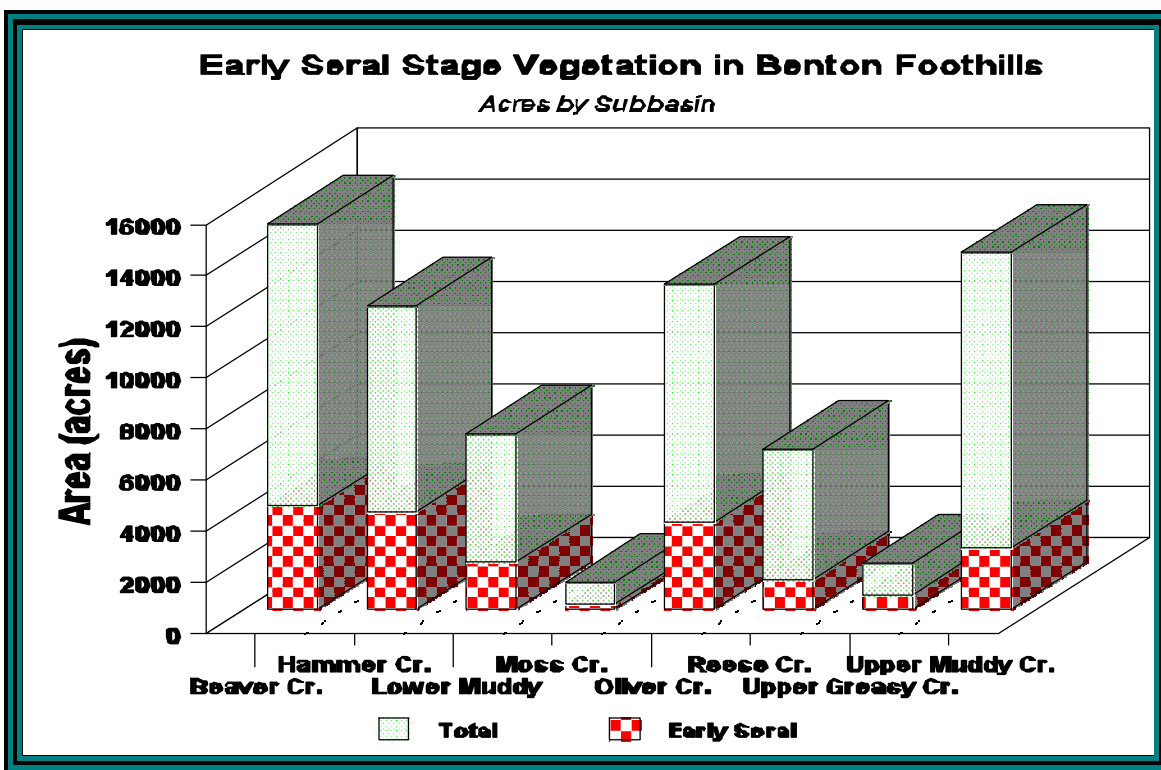
Figure 3. Early Seral Stage Vegetation in Benton Foothills

An additional element implicated in the alterations in the timing and amplitude of peak flows is the temporary conversion of mature forest to early seral stage vegetative cover following harvest. The mechanisms most often cited for this effect are the reduction in evapotranspiration, increases in surface flow, and increased snow packs associated with openings. These effects are expected to last approximately ten years. Currently, 17,590 acres (22%) of the Upper Muddy Creek are in an early seral vegetation class (Figure 3). If only the forested acreage is considered, 35% is in an early seral growth stage. Beaver Creek sub-basin has the greatest total (4,060 acres, 37%) early seral class vegetation while Hammer and Upper Greasy have the highest percent early seral (48 and 45, respectively). Thus nearly half of the forested portions of Hammer Creek are in early seral age class vegetation.

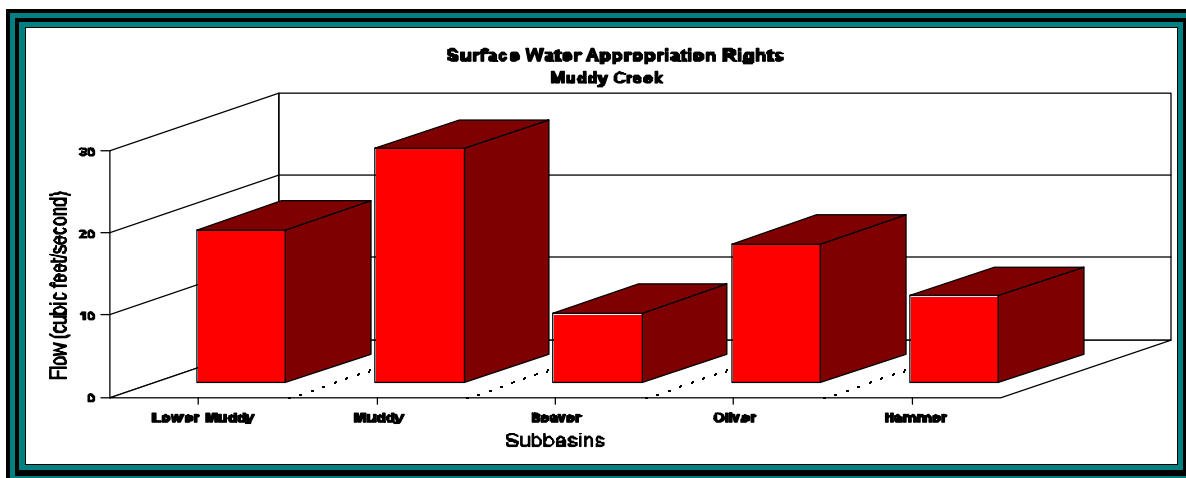
## **Figure 4. Surface Water Appropriation Rights by Stream**

Oregon State's water appropriations doctrine is based on first-in-time/first-in-right. Holders of water rights are granted priority dates corresponding to the date of application. These rights are held as long as state requirements continue to be met. The state requires that a use or withdrawal right be directly applicable to a designated beneficial use. For Muddy Creek, beneficial uses of surface waters include: domestic water consumption, fisheries, agriculture (including irrigation and livestock), recreation, wildlife, fire control, and power. As of March 1997, active surface water rights in the Muddy Creek River system as a whole totaled approximately 85cfs. Although there are withdrawal rights for domestic consumption on all the major Muddy Creek tributaries, most rights are for irrigation. There are no municipal surface water rights in this watershed.

In June 1966 the Oregon State Water Resources Board (now the Water Policy Review Board) established minimum flow reservations "for the purpose of maintaining a minimum perennial streamflow sufficient to support aquatic life and recreation." All water rights granted after the June 1966 date are subject to the minimum flow reservations. This has resulted in the appropriation and utilization of essentially all available streamflows on Muddy Creek during the late summer and early fall period of critical years. During drought years, water appropriations on Muddy Creek likely exceed base flow capacity.

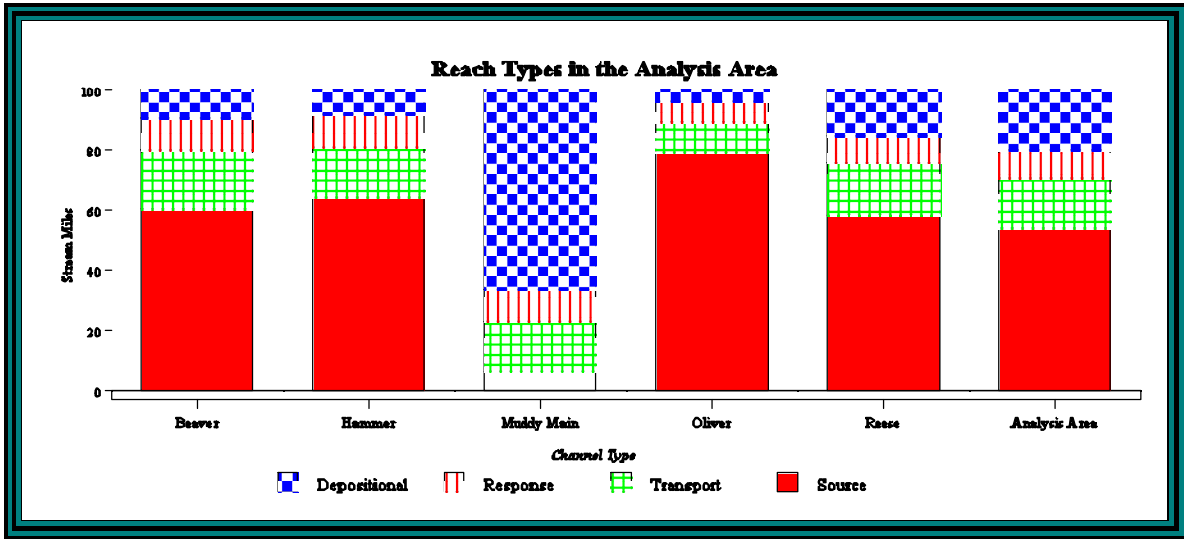
**Figure 5. Reach Types in the Analysis Area**

Transport reaches have a relatively high gradient (4-20%), are often resistant to changes in

stream morphology, and tend to act as conduits for material from high gradient reaches to depositional and response reaches. These reaches typically have a cascade morphology, a large cobble or boulder substrate, and resistant banks with little or no flood plain development. They may be intermittent or perennial. Riparian vegetation is variable but tends to be dominated by conifer. There are approximately 67 miles (17% of total stream mileage) of transport reach stream channels in the analysis area; 7.2 miles (11% of the total) are on BLM lands. As with source reaches, the current functional condition of transport reaches on BLM lands is largely unknown.

Field investigations to date indicate that source and transport channels in the forested uplands likely have higher sediment loads and reduced roughness, particularly large woody debris, relative to reference condition (see Fisheries section). On stable channels, the main supply mechanism for sediment appears to be ravel from the adjacent, over steepened hillslopes. Some of this material, mostly gravel size, is retained primarily behind dams created by large woody debris. In many sections where large woody debris is uncommon, gravels are being quickly transported downstream through long sections of channel degraded to bedrock. The long-term trend (next 100 years) on these channels is for slow recovery to near reference condition as large woody debris increases and channels capture and retain more substrate.

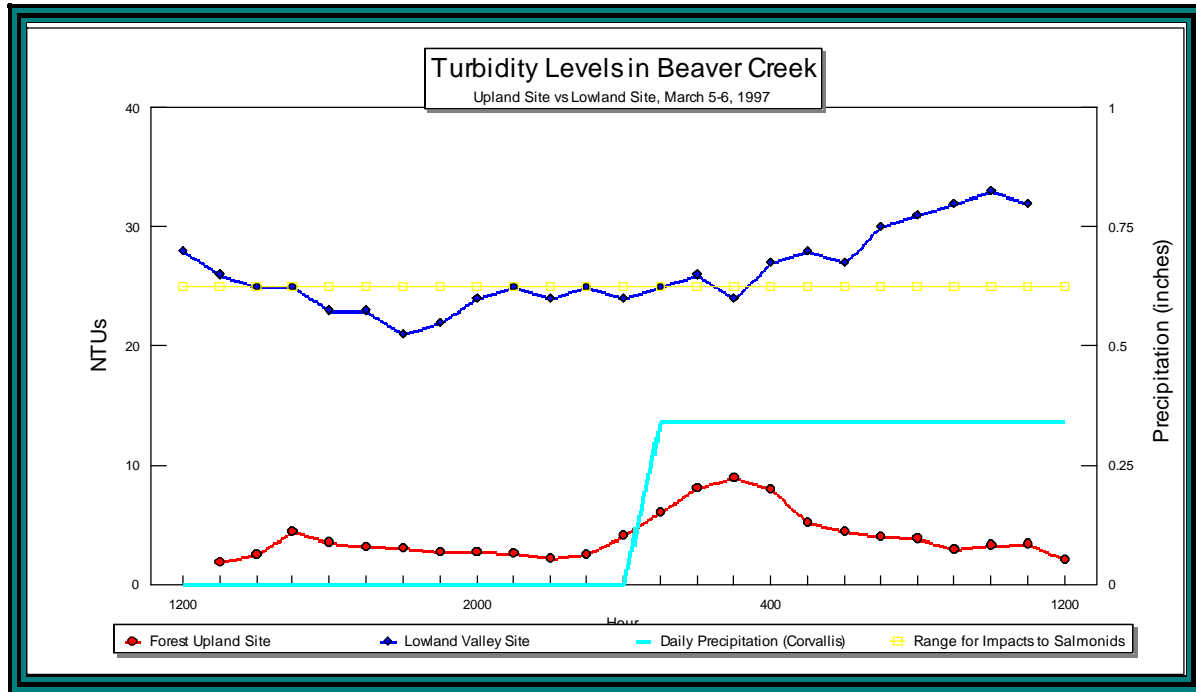
**Figure 6. Turbidity Levels in Beaver Creek**

Turbidity samples were collected during March 1997 at two sites on Beaver Creek: a lower site at the bridge crossing Beaver Creek on Bellfountain Road and an upper watershed site on a third order tributary to Beaver Creek that drains headwaters primarily managed by the BLM (Cheyenne Creek, T.13S., R.6W., Sections 17 and 19). This data is displayed in Figure 6.

These samples demonstrate the relationship of turbidity in forested uplands relative to lower agricultural areas generally observed on streams in the Benton Foothills. The Nephelometric Turbidity Units (NTU) levels at the forested site are within the range that has been measured at other forested sites in the Marys Peak Resource Area during winter base flow. The NTU levels at the lower site are an order of higher magnitude representing both the higher stream energy expected in a larger channel and the high concentrations of suspended sediment observed at this site. These levels of turbidity, if sustained over long periods during winter base flow, are high enough to impede anadromous fish survival. The consequences of high turbidity and the condition of other water quality parameters for the aquatic environment is discussed in the fisheries section of this analysis.
