In: Proceedings of 4th International bridge engineering conference; 1995 August 28–30; San Francisco, CA. Washington, DC: National Academy Press: 395-404; 1995. Vol. 2.

Crash-Tested Bridge Railings for Timber Bridges

Michael A. Ritter, *Forest Service, U.S. Department of Agriculture*
Ronald K. Faller, *University of Nebraska-Lincoln*
Sheila R. Duwadi, *Federal Highway Administration*

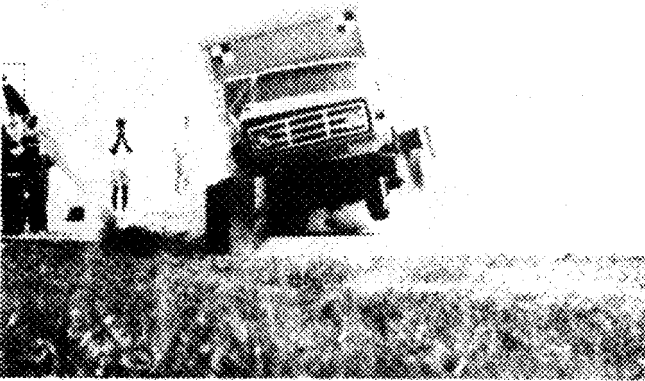
FIGURE 1 Crash-test sequence for 8172-kg (18,000-lb) truck traveling at 80.5 km/hr (50 mph), hitting railing at 15-degree angle to longitudinal railing axis.

Vehicle propulsion and guidance were provided by steel cable configurations. For propulsion, a reverse cable tow with a 1:2 mechanical advantage was used. A cable was attached to the front of the vehicle, routed through a series of pulleys, and connected to a tow vehicle that traveled in a direction opposite to the test vehicle. The unoccupied test vehicle was then pulled by the tow vehicle and released from the tow cable approximately 9.2 m (30 ft) before impact. A vehicle guidance system developed by Hinch was used to steer the test vehicle (9). Using this system, the left front wheel hub is attached to a tensioned steel cable that maintains the vehicle's direction along a designated straight path. Approximately 9.2 m (30 ft) from impact, the guidance connection is sheared off and the vehicle separates from the guidance cable. A crash-test sequence for an 8172-kg (18,000-lb) vehicle is shown in Figure 1.
