AN EVALUATION OF VERTICAL EXHAUST STACKS AND AGED PRODUCTION EMISSION CONTROL DEVICES TO PREVENT CARBON MONOXIDE POISONINGS FROM HOUSEBOAT GENERATOR EXHAUST

REPORT DATE:
October 2003

REPORT NO.:
EPHB 171-32a

Site Surveyed: Callville Bay Marina
Boulder City, Nevada

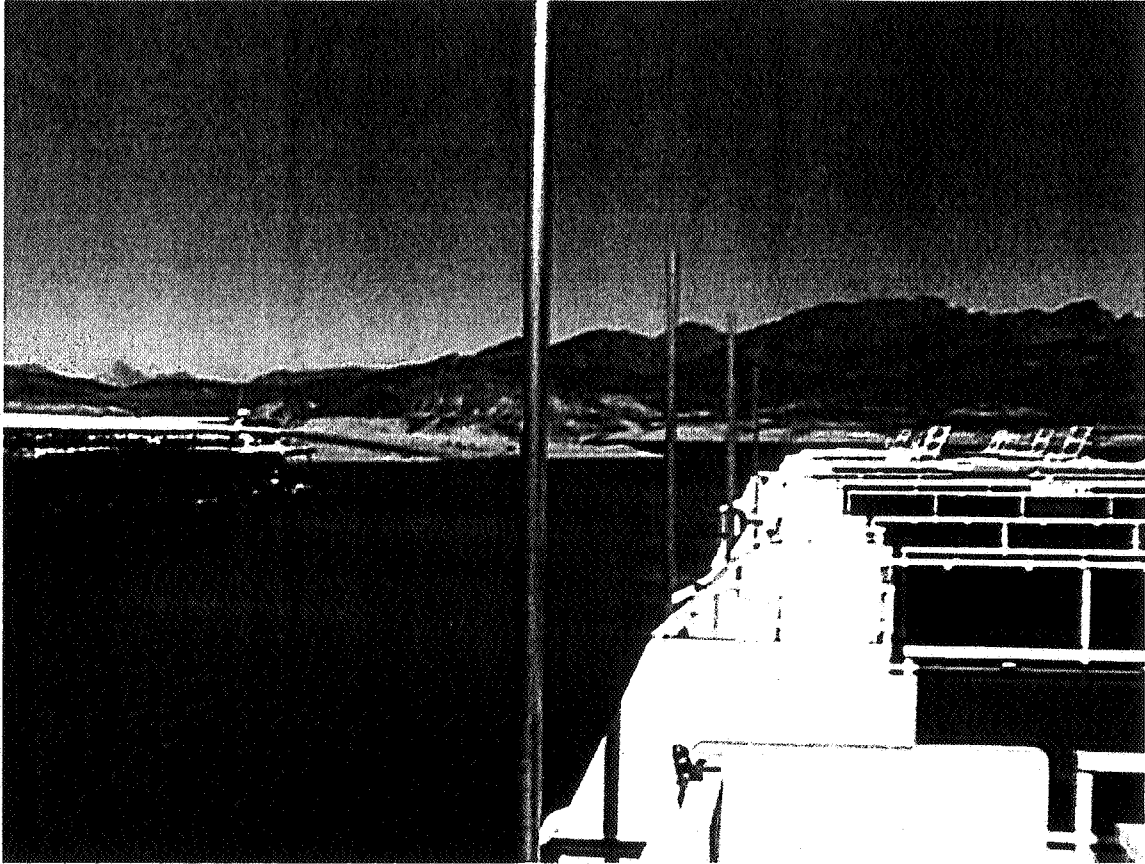
Figure 1. Vertical Exhaust Stacks on the Rear deck of the Forever Resort's Houseboat rental fleet.

Houseboat numbers 240, 185, and 228 each had a continuous, vertical exhaust stack retrofitted to their generator sets. The exhaust stacks were designed to comply with the revised American Boat and Yacht Council (ABYC) Standard P-1 for recreational boat exhaust. A 2-inch nominal, schedule 40 aluminum pipe, having an approximately 2.5-inch outside diameter and 2.0-inch inside diameter was used as the stack. On each houseboat, a portion of the stack extended through the boat's lower stern deck and was clamped to a high temperature exhaust hose. To allow the pipe to pass from beneath the lower swim deck to 9 feet above the upper deck, a hole was made in the lower stern port-side engine compartment and the stern port-side of the upper deck which the pipe passed through. The original lift muffler was removed, and a Combo-Sep® muffler/gas/water separator (Centek Industries, Thomasville, GA) was installed to separate the exhaust gases from the water using gravity and centrifugal force.

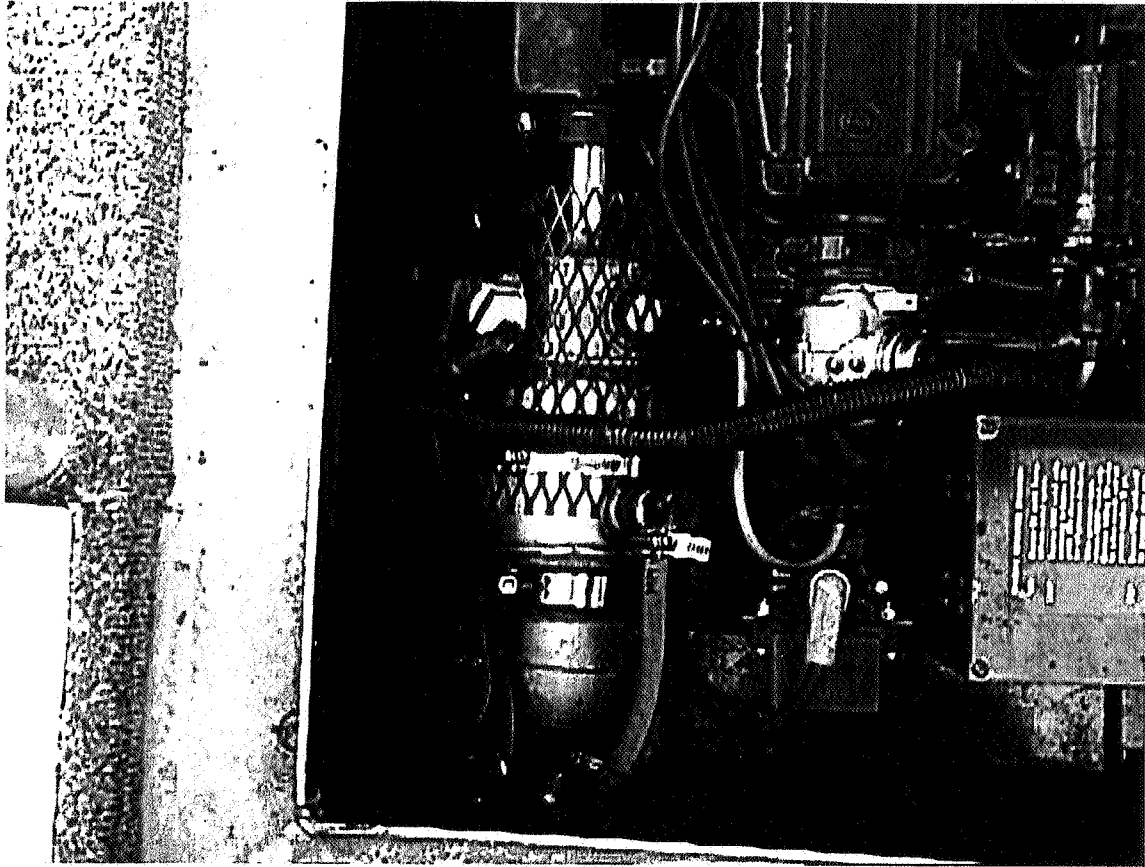
Figure 2. Production ECD with heat shield attached to Westerbeke generator. Note that this ECD has a thermocouple installed to shut off the generator if the temperatures gets too high.

On all of the units that failed, none had a high temperature shut-off safety switch. They were early production units that the owners did not want the Generator shutting down while being rented. A thermal safety switch has been installed on approximately 80 newer ECDs. This switch shuts down the generator if the temperature exceeds 500 °F, but is not designed to indicate that high CO concentrations are present. According to Enviromarine, the surface temperature on the ECD casing should be between 180 °F and 280 °F.

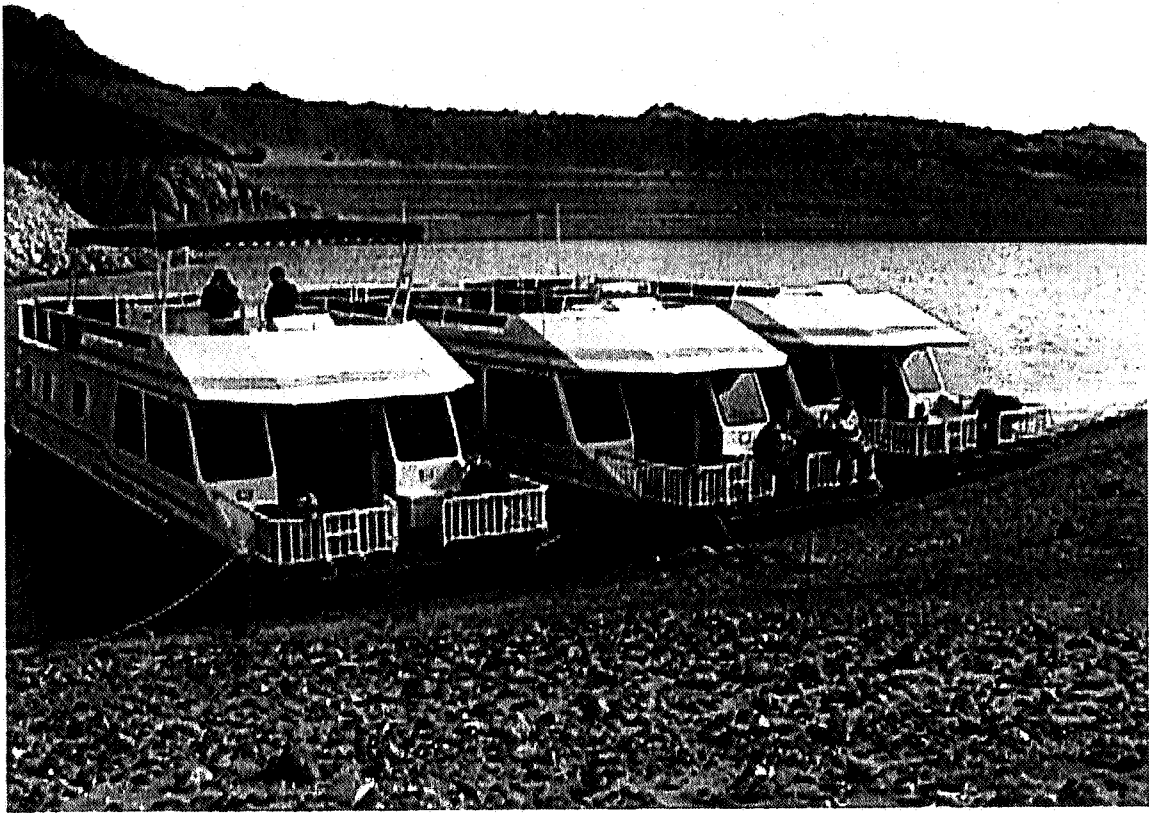
Figure 3. Three houseboats tied together and beached during vertical exhaust stack testing.

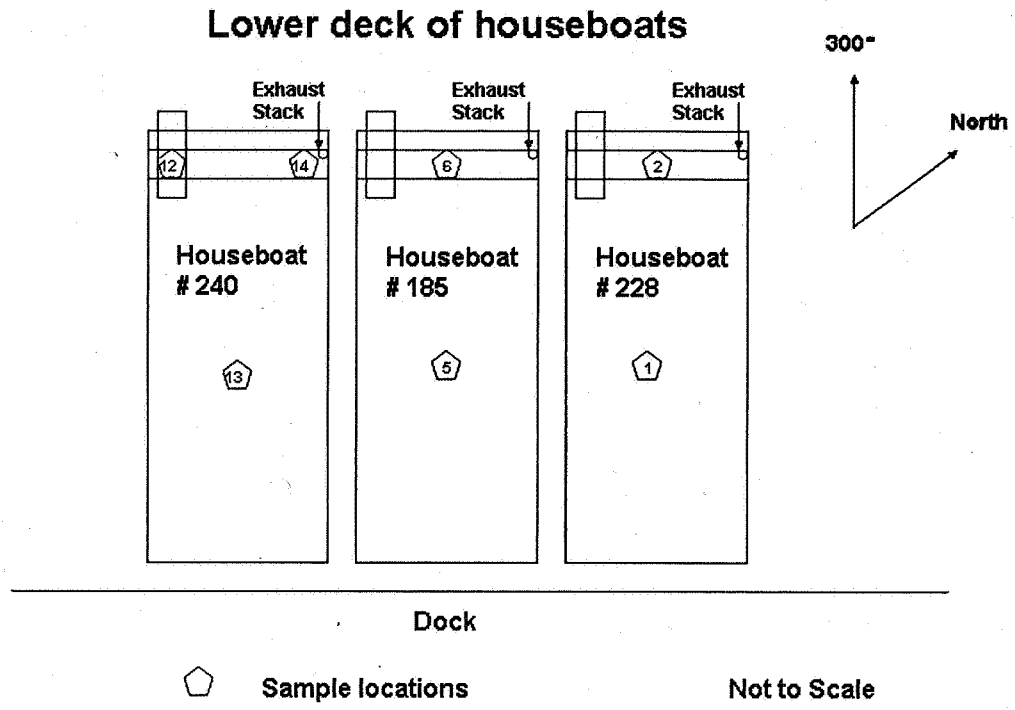
Figure 4. Sampling locations on boats evaluated Monday afternoon (Lower deck)

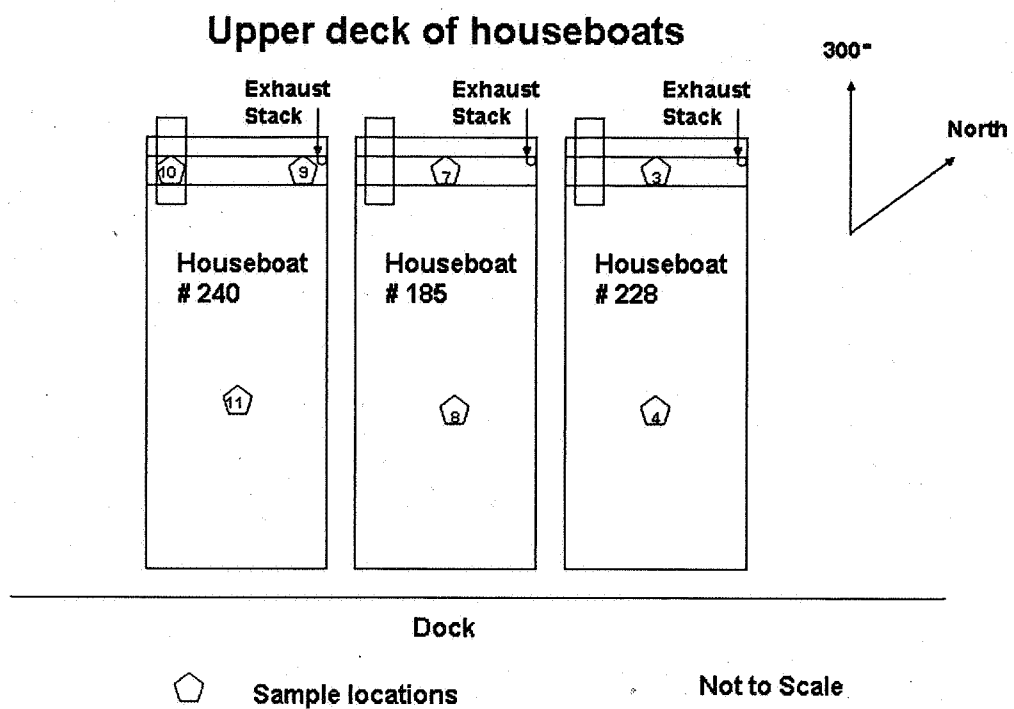
Figure 5. Sampling locations on boats evaluated Monday afternoon (Upper deck)

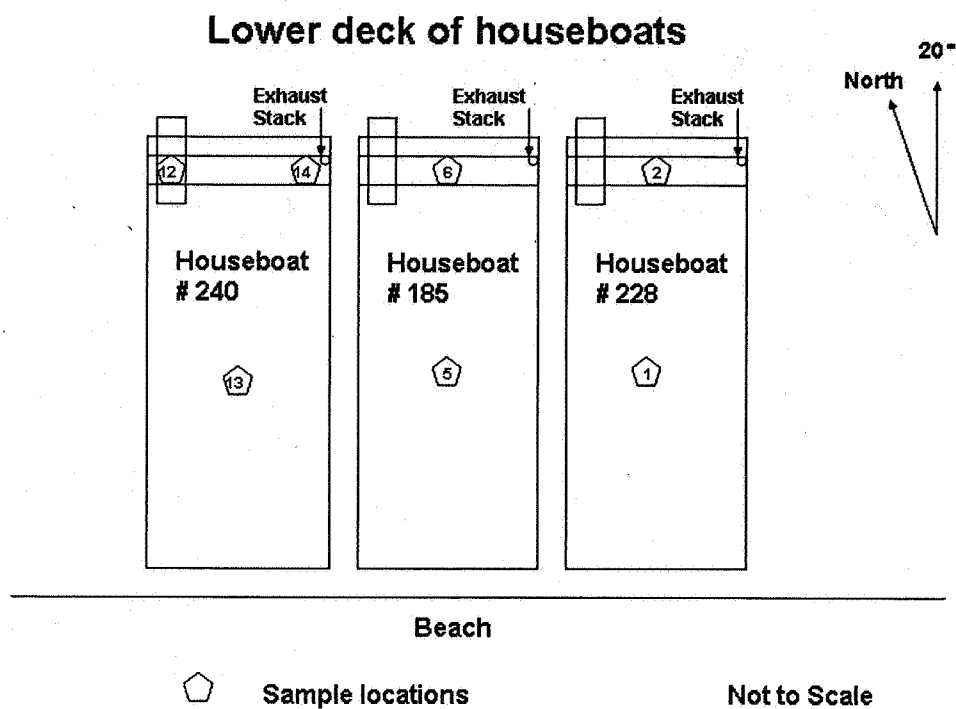
Figure 6. Sampling locations on boats evaluated Tuesday afternoon (Lower deck)

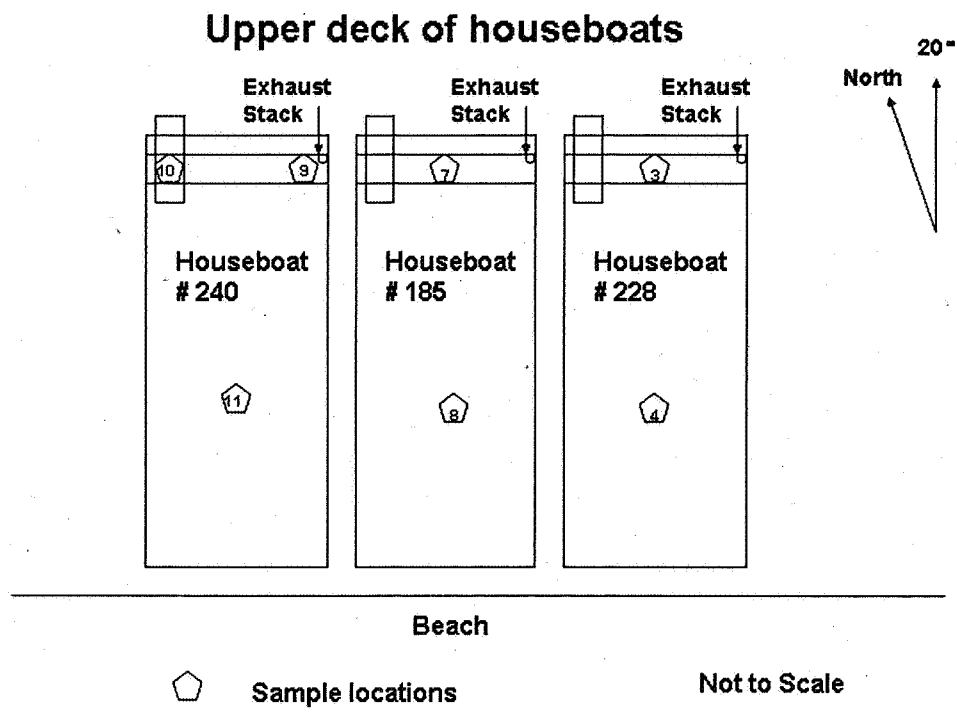
Figure 7. Sampling locations on boats evaluated Tuesday afternoon (Upper deck)

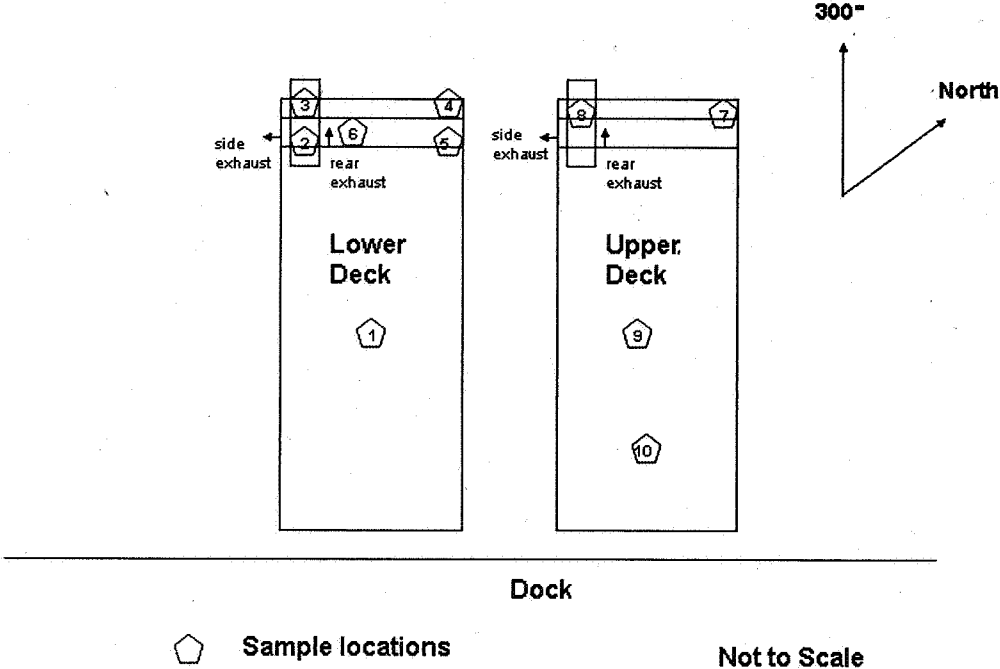
Sampling locations for ECD testing of houseboat #22 and # 340

Figure 8. Sampling locations on boats #22 and #340 evaluated with ECD

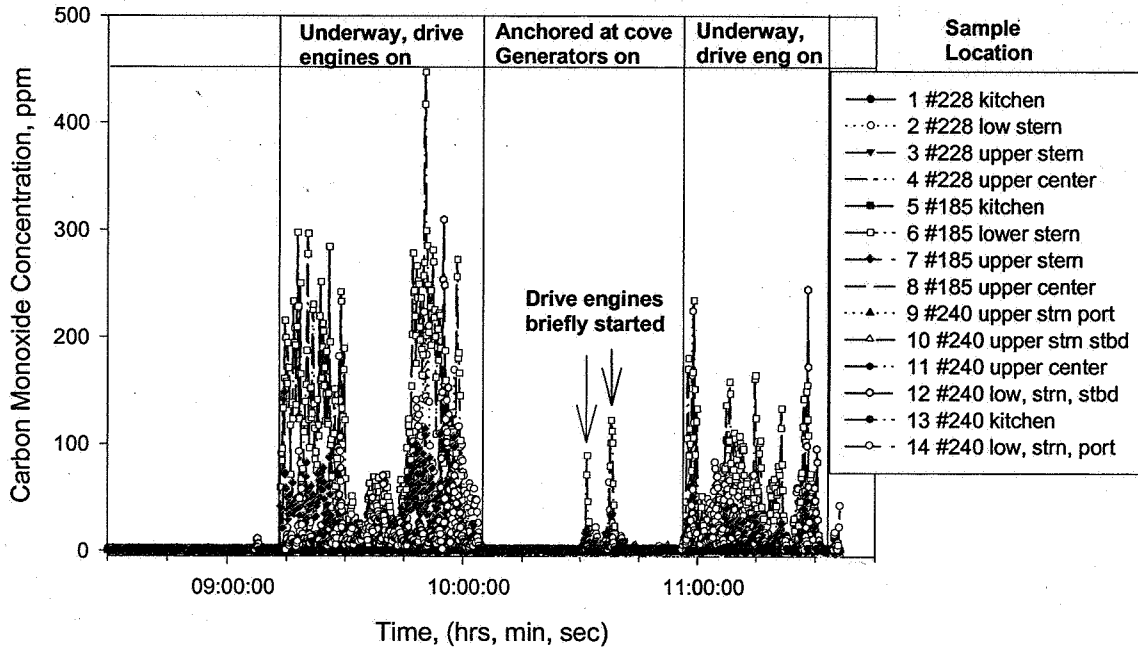
Three Houseboats underway and Rafted together, stationary

CO concentrations for the three rafted houseboats are shown in Tables I through IV and in Figure 9. Figure 9 shows three different conditions:

Figure 9. Comparison of CO concentrations with 3 houseboats with vertical exhaust stacks underway and 3 houseboats tied together and stationary. (Tues. aft. 10/1)

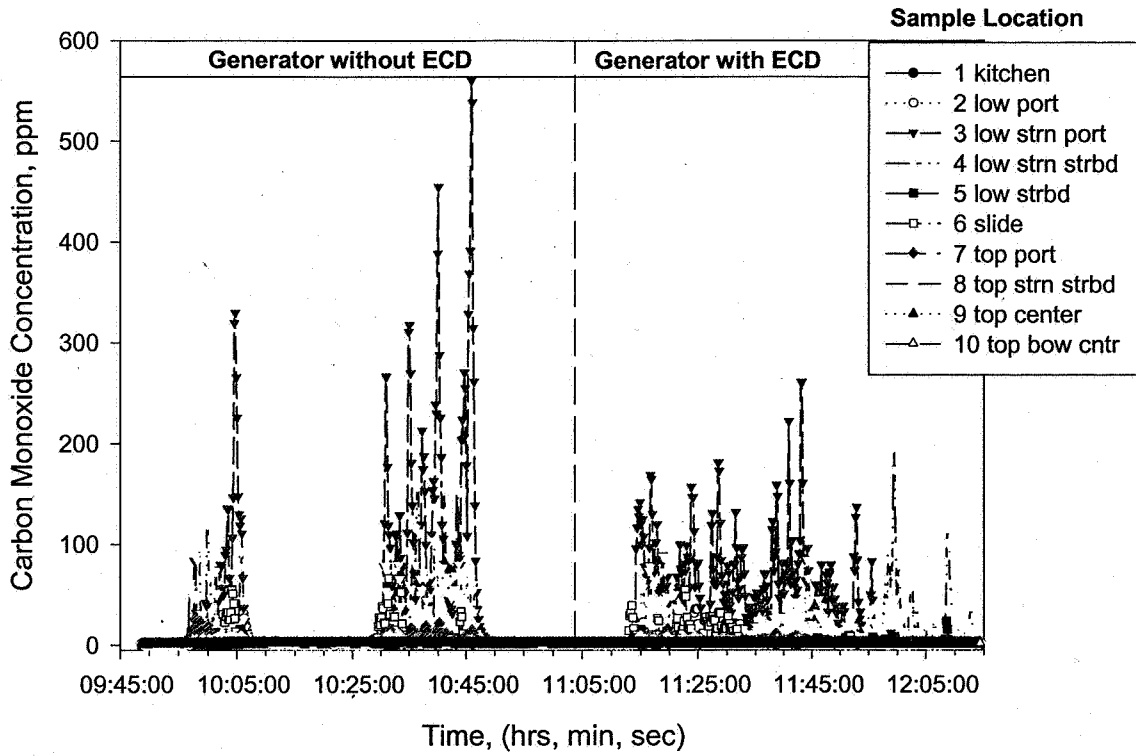
Wednesday, (10/2/02) Lake Mead Data

Results from the ECD evaluation raised several concerns. Performance of the ECD dramatically degraded compared to previous evaluations when the ECD was new. Mean CO concentrations of approximately 44 ppm were measured on the lower, stern deck of houseboat 22, and a peak CO concentration of 260 ppm was measured exceeding the NIOSH ceiling level. On houseboat 340 a mean CO concentration of 70 ppm was measured on the lower stern deck and a peak of 563 ppm was measured. These high concentrations exceeded acceptable levels and present a potential health hazard.

Figure 10. CO sampling on houseboat #22 showing degradation in the ECD's performance (Wed, 10/2).

- 3) The performance of the emission control device (ECD) during the current evaluation has raised several important issues concerning long-term performance. Due to the complications observed, including degradation in CO removal efficiency and reported high-temperature failures, additional testing of this device is necessary.

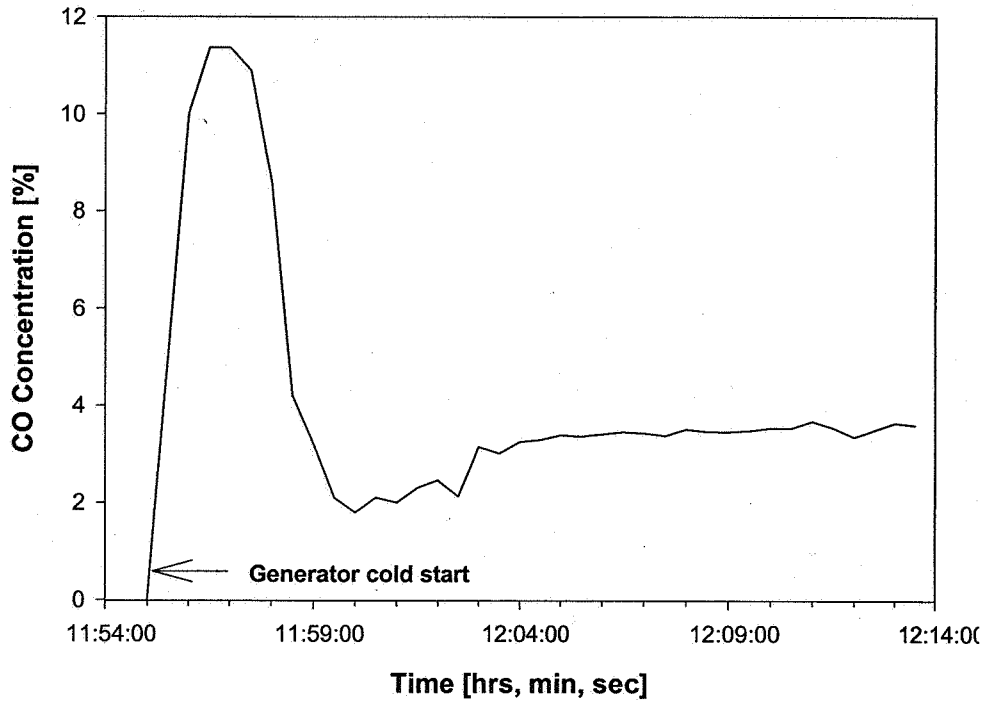
Houseboat #22
Generator cold started with ECD
Measurement in Exhaust Stack
10/3/03

Figure 12. Cold-start data on Houseboat 22 with ECD.

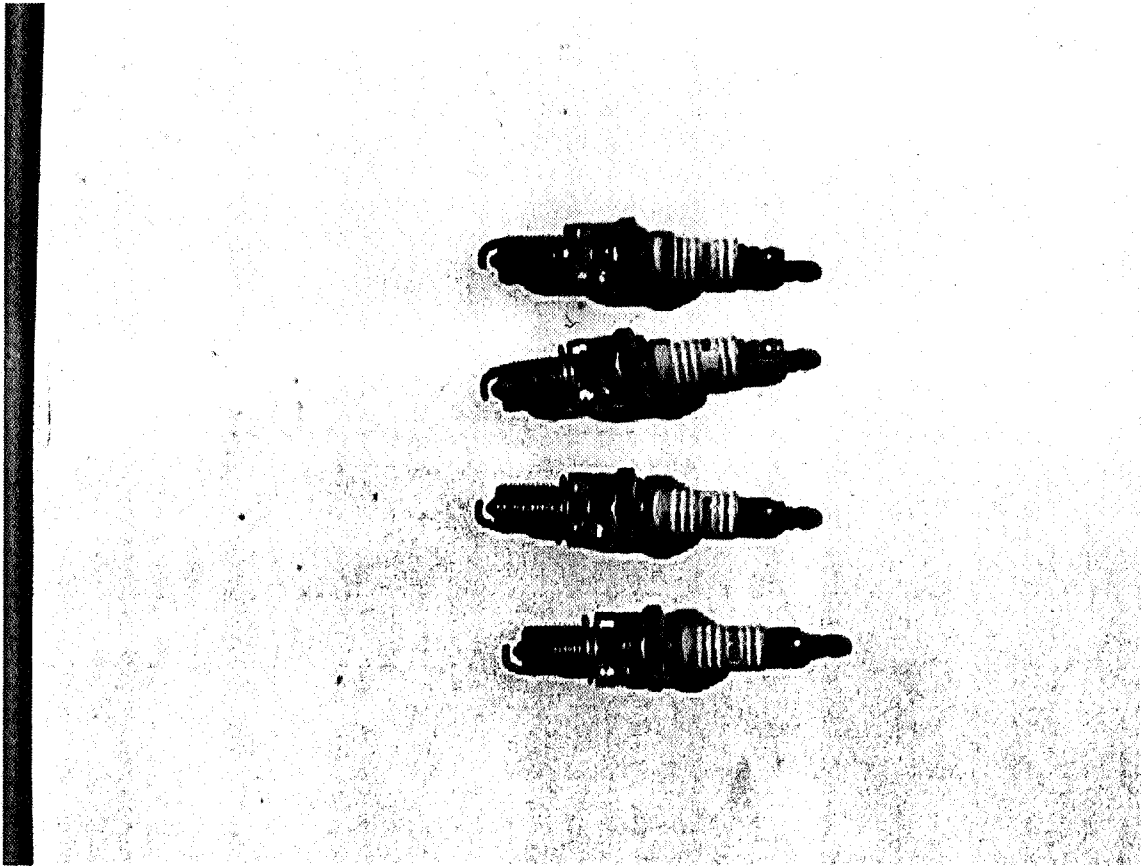
ECD performance is related to generator operation and maintenance. Generators can run inefficiently, due to fouled spark plugs, bad ignition wires, defective carburetors, or malfunctioning chokes. Poor operation can cause the CO and hydrocarbon concentration to increase, and the electronic spark inside of the ECD can ignite unburned fuel in the catalyst. Over time (sometimes a few hours) this event can dramatically degrade performance or even destroy the ECD. An examination of the existing generator, spark plugs, and exhaust elbows showed that the spark plugs were badly fouled and there was significant blockage in an exhaust elbow that could have caused the poor ECD performance that was observed (Figures 13 and 14).

Figure 13. Badly Fouled spark plugs on houseboat generator using the ECD

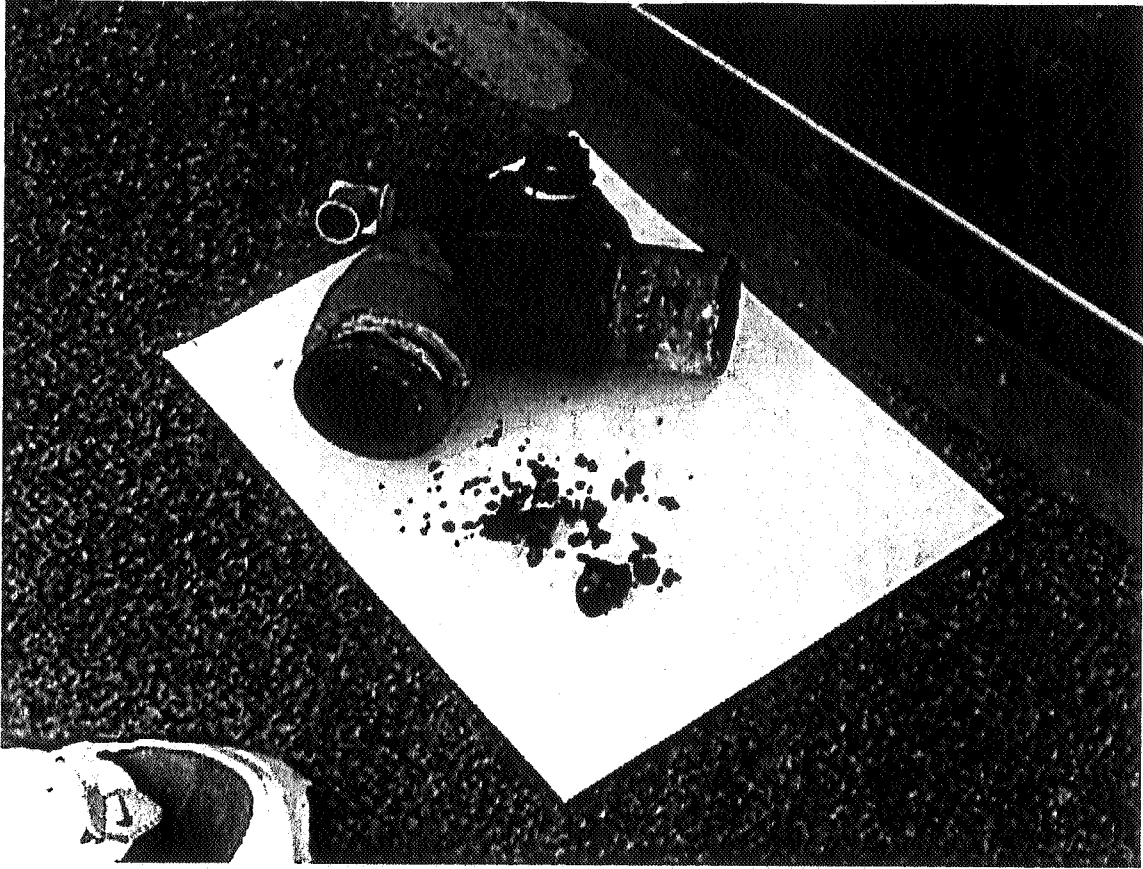
Figure 14. Carbon deposits found in the mixing elbow of the generator and ECD exhaust.
