# It Happened...

## Best Practices Fire Protection

Card No. BFP-15

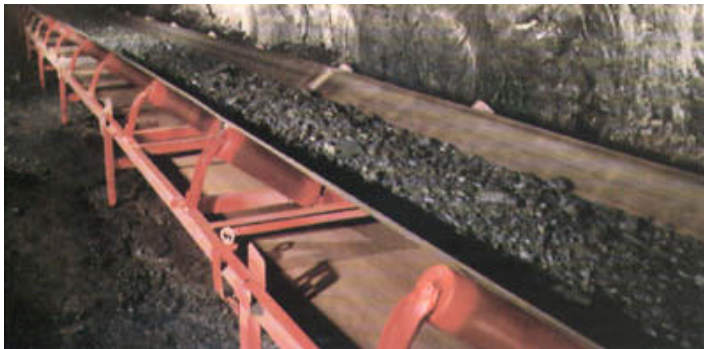
*Example of a typical belt conveyor*

*BELT CONVEYORS require constant maintenance and monitoring. Belt slippage tests could be designed with a handle or small hydraulic jack that permits the examiner to physically raise the belt off of a roller in order to simulate belt slippage and test for conveyor sequencing.*

- **ALWAYS** replace worn or damaged idlers on a conveyor line as soon as possible.
- **ALWAYS** investigate the smell of burning rubber coming from a conveyor line.
- **ALWAYS** remove accumulations of float dust from conveyor lines and make certain of adequate rock dusting.
- **ALWAYS** plainly mark locations of fire taps along conveyor lines.
- **ALWAYS** make certain that threads on fire taps along conveyor lines are covered and clean.
- **ALWAYS** make certain that fire hose provided along conveyor lines is properly stored in containers.
- **NEVER** take fire hose from conveyor lines to use for purposes other than fire fighting.
