The Official Newspaper of San Francisco Maritime National Historical Park April, May, June 2006

Museum Headed to Drydock

The Official Newspaper of San Francisco Maritime National Historical Park September, October, November 2008

Restored 1939 Bathhouse Building Sparkles Again

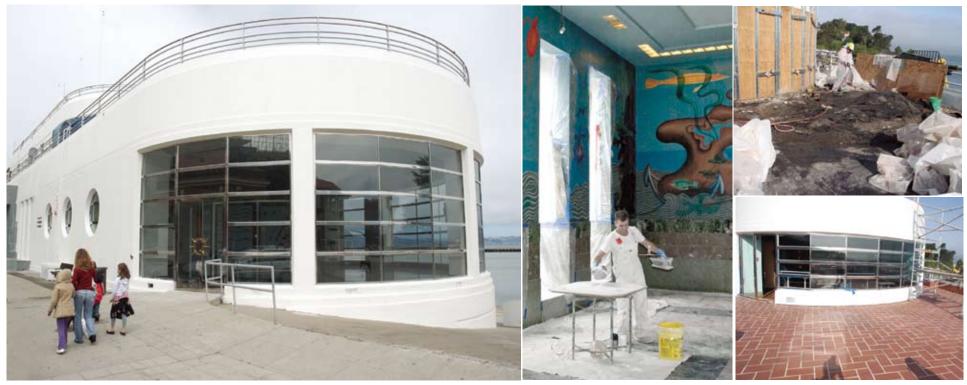
Over time, the roof tiles cracked and separated, and the red slate was buried under layers of sealant and tar applied to stem the leaks. Although somewhat effective, this treatment obscured an integral element of the building's character. Contractors had to jackhammer the fused tiles/sealant out chunk by chunk -- it may have been the City's only rooftop excavation! (Photos above far right.)

held tools. They are all unique constructions, handmade on-site to fit into their own particular openings. Unfortunately, in today's templated and pre-cut world, this made them extremely difficult to duplicate and install. But it is a part of the building that was designed to be seen and appreciated, and we could do no less than retain the architect's original vision. (Photo above left.)

Restoration of the lobby murals continues, and in future projects conservators will treat the green slate entranceway and the building's many terrazzo floors. (Photo above middle)

Phase one of the Aquatic Park Bathhouse/Amphitheater rehabilitation began in May 2006, when the Museum was closed to relocate the collections and exhibits. The construction work began in October, and first addressed the building's roof, waterproofing and drainage, and window systems. With that phase now complete, it is a good time to review what has been accomplished.

Although the building itself is rather sturdy, the original roof system was actually quite fragile. Consisting of nearly 18,000 red slate tiles, it was designed to drain down through the building itself, using open pipes that ran precariously between ceilings and walls, and clogged frequently over the years – spilling rainwater into some interior spaces.
