## Appendix BB

Sago Mine MSHA ID 46-08791

Wolf Run Mining Company

Sago Mine in relation to recorded locations of lightning strikes, a lightning-damaged poplar tree, and the mine's phone and power lines.

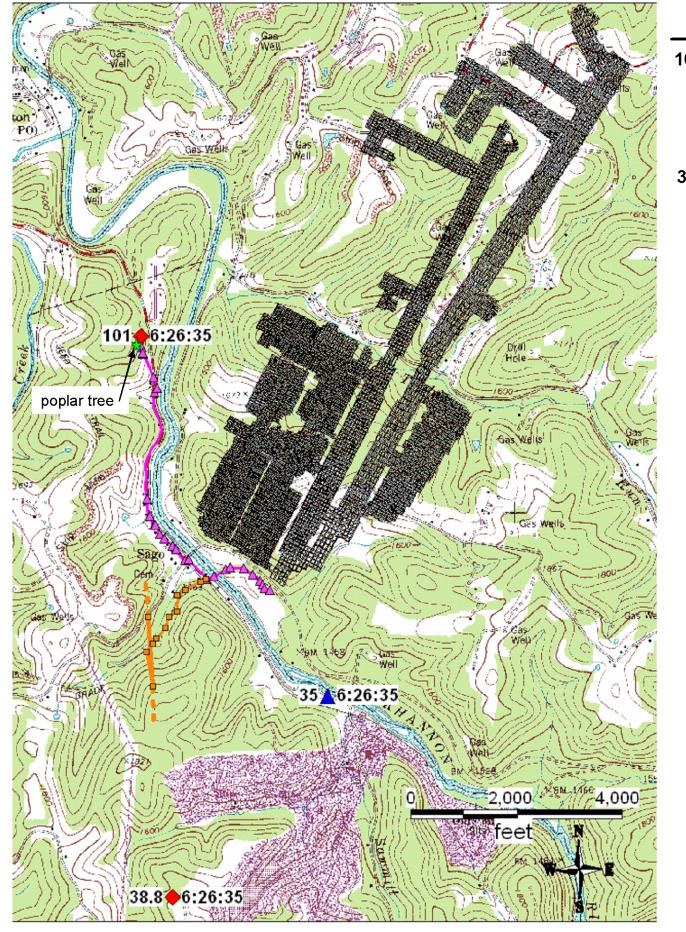
Location of lightning strike reported by Vaisala's National Lightning Detection Network (NLDN). Number to left of symbol represents the peak current in kilo-amps; number to right of symbol represents the time that the peak current was recorded.

Location of lightning strike reported by Weather Decision Technologies, Inc.'s U.S. Precision Lightning Network (USPLN). Number to left of symbol represents the peak current in kilo-amps; number to right of symbol represents the time that the peak current was recorded.

Sago Mine workings.

Locations of power line poles, with trace of power line (dashed where main line is projected).

Locations of telephone poles and junction boxes, with trace of phone line.

Location of large poplar tree shattered by lightning.
