U.S. Department of Labor

April 19, 2007

Executive Summary of Investigation of Pyott-Boone Electronics
MineBoss Monitoring and Control System

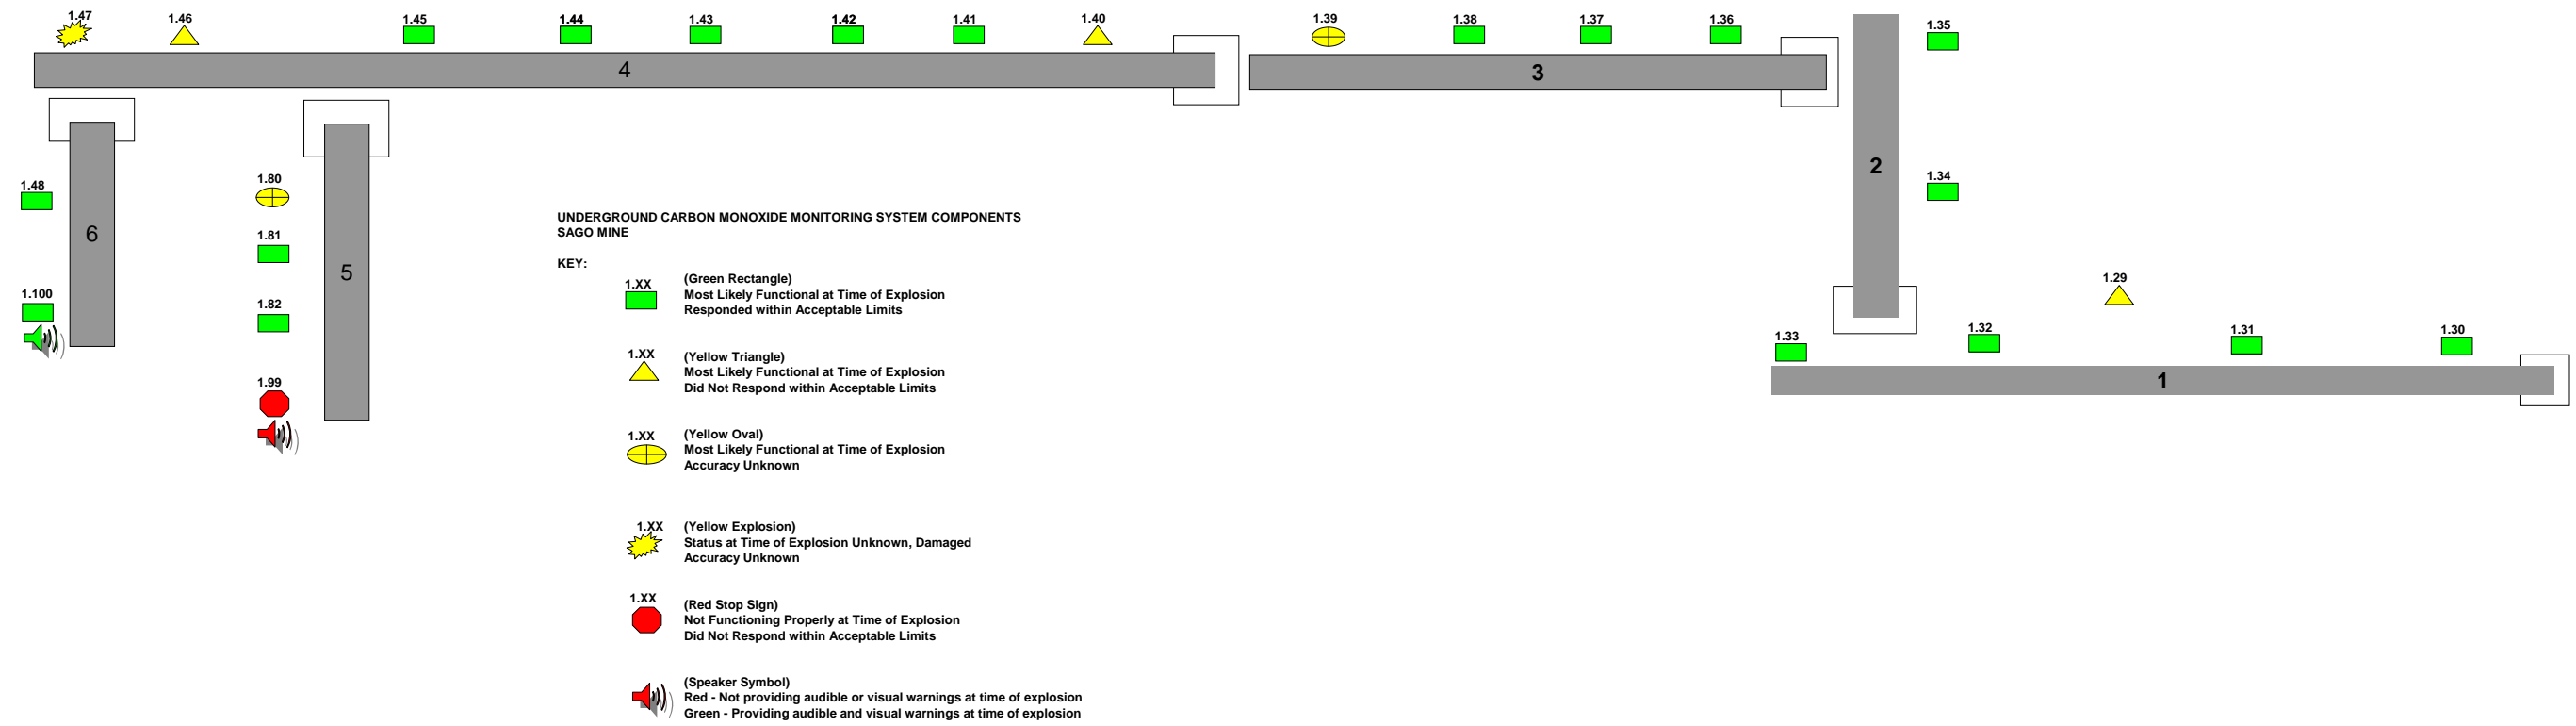
The following are the significant findings of the investigation. Following these items is an approximate reproduction of the map of the underground components of the CO monitoring system, with graphical reproduction of each device.
