**Arsenic Removal from Drinking Water by Adsorptive Media
U.S. EPA Demonstration Project at Taos, NM
Final Performance Evaluation Report**

**Battelle
Columbus, OH 43201-2693**

**Contract No. 68-C-00-185
Task Order No. 0029**

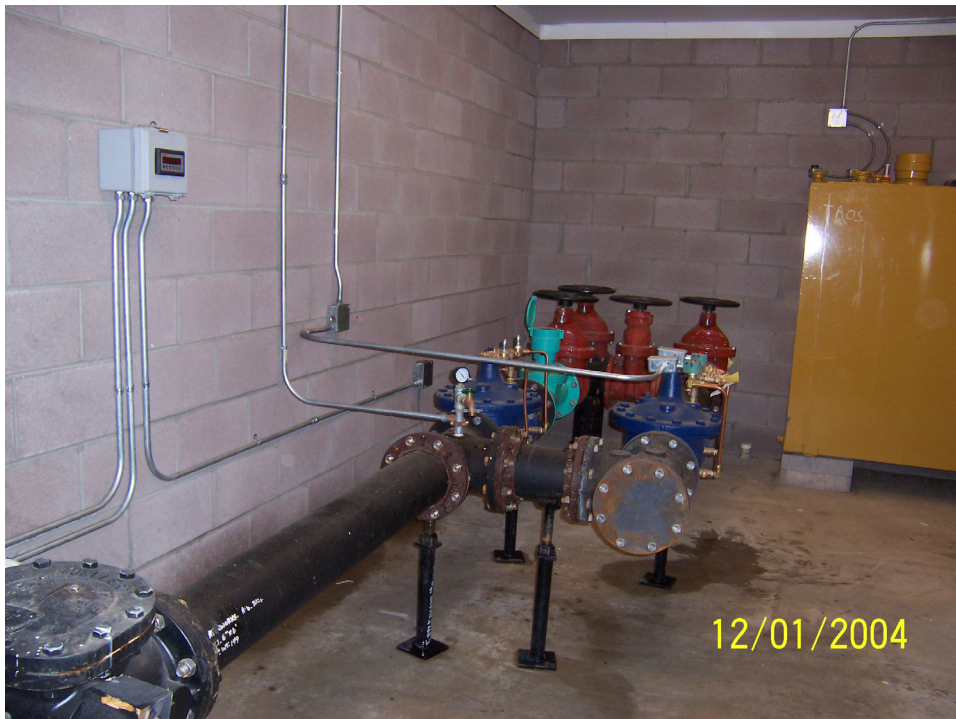
Figure 4-2. Inside of Well 8 Pump House

Located approximately 20 ft from the wellhead, the Well 8 pump house (Figure 4-2) housed all relevant piping and instrumentation, including one control panel, one hour meter, two electric meters, two pressure gauges, one flow totalizer/meter, and one raw water sample tap. When Well 8 was activated at the pump house, water was initially purged into a holding pond (Figure 4-3) for 5 min before being directed to the treatment building (or booster pump station). The treatment building, as originally designed, was used to house an infiltration gallery system comprising of a 10-ft-diameter by 6-ft-tall steel filtration vessel (Figure 4-4), a MIOX injection system, and two booster pumps. The steel filtration vessel, however, was never used and it was removed to make room for the arsenic removal system. Modifications to the treatment building, as discussed in Section 4.3, included a concrete pad, an overhead door, and piping and electrical connections (Figure 4-5).

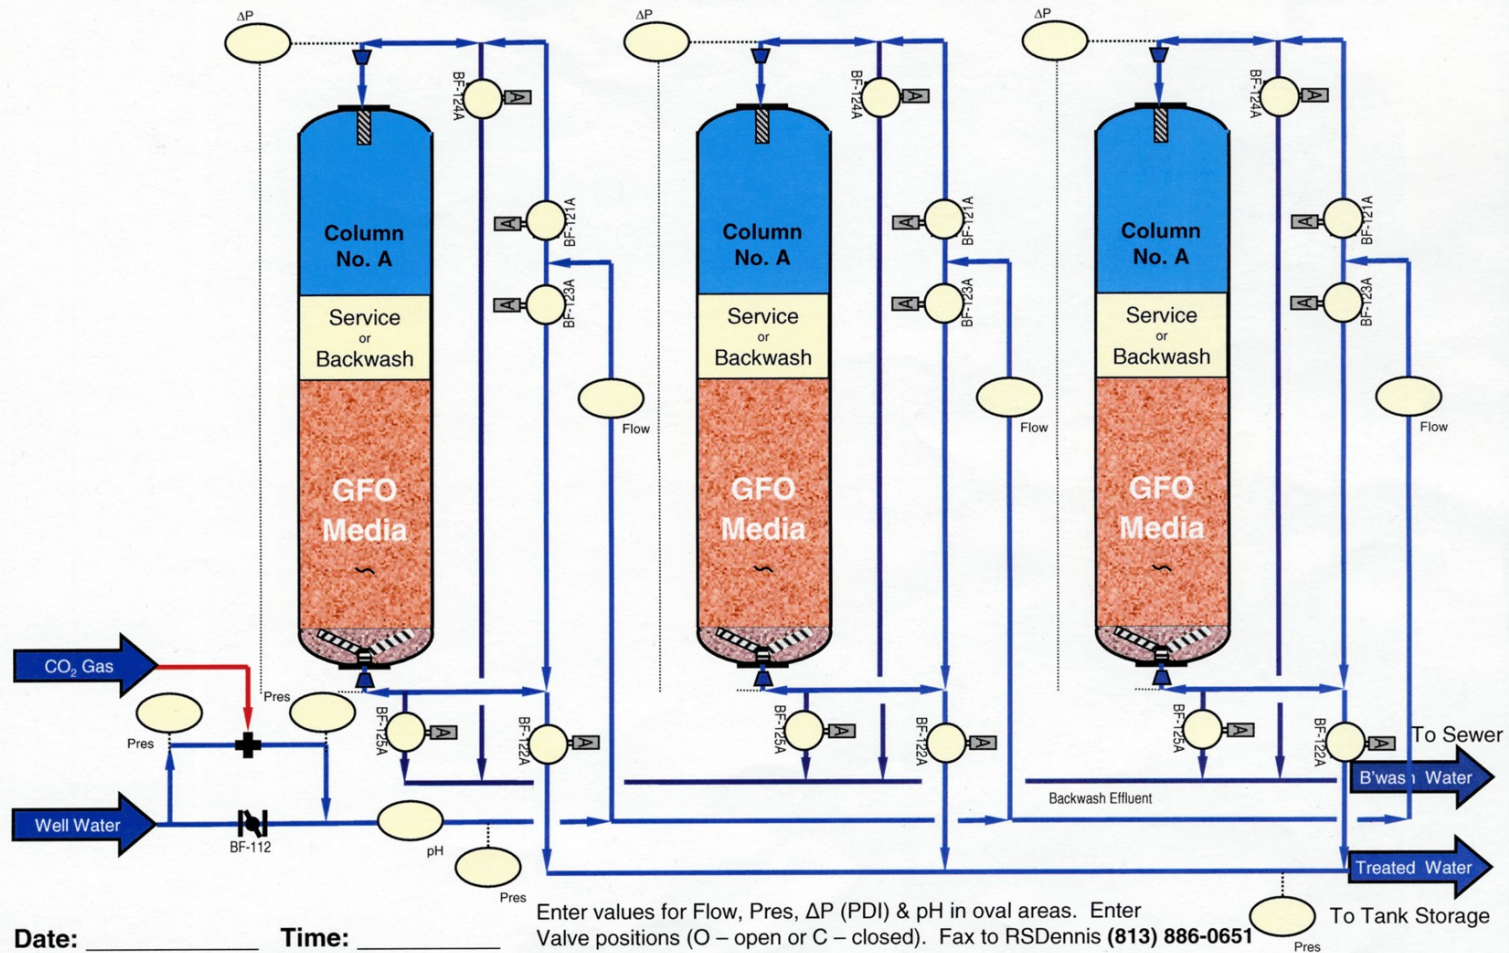
Figure 4-9. Schematic of STS's APU-450 Arsenic Removal System

- **Intake.** Raw water was pumped from Well 8 and transported to the treatment plant building via a 0.8-mile-long, 10-in-diameter HDPE pipeline. Water entered the building via a 6-in-diameter Schedule 80 PVC pipe to the tie-in point, where the inlet piping was connected to the system through a 6-in-diameter schedule 80 PVC pipe.

- **Adsorption.** The APU-450 system consisted of three 63-in × 86-in vessels, designed to hold 60 ft³ of pelletized SORB 33TM media supported by a gravel underbed. The skid-mounted vessels were made of fiberglass reinforced plastic (FRP), rated for 150 psi working pressure, and piped to a valve rack mounted on a polyurethane-coated, welded frame. According to the original system design with a flowrate of 450 gpm, the empty bed contact time (EBCT) for each vessel and the system was 3.0 min and the hydraulic loading was 6.9 gpm/ft².

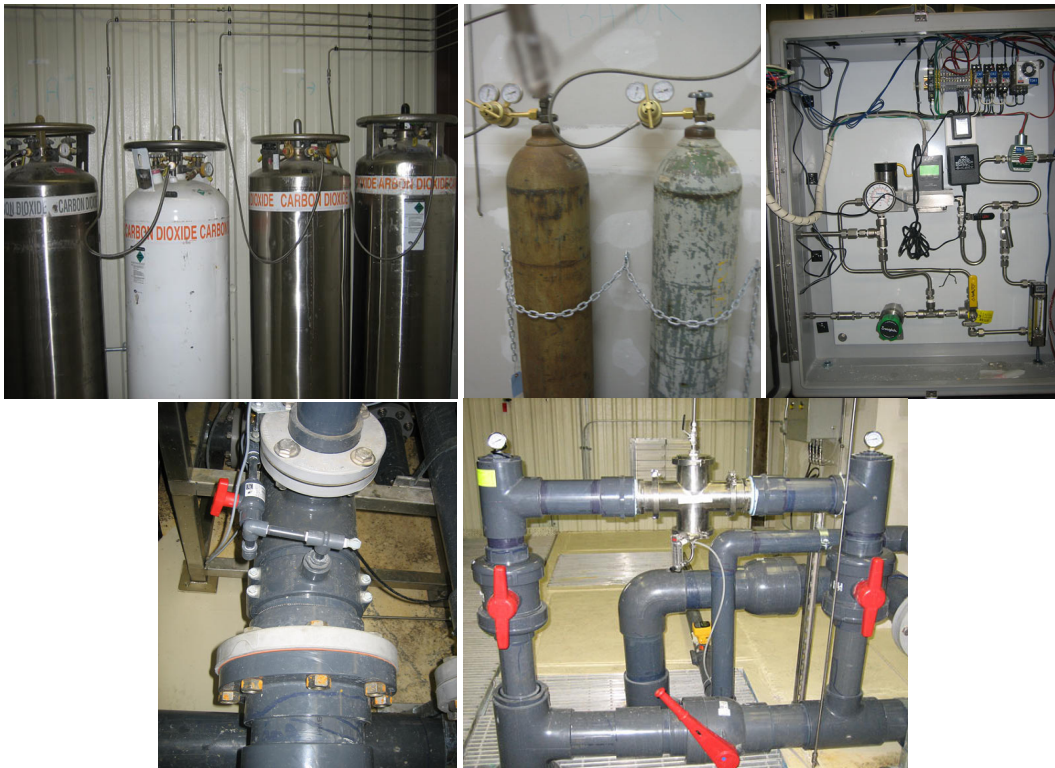
Figure 4-12. Carbon Dioxide Gas Flow Control System for pH Adjustment
(Clockwise from Top Left: CO₂ Supply Assembly with Four 380-lb Dewars and Two 50-lb Cylinders; pH Control Panel; Sanitary Cross and CO₂ Loop; and Port for pH Probe)

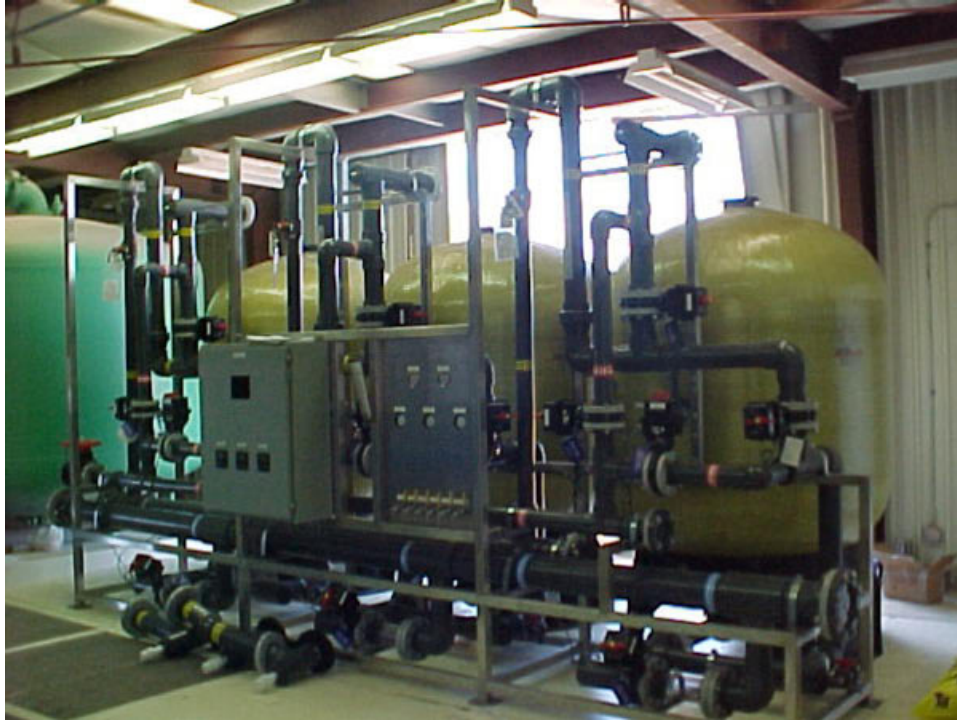
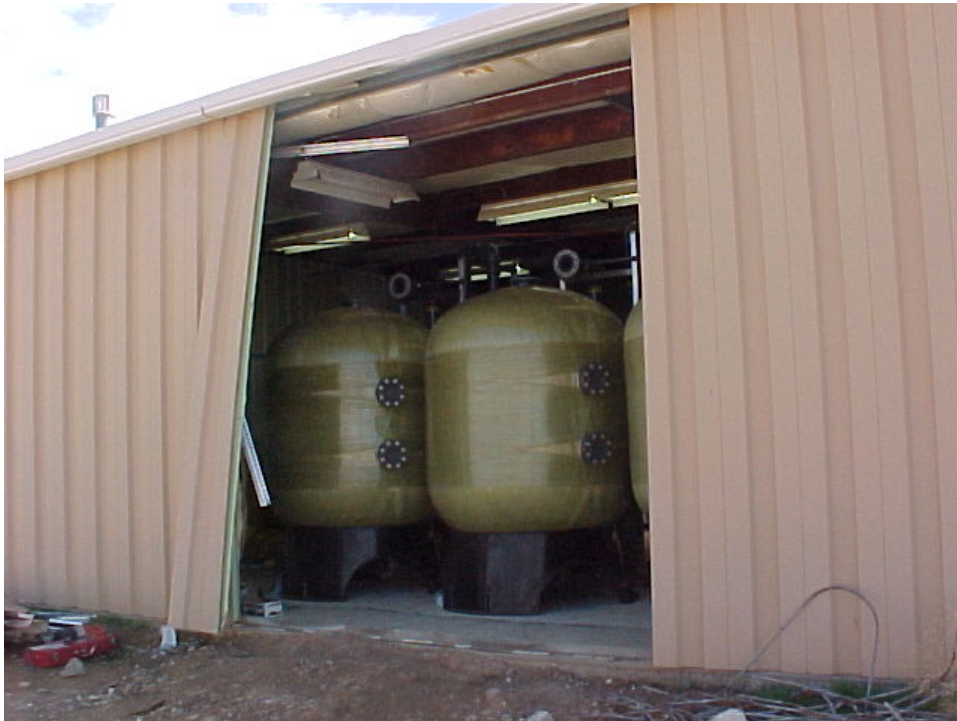
Figure 4-15. Removal of Treatment Building Side Wall Panel for APU-450 System Off-loading

4.3.2 Building Construction. The steel filtration vessel in the existing treatment building was removed to make room for the arsenic removal system. The building was then modified to include a concrete pad and piping and electrical connections (Figure 4-14). The metal side wall panel was temporarily removed to allow for off-loading of the APU-450 arsenic treatment system into the treatment building (Figure 4-15).

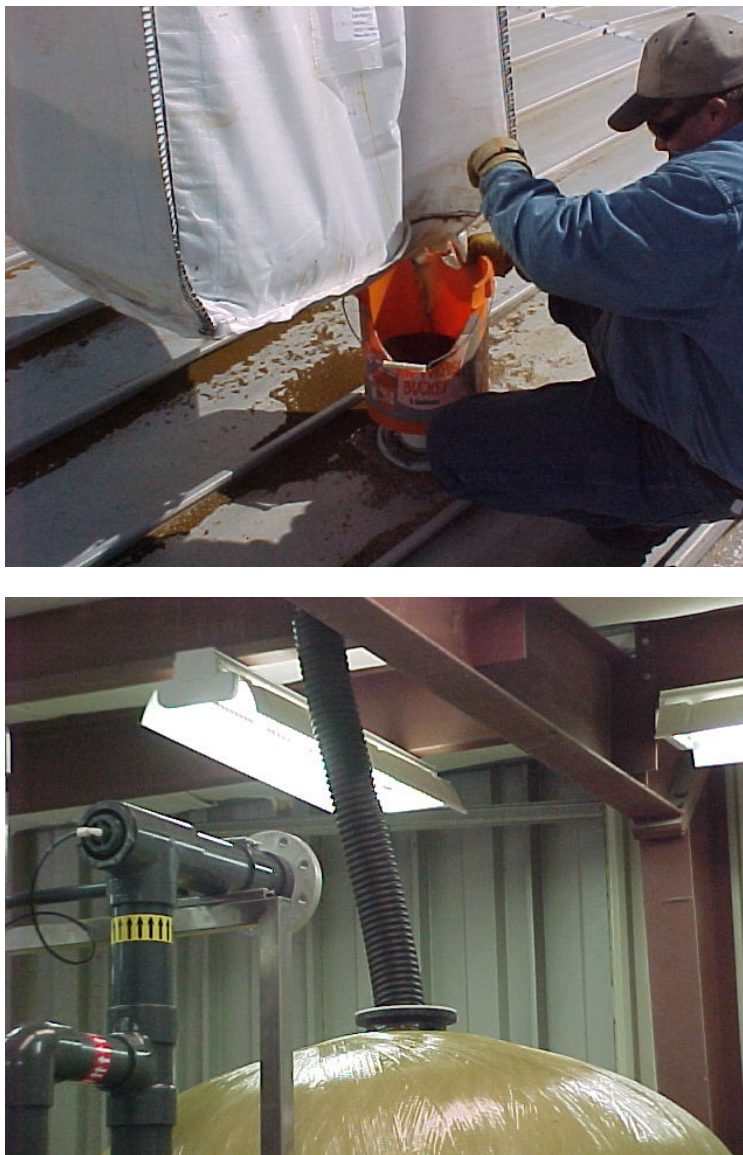
Figure 4-17. Media Loading

4.3.5 Media Loading. Media loading was performed by STS on October 17, 2006. The media in super sacks was hoisted to the top of the canopy using a boom truck and loaded through a 12-in × 4-in rigid funnel connected to the top nozzle by a roof hatch and a 6-in PVC pipe into the adsorption vessel partially filled with water (Figure 4-17). A garden hose was used to completely submerge the media, which was allowed to soak for about 4 hr. The top hat distributor with the new sealant was then reconnected to the top piping. STS was onsite on November 1, 2005, to backwash the vessels. However, a leak was discovered for Vessel C and the media in that vessel had to be removed via vacuum and captured into two super sacks. Based on tests conducted by STS's technical center, a 0.85 mm screen recovered 781.6 gm of wetted media compared to 786.4 gm of wetted media that was vacuumed. After the new Vessel C was installed on November 29, 2005, STS re-loaded the gravel and media. The vessels were backwashed on December 7, 2005, with flowrates ranging from 200 to 210 gpm for approximately 30 min. The freeboard heights along with the calculated media volumes in the vessels are summarized in Table 4-8.

Before backwash, freeboard measurements taken from the top of the underbedding gravel to the top of the nozzle head were 66, 65, and 66 in for Vessels A, B, and C, respectively. Freeboard measurements taken from the top of each media bed to the top of the nozzle head were 28, 29, and 28 in for Vessels A, B, and C, respectively. Therefore, the bed depths for Vessels A, B, and C were 38, 36, and 38 in, equivalent to 68.4, 64.8, and 68.4 ft³ of media, respectively, in the vessels. The freeboard measurements after backwash were taken again, with the total media volume increasing slightly from 202 ft³ to 216 ft³. In general, free board heights measured after backwash are more accurate because the surface of the media beds is more even after backwash. However, some bed compaction is expected once the media beds are put into service under pressure. For the purpose of this study, the media volumes obtained after backwash were used for all bed volume calculations. (Note that the total amount of media calculated from the freeboard measurements after backwash was 20% more than that used for the system design, but only 3.3% more than that shipped to the site in super sacks).

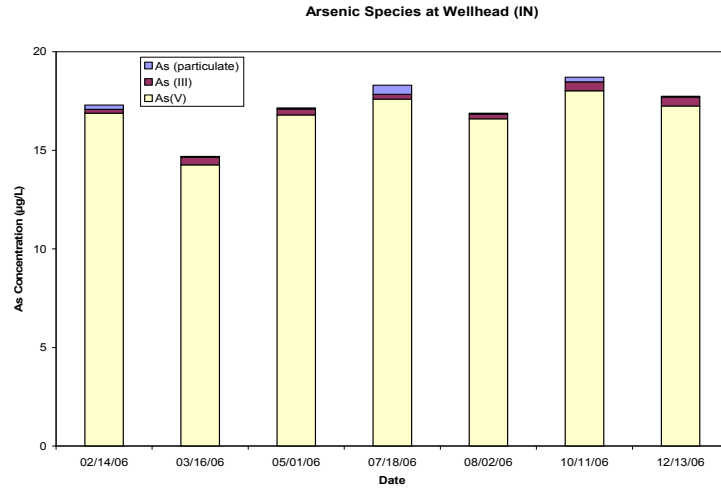
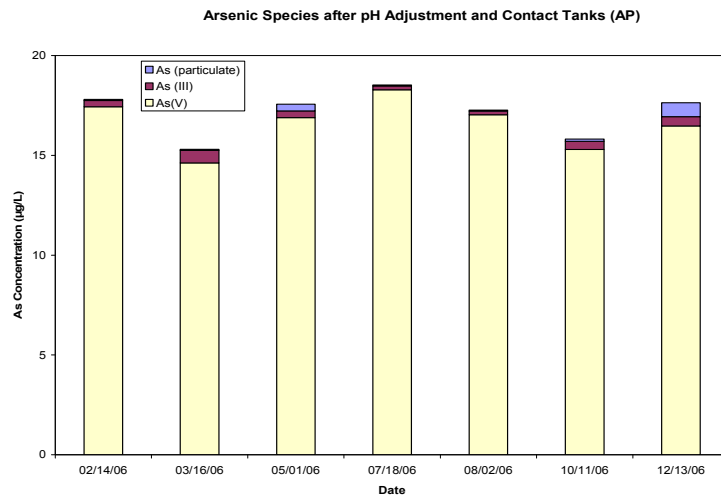
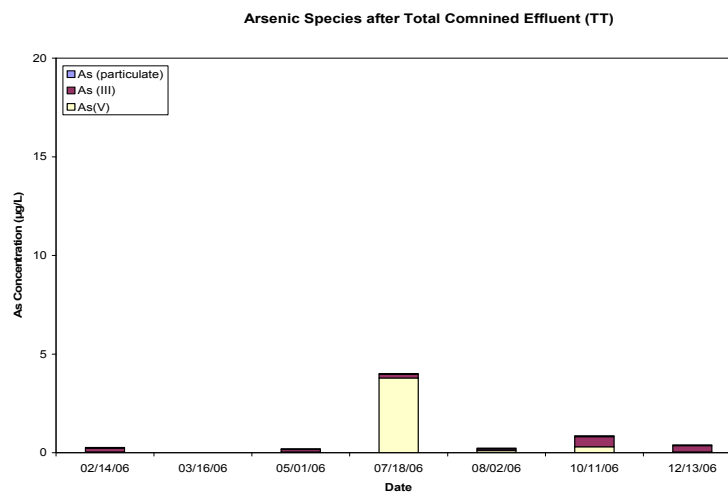
Figure 4-19. Concentrations of Various Arsenic Species at IN, AP, and TT Sampling Locations
