Old Inger Oil Refinery
Ascension Parish, Louisiana
March 2002
(after completion of Bioremediation)

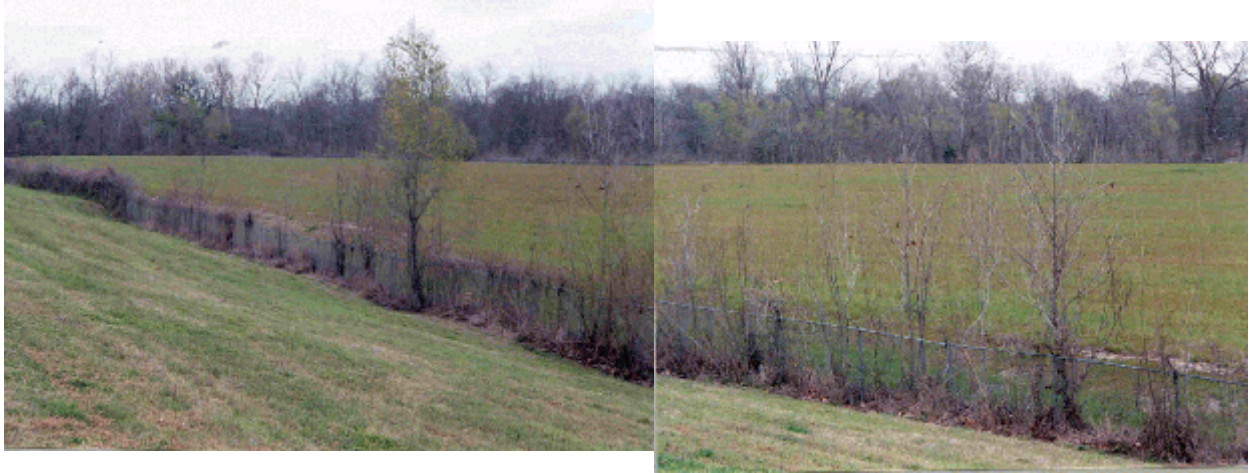
Photographs of the former Land Treatment Unit (LTU) after the cap and vegetative cover were installed at the end of the “Bioremediation Process” as part of the Remedial Action (RA) Phases IV-B and IV-C. (Looking north, photo take from levee that separates the Mississippi River from the Old Inger site)

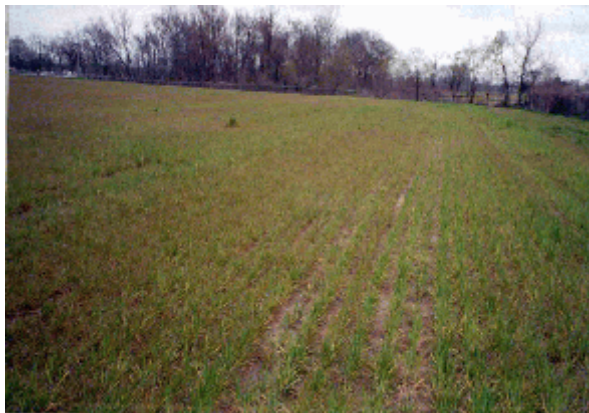
Current condition of the area of the former lagoon and tanks. Lagoons removed (1990 - 1992), tanks removed (removed 1999) soils excavated, treated in the LTU, backfilled and the levee). area graded, capped and vegetated (2000-2001). (Onsite photo, view towards the north).

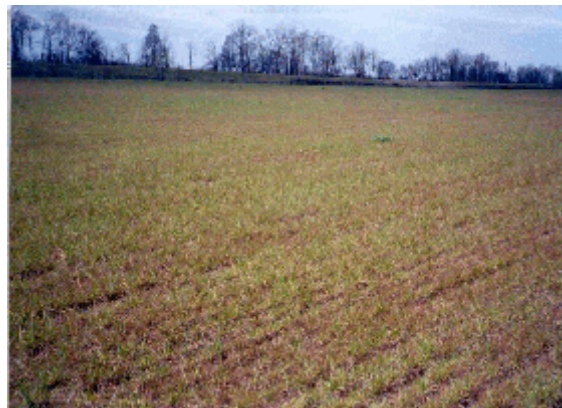
Current conditions of the area where abandoned tanks and structure of the former refinery were located. (View west, towards the Mississippi River).

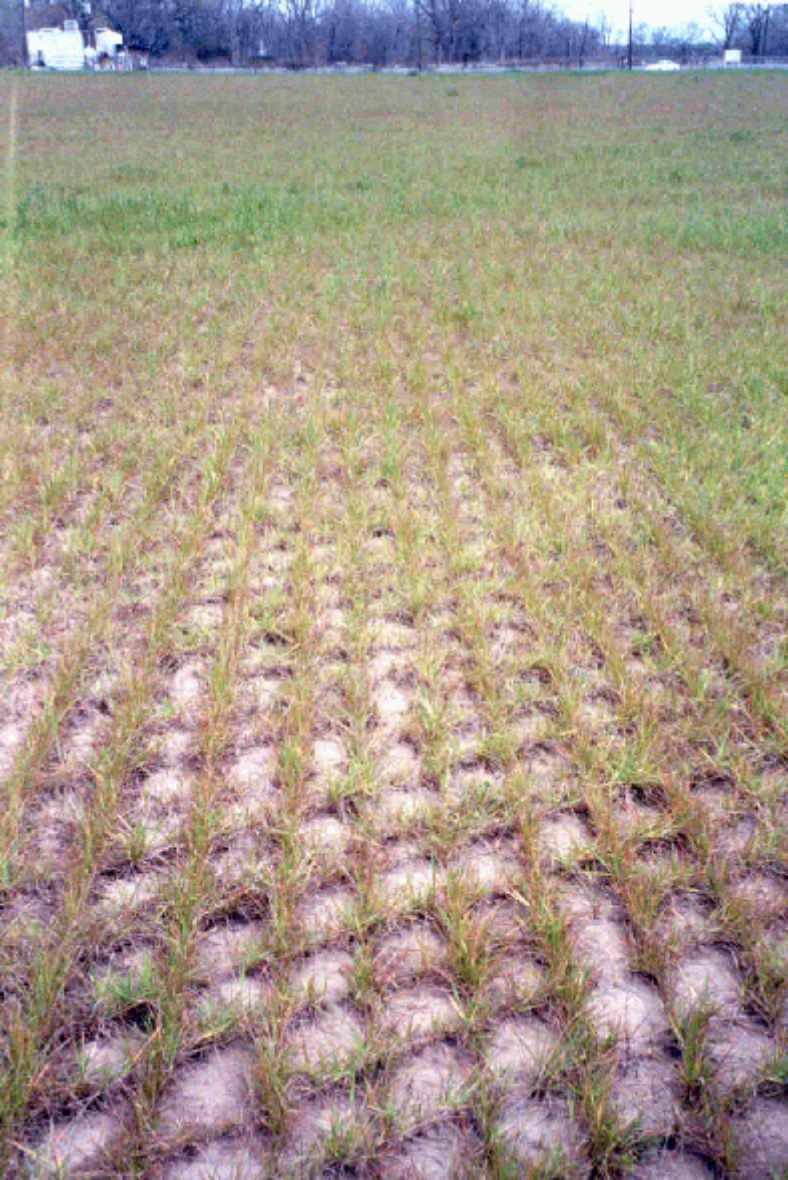
Detail of grass cover (onsite picture, looking east). As part of the remedial action, contaminated soils were removed from the lagoon and waste disposal areas. Soils were treated in the LTU. After treatment soils were backfilled into the former excavation areas. The site was graded to provide adequate drainage, capped with a clay cap, top soil was placed over the cap and the entire site was vegetated with grass.
