A Guide to Mercury Assessment and Elimination in HealthCare Facilities

Diana M. Bontá, R.N. Dr.P.H., Director
DEPARTMENT OF HEALTH SERVICES
September 2000

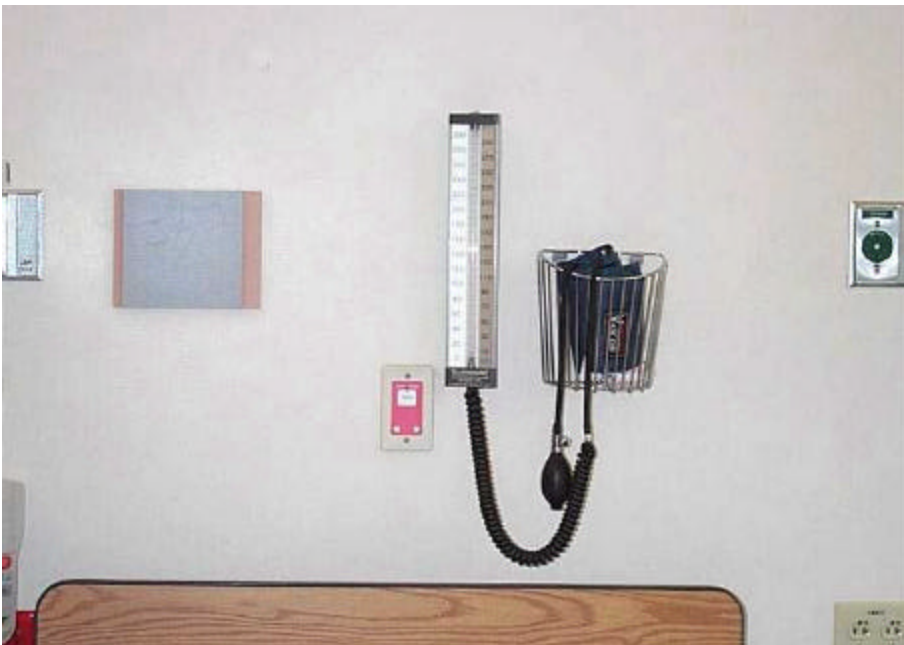
Figure 1
Bedside mercury sphygmomanometer commonly found in hospitals. (Pollution Prevention Project Photograph)

The sphygmomanometer that traditionally has been used in hospitals to monitor blood pressure contains mercury. Until recently, this was the only accurate sphygmomanometer on the market. Although technical developments have given the mercury-free aneroid sphygmomanometers an accuracy rating similar to the mercury units, it is often difficult to convince some practitioners to change. Arguments are made that aneroid sphygmomanometers add to the burden of hospital maintenance staff because of the need for periodic calibration. The fact is that mercury sphygmomanometers also need periodic maintenance. The expense and time of managing maintenance, spills and disposal of mercury sphygmomanometers can outweigh the time needed for calibration of the aneroid units.

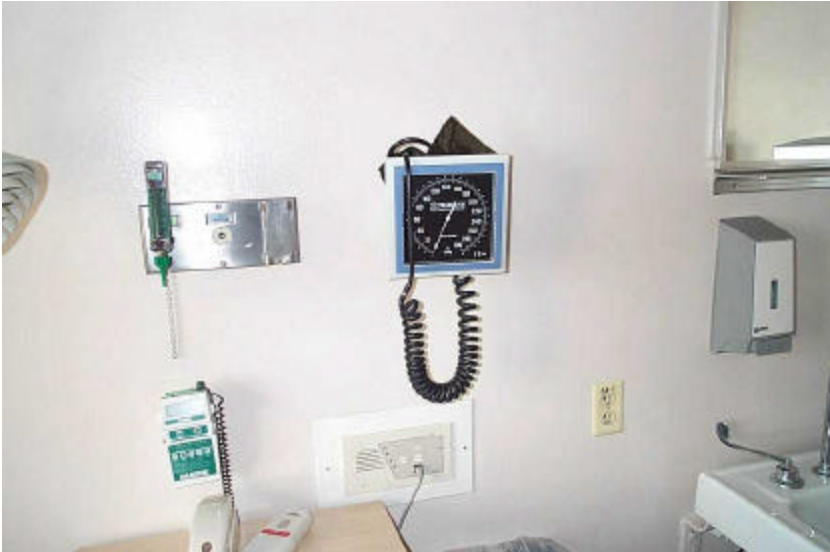
Figure 2 The bedside mercury sphygmomanometer has been replaced with an aneroid unit. (Pollution Prevention Project Photograph)

Many hospitals are in the process of replacing mercury sphygmomanometers and have found that companies that manufacture aneroid sphygmomanometers have policies that make replacement more economically feasible. These companies may take back and recycle mercury units on a one-for-one basis when their aneroid units are purchased. The purchasing department of a hospital can negotiate with these companies to get the best price for the number of mercury sphygmomanometers they want to replace and not to be burdened with additional mercury disposal costs.

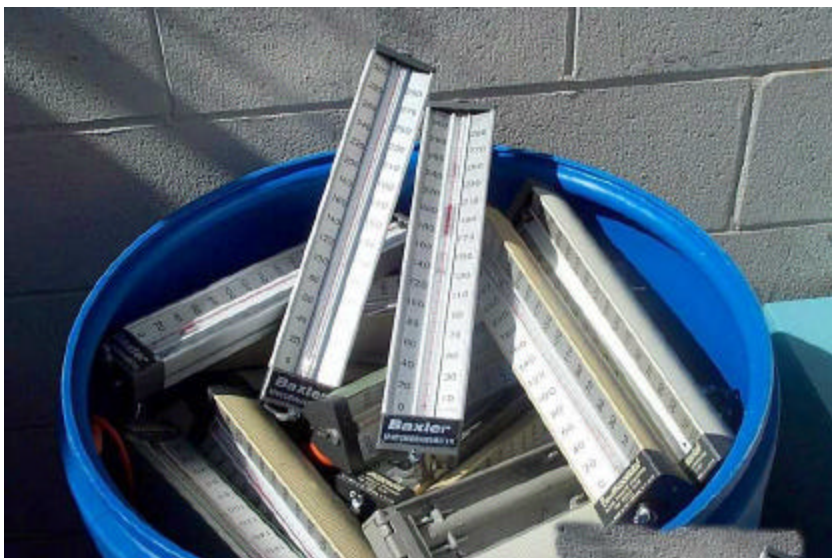
Figure 3 Unless recycled, the 90 sphygmomanometers, along with thermometers and bougies not seen, would have to be managed as hazardous waste at great expense. There are programs to exchange both bougies and sphygmomanometers. (Pollution Prevention Project Photograph)

Sphygmomanometers have been found stored loose in boxes in facilities where aneroids had been installed, and in hazardous waste storage, awaiting recycling, as seen in Figure (3).

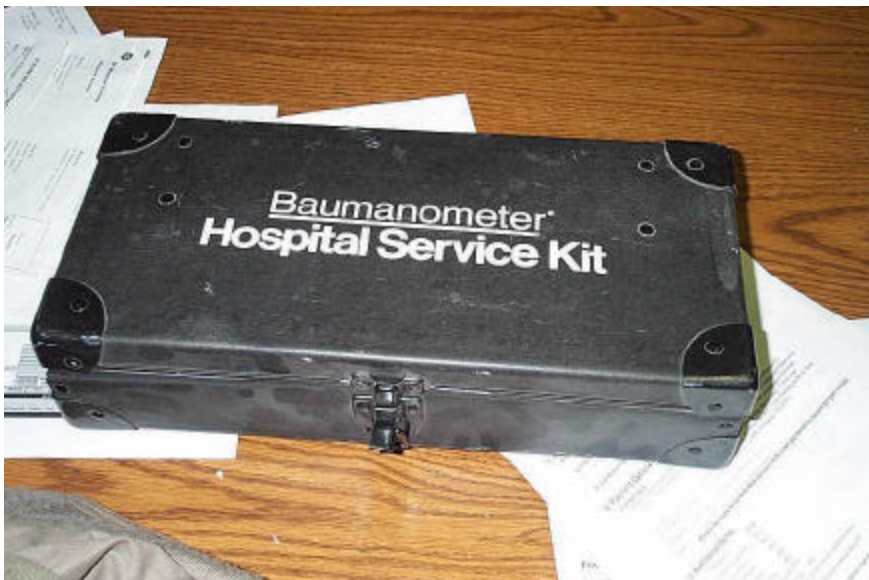
Figure 4 This sphygmomanometer service kit is provided for the Baum sphygmomanometer. The mercury from this kit may be consolidated with that from other sources to be recycled. Sphygmomanometer exchange programs may agree to accept this source of mercury. (Pollution Prevention Project Photograph)

One significant source of mercury that must not be overlooked when conducting a mercury audit of a hospital is contained in the sphygmomanometer service kit. Typically, along with spare parts and fittings, such a repair kit will come with one or more one-pound bottles of triple-distilled mercury. If the service kit has been used at all, there may well be another bottle of waste mercury. The service kit may be all that remains at a facility that has changed out all its mercury sphygmomanometers. Extra bottles of mercury have also been discovered separate from the kit. One pound of mercury is about 33 milliliters, or about the volume of a nasal or ophthalmic solution bottle. One can see how easily such a small container could be overlooked in the engineering department of a large hospital.

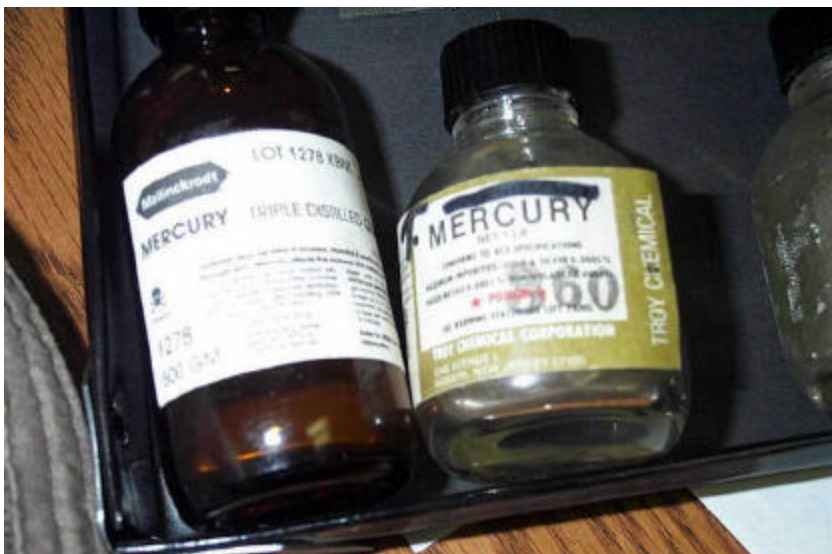
Figure 5 The bottle of "new" mercury (left) weighs 500 grams (454 grams is a pound). The waste mercury (right) was estimated at 0.3 pound. (Pollution Prevention Project Photograph)

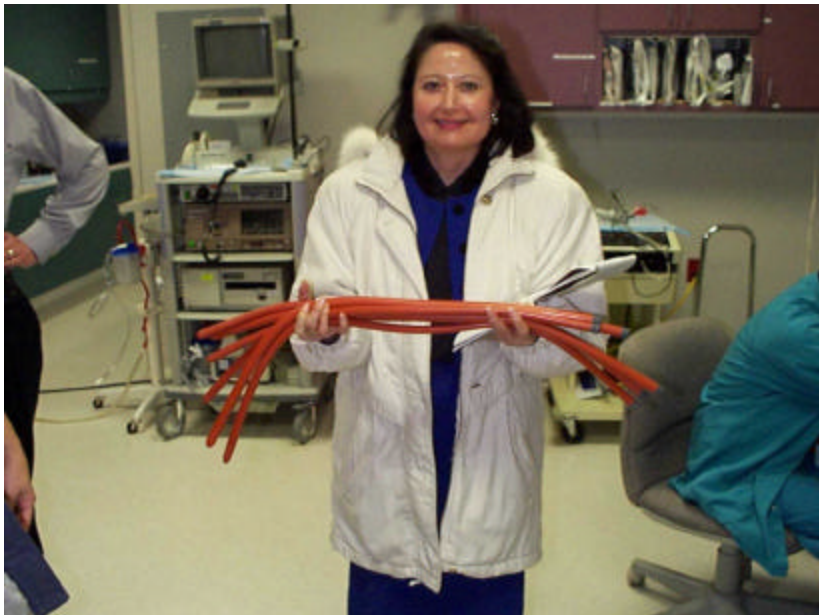
Figure 6 This set of esophageal dilators (bougies) weighs about 12 pounds. The weight is necessary to insert the device into the patient's stenosed (constricted) food tube. These mercury-weighted bougies have been replaced with tungsten gel filled models. (Pollution Prevention Project Photograph)

Appreciation and thanks are given to the participating Bay Area hospitals and special acknowledgement is made to the California Department of Toxic Substances Control's (DTSC) Office of Pollution Prevention and Technology Development, for their advice, funding and guidance throughout this project. DTSC provided the funding necessary to carryout the mercury elimination portion during the first year of the P-2 Project. Special recognition is made for the assistance provided by Mary Pride, DTSC's Contract Manager for this project. She can be seen holding mercury bougies in Figure 6 of this document.

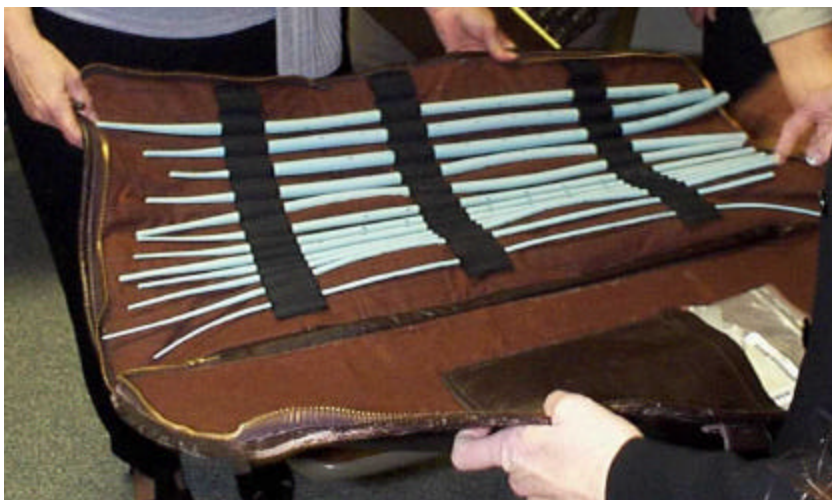
Figure 7 A complete set of tungsten gel-weighted bougies, stored in the leather zippered case that formerly held the mercury ones. (Pollution Prevention Project Photograph)

The silicone tungsten gel bougies are green, easily differentiating them from the orange rubber mercury bougies. At least one company has a trade-in policy that gives a 10 percent rebate toward purchase of a new mercury-free bougie and also includes free recycling of the old one.

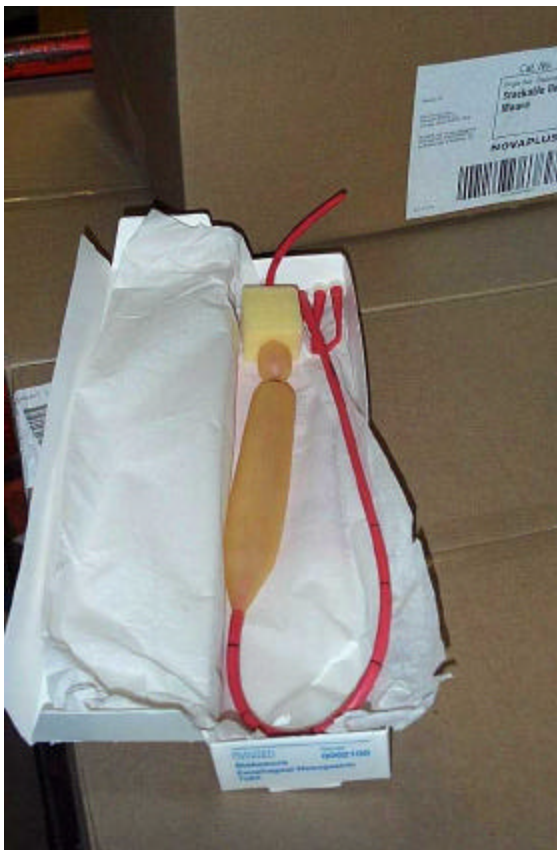
Figure 8 A Blakemore tube has three connections. One inflates the bulb, one inflates the tube, and one is for gastric lavage and administering fluids. (Pollution Prevention Project Photograph)

The Blakemore tube (Sengstaken-Blakemore tube) (shown above) is a device used to stop the bleeding of esophageal varices varicose veins in the esophagus. It consists of two balloons; one inflated in the stomach to hold the device in place, the other inflated inside the esophagus to compress the bleeding vessels. The Blakemore tube is an absolute necessity in the emergency room, older devices have a mercury-weighted tube allowing it to be placed in a similar

fashion as the Miller Abbot tube. A solid rubber weight replaces the mercury in the mercury-free device.

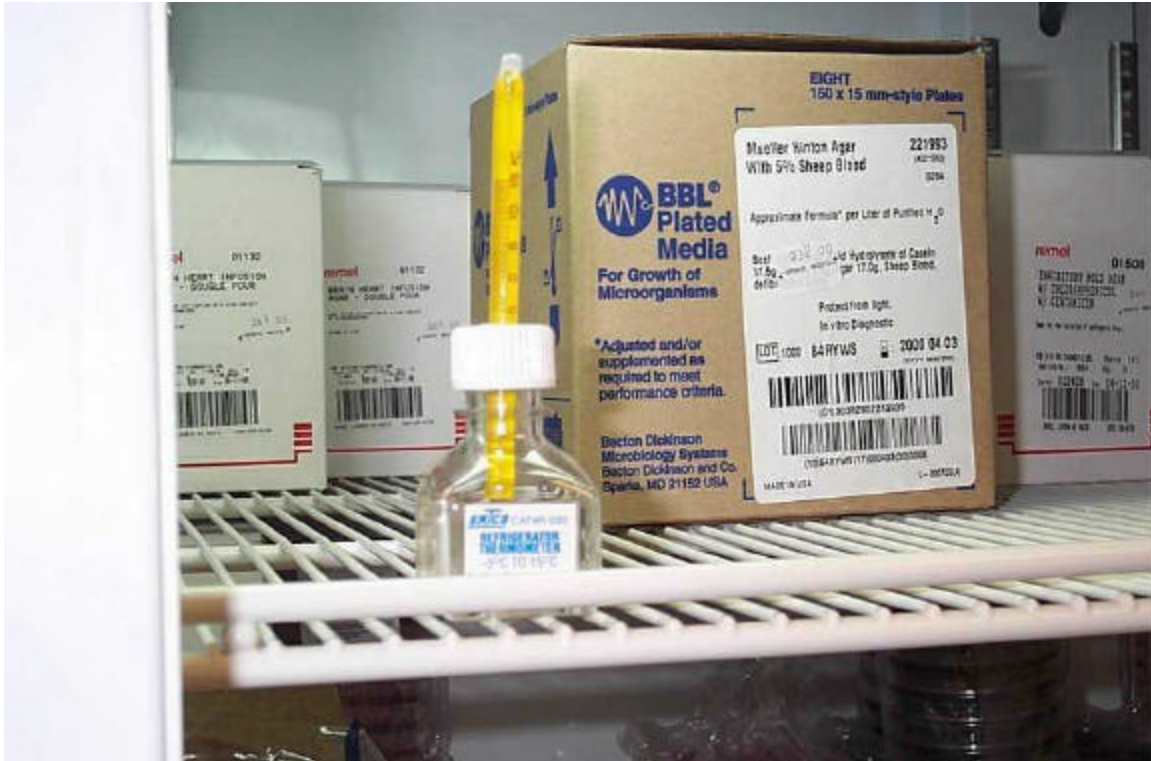
Figure 10 Every hospital refrigerator must have a thermometer. This mercury thermometer could easily be replaced with an alcohol/spirit thermometer. (Pollution Prevention Project Photograph)

Refrigerators in hospitals must all be equipped with thermometers as shown in Figures (10) and (11). They are nearly always placed in a bottle of buffer fluid which prevents fluctuations in indicated temperature when the door is opened. A yellow-stem thermometer with a silver bulb and column is mercury, a white-stem thermometer with a red or blue column is alcohol/spirit thermometer.

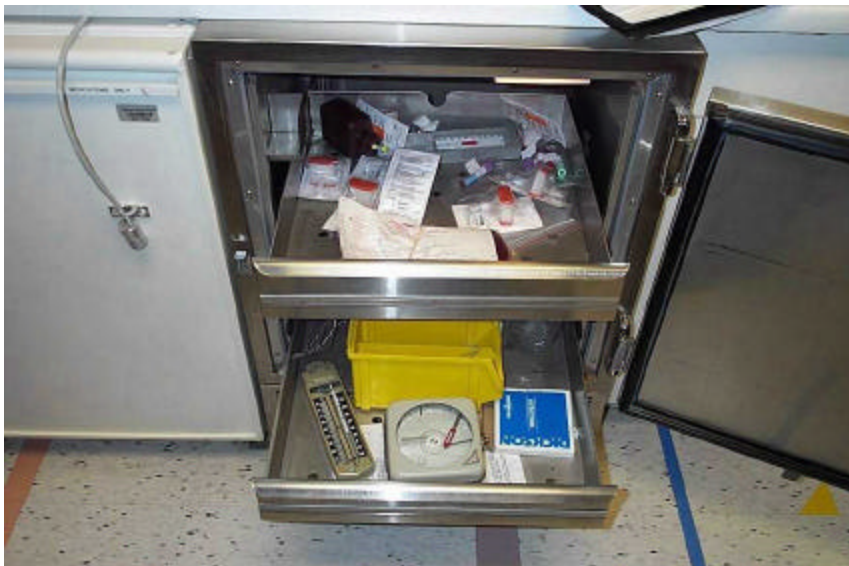
Figure 11 On the bottom shelf of this refrigerator are (left) a mercury minimum/maximum thermometer, and (center) a non-mercury recording thermometer. Uppershelf, at 1 o'clock, a home refrigerator alcohol/spirit thermometer. At 11 o'clock, a "lab quality" mercury one. Mercury thermometers should be replaced with non-mercury thermometers and the number of thermometers in use could be reduced (Pollution Prevention Project Photograph)

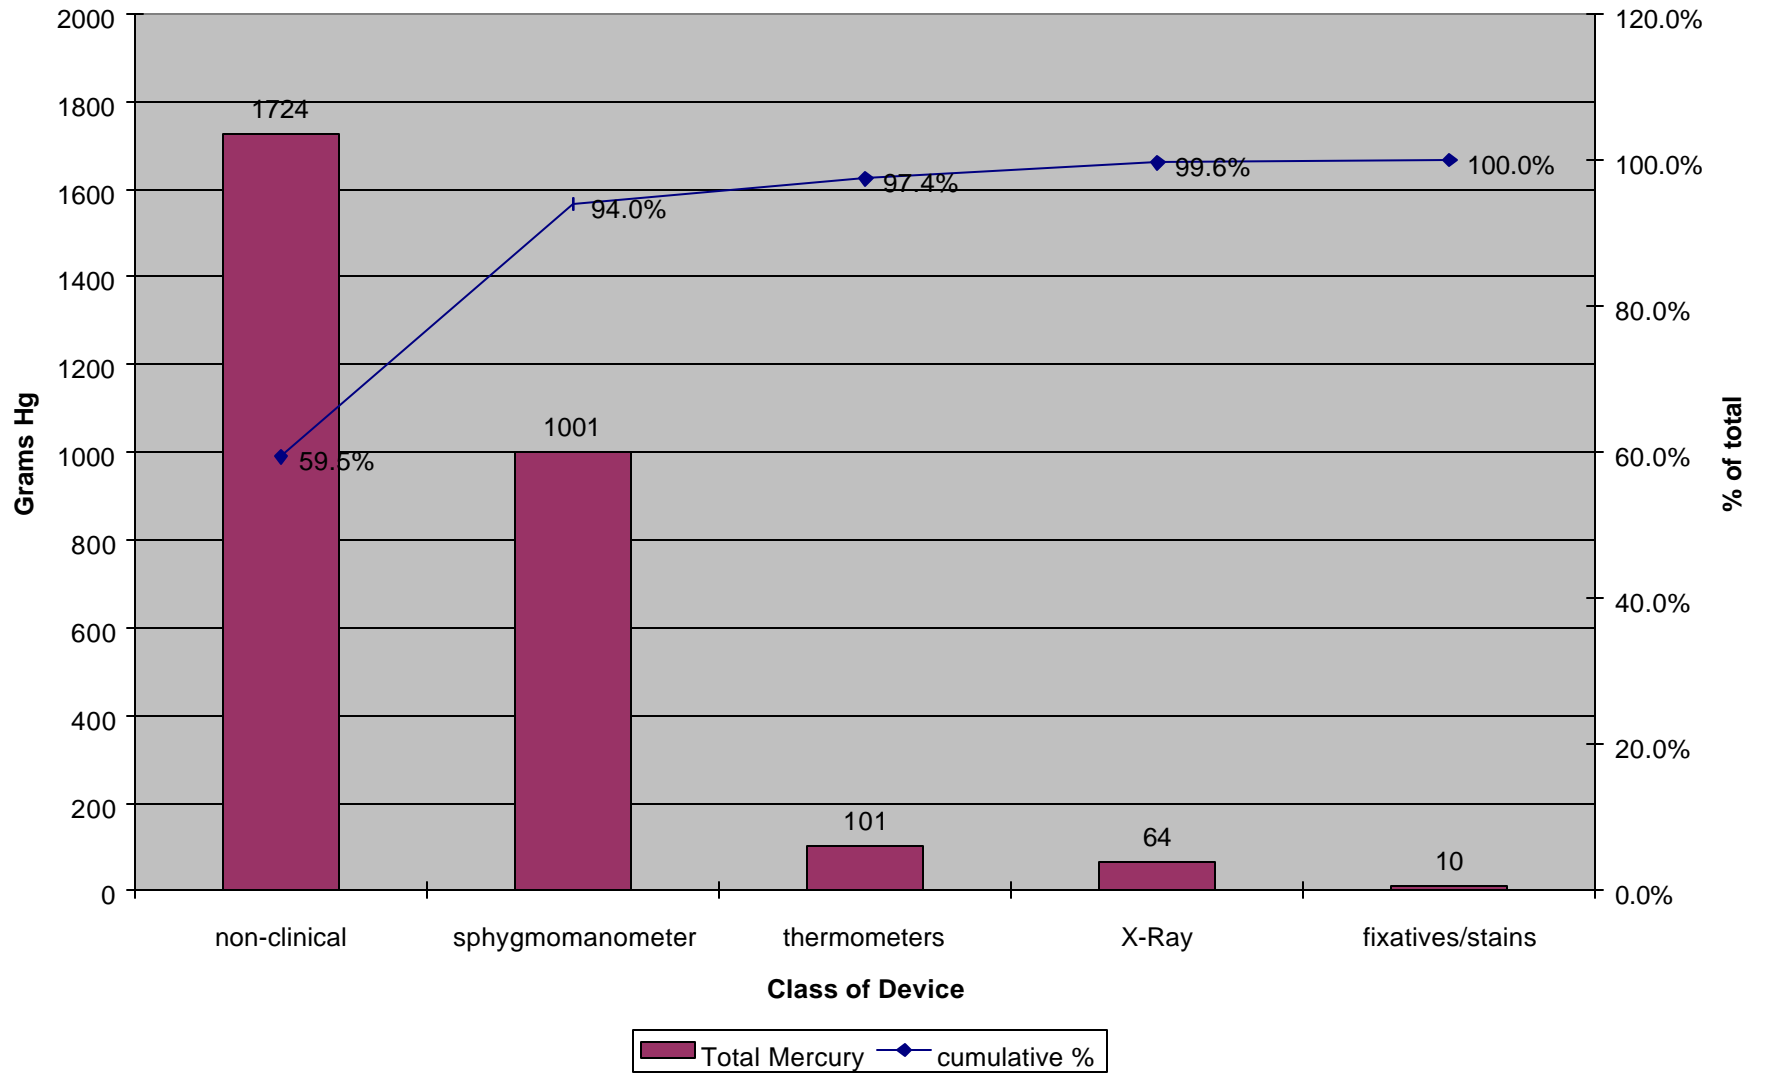
Chart 2
Total Mercury Facility 2

TABLE 2. Mercury assessment data. Facility 2.

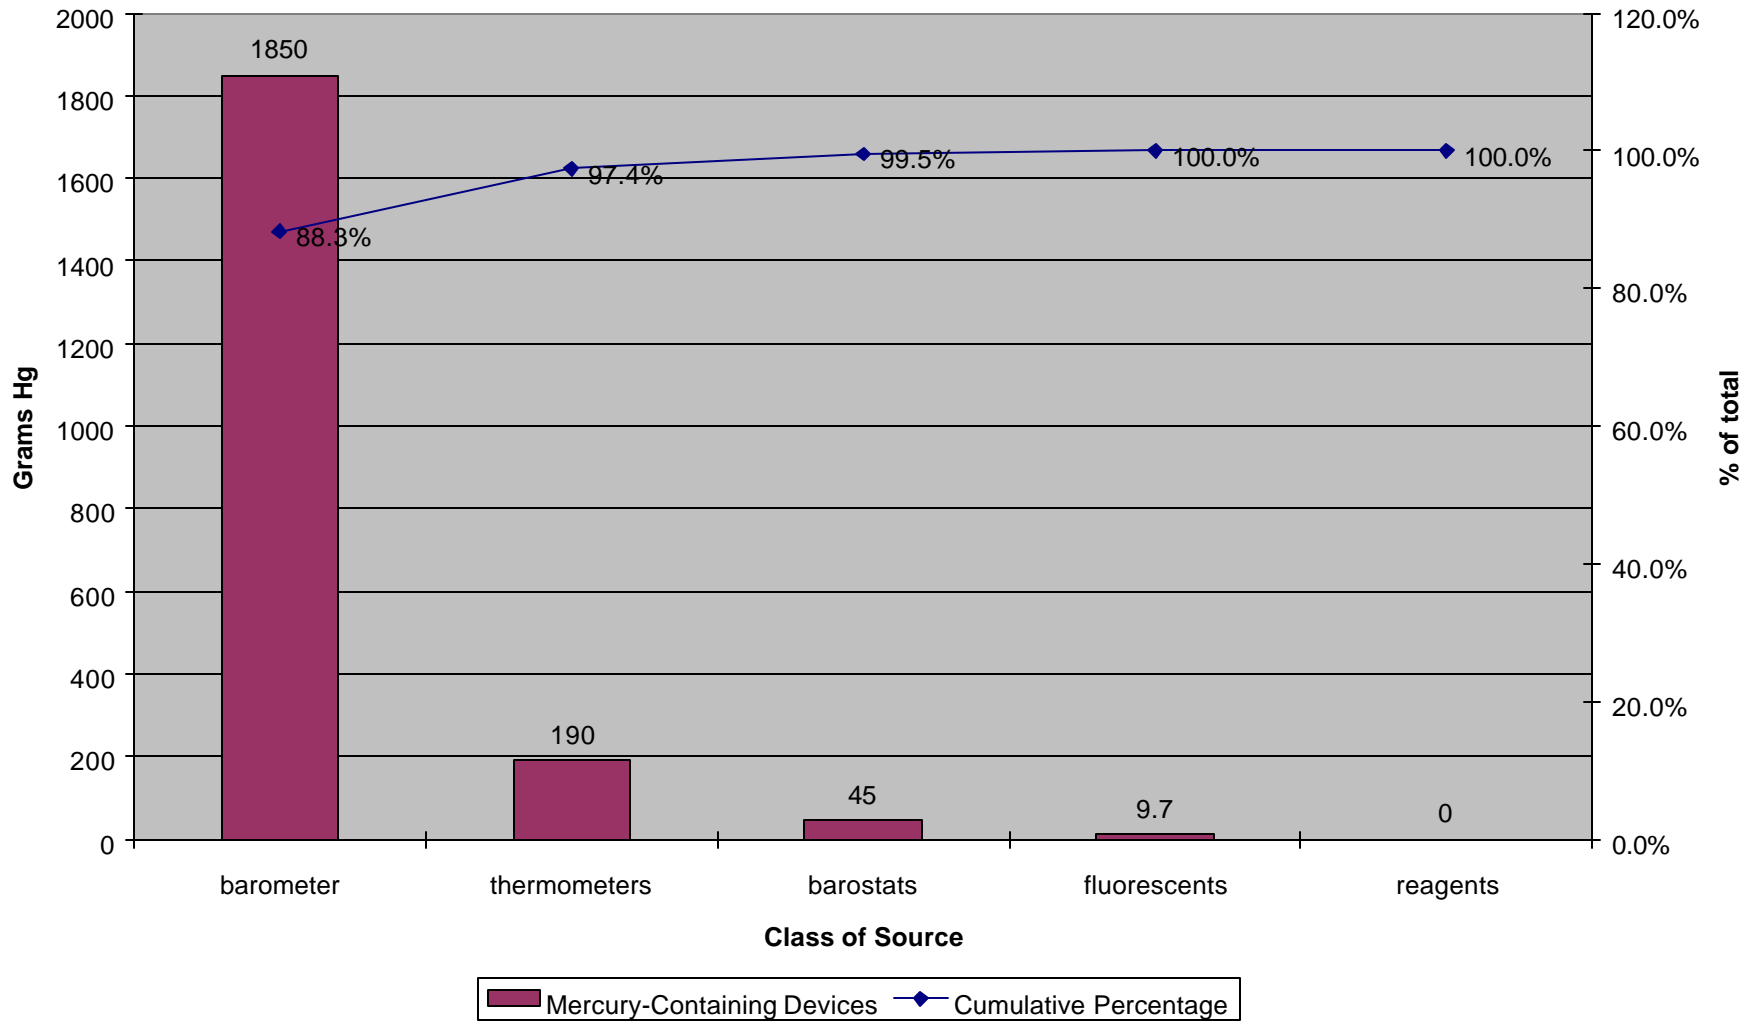
Chart 3
Total Mercury Facility 3
Cumulative Percent

TABLE 3. Mercury assessment data for Facility 3.

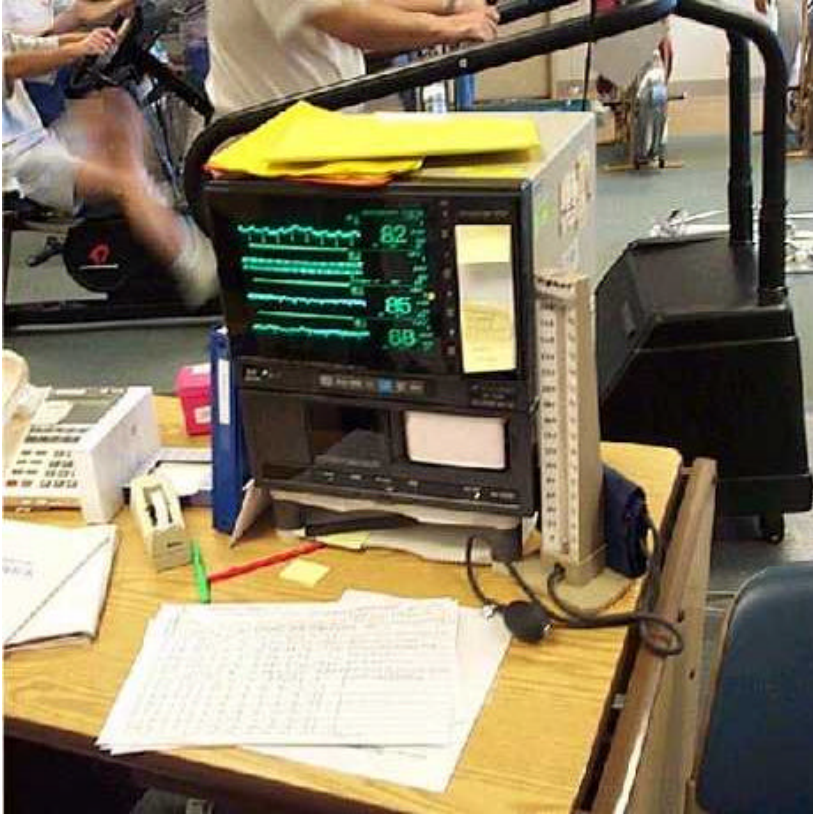
Figure 13 A mercury sphygmomanometer is located next to state-of-the-art monitoring equipment. (Pollution Prevention Project Photograph)

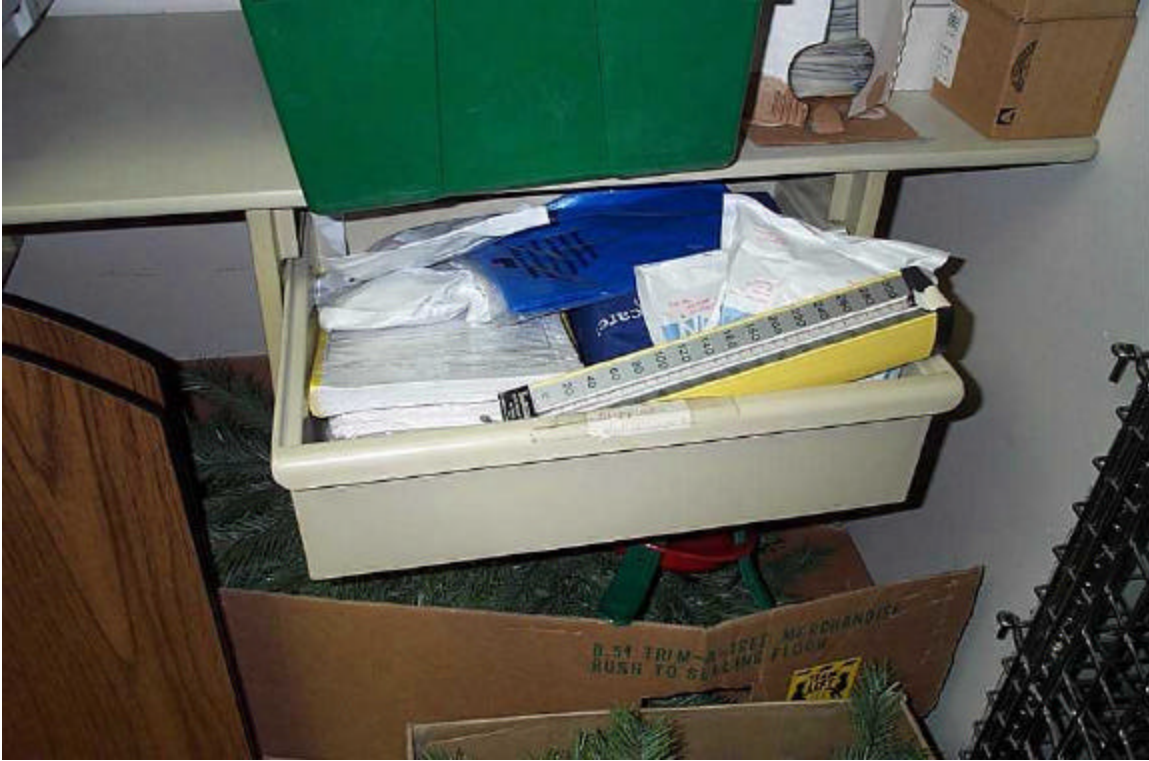
Figure 14 This neglected storeroom drawer held 2 mercury sphygmomanometers which had been replaced by aneroid units. (Pollution Prevention Project Photograph)

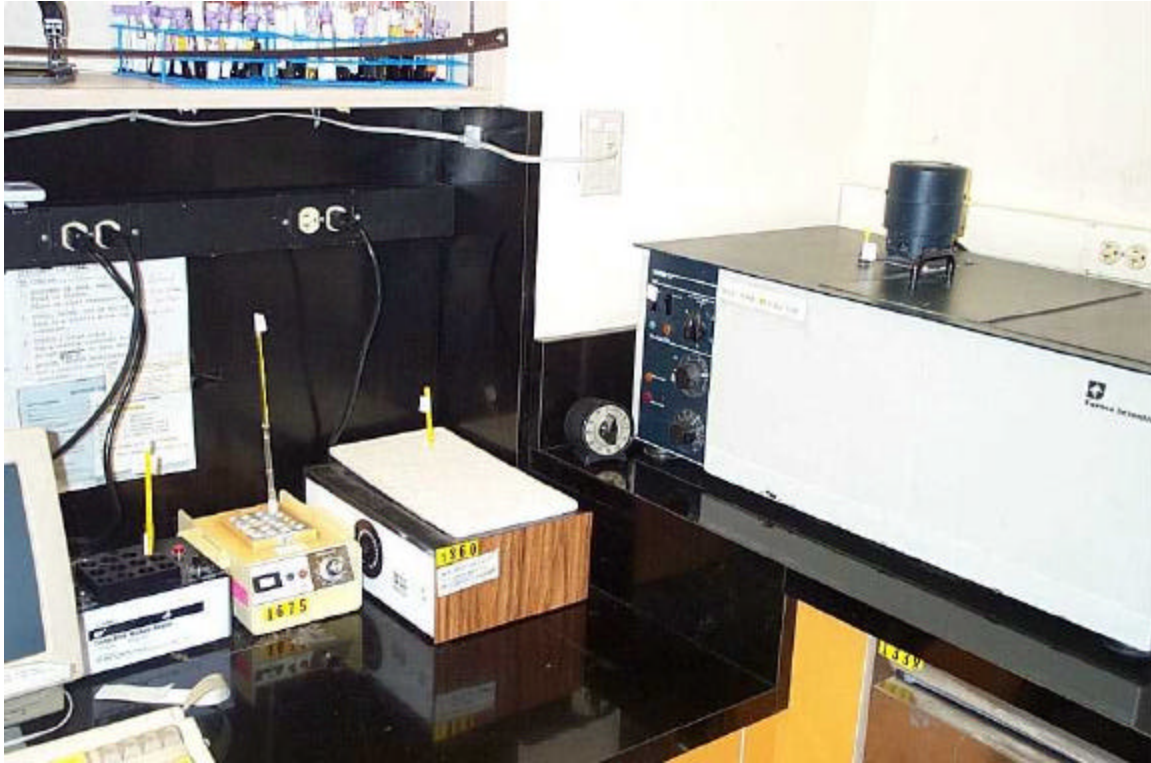
Figure 15 Laboratory thermometers monitor temperatures of various laboratory apparatus, including water bath to the right, heat blocks to the left. (Pollution Prevention Project Photograph)

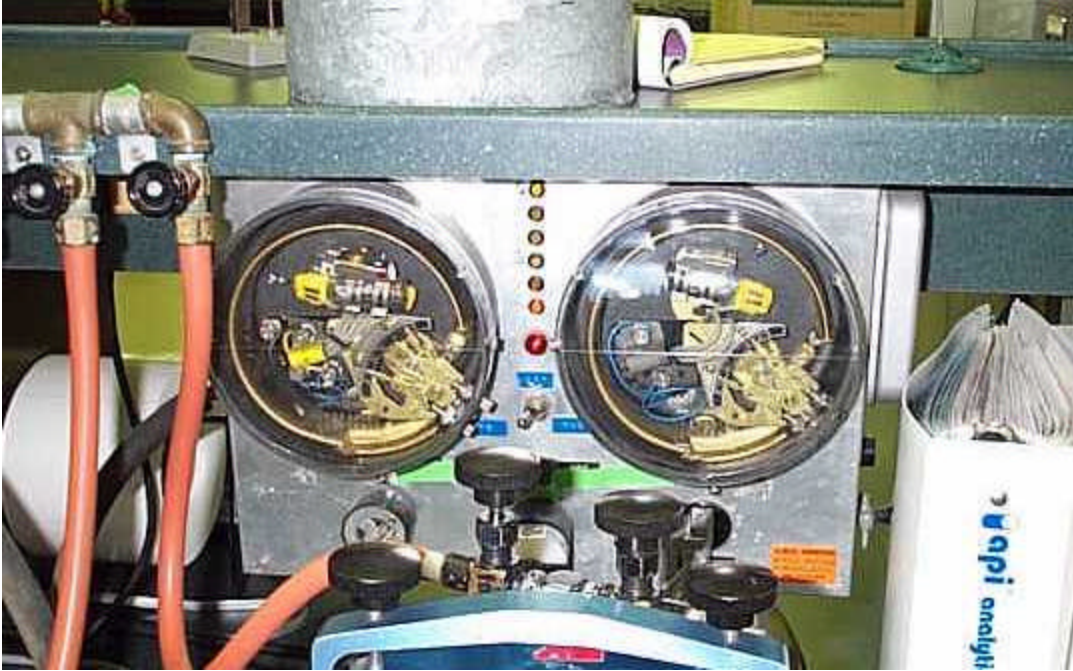
Figure 16 This mercury barostat detects small changes in the vacuum system in the laboratory, switching the vacuum pumps on and off to maintain a constant vacuum. (Pollution Prevention Project Photograph)

Mercury switches may be found throughout the hospital. Switches are electromechanical devices, which allow electrical current to be applied or not applied to an electrical device. As a metal, mercury is one of the poorest electrical conductors, but still quite adequate to make it useful in making or breaking circuits many more times than other mechanical contacts before failure. Mechanical contact may also be made with very minimal force, making these switches quite sensitive in the barostat shown in Figure 16 (160 mercury switches control vacuum pressure).

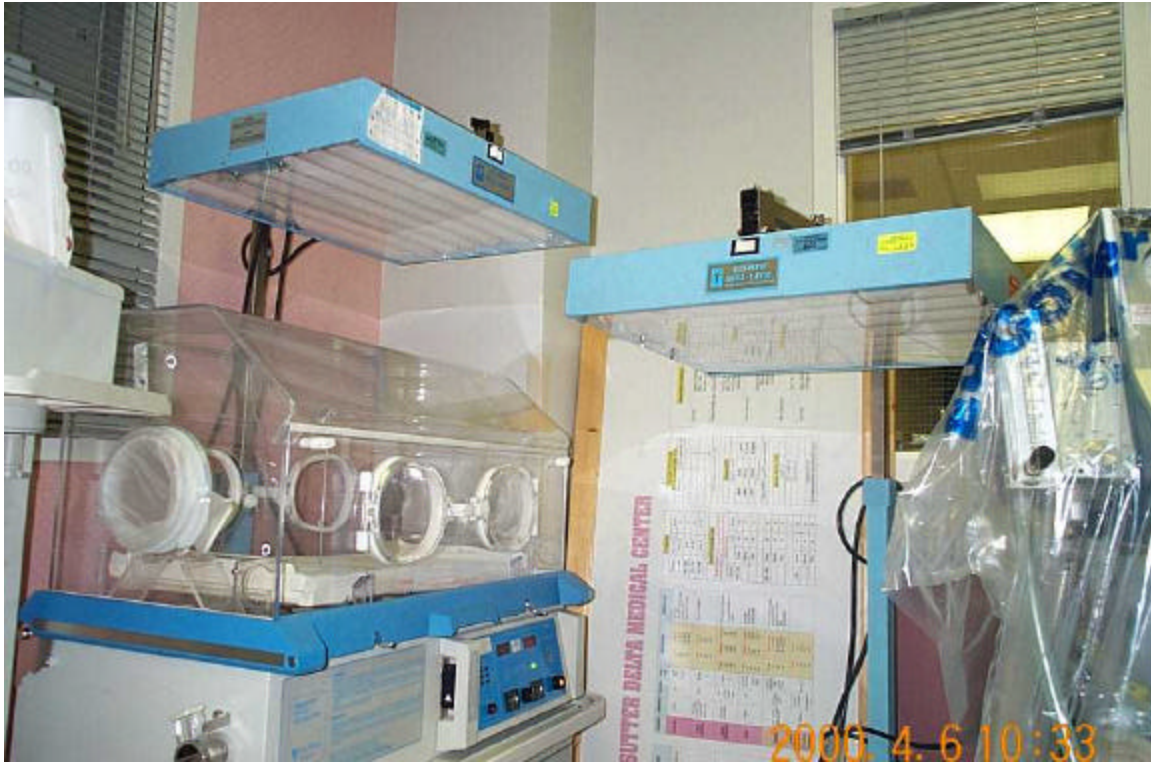
Figure 17 Extra “bili” lights in a crowded storeroom near the nursery. (Pollution Prevention Project Photograph)

All fluorescent tubes contain mercury. Mercury vapor carries the electrical current, which in turn activates the phosphors on the surface of the tube to luminesce. Fluorescent lighting is found throughout facilities. In addition to the general facility lighting, “bili” (bilirubin) lights as shown in Figure (17) emit light in a spectral range that destroys bile pigments present in neonatal jaundice.

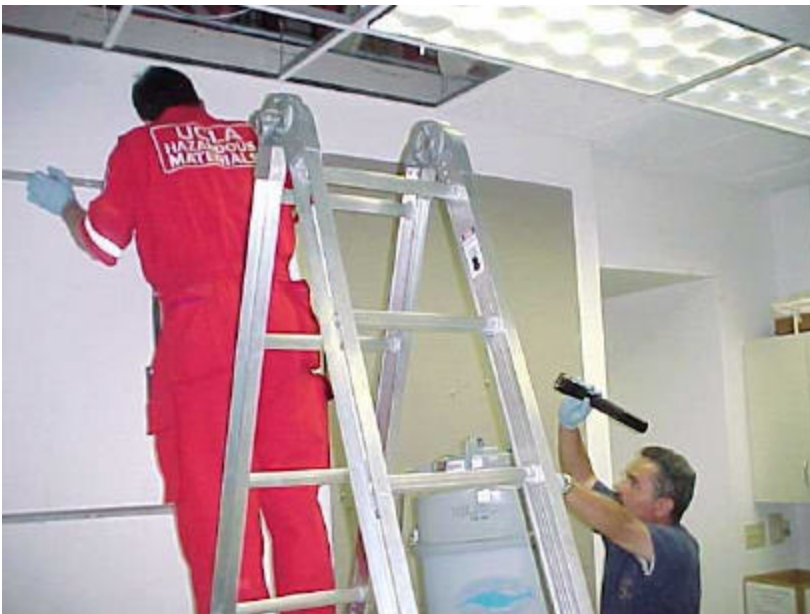
Figure 20 Investigating the extent of damage to ceiling tiles from a mercury spill. (Photograph courtesy of UCLA, Office of Environment, Health & Safety)

The UCLA Haz Mat Unit responded to this mercury spill and isolated the affected office. An investigation to determine the extent of damage to the ceiling tiles was conducted. The office environment was monitored using a mercury vapor meter. Mercury indicator powder was used to pinpoint and define mercury hot spots.

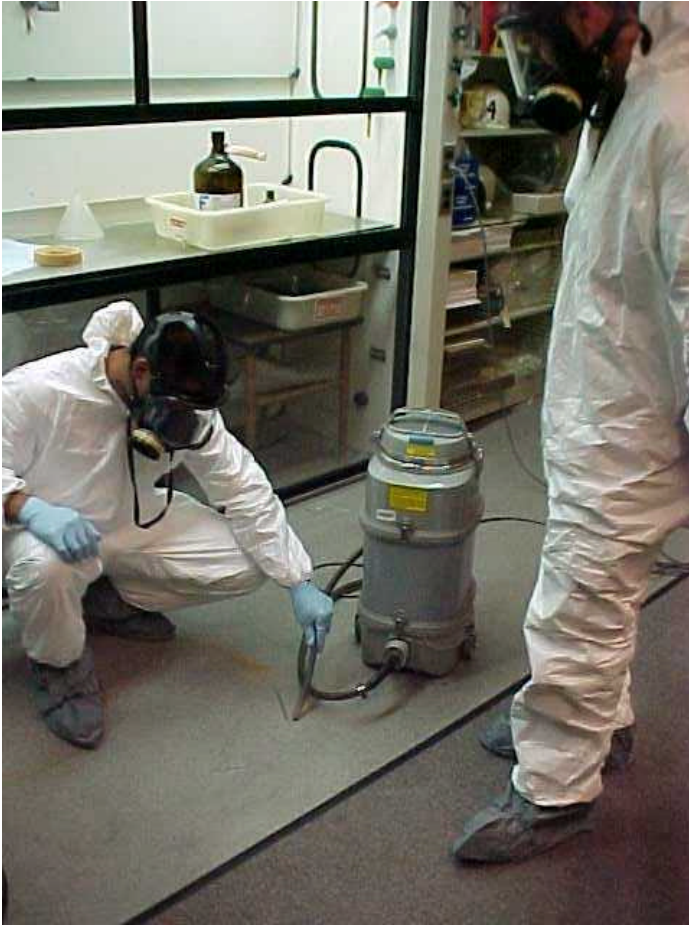
Figure 21 Staff using a mercury vacuum to clean up mercury from office carpet. (Photo courtesy of UCLA, Office of Environment, Health & Safety)

Staff from the Haz Mat Unit wearing personal protective equipment initiated clean up activities using adsorbent, a mercury vacuum and a micro vacuum cleaner. Continual monitoring with the mercury vapor meter revealed how difficult clean up of this spill had become. The carpeting in the office was removed after repeated attempts to clean it with the mercury vacuum failed to reduce the mercury to non-detectable levels as measured by the mercury vapor meter. The mercury penetration into the photocopying machine was so extensive that the unit had to be removed from service and sent for disposal as hazardous waste.

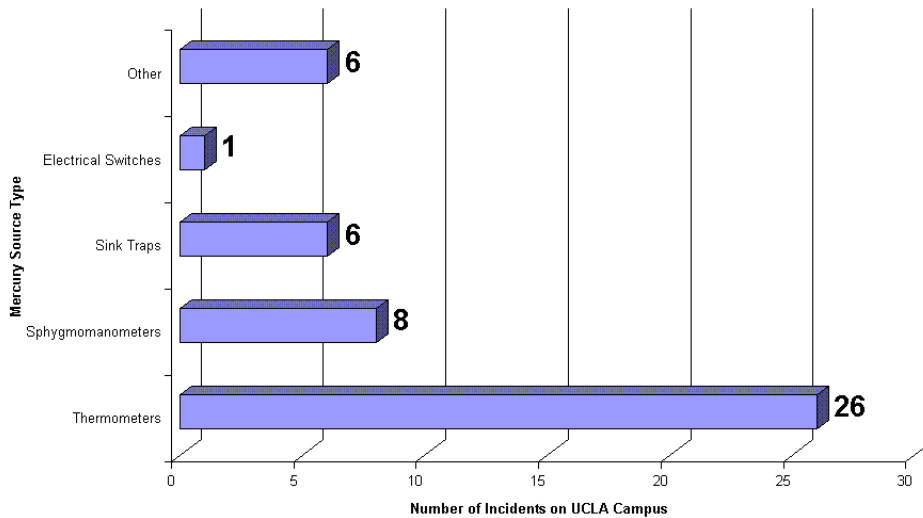
Types of Mercury Spills at UCLA, 1997-1999

Figure 23 Mercury spills on UCLA campus 1997-99 by source type. (Graph courtesy of UCLA, Office of the Environment, Health & Safety)

A total of 47 mercury spills were recorded on the UCLA campus from 1997 through 1999. A breakdown of the sources of these spills is presented in Figure 23. As can be seen from the data presented in Figure 23, thermometers accounted for 26 (55.3 percent) of the incidents. Sphygmomanometers were the second most frequent source of mercury spills during the 1997-99 period with eight spills representing 17.0 percent of the total events. Sink traps accounted for six mercury spills, including the CHS event, which represented 12.8 percent of the incidents. It is interesting to note that 42 percent of the hazardous materials incidents responded to by the UCLA Haz Mat Unit involve mercury. The UCLA Haz Mat Unit expended 280.59 hours responding to hazardous waste incidents during the years 1997-99. The personnel costs for the Haz Mat Unit are computed at \$100 per hour resulting in a cost of \$28,059 for the three year period.
