# LESSONS LEARNED DATABASE

**Title:** Preliminary Findings- Plutonium-238 Uptakes at Los Alamos National Laboratory

**Identifier:** HQ-EH-2000-01

**Date:** 2000-05-24

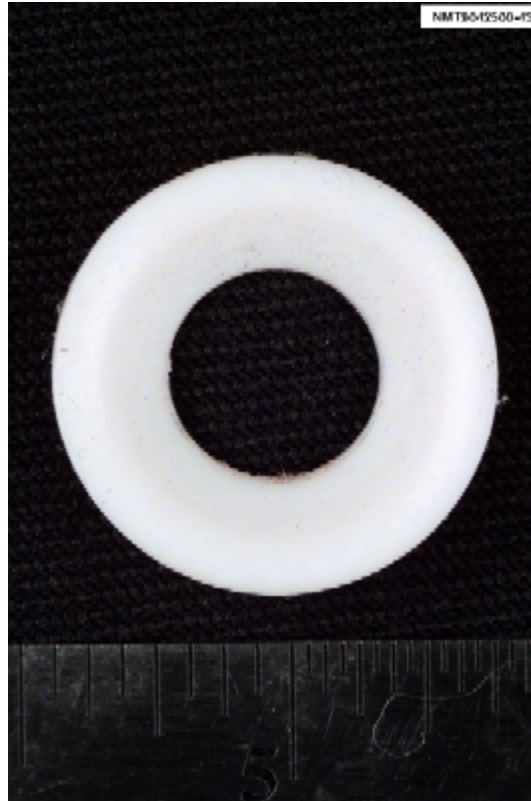
Figure 3: New Teflon® Valve Seat
