Optimizing Maintenance Activities
Tenth Report

**REPAIR OF CONCRETE
PAVEMENT JOINTS**

*Combined State Studies
Of Selected Maintenance Activities
A Cooperative Analysis By Teams From
Iowa, Kansas, Nebraska, South Dakota*

**VALUE ENGINEERING STUDY OF
PAVEMENT JOINT REPAIR**

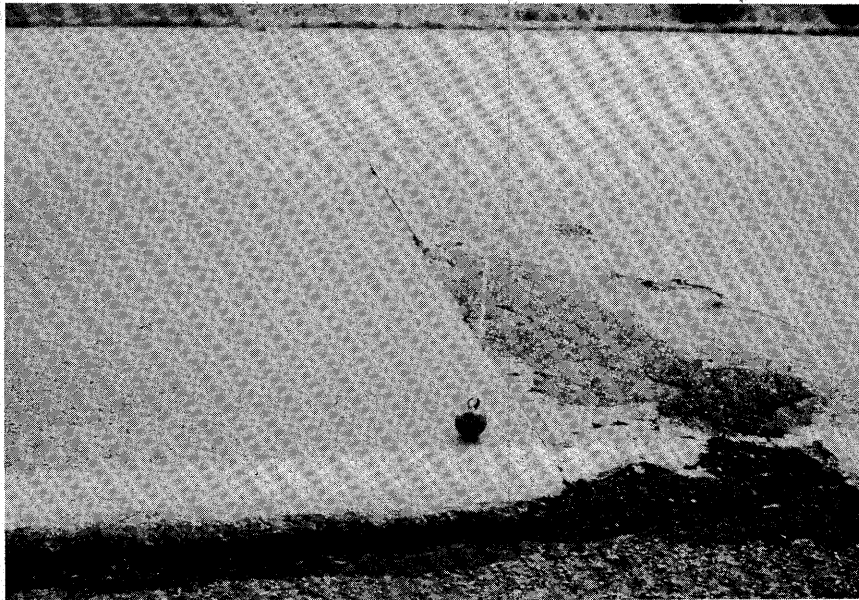
FIGURE 1 – LOCATE JOINT

Combine visual inspection and sounding to check condition of joint area concrete.

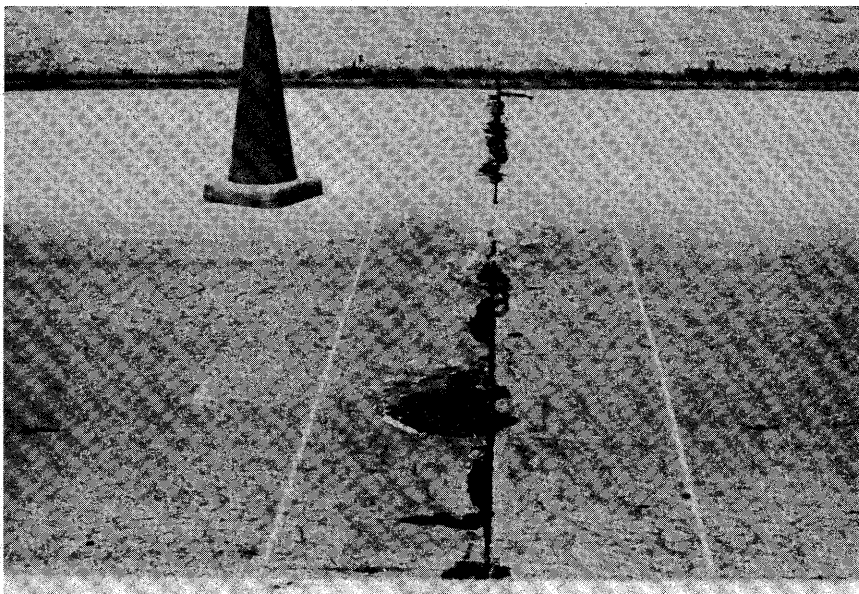
FIGURE 2 – MARK AREA

Use minimal marking or none at all on initial surveys to determine joint condition. Reserve extensive use of marking only where required to delineate damaged areas during construction of the joint repairs.

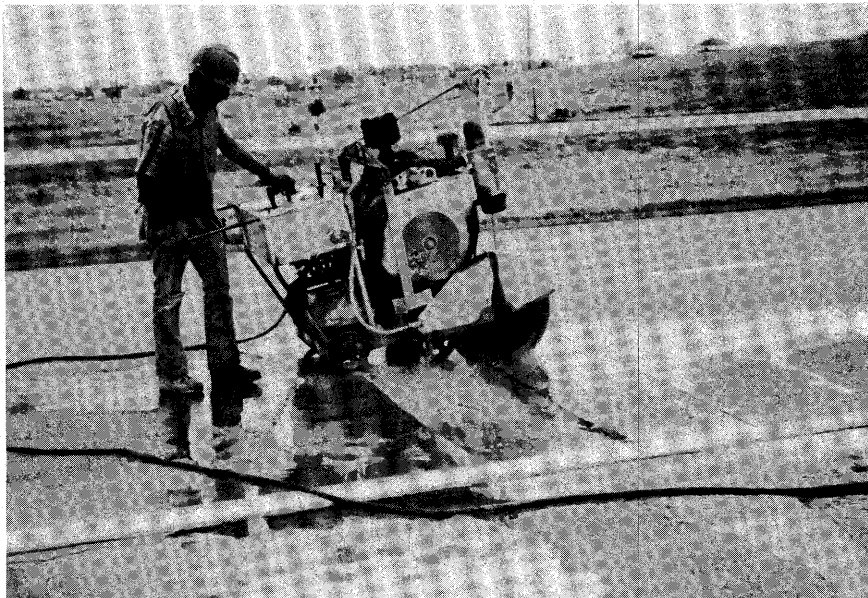
FIGURE 3 – SAW AREA
Diamond-blade saw in operation on partial-depth joint repair.

Partial-depth diamond blade sawing (2 - 3 inches deep) is recommended around the boundaries of partial-depth repairs where the concrete is to be removed by jackhammering. One state with extremely hard coarse aggregate and only physical damage at the joints has obtained satisfactory results by diamond blade sawing the perimeter of the partial depth repairs to a minimum depth of one inch. The depth of repair required in these cases is minimal compared to that required for joint distress associated with D-cracking and cement-aggregate reactions. The clean, straight line cuts facilitate removal of the old concrete, aid in edge finishing of the new concrete, minimize the possibility of spalling and provide for a smoother ride.

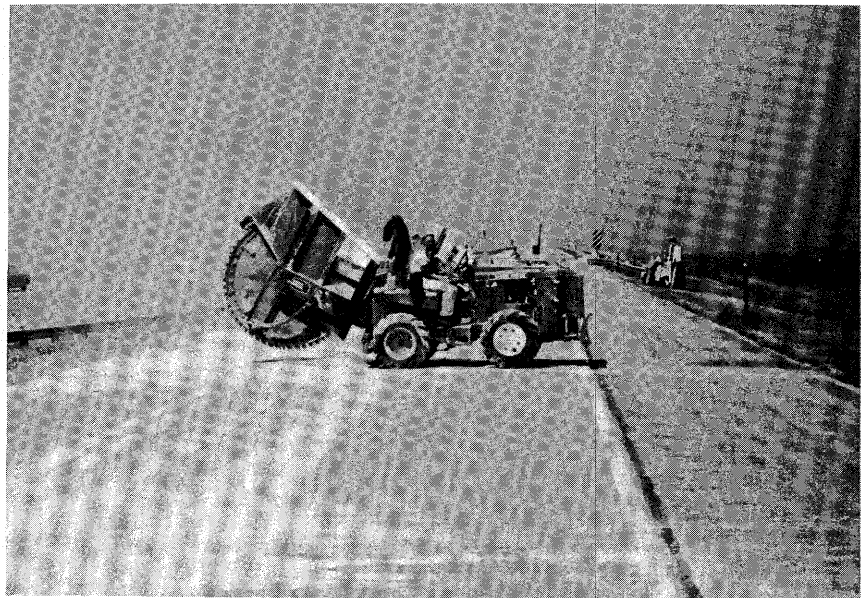
FIGURE 4 – ROCK SAW (WHEEL CUTTER)
Rock saw (wheel cutter) completed full-depth lane width cut.

- (b) The width of cut produced by the rock saw is capable of relieving compressive pressures adjacent to the cut in the pavement slab. Also, the width of cut, approximately four inches, is great enough to permit access to the under side of the slab sections with special lifting devices to remove the deteriorated concrete in one piece.

- (c) The rock saw tends to tear and spall the concrete at the top edges of the cut. The degree of tearing and spalling is somewhat dependent upon the quality of concrete and the type of coarse aggregate involved. These irregular edges may not be acceptable as the finished edge around the perimeter of the repair to some agencies. Partial-depth diamond-blade saw cuts in the pavement surface adjacent to the rock saw cuts can be used to provide a sharply defined edge and to produce a joint with less tire slap and a smoother ride. Due to the shelf that is produced by the diamond-blade saw cut it will be necessary to prepare the faces of the old concrete to a near vertical plane using 15 pound chipping hammers or similar equipment.

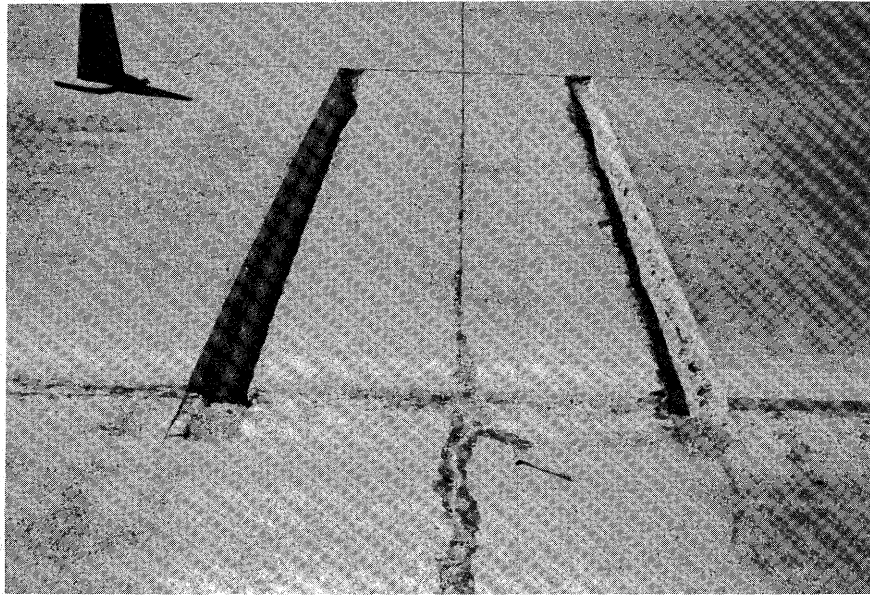
FIGURE 5 – COMBINATION SAW CUT

Full-depth rock saw cut with partial-depth diamond blade saw cut adjacent to it.

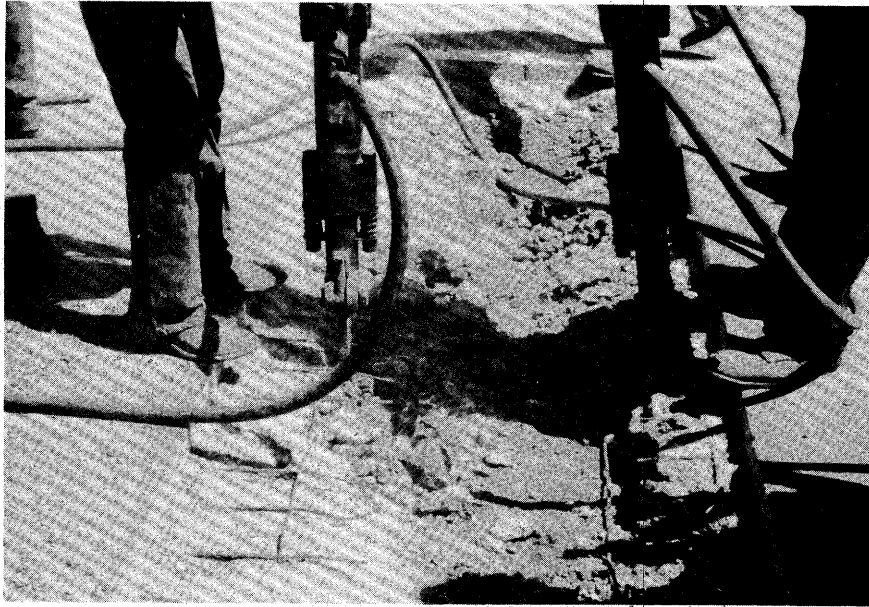
FIGURE 6 – BREAK CONCRETE
Breaking concrete with jackhammers.

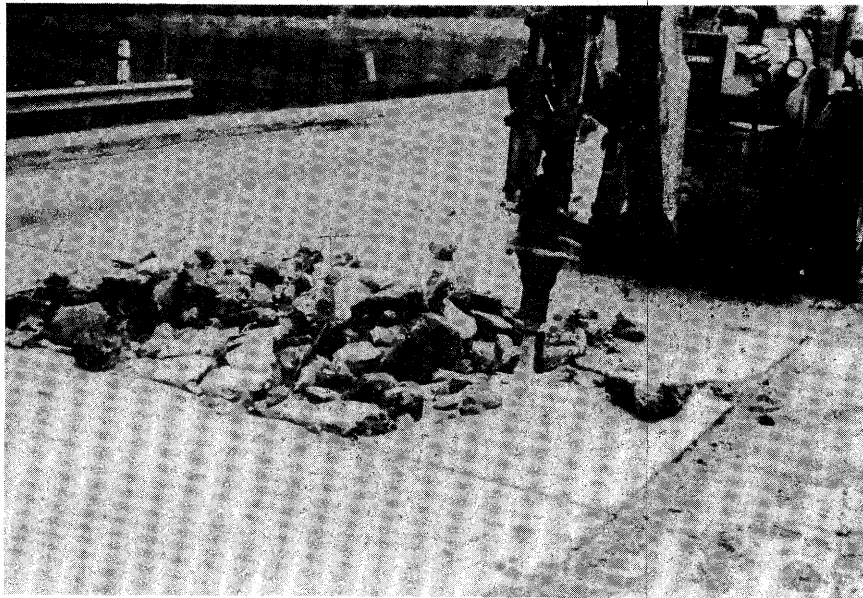
FIGURE 7 – BREAK CONCRETE
Breaking concrete with pavement breaker.

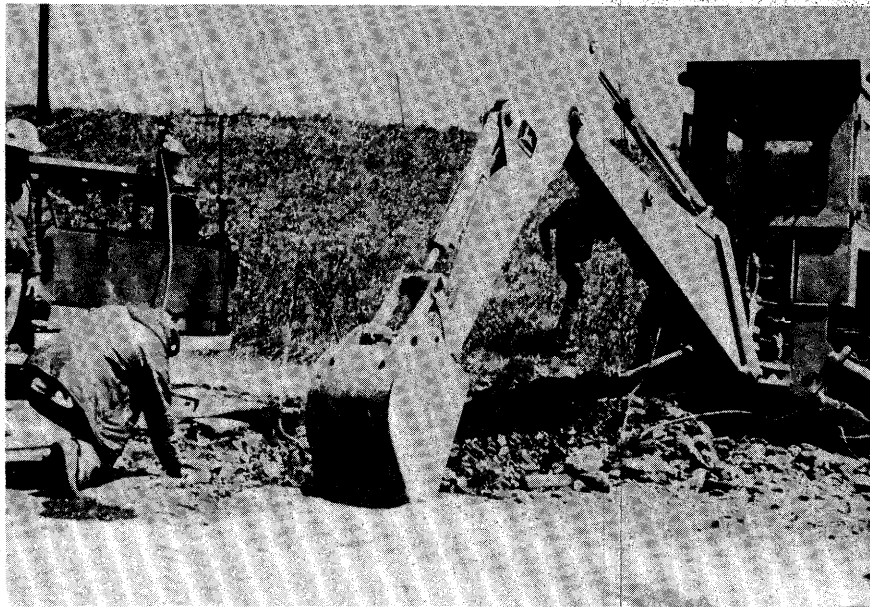
FIGURE 8 – REMOVE CONCRETE

The backhoe is favored by some states for the removal of broken concrete.

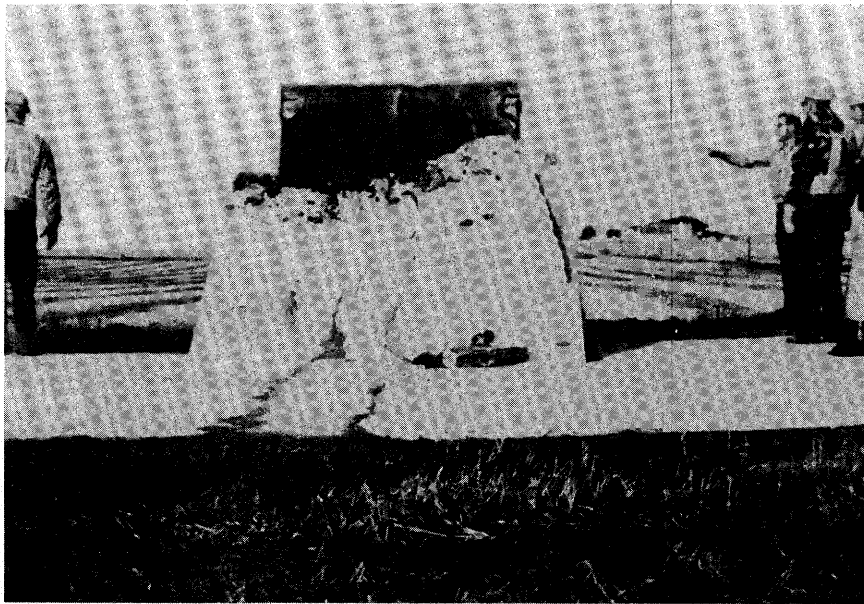
FIGURE 9 – REMOVE CONCRETE

A front-end loader removes concrete from a full-depth joint repair section.

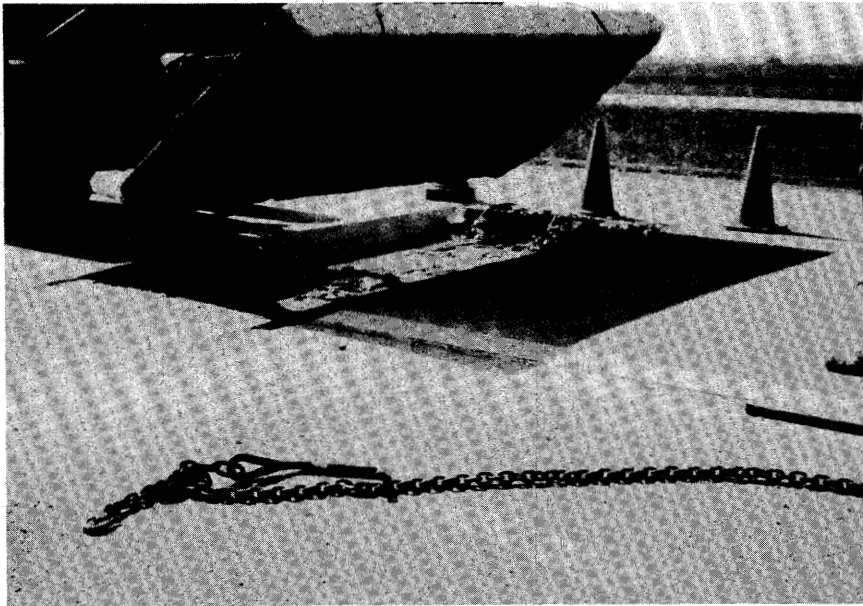
FIGURE 10 – REMOVE CONCRETE

Using a front-end loader with slings to remove full-depth joint repair section disturbs base very little.

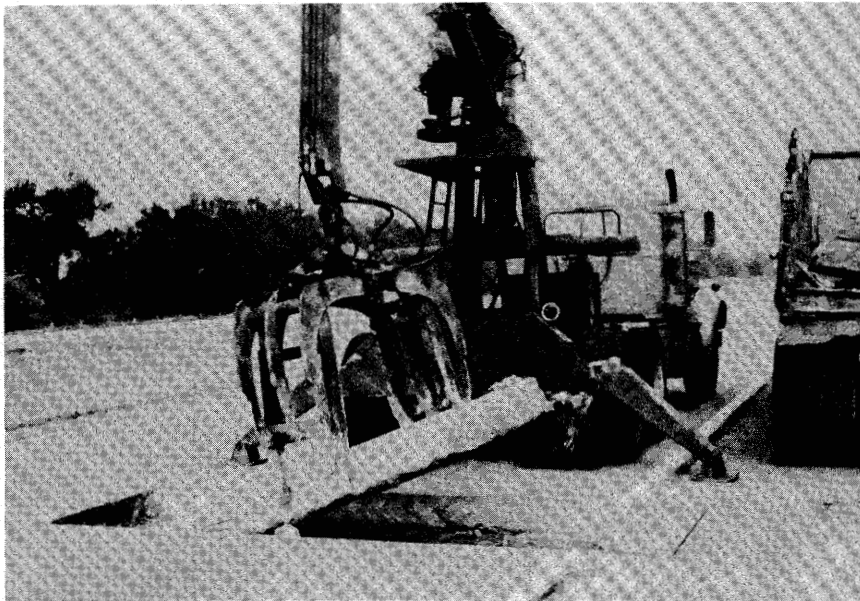
FIGURE 11 – REMOVE CONCRETE

Specialized equipment removes full-depth joint repair section with minimum disturbance of base.

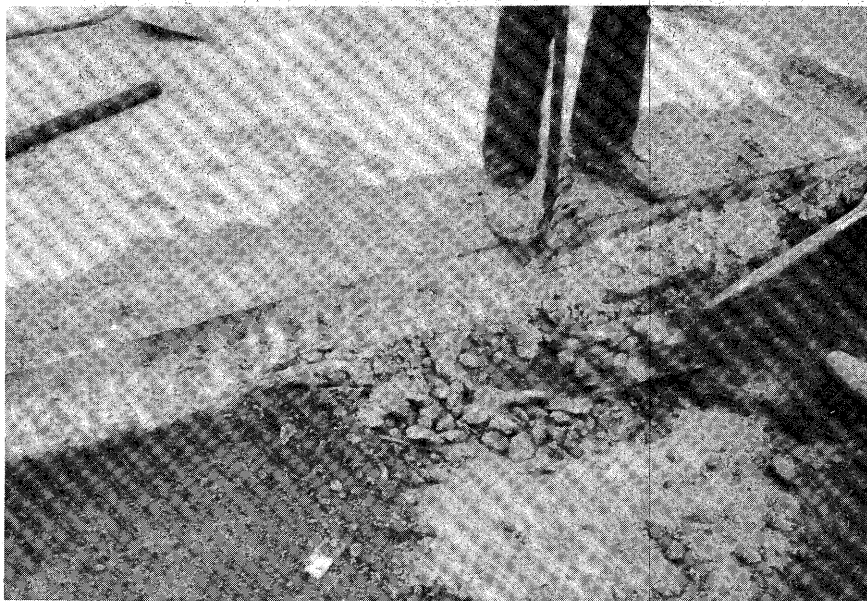
FIGURE 12 – CLEANING REPAIR AREA

Full-depth repair section prepared with a rock saw and a diamond-blade saw. The face of the cut has been prepared to a near vertical face. Projecting wire mesh is being clipped off. A small amount of old broken concrete is being removed with a shovel.

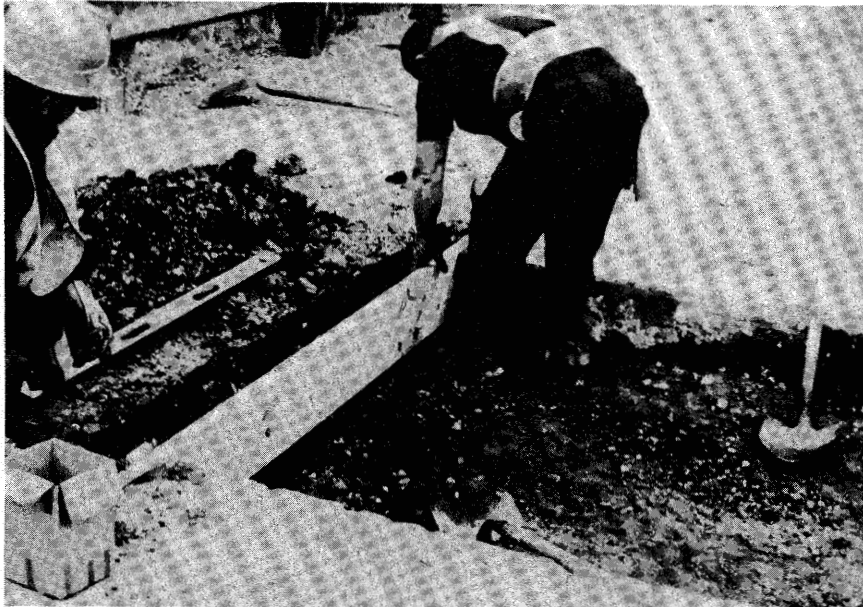
FIGURE 13 – PLACE FORM
A removable wood form is being installed.

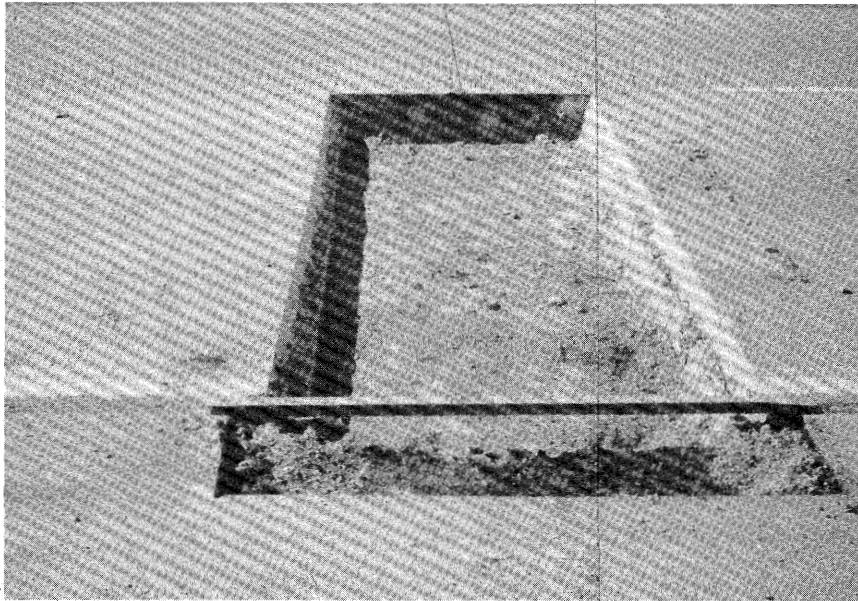
FIGURE 14 – PLACE FORM
An angle iron edge form in place.

The states in this study were in general agreement that the use of an angle iron (1" by 3" or 2" by 3") of sufficient length would be adequate for forming the patch edge. The angle iron is easily installed and removed to be reused on subsequent patches.

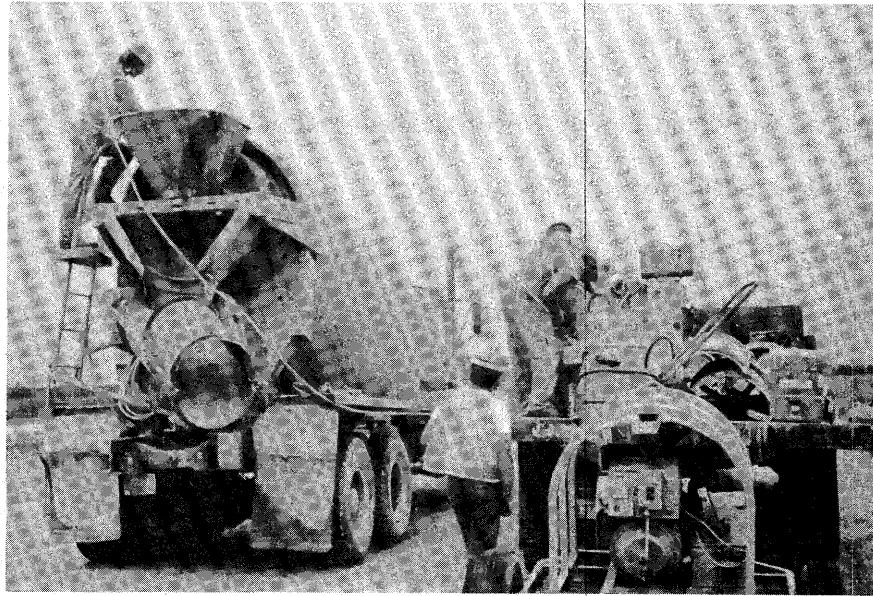
FIGURE 15 – MIX CONCRETE
Adding premixed calcium chloride to ready-mixed concrete prior to concrete placement.

When calcium chloride is to be added to accelerate the set of the concrete, it is recommended that the admixture be premixed with water off of the project prior to beginning repair operations. This eliminates the need to carry scales, bulk bags of material, water and large mixing containers to the field. It also reduces manpower activity in the field at the time of concrete placement. The premixed calcium chloride solution is dispensed by volume into the concrete mix just prior to placement at the repair site. Successful use of such a procedure requires planning for rapid discharge of the concrete into the repair work.

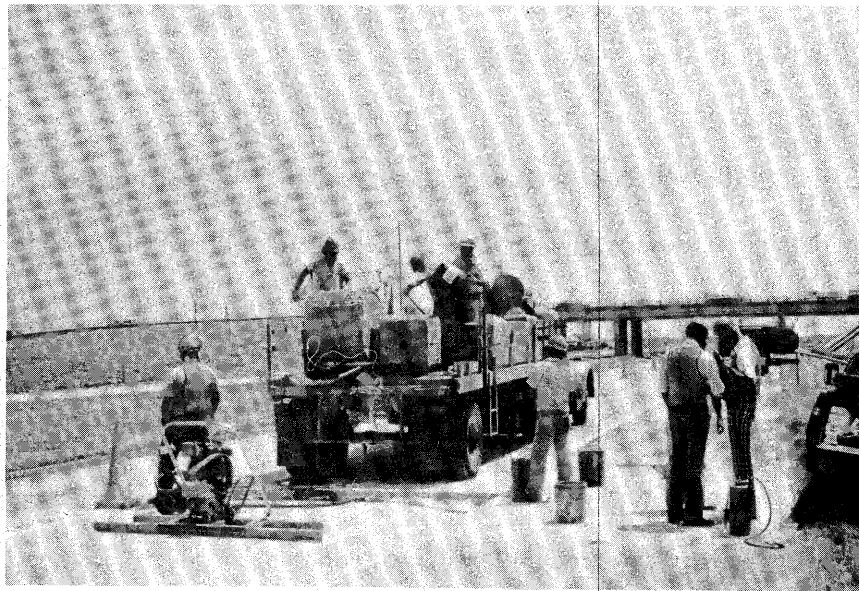
FIGURE 16 – MIX CONCRETE
Truck equipped with materials and small mixer for small volume maintenance work.

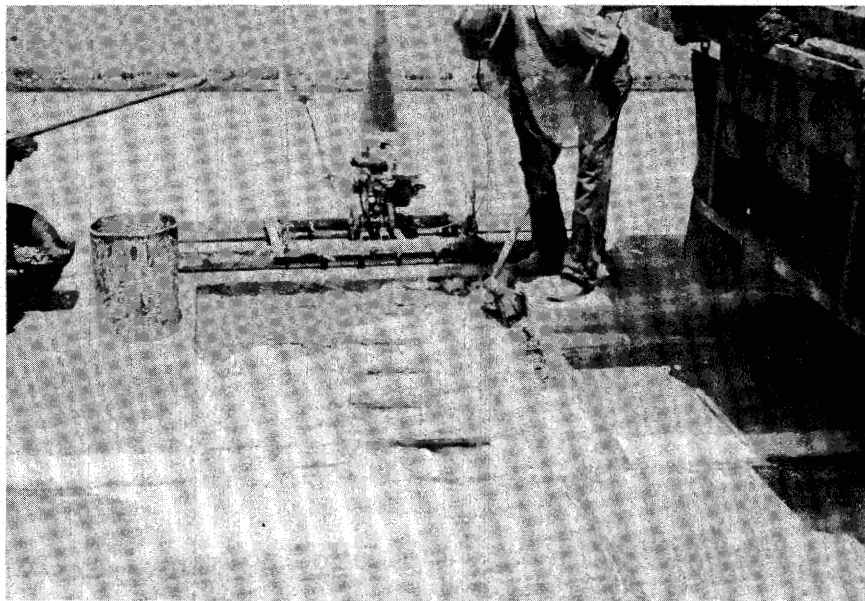
FIGURE 17 – GROUT AREA
Placing grout in partial-depth joint repair.

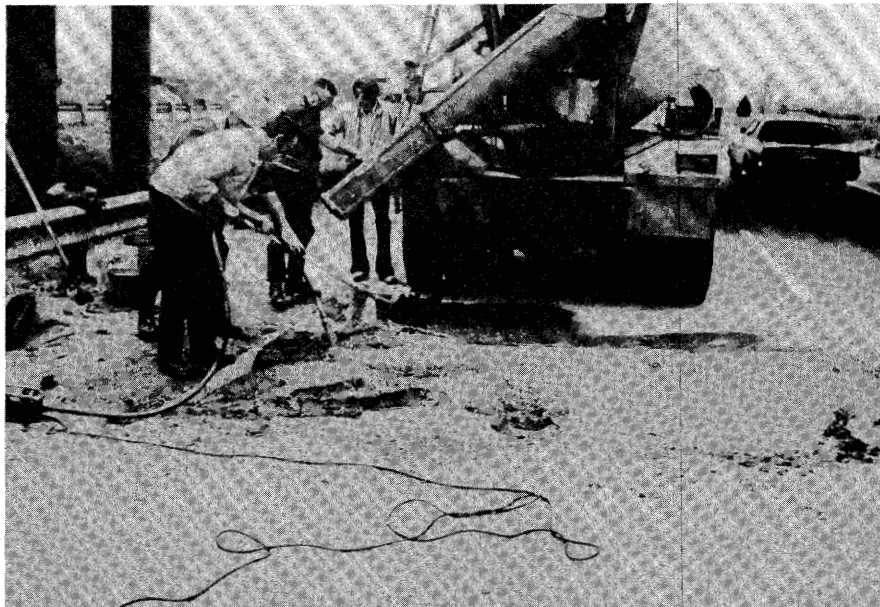
FIGURE 18 – PLACE CONCRETE AND STRIKE OFF
Internal vibration.

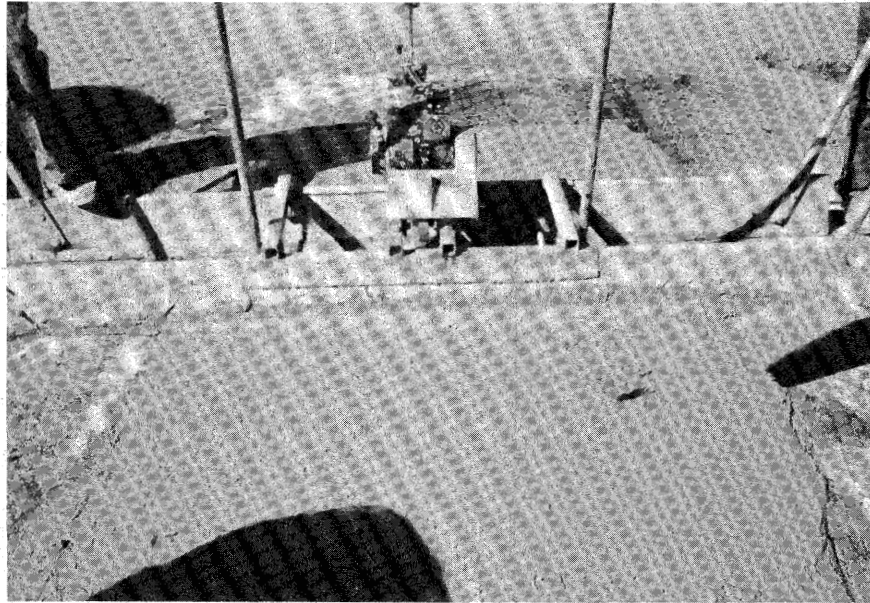
FIGURE 19 – PLACE CONCRETE AND STRIKE OFF
Vibrating screed used to strike off concrete.

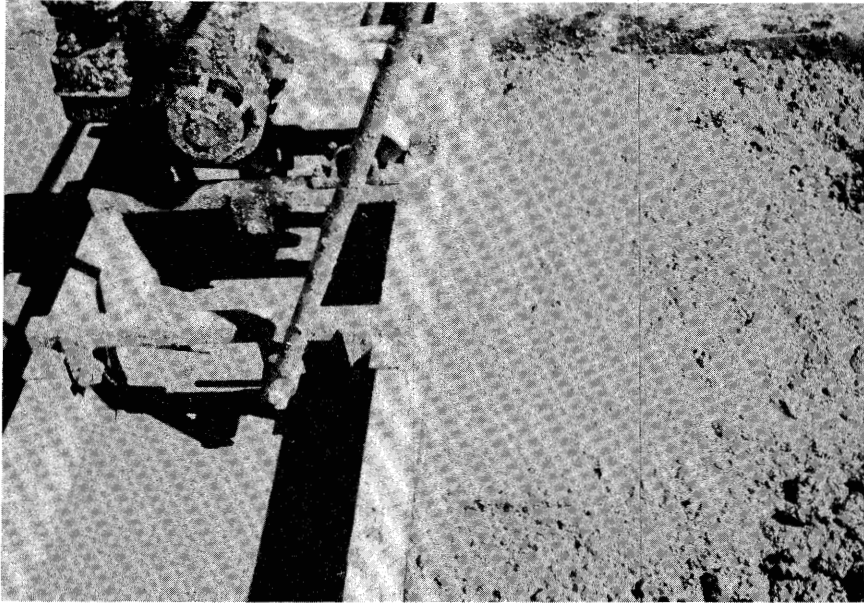
FIGURE 20 – FINISH CONCRETE
The vibrating screed will generally leave an adequate surface finish.

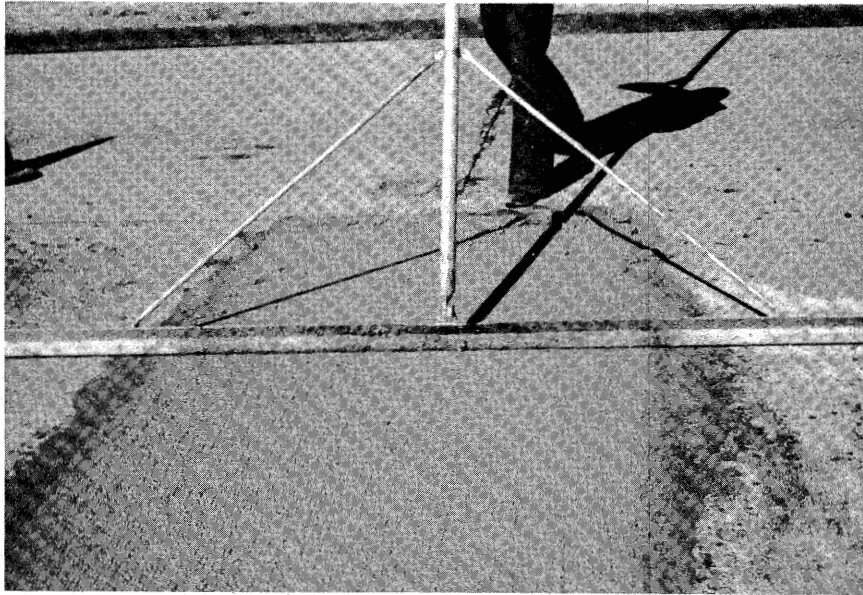
FIGURE 21 – FINISH CONCRETE
Occasionally, additional floating is required to provide a level patch.

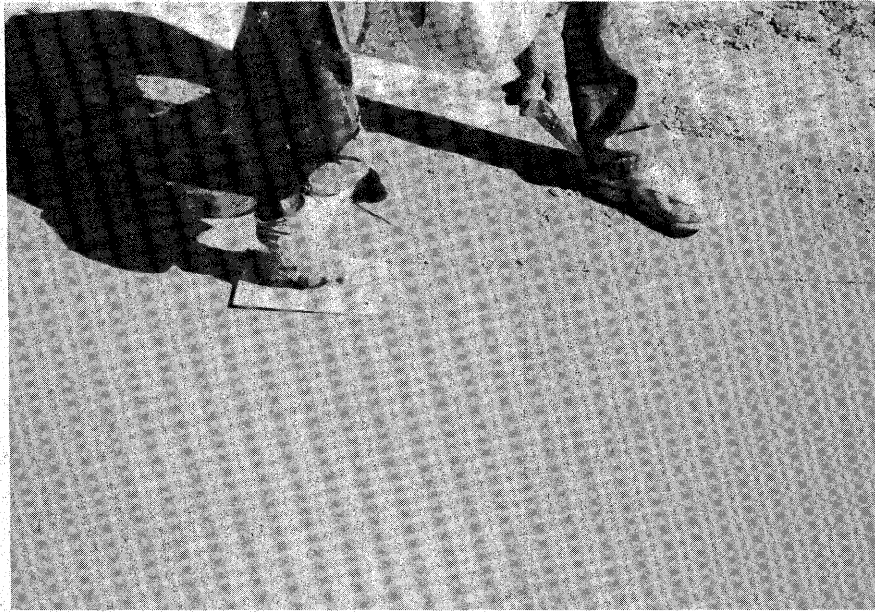
FIGURE 22 – FINISH CONCRETE
Edge finishing a full-depth patch.

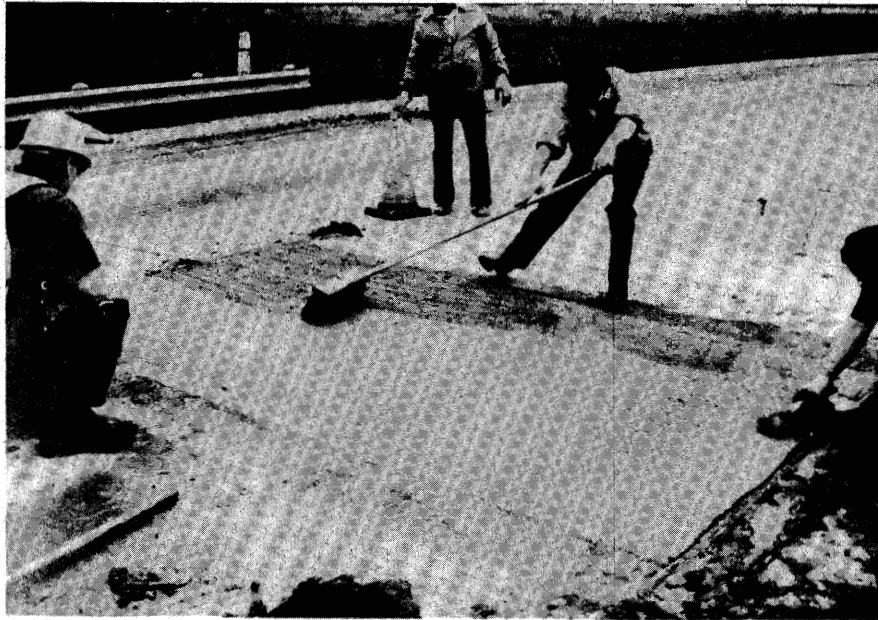
FIGURE 23 – TEXTURE CONCRETE
Broom texturing patch.

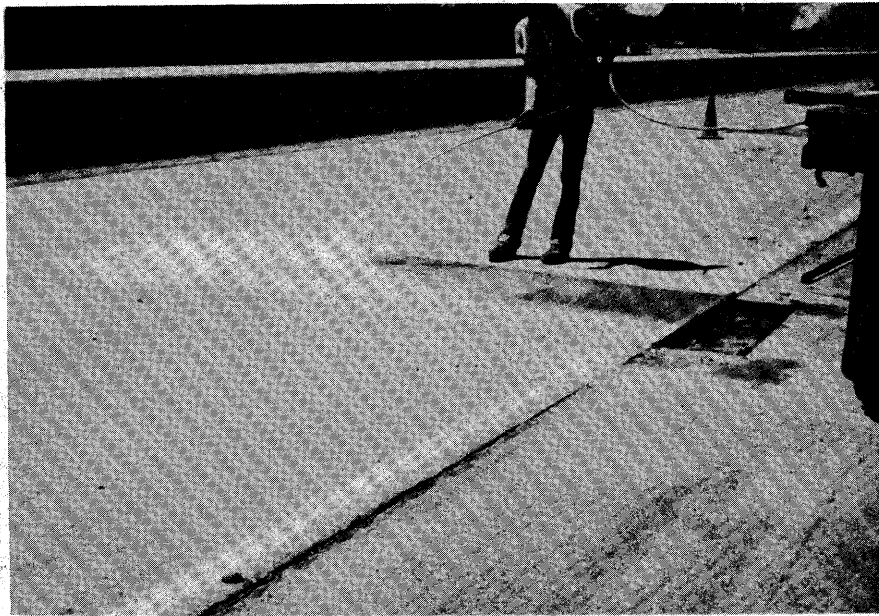
FIGURE 24 – CURE CONCRETE
Curing patch with white pigmented liquid membrane-forming compound.

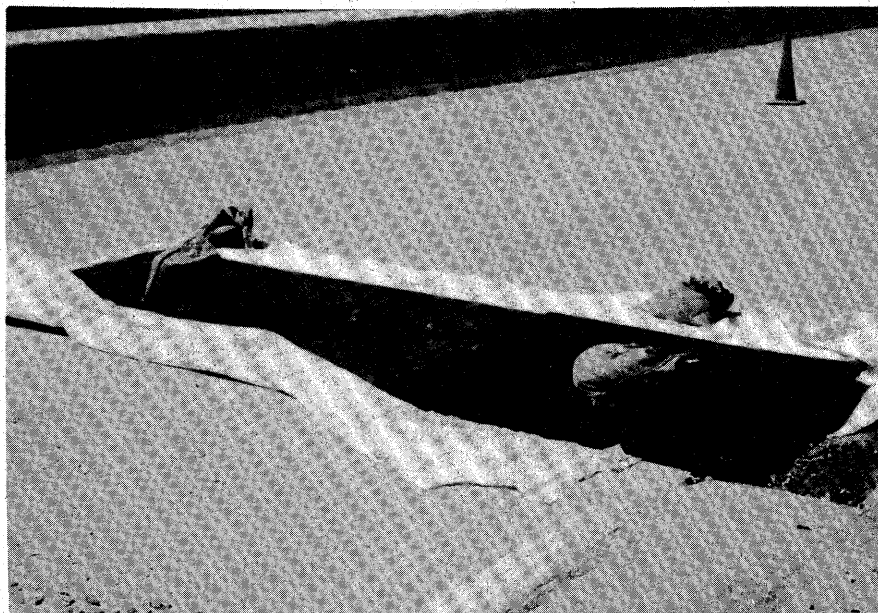
FIGURE 25 – CURE CONCRETE
An accelerated set concrete patch with curing compound, covered with polyethylene film and insulation board.

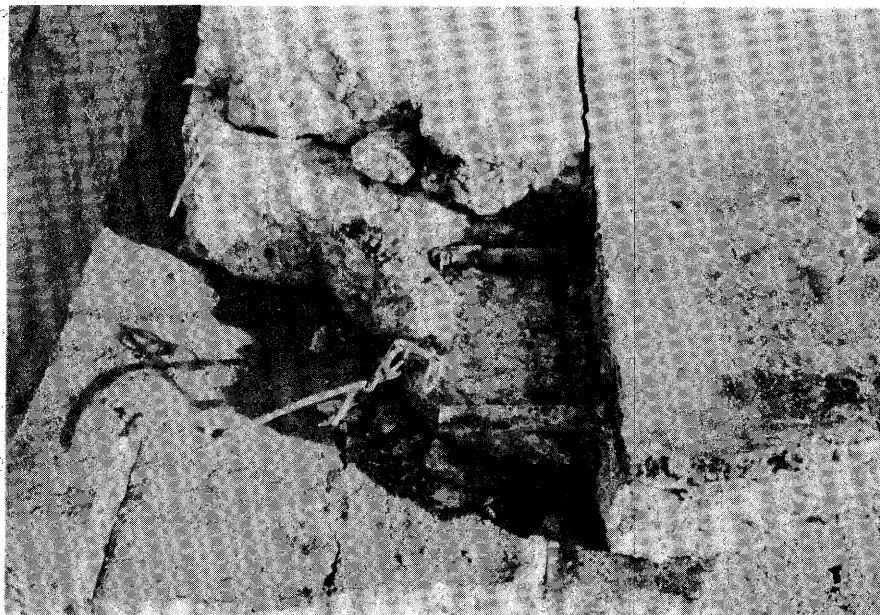
FIGURE 26 – DELAMINATION AT DOWEL BAR LEVEL

A questioning attitude was indicated among some participants of the study concerning the role of dowel bars in the functioning of transverse pavement joints. Where joint problems have developed on pavements undergoing cement aggregate reactions or "D" cracking, the adverse effects from the presence of dowel bars are particularly evident on the old full depth sections of concrete removed during joint repair operations. Delamination of the concrete at the dowel bar level is frequently observed in these sections upon removal. It is speculated in these cases, that differential vertical motion of the concrete on either side of the joint causes the dowel bars to act as levers to pry the structurally weakened concrete apart. The onset of such delaminations is usually the forerunner to breakup of the surface concrete directly over the delamination zones. A delaminated

condition is frequently found at pavement joints which appear structurally intact at the surface. Subsequent breakup of the surface area concrete then occurs, as the pavement is subjected to the continued effects of traffic and weather.

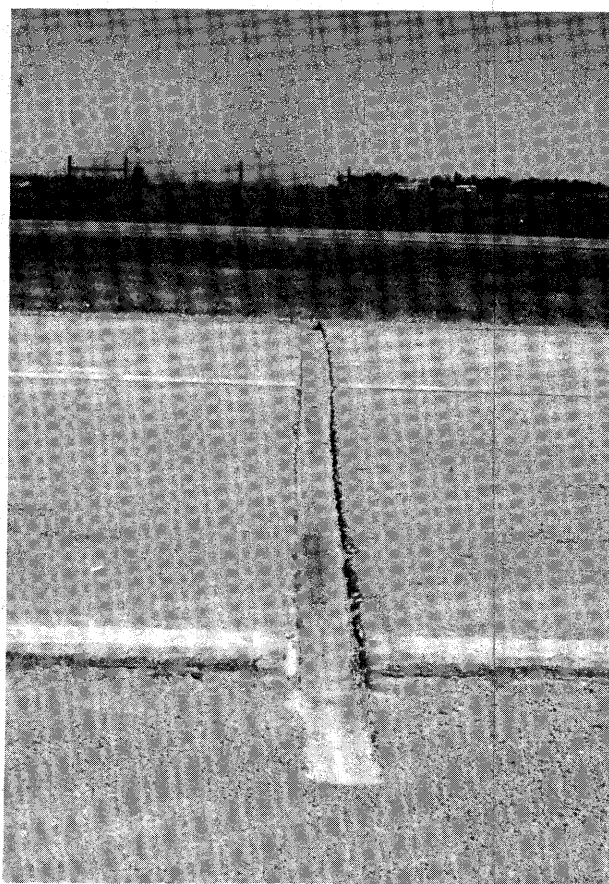
FIGURE 27 – COMPLETED PRESSURE RELIEF JOINT

It is desirable to saw pressure relief joints when temperatures are lower and the effects of thermal expansion are minimal. Spring and fall are better times from a seasonal standpoint while early morning and nighttime would be preferred on a daily basis.
