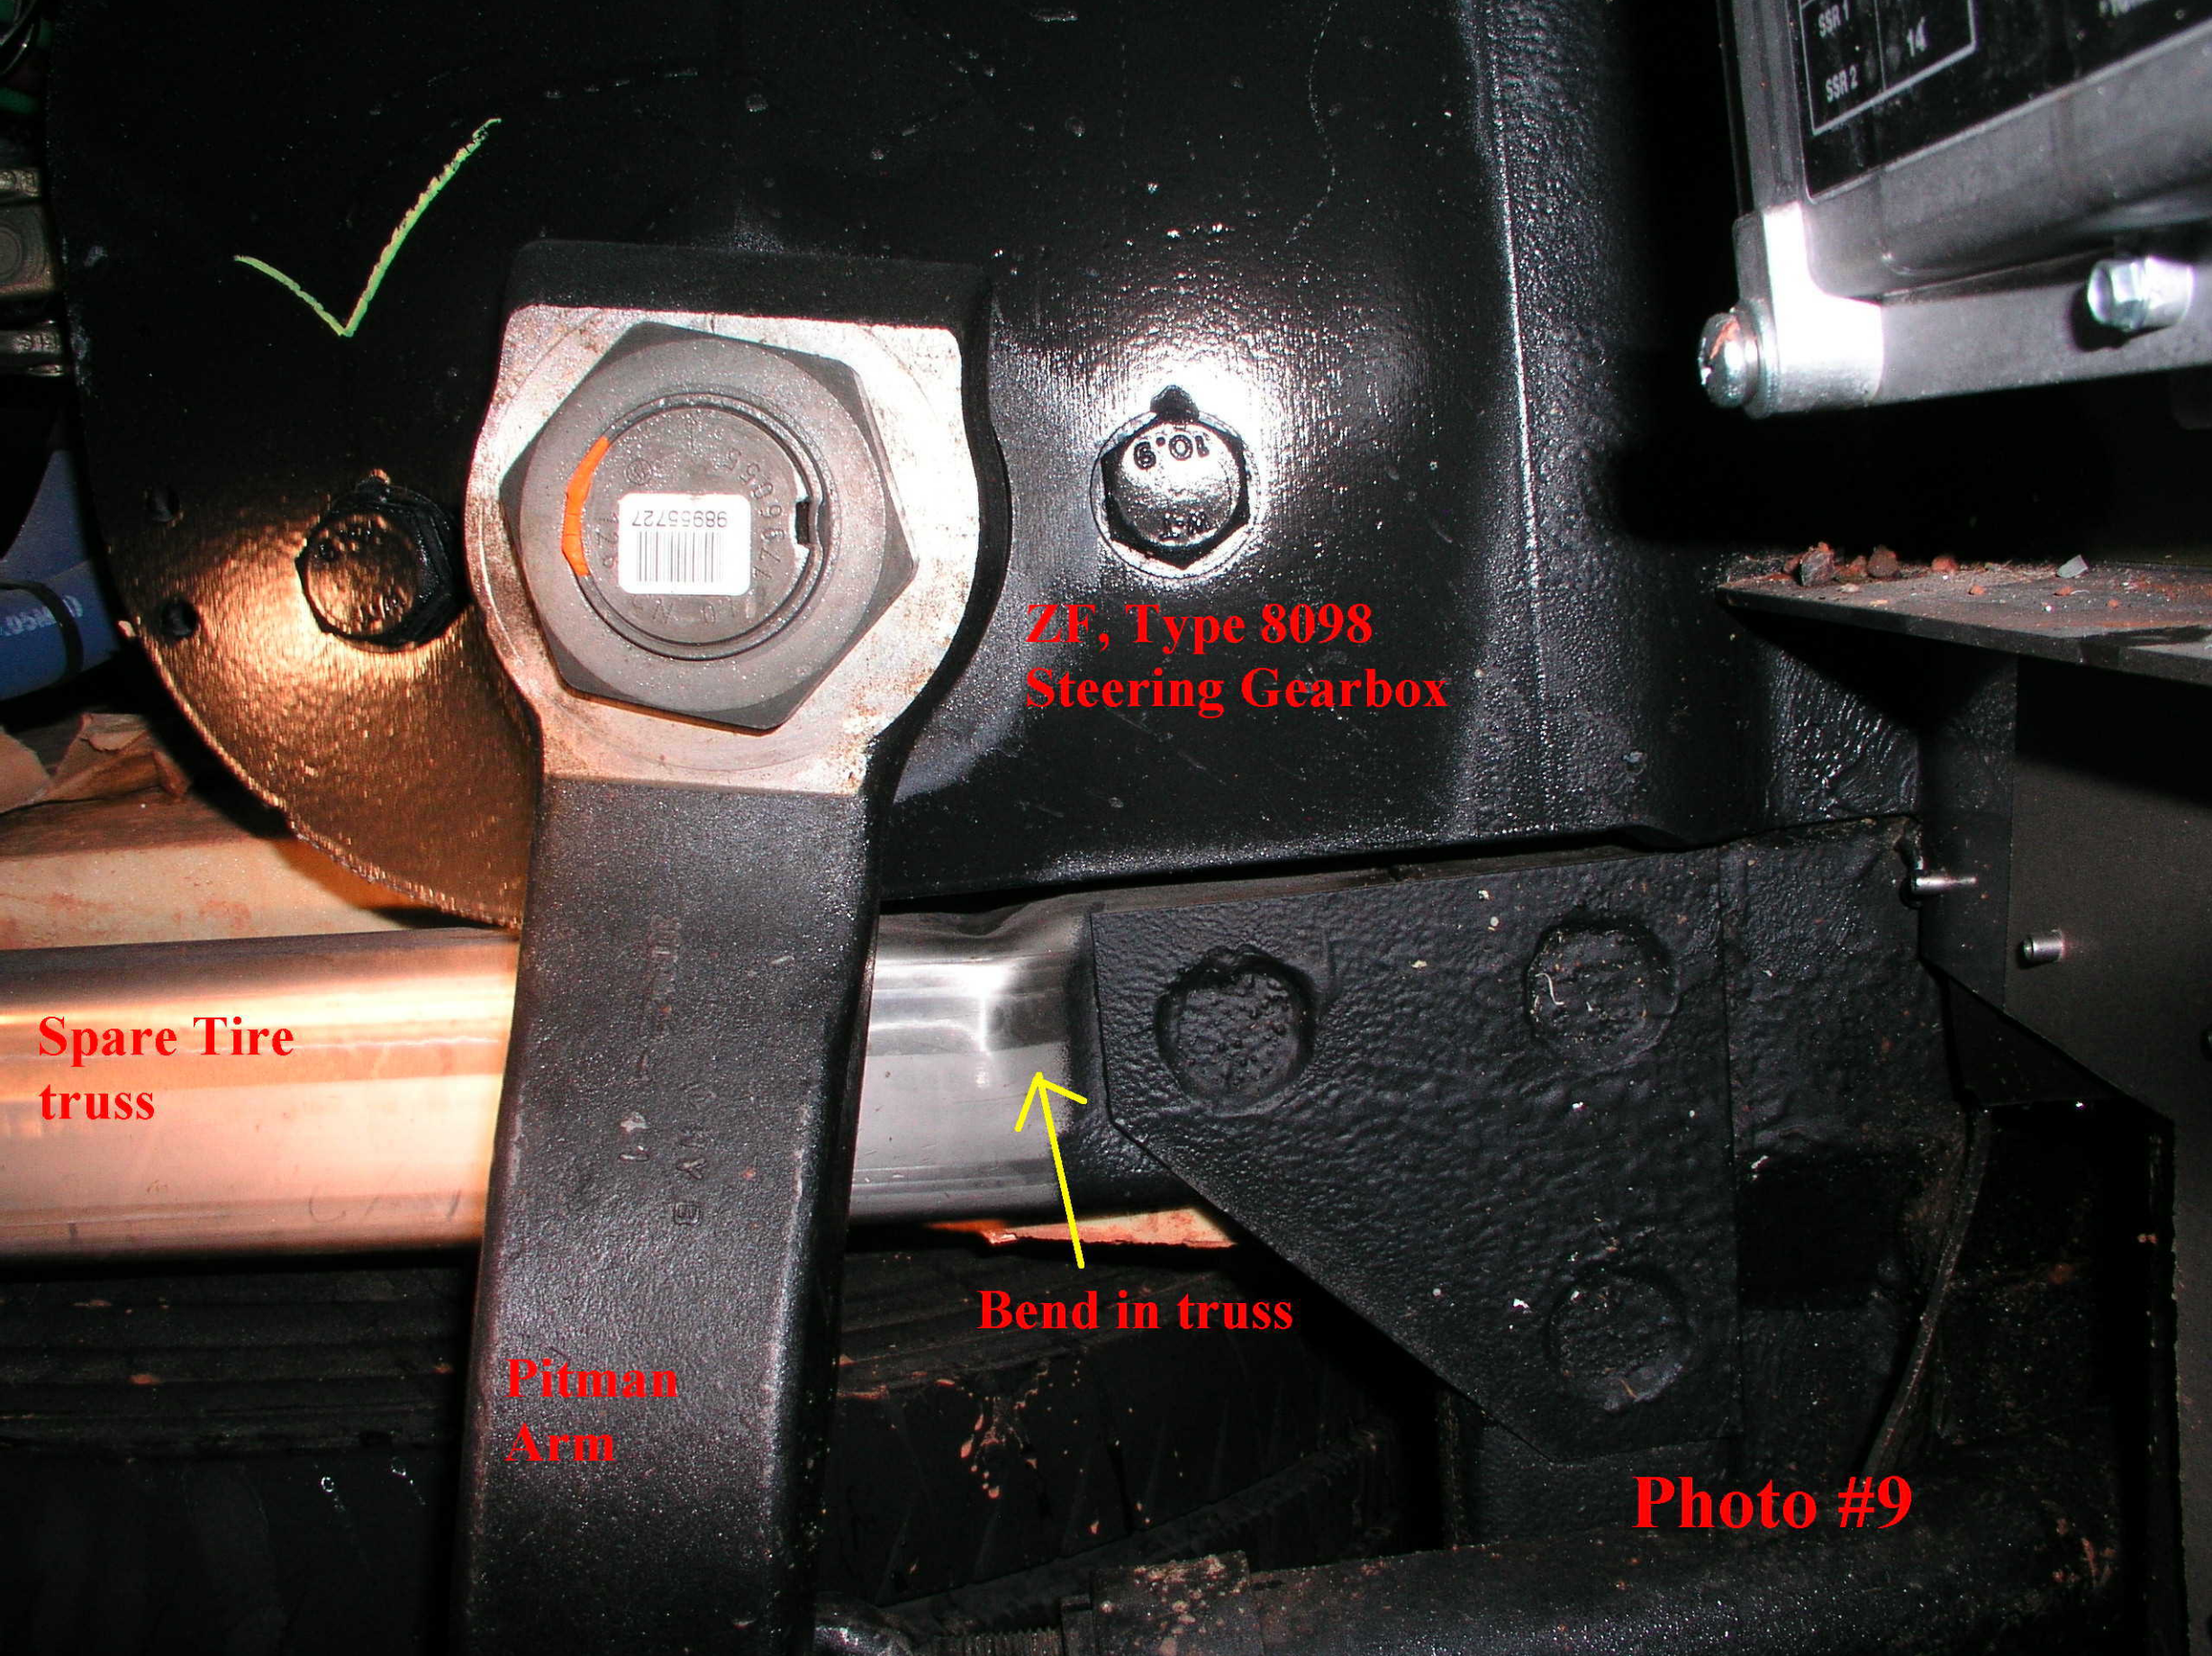
Photo #9

**ZF, Type 8098
Steering Gearbox**

**Spare Tire
truss**

Bend in truss

**Pitman
Arm**

Veh. Photo #09 - Crease in spare tire truss near the firewall
