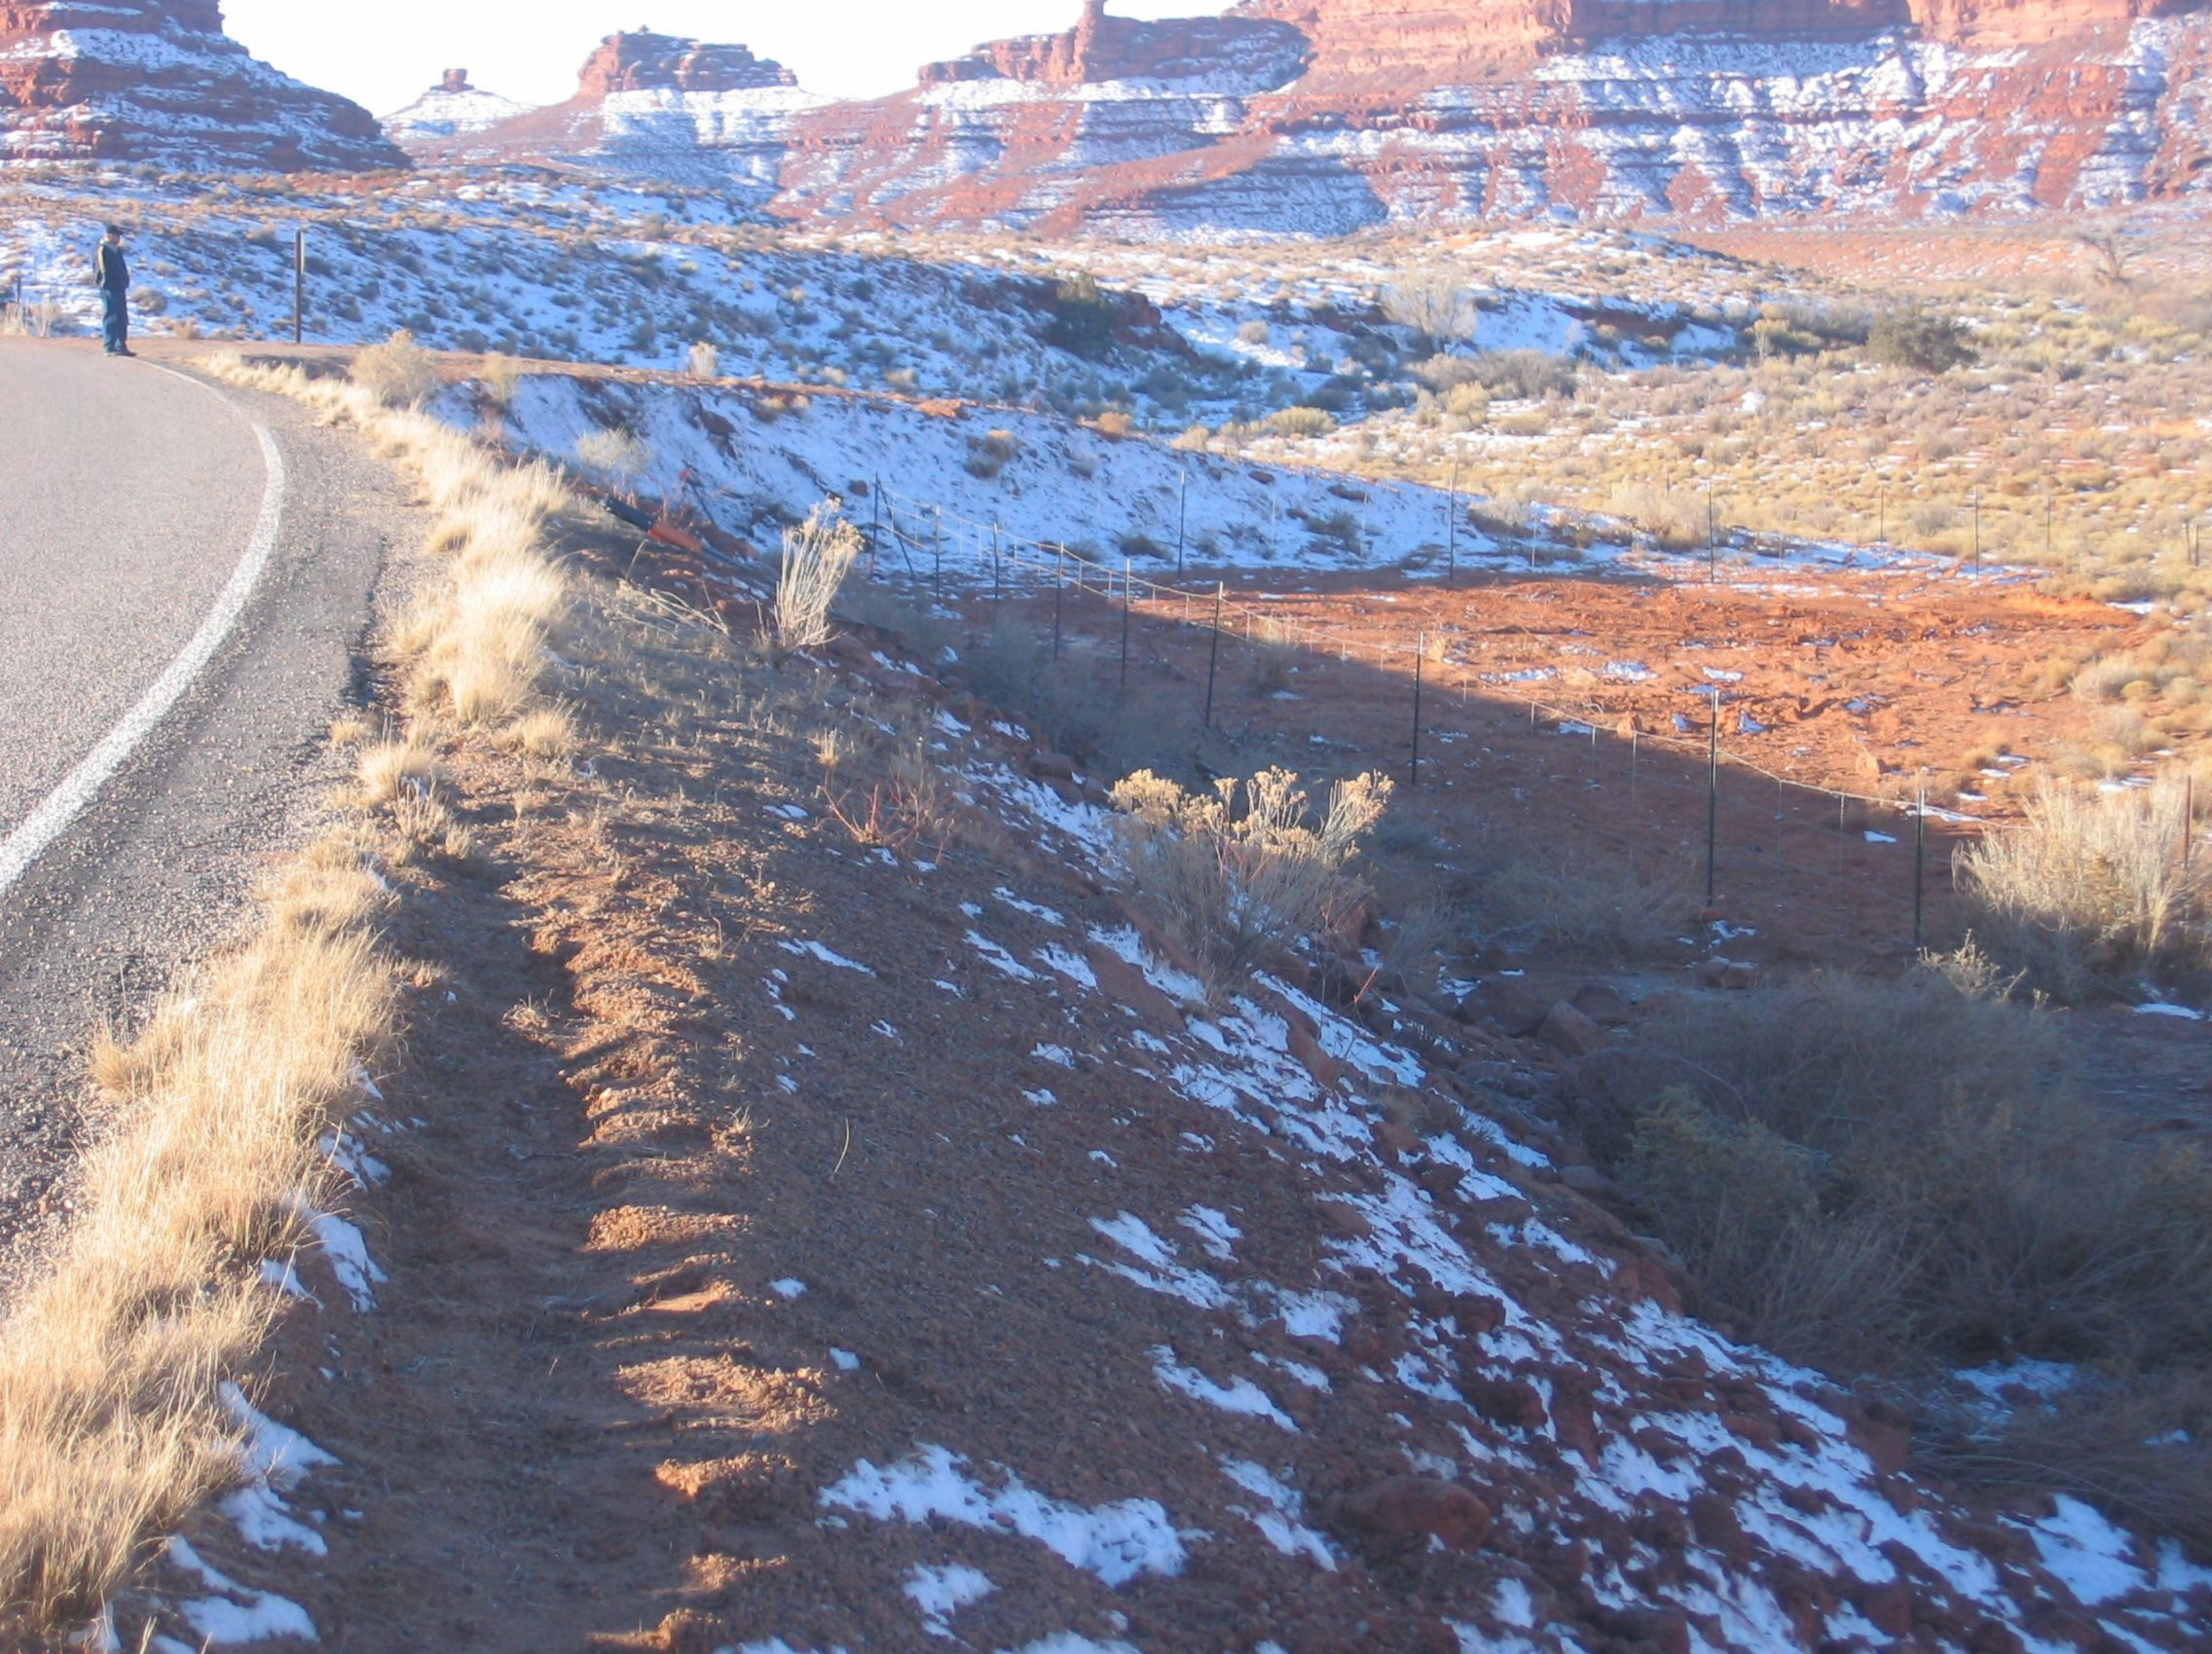
Hwy. Photo #17 - Note the furrowing of the motorcoaches' left front tire as it curves back toward the white painted edge line.
