Wrong Runway Departures

Aviation Safety Information Analysis and Sharing

July 2007

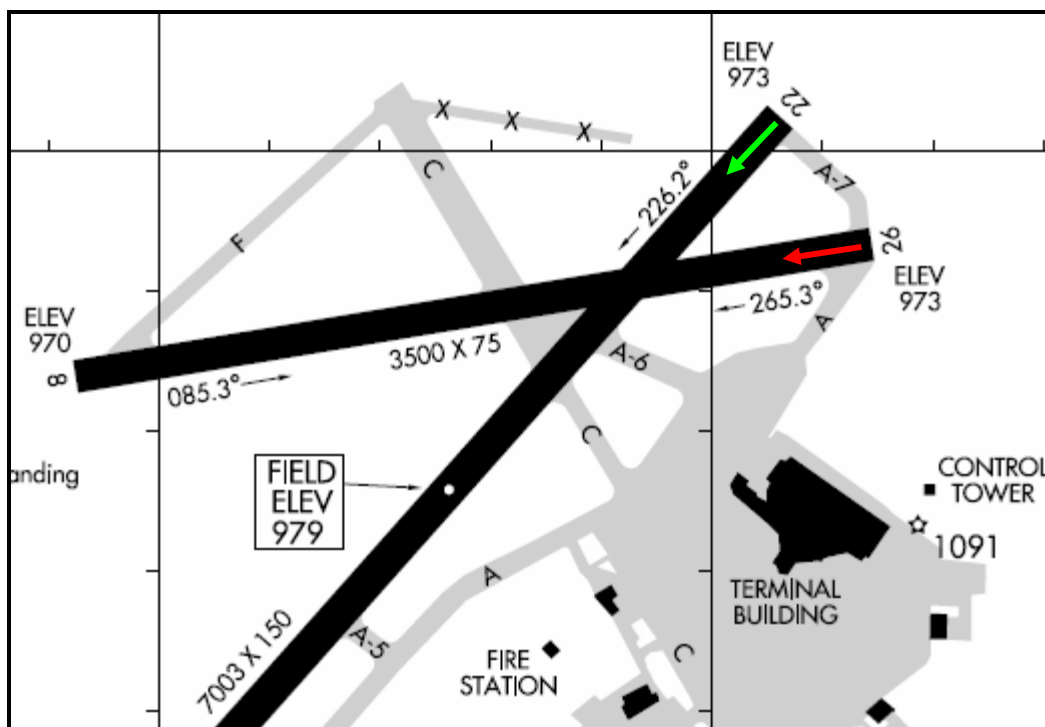
Figure 1. Blue Grass Airport

Tremendous strides have been made in reducing the threat of runway incursions at our nation's airports. Focusing on preventing collisions between airplanes has led to new technologies, new air traffic control (ATC) and flightcrew procedures, and changes in how airports are illuminated and marked. The wrong runway event reports had very similar circumstances to runway incursion reports in that the actions taken by the flightcrews did not match their intentions. On August 27, 2006, Comair, Inc. (doing business as Comair Airlines doing business as Delta Connection) (Comair), flight 5191, operating under part 121 of Title 14, Code of Federal Aviation Regulations (14 CFR), crashed during takeoff from Blue Grass Airport in Lexington, Kentucky. The flight had been cleared for takeoff on runway 22¹; however, the flightcrew inadvertently taxied onto runway 26² and ran off the end of the runway during the takeoff roll (see figure 1). The airplane was destroyed and of the 47 passengers and 3 flightcrew members aboard the airplane, 49 were killed and 1 received serious injuries.

¹ All intended departure runways are represented by a green arrow on the airport diagrams.

² All actual runways used for takeoff are represented by a red arrow on the airport diagrams.

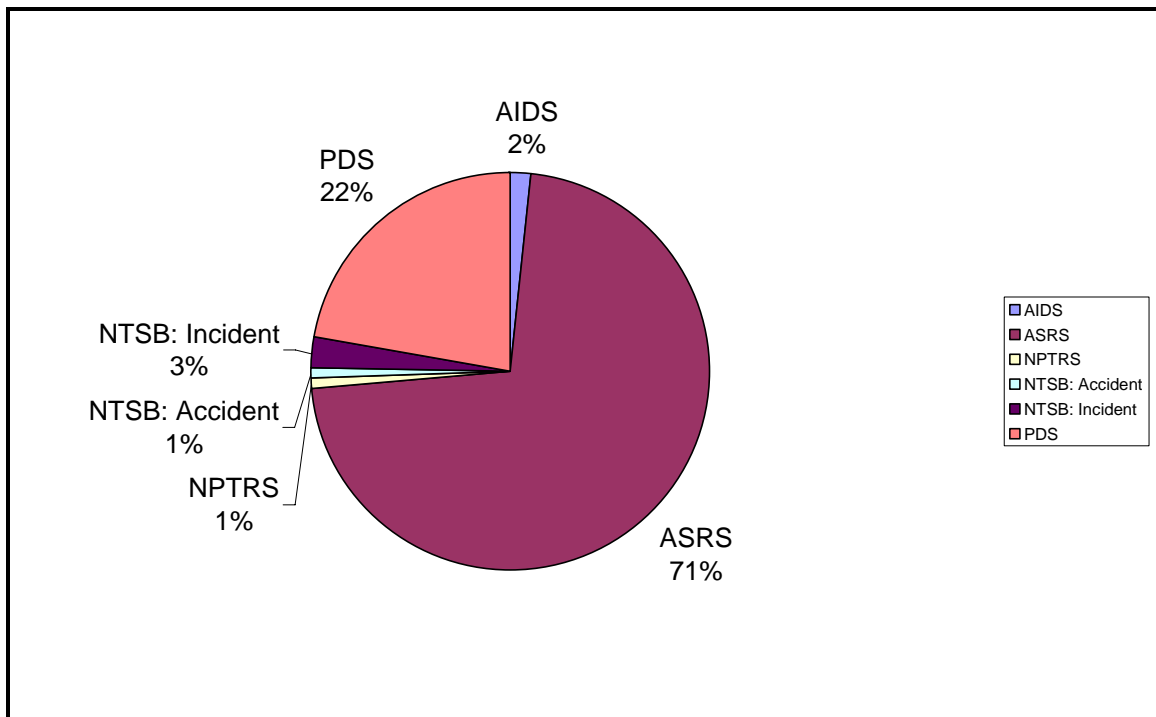
Figure 2. Percent of Part 121 Event Reports By Database

The ASRS database contained the majority of the part 121 events, followed by the PDS, NTSB, AIDS, and NPTRS (see figure 2). The reports collected in the ASRS database are voluntarily submitted and therefore capture only the occurrences that have been reported. The narrative fields of the ASRS event reports provided the best source of information for determining the contributing factors because they are first-hand accounts of the events from the flightcrew members involved.

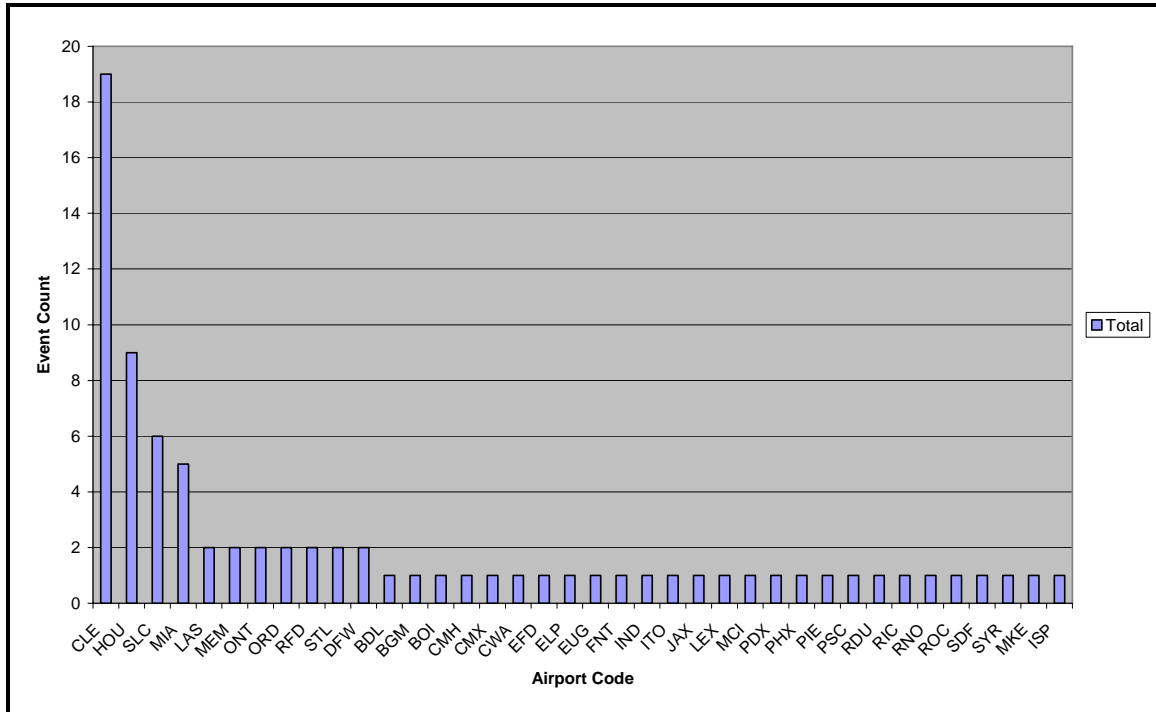
**Figure 3. Part 121 Wrong Runway Events by Airport (1981 – 2006)
(80 Events Scored by JIMDAT)**

The 80 remaining part 121 wrong runway events reviewed occurred at many airports (see figure 3); however, the following airports had the highest number of overall events:

- Cleveland Hopkins International Airport (CLE) 24%
- Houston Hobby Airport (HOU) 11%
- Salt Lake City International Airport (SLC) 8%
- Miami International Airport (MIA) 6%

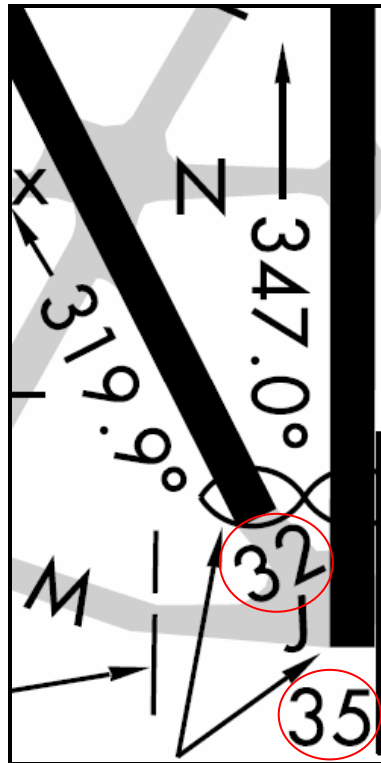
Figure 4. Example of Multiple Runway Ends in the Same Location (Salt Lake City International Airport)

- *A similar layout, with one taxiway leading to an area with multiple runway thresholds located in close proximity to one another.* The analysis of the wrong runway events revealed that most events took place in the areas where multiple runway thresholds are in close proximity. These areas present an opportunity for flightcrew members to taxi the airplane onto the wrong runway. This is especially true when flightcrew members have to cross one or more runways on the same taxiway. In some cases, multiple runway ends are in the same location (see figure 4).

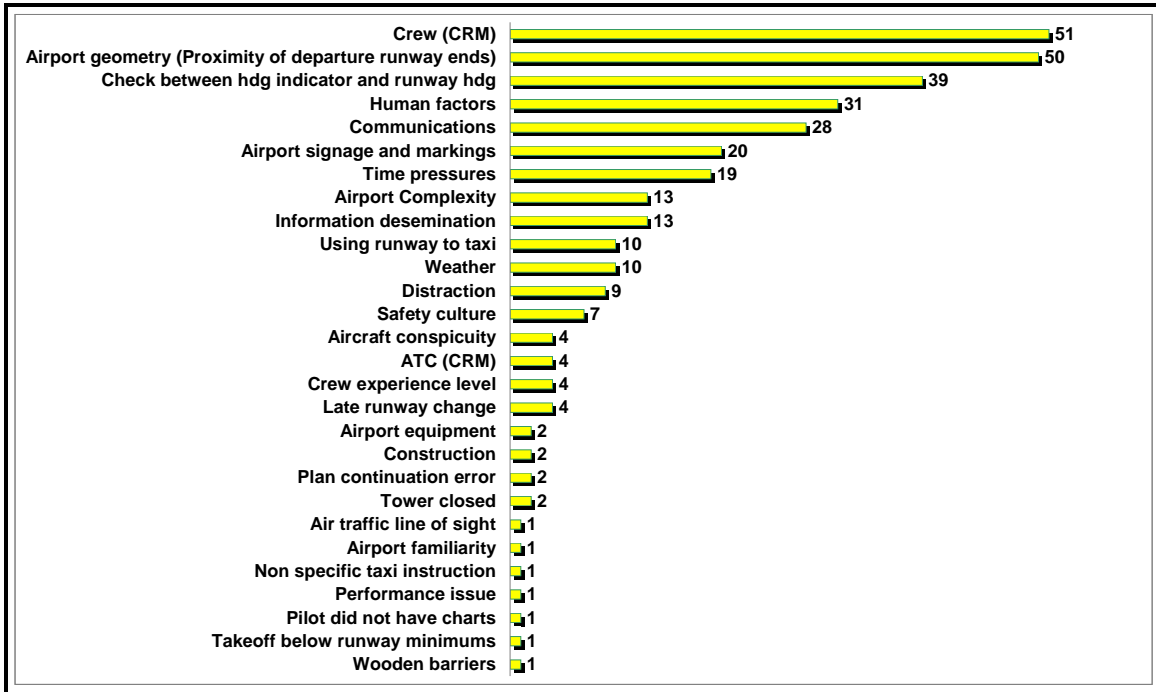
Figure 5. Wrong Runway Contributing Factors Citations

In addition to the common wrong runway contributing factors present at the airports, the factors referenced in figure 5 were identified and addressed in the mitigations.

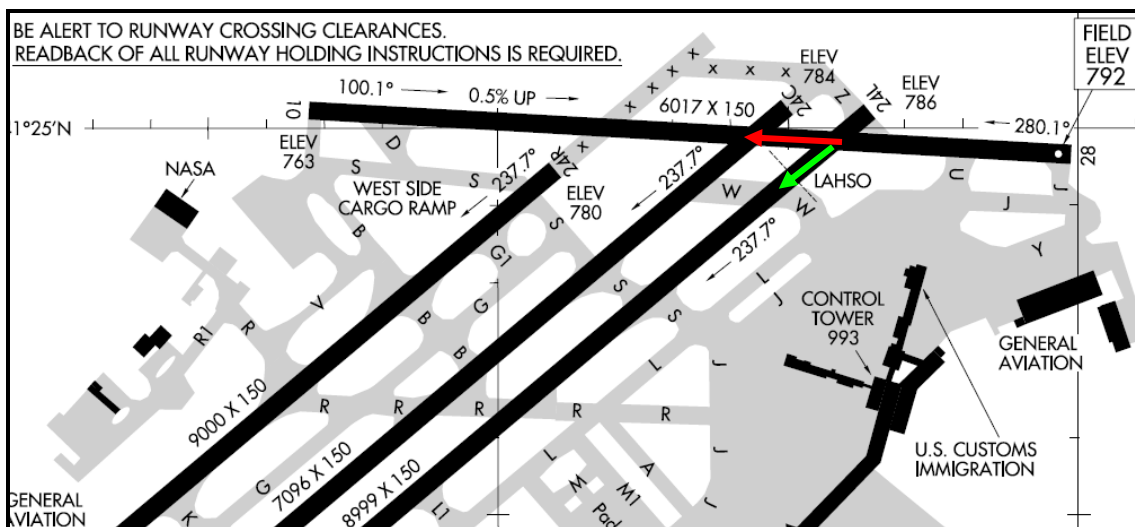
Figure 6. Cleveland Hopkins International Airport

The following is a summary of an event described in a report from Cleveland Hopkins International Airport submitted to the ASRS database following an event in 1993. Note that runway 23L referenced in the narrative is now designed as runway 24L as shown in figure 6.

Because of confusion at the intersection of runways 23L and 23R and 28 at the approach end of the runways, we initiated a takeoff on the wrong runway for which we had been cleared. We had been cleared for takeoff on runway 23L. Because of the short distance between the terminal and the runways, we had a very short taxi time.

Just as we reached the hold short lines, we had completed our taxi checklist and were immediately cleared for takeoff on 23L. As the Captain taxied out to line us up (he has the nose steering on his side only), I ran my line-up checklist and he said “Hello” to the passengers over the PA system. Lined up on the wrong runway. I took the throttles and we proceeded down the wrong runway. The tower controller called us to tell us we were taking off on the wrong runway. We were at about 35 knots and so I aborted.

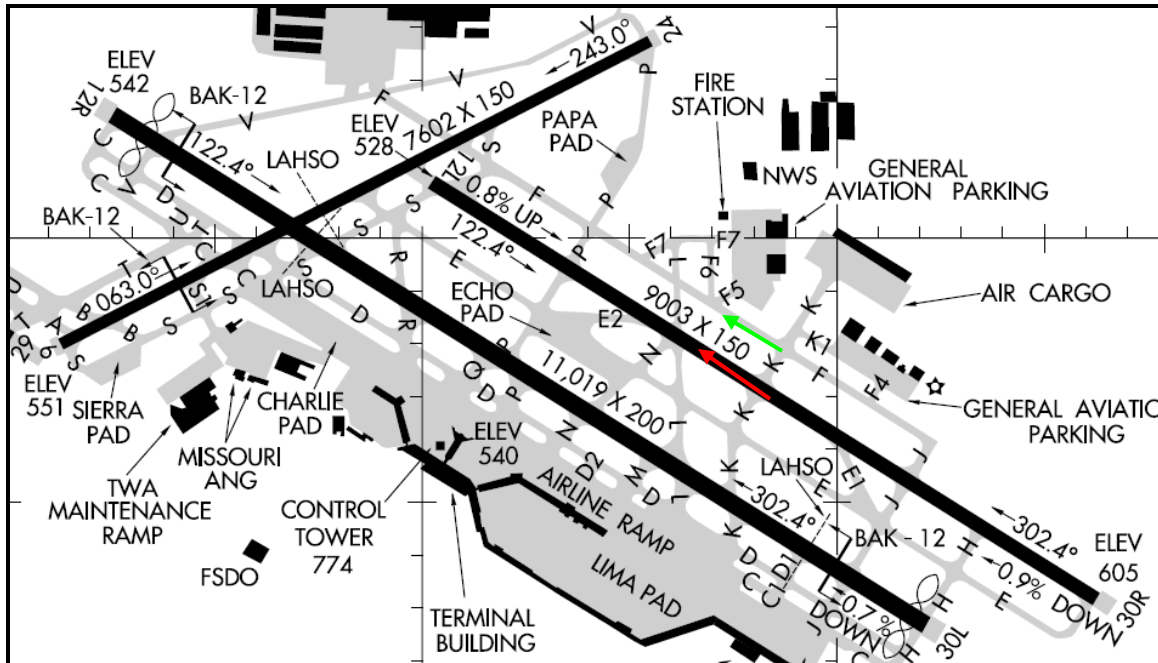
Figure 7. St. Louis Lambert International Airport (Accident Event)

At the time of the accident, ATC used runway 31, which is depicted as taxiway F on the airport diagram, as a joint use runway and taxiway (see figure 7). Runway 31 was marked with standard runway markings but was only 75 feet wide, giving it the appearance of a taxiway. The Automatic Terminal Information System (ATIS) current at the time identified runways 30R and 30L as the active runways for arrivals and departures but failed to mention the occasional use of runway 31. ATC personnel were not able to maintain visual contact with the Cessna after it taxied from the well-lighted ramp area into the runway/taxiway environment of the northeast portion of the airport. The NTSB stated that the pilot of the Cessna acted on an apparently preconceived idea that he would use his arrival runway, runway 30R, for departure.

After receiving taxi clearance to back-taxi into position and hold on runway 31, the pilot taxied into a position at an intersection on runway 30R, which was the assigned departure runway for the MD-82. The flightcrew of the MD-82 was not able to see the Cessna until a moment before impact. The collision killed the two people aboard the Cessna.

The NTSB concluded that the cause of the accident was the Cessna 441 pilot's mistaken belief that his assigned departure runway was runway 30R. This resulted in his undetected entrance onto runway 30R, which was being used by the MD-82 for its departure. Contributing to the accident was the lack of ATIS and other aeronautical information regarding the occasional use of runway 31 for departure.

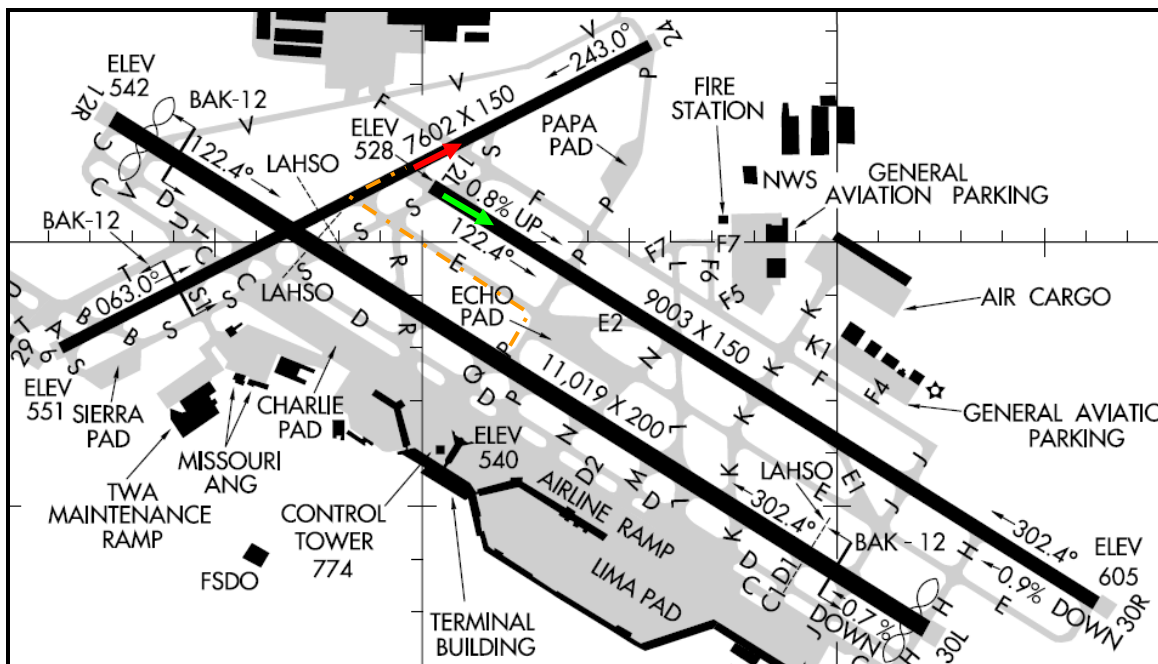
Figure 8. St. Louis Lambert International Airport (Incident Event)

An air carrier MD-80 was the second airplane holding in line on taxiway P for a departure on runway 12L (see figure 8). The first airplane in line for runway 12L could not depart because of a traffic sequence conflict. The MD-80 was given amended taxi instructions to taxi onto runway 6, which was inactive, via taxiway E and to hold short of runway 12L on runway 6. The airplane was then cleared for takeoff on runway 12L. The flightcrew read back the instructions correctly, and then proceeded to commence takeoff on runway 6 with 3,000 feet remaining on the runway. The St. Louis tower observed this and advised the flightcrew to abort the takeoff. The airplane rolled out to the end of runway 6 and made a 180 degree turn.

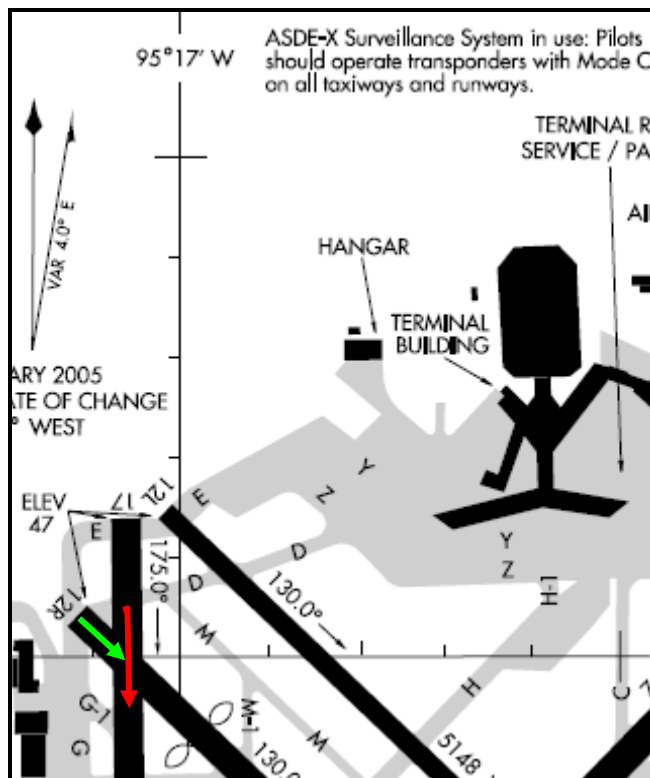
Figure 9. Houston Hobby Airport

The NTSB also investigated an incident in 1989 where an American Airlines, Inc., MD-80 was cleared for takeoff on runway 12R, but departed from runway 17 (see figure 9). Making the matter worse was the fact that the south 2,200 feet of runway 17 was closed because of construction as noted by notices to airmen (NOTAMs) and ATIS. As the airplane rotated, it struck sections of wooden barriers that had been placed across runway 17, causing minor damage to the airplane. The flightcrew's failure to follow taxi instructions and to ensure they were on the proper runway before initiation of the takeoff roll was the cause of the incident. Seventy-three days before this incident, the NTSB noted that another air carrier airplane was cleared for takeoff on runway 12R and also inadvertently departed on runway 17.

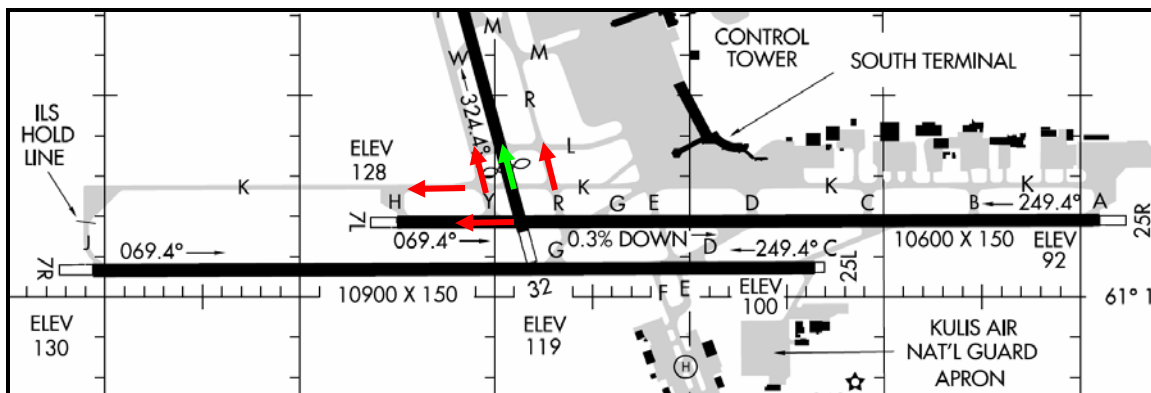
Figure 10. Ted Stevens Anchorage International Airport

Part 129 air carriers exhibited the same contributing factors found in the part 121 events. Remarkably, four of the seven part 129 events occurred at Ted Stevens Anchorage International Airport (ANC) when the flightcrew was cleared for departure on runway 32 (see figure 10). With this runway assignment, flightcrews taxied to or departed from runways and taxiways other than the one assigned by ATC, as summarized below.

2002 — A China Airlines A-340 was cleared for takeoff on runway 32, but departed from taxiway K.

2005 — An all-cargo MD-11 was issued a takeoff clearance for runway 32 but departed from taxiway Y.

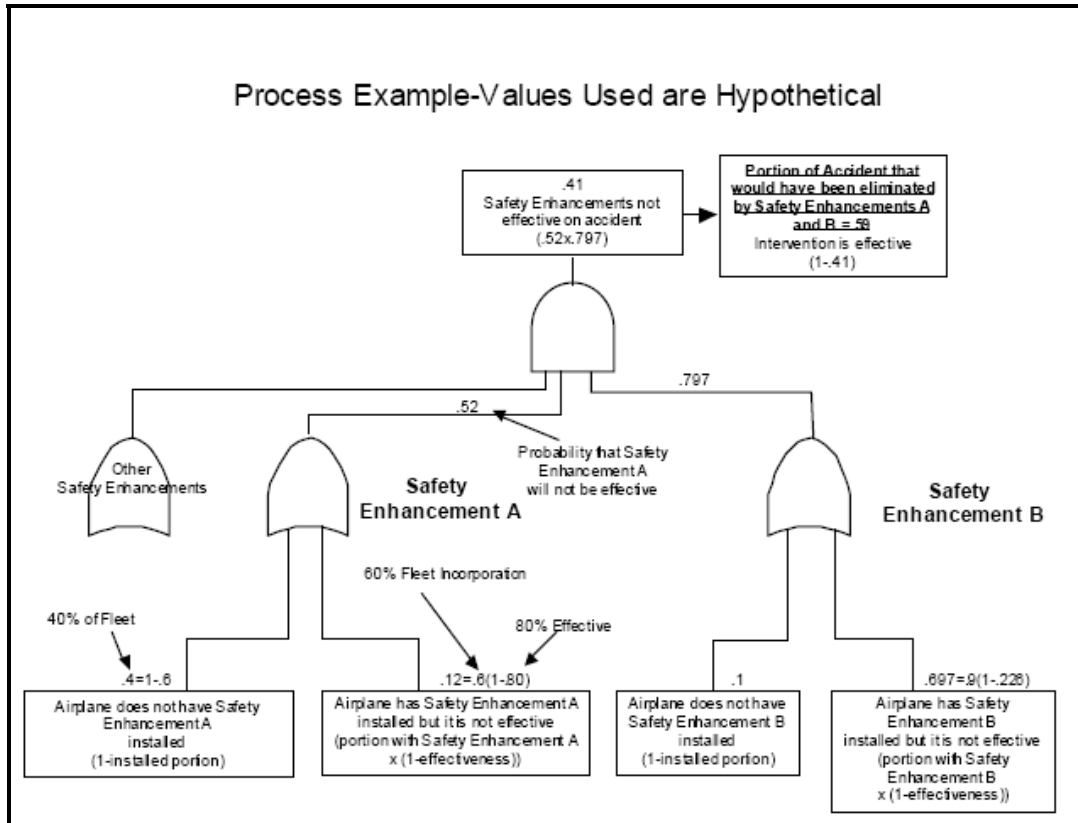
Figure 11. Logic Diagram Mathematical Model

The JIMDAT spreadsheet tool will also develop the Total Risk eliminated for a combination of enhancements against the data set. This is done by using a logic diagram mathematical model similar to that used in fault tree calculations (see figure 11). The effectiveness and implementation of each safety enhancement are inputs to the model.

The severity eliminated by a set of safety enhancements is determined by summing the products of the logic diagram mathematical model values, incident/accident severity, and future risk factor across all incident and accidents in the data set. The Total Risk Eliminated is then calculated by dividing the severity eliminated by all safety enhancements working together by the total severity of the incident/accident data set. The Total Risk eliminated for a set of enhancements also represents a portion of the threat eliminated and is often expressed as a percentage by multiplying by 100.

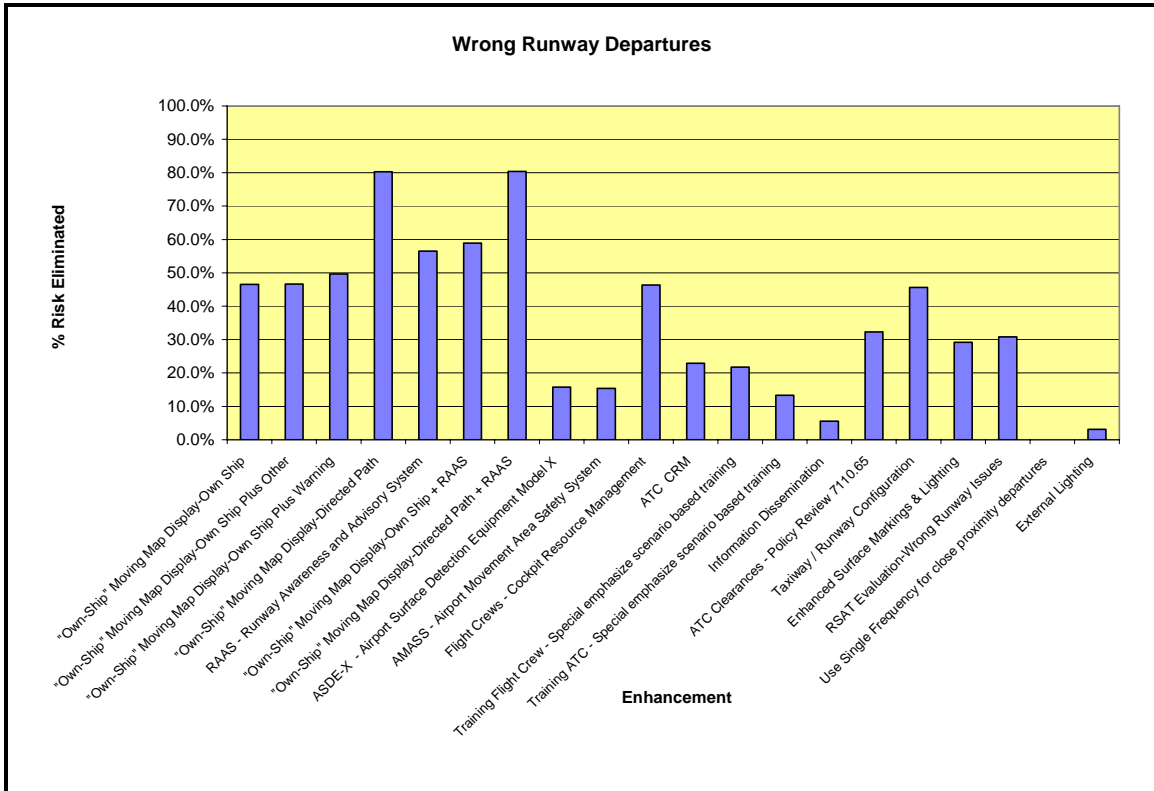
Figure 12. JIMDAT Scoring of Risk Eliminated by Wrong Runway Safety Enhancements

Using the JIMDAT scoring methodology, the enhancements recommended by the SMEs were found to have the potential to eliminate 98 percent of the risk of wrong runway departures (see figure 12).

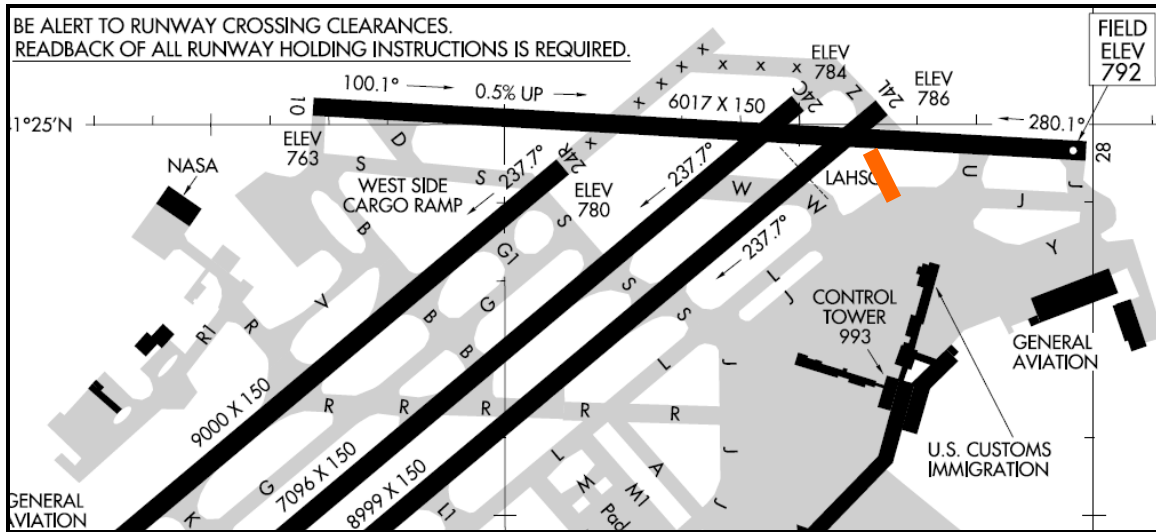
**Figure 13. Cleveland Hopkins International Airport
(Taxiway T Shown in Orange)**

the intersection of the two runways, with the threshold of a third runway (24C) relatively close by, presented an opportunity for pilot deviations and inadvertent use of runway 28 instead of runway 24L. The threat was worsened by the fact that at the time there were no holding position markings for runway 24L on runway 28. Removal of taxiway T also lengthened the taxi time from the terminal to the runway environment, which lessened time pressures on flightcrews attempting to complete pre-takeoff checklists while taxiing.

Another change that occurred in the mid-1990s at the Cleveland airport was the implementation of new marking standards. The primary impact of these new standards was the use of surface painted holding position and runway signs on taxiway surfaces. Unfortunately, surface painted runway signs could not be used at Cleveland to address the problems with pilots taxiing to runway 24L, because surface painted signs could not be employed on runway 10/28, which is an active runway.

Finally, because runway 10/28 was frequently used as a taxiway to gain access to runway 24L, the airport obtained waivers from the standards to install some innovative lighting and marking improvements. Runway 28 now has holding position markings and in-pavement and elevated runway guard lighting at the holding position for runway 24L. The runway also has taxiway centerline lights installed. When these lights are activated, they are required to be set to intensity level three, and the runway side lights for runway 28 are deactivated. Since the installation of these devices, incidents involving failure to hold short of runway 24L or inadvertently use the wrong runway when cleared for departure from runway 24L have decreased significantly.

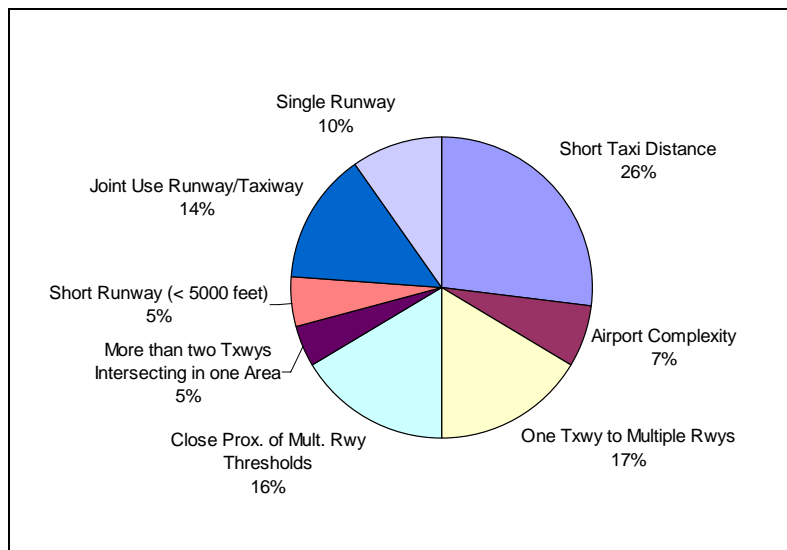
Figure 14. Percentage of Part 139 Airports With Associated Wrong Runway Threat Areas

A preliminary review of the 355 part 139 class I airports shows that even though wrong runway events have not occurred at each location, many of the airports have similar physical characteristics that were found to be contributing factors (see figure 14).

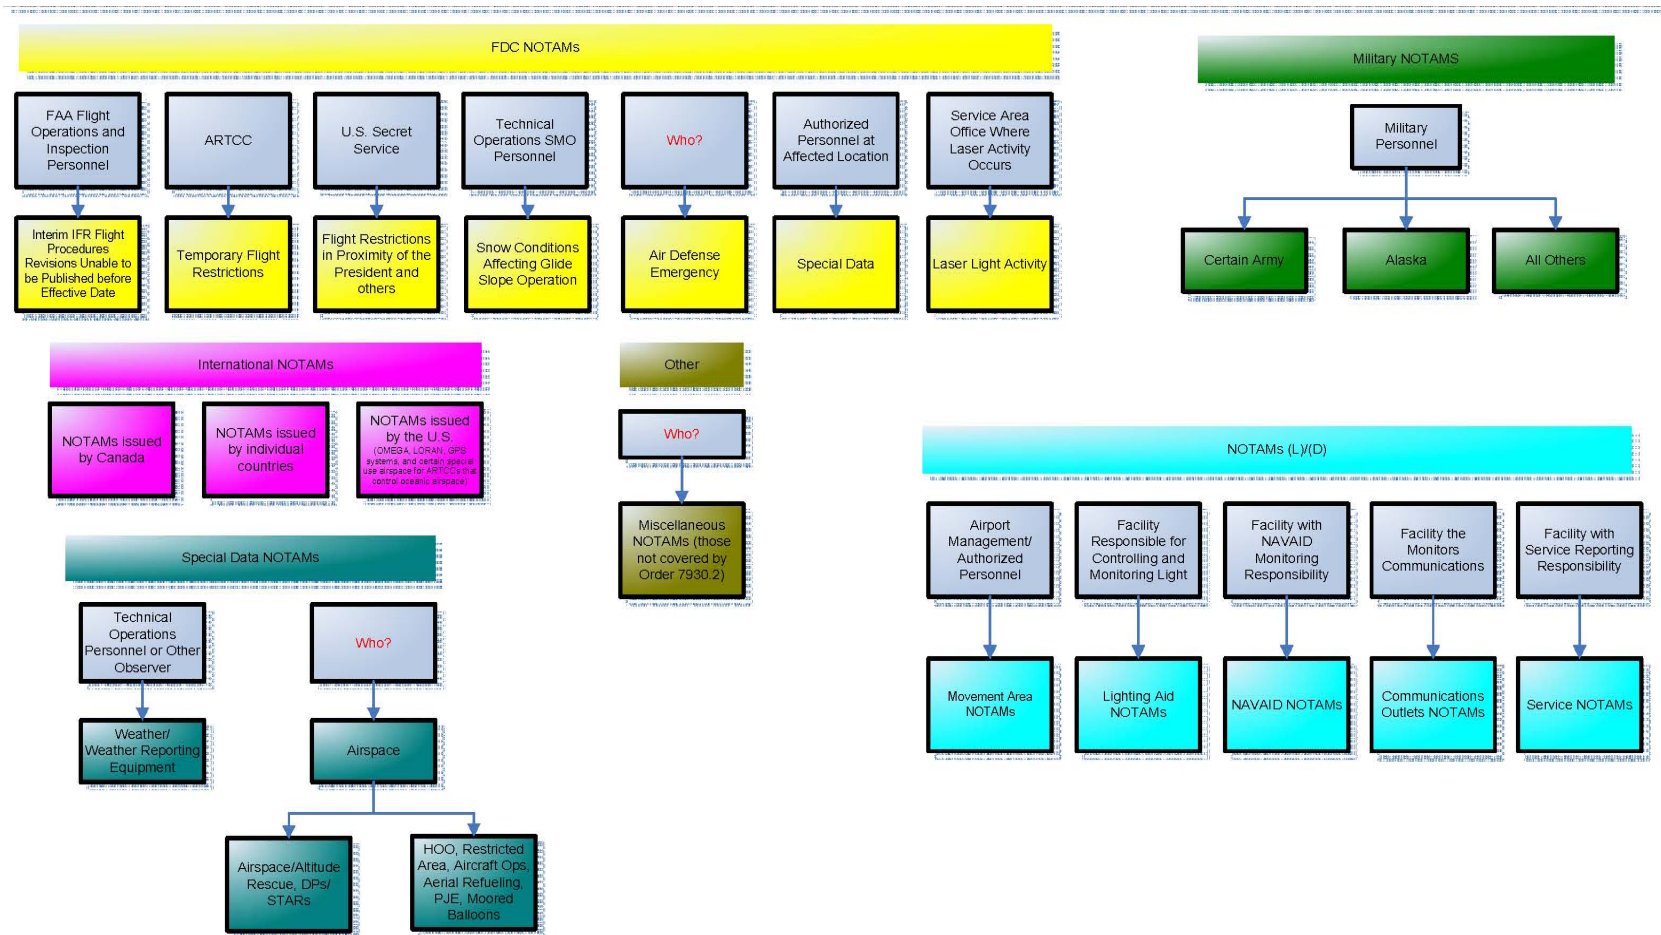
Figure C-1. NOTAMs by Type and Who Initiates the NOTAM for What Type of Action

NOTAM D	Wide dissemination NOTAM (Information distributed by means of telecommunications concerning the establishment, condition, or change in any aeronautical facility, service, procedure, or hazard, the timely knowledge of which is essential to personnel concerned with flight operations.)
NOTAM L	Local dissemination NOTAM (Information that requires local dissemination.)
NOTAM	Notice to Airman
ODP	obstacle departure procedure
SID	standard instrument departure
PJE	parachute jumping/sky diving
SIAP	standard instrument approach procedures
SMO	System Management Office
STAR	standard terminal arrivals
USNOF	U.S. NOTAM Office
USNS	U.S. NOTAM System
VFR	visual flight rules
WMSCR	Weather Message Switching Center Replacement (Network that serves as the Federal Aviation Administration gateway for the receipt and distribution of weather data and NOTAMs within the National Airspace System.)
