RI 9656

Self-Contained Self-Rescuer Field Evaluation: Seventh-Phase Results

Nicholas Kyriazi and John P. Shubilla

March 2002

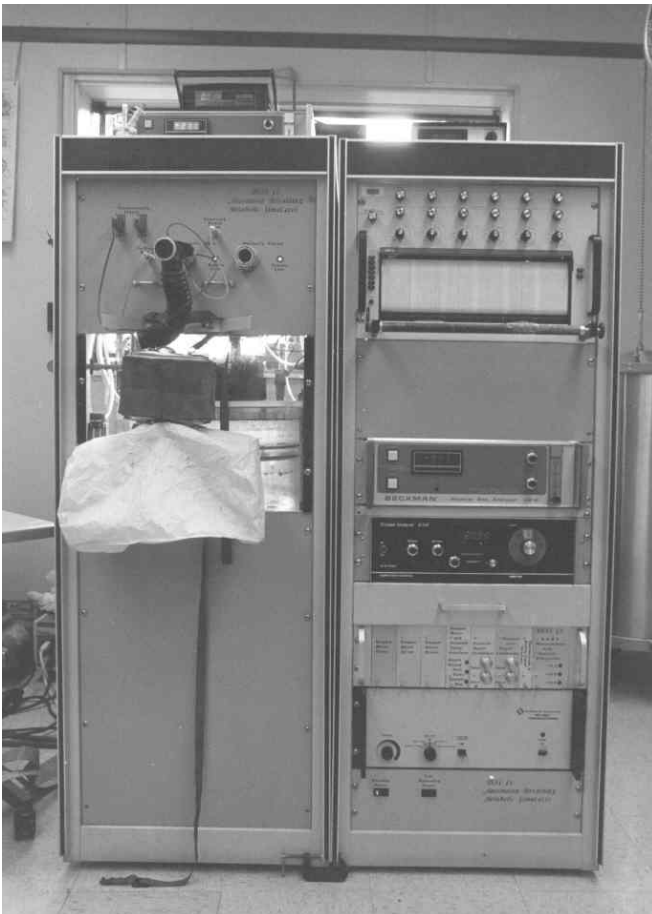
Figure 1.—Breathing and metabolic simulator.

This study involves testing approximately 100 SCSRs in each phase. This report describes findings in the seventh phase of testing from May 1999 to August 2000. Previous reports describe phases 1 through 6 [Kyriazi et al. 1986; Kyriazi and Shubilla 1992, 1994, 1996, 2000]. Ninety percent of the apparatus were tested on a breathing and metabolic simulator (BMS) (figure 1) and 10% on human subjects on a treadmill.

The parameters monitored were inhaled levels of CO₂ and O₂, end-of-inhalation wet- and dry-bulb temperatures, and inhalation and exhalation peak breathing pressures in both the BMS and treadmill testing. In the BMS testing, however, *average* inhaled levels of gas concentration were measured as opposed to the *minimum* values of CO₂ and *maximum* values of O₂ in the treadmill testing. *Average* inhaled gas levels include the effect of apparatus dead space, whereas *minimum* values of CO₂, for example, are only the lowest level of gas concentration during inhalation. The BMS measures average inhaled values by electronically summing all of the CO₂ and O₂ over each inhalation cycle, weighted by the instantaneous flow rate. The BMS also measures minimum inhaled CO₂ levels.

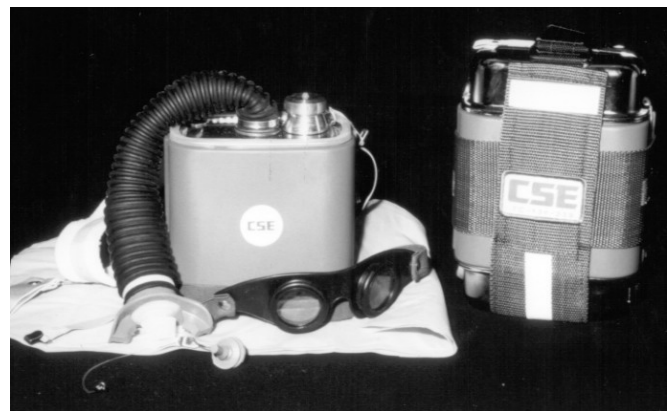
Figure 2.—Cased and uncased CSE SR-100 self-rescuer.

The SCSRs tested were manufactured by CSE Corp., Draegerwerk AG, Mine Safety Appliances Co., Inc. (MSA), and Ocenco, Inc. They were sampled according to estimated market share (table 1). The apparatus are shown in figures 2 through 6.

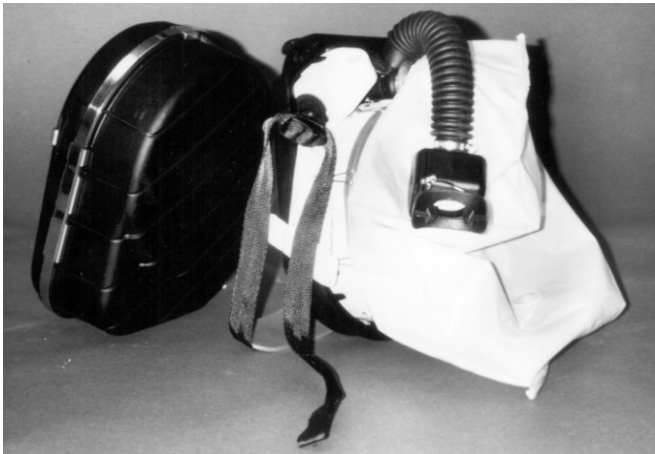
Figure 3.—Cased and uncased Draeger OXY K-Plus self-rescuer.

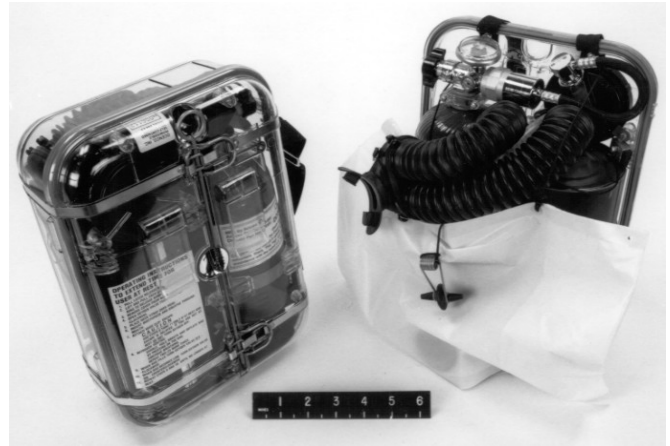
Figure 5.—Cased and uncased Ocenco EBA 6.5 self-rescuer.

The O₂ constant-flow rate is checked on the Ocenco EBA 6.5, a compressed-O₂ apparatus. The NIOSH-required flow is 1.5 L/min at ambient temperature and pressure (at NIOSH in Morgantown, WV), dry (ATPD).

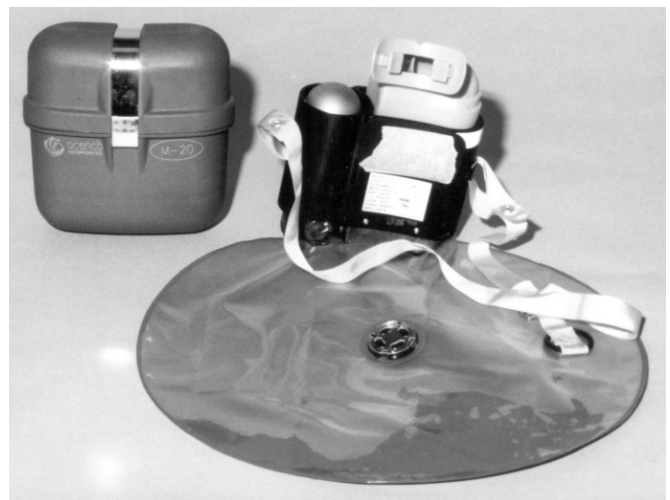
Figure 6.—Cased and uncased Ocenco M-20 self-rescuer.

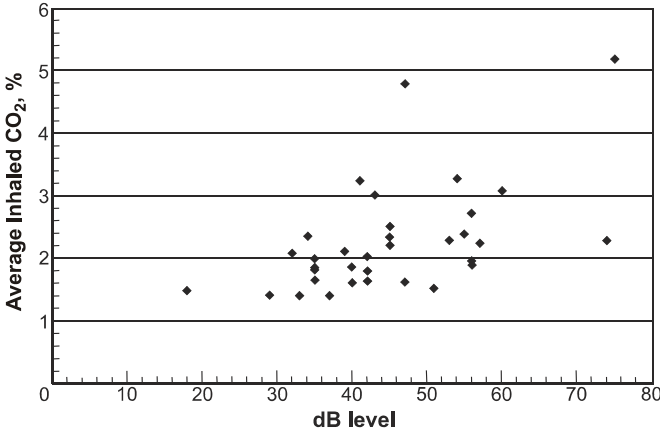
Figure 12.—CSE SR-100 DB level versus CO₂ level.

As in the previous two phases, the Wilcoxon rank-sum test [M=3; N=21] for average inhaled CO₂ showed a significant difference between new and deployed units, with deployed units having higher values than new ones (table 3). CSE's noise test, developed to detect bed degradation, was not being used at the mines during the collection of all the apparatus in this phase of testing. Therefore, some apparatus were collected that had noise levels that would have required them to be removed from service. They were tested anyway to see how they performed. In general, the higher the decibel level, the higher the CO₂ level; however, the correlation coefficient was only 0.51 in this phase versus 0.85 for 17 apparatus tested in the previous phase. We have no explanation for this disparity at present but, for the apparatus tested here, only when decibel levels were under 34 was one guaranteed that average inhaled CO₂ levels would remain under 4% during the life of the unit (figure 12).
