INTERIM REPORT--YEAR 2

*Geomorphic Impacts of Lake Livingston
on the Lower Trinity River, Texas*

Report to the Texas Water Development Board, Austin
TWDB Contract Number 2002-483-442

Jonathan D. Phillips
Southern Landscape Systems Research Program
Department of Geography
University of Kentucky

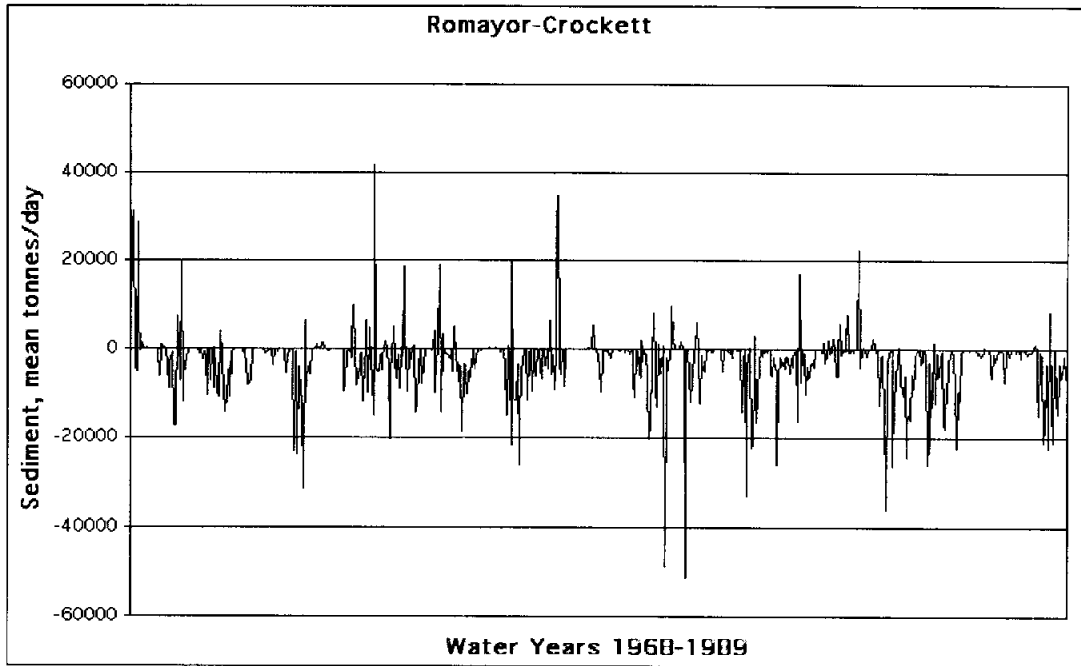
figure 11

Fig. 11. Comparison of sediment loads (daily means for 10-d periods) from Crockett to Romayor and Romayor to Liberty; obtained by subtracting Crockett from Romayor and Romayor from Liberty values, respectively.

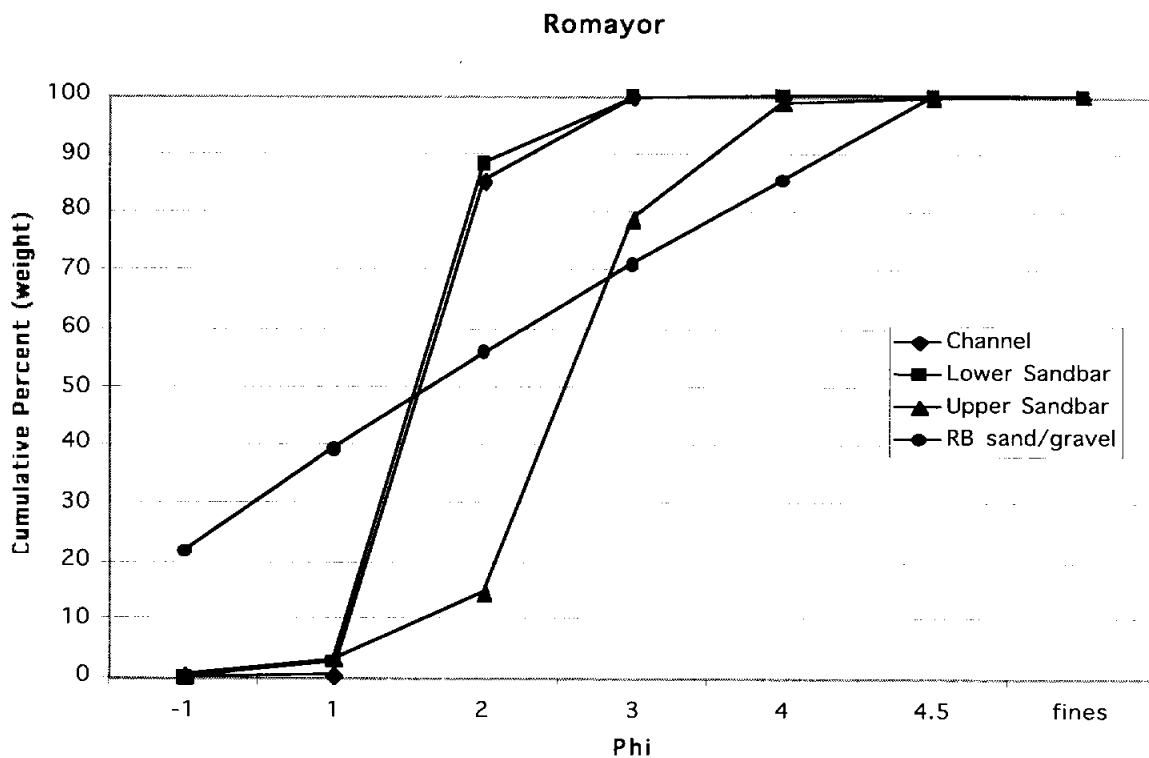
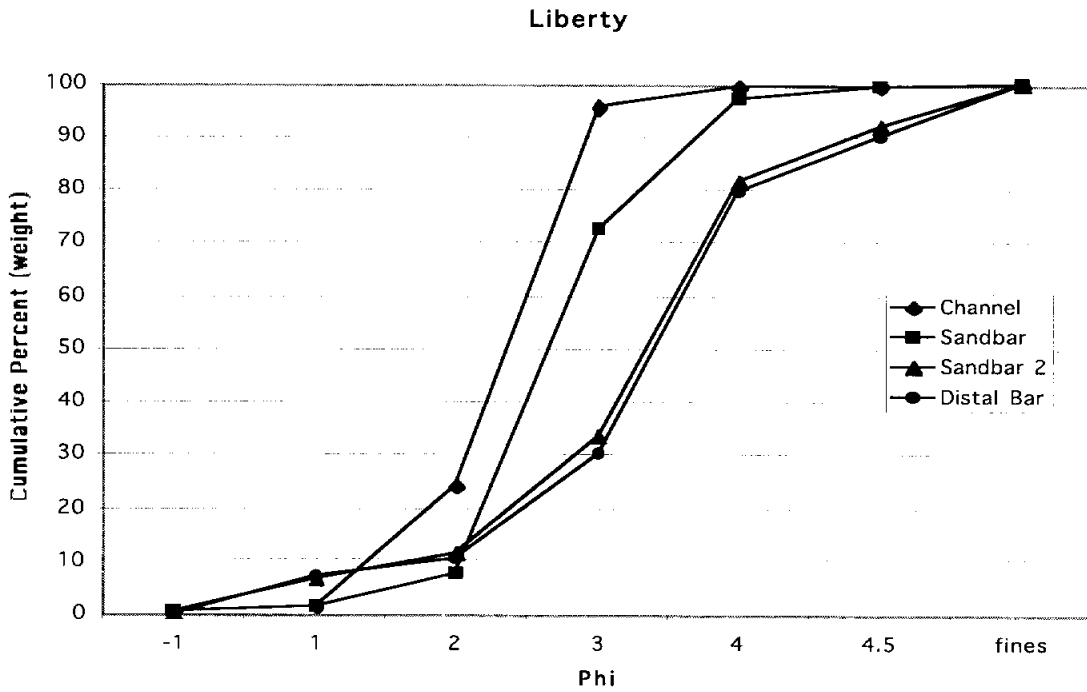
Figure 9 (continued from previous page). Grain size distribution curves.

Grain size distributions focussing on the sand fraction were examined for sediments collected from channels and bars at four sites (Romayor, Cypress Lakes Beach, Moss Hill, and Liberty. Samples were air-dried, disaggregated, and sieved using an ATM sonic sifter. Sieve sizes represented -1, 1, 2, 3, 4, 4.5 phi units, corresponding with the gravel, and the very coarse, coarse, medium, fine, and very fine sand fractions. Grain size distribution curves are shown in Figure 9. Laboratory analyses of other samples have been completed, but are not presented here..
