# MSHA PROXIMITY DETECTION

David Chirton  
New Technology Program Manager  
Approval and Certification Center  
Mine Safety and Health Administration

February 2, 2009

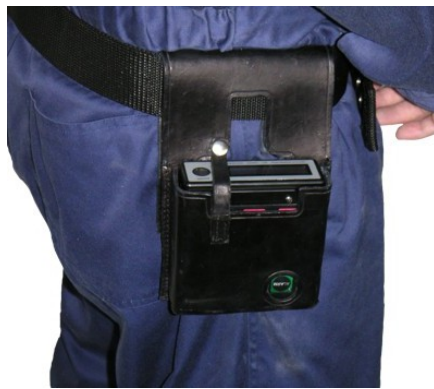
Figure 3 - Nautilus Beltpack

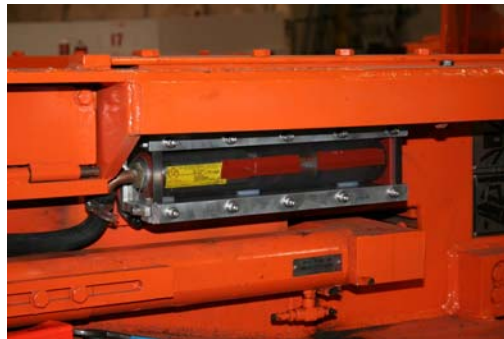
Figure 5 - Geosteering Field Generator

Only the right side of the machine was protected in the TramGuard™ field tests through use of three machine-mounted field generators, one mounted on the conveyor boom, one mounted on the right rear of the machine frame, and one mounted on the right front of the machine frame. No warning light was used. The system was designed to inhibit tram movement when the warning zone was breached and de-energize the pump motor when the shutdown zone was breached. Proximity detection was disabled when the cutter motors were energized. Only one personal alarm device (PAD) worn by the machine operator was tested (see Figure 6).

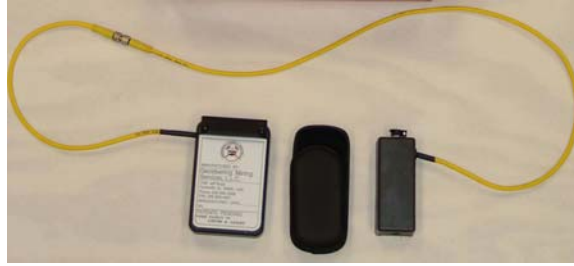
Figure 6 – Geosteering PAD
