AL NAHRWAN  
WATER SUPPLY PROJECT  
AL NAHRWAN, IRAQ

**SIGIR PA-05-003**  
**MARCH 15, 2006**

## Al Nahrwan Water Supply Project

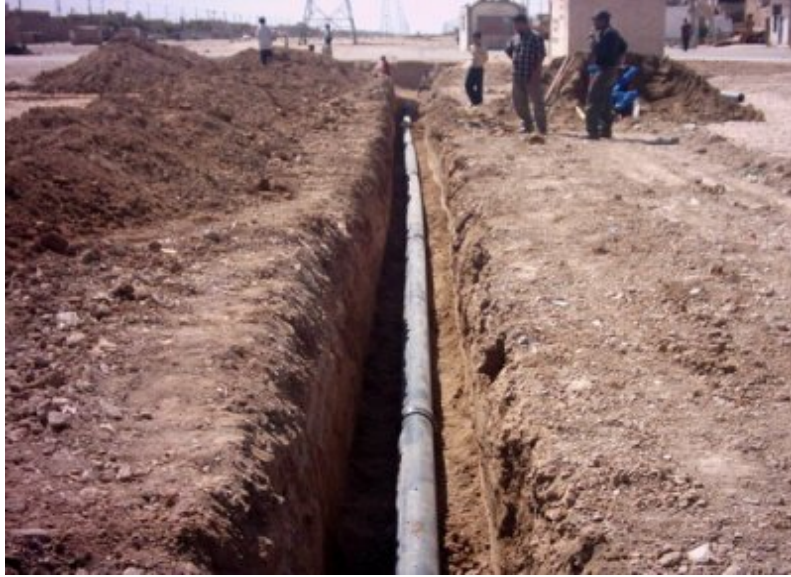
The contract and design specifications required the supply and installation of approximately 1500 meters of 200 millimeter (8 inch) UPVC to connect an existing 450 millimeter (18 inch) water main to an existing housing area. This work required the excavation of a trench, placement of a sand base, installing the pipe, connecting the 200 millimeter new pipe to the 450 millimeter existing water main, and then backfilling and grading.

**Photo 2: Installation of 200 mm UPVC pipeline**

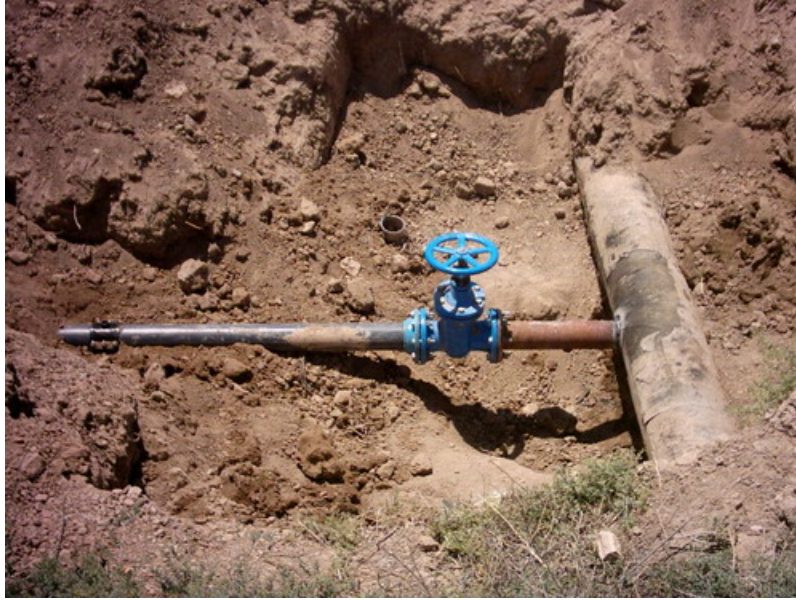
According to the USACE quality assurance reports and contractor quality control reports, the materials arrived on site on March 26 and 28, 2005, and were inspected by the USACE QAR on March 28, 2005. Excavation required for the installation of the pipe was initiated May 19, 2005, and the placement of the pipeline and connections and backfilling was completed on May 22, 2005 (Site Photo 3). The

Photo 3: 110 mm connection to 300 mm existing pipe

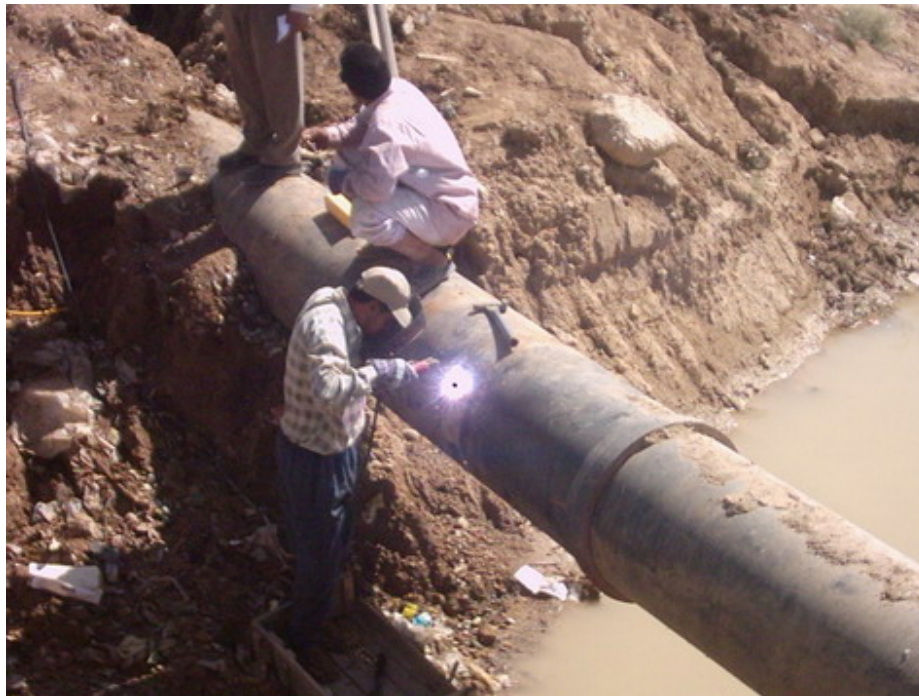
**Photo 7: Repair of water main after disconnecting illegal connection**

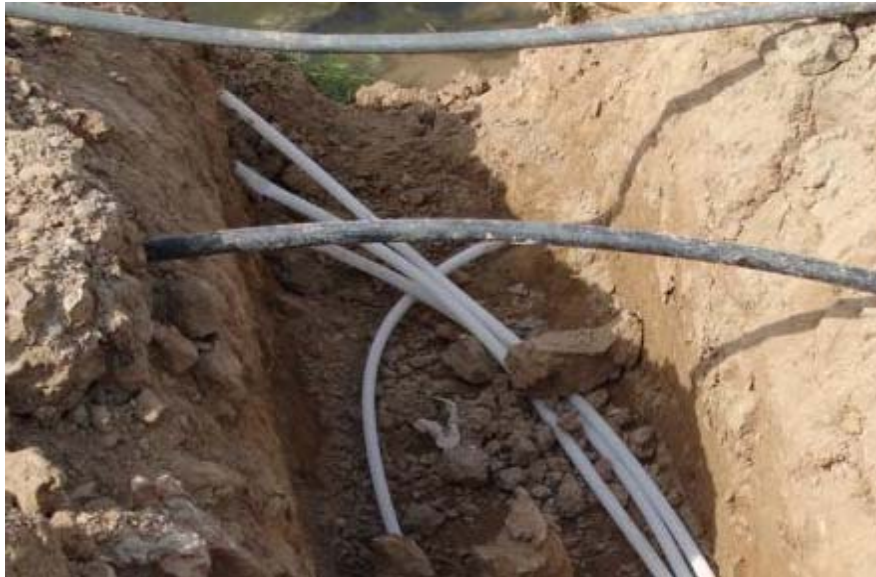
**Photo 9: Placement of 15 millimeter water lines in excavation**
