AL FATAH RIVER CROSSING  
TIE-INS  
AL FATAH, IRAQ

**SIGIR PA-05-012**  
**MARCH 15, 2006**

## Al Fatah River Crossing Tie-Ins at Al Fatah, Iraq

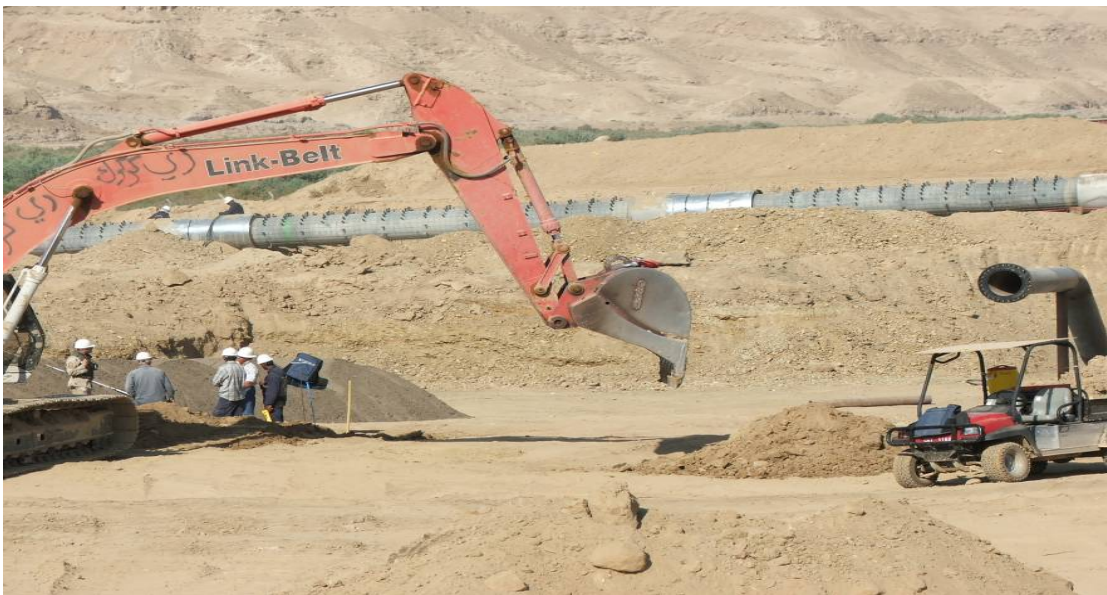
**Site Photo 2: Excavation of Kirkuk (east side) Manifold Site**

The PSSR required that locations for the two new manifold systems be finalized, and excavation for the manifold vaults be completed. The manifolds will be in reinforced concrete vaults, one on the east side of the river (Kirkuk manifold) and one on the west side (Baiji manifold). Site Photo 1 shows the Al Fatah River Crossing, with east side to the right of the photo and the west side to the left of the photo. The design dimensions for the Kirkuk Manifold Vault are 18 meters (m) long, 6 meters wide. The surface of the vault is to be approximately 4.5 meters above the lower surface of the pipelines after pipeline placement. During the site visit, the assessment team verified that the excavation of the Kirkuk Manifold was nearly complete. Site

Photo 2 shows the excavation of the Kirkuk Manifold site. The excavation appears consistent with design requirements.

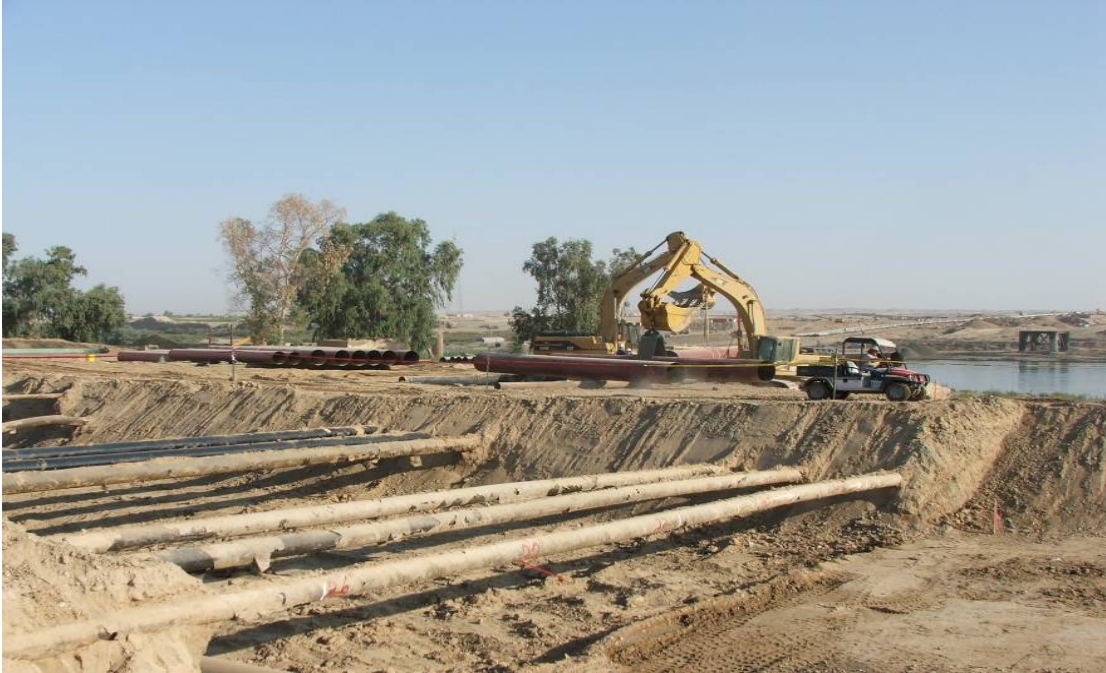
Site Photo 3: Excavation of Baiji (west side) manifold site

The design dimensions for the Baiji Manifold Vault are 19 m long and 5.2 m wide. The surface of the vault is to be approximately 4.5 m above the lower surface of the pipelines after pipeline placement. During the site visit, the assessment team verified that the excavation of the Baiji Manifold site was nearly complete. Site Photo 3 shows the excavation of the Baiji Manifold site. The pipelines shown in Site Photo 3

are existing pipelines that were not part of this project. The excavation appears consistent with design requirements.

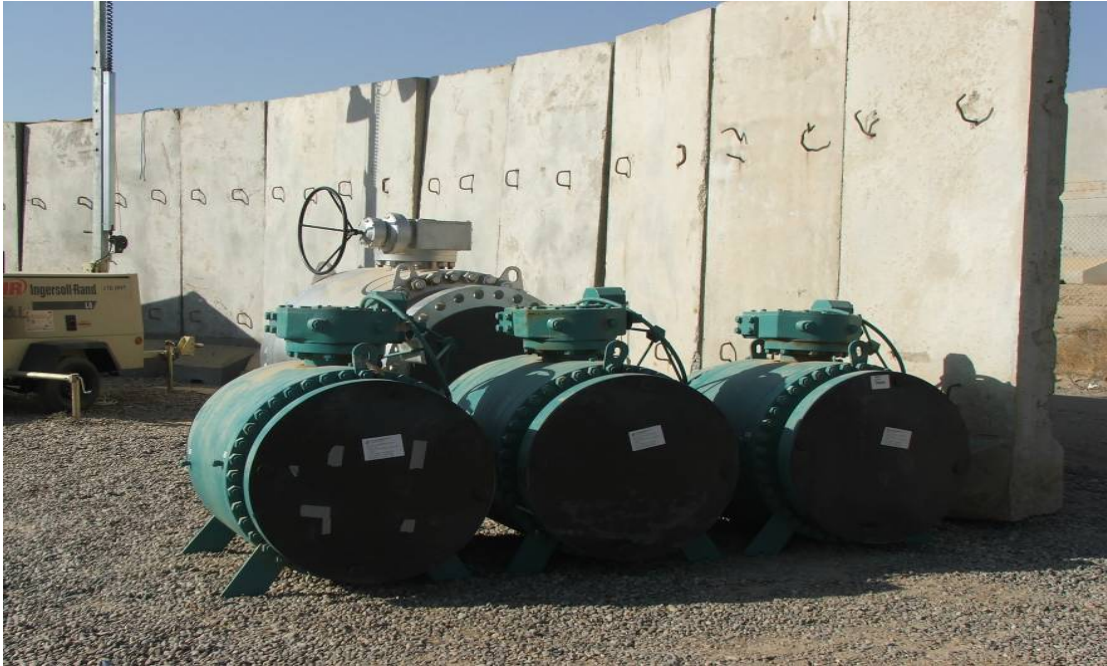
**Site Photo 4: Pipeline Valves to be used for Manifold Construction**

The assessment team observed, during site visit, that valves and fittings had been transported to the Al Fatah site. The fabrication of the manifold system had not been started; therefore, the manifolds were not assessed.

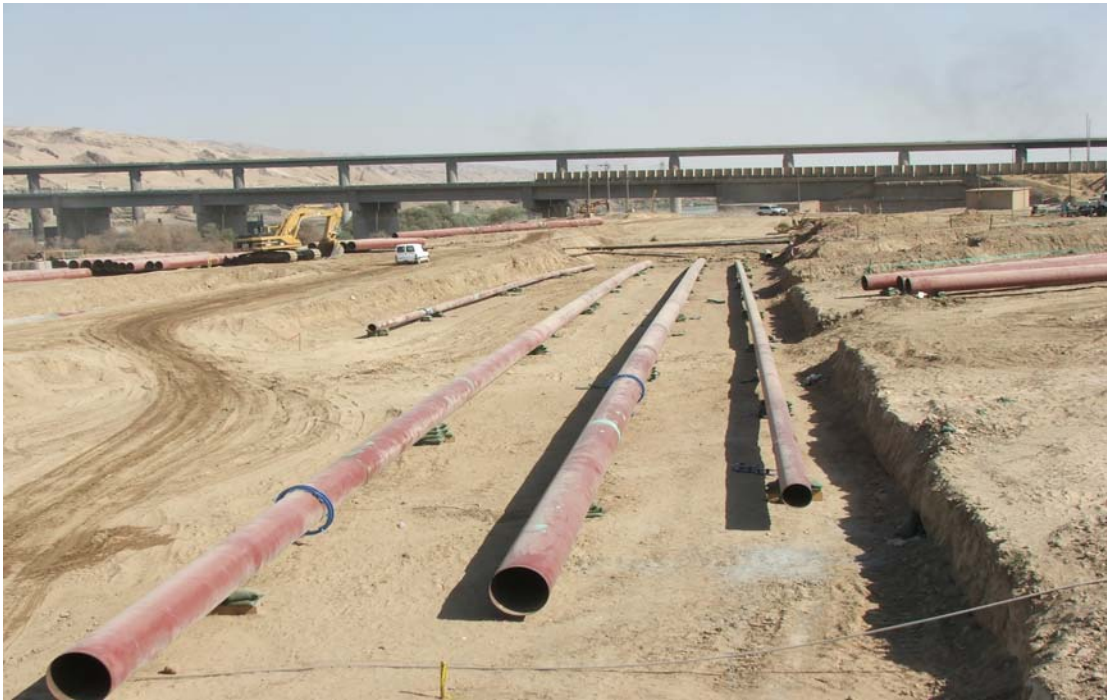
**Site Photo 5: Pipelines to be connected to the Baiji Manifold**

The PSSR required that the Kirkuk and Baiji Manifolds be field fabricated and consist of a combination of pipes and valves. All pipeline welds, including the manifolds, require 100 percent radiograph examination, in addition to corrosion control testing. The completed manifolds will be installed in concrete vaults and connected to the existing pipelines on one side and the Al Fatah River crossing to pipelines on the other. The valves and fittings, which were located near Kirkuk, had to be transported to the Al Fatah site. The PIJV transported the valves and fittings for the manifold to the river site. The subcontractor was responsible for offloading, storing, and staging the valves and fittings. Site Photo 4 shows the pipeline valves which will be used for the manifold construction. Site Photo 5 shows the pipelines which will be connected to the Baiji Manifold.

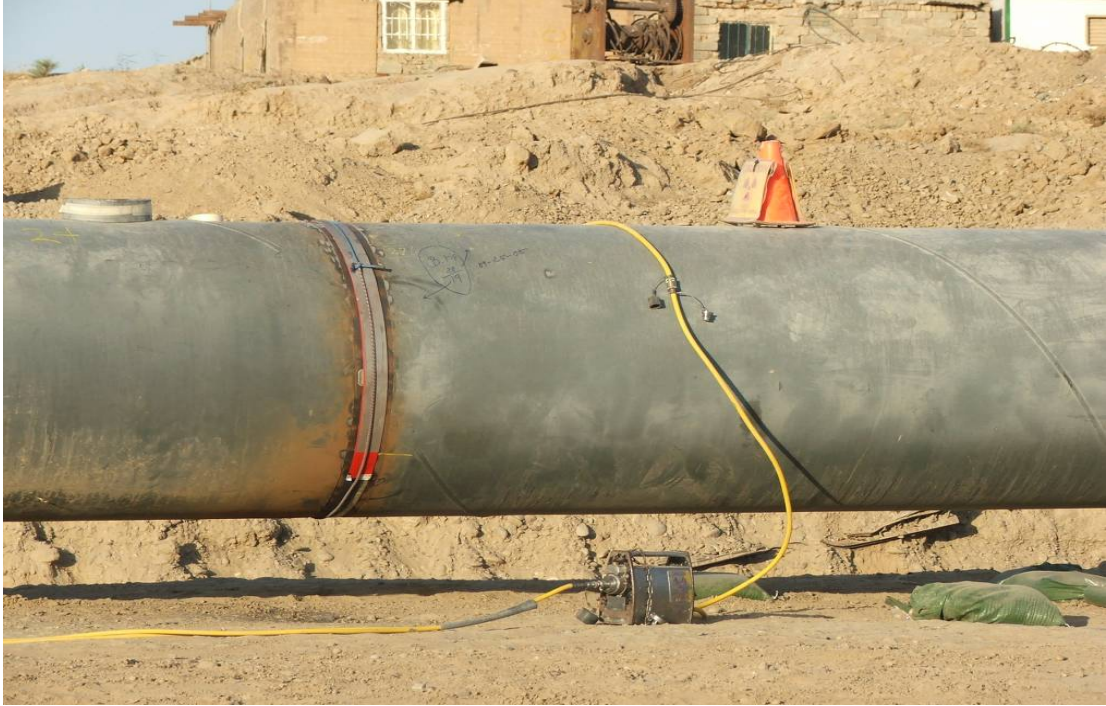
**Site Photo 6: Radiography (x-ray) Test In Progress on 40"Pipe Weld**

- **Construction Conformity:** The Phase II PSSR specified that all welds "(100 percent)" must be radiographed (X-rayed) to ensure adequate pipe strength and seal. As a result, injury risk to personnel working around the pipe following commissioning will be decreased, while product loss via leaking will be avoided. Site Photo 6 shows a radiography process that produces a filmstrip unique to each weld. Site Photo 7 shows a properly marked pipe weld. Specifically, the welders that performed the work are identified by number (19/20) and the weld is dated "(9-24-05)" and numbered "(27)". This information is necessary in tracking welder performance and weld quality.

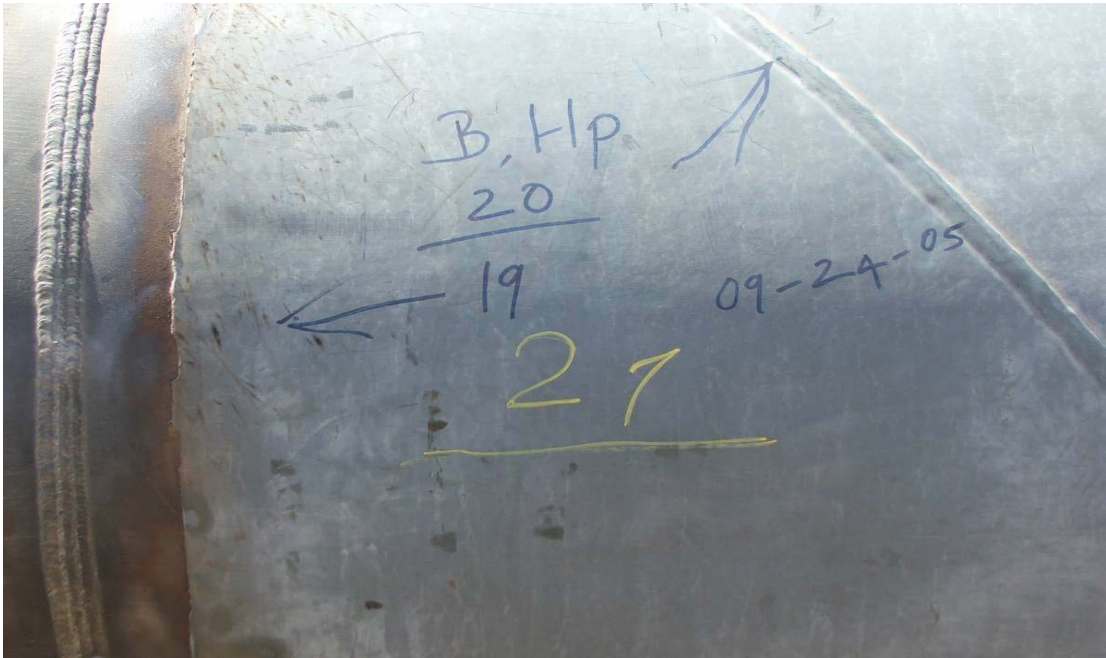
**Site Photo 7: Visually Acceptable and Properly Marked Weld Waiting for Radiograph Test**

The Al Fatah River Crossing Tie-Ins project will be completed by the same contractor and same QC Team as the Al Fatah River Crossing project. The Al Fatah River Crossing project, which was assessed under a separate project report, demonstrated excellent adherence to QC. This should continue throughout the Al Fatah River Crossing Tie-Ins project. For illustrations of QC procedures used during the Al Fatah River Crossing project, see Site Photos 6 and 7.

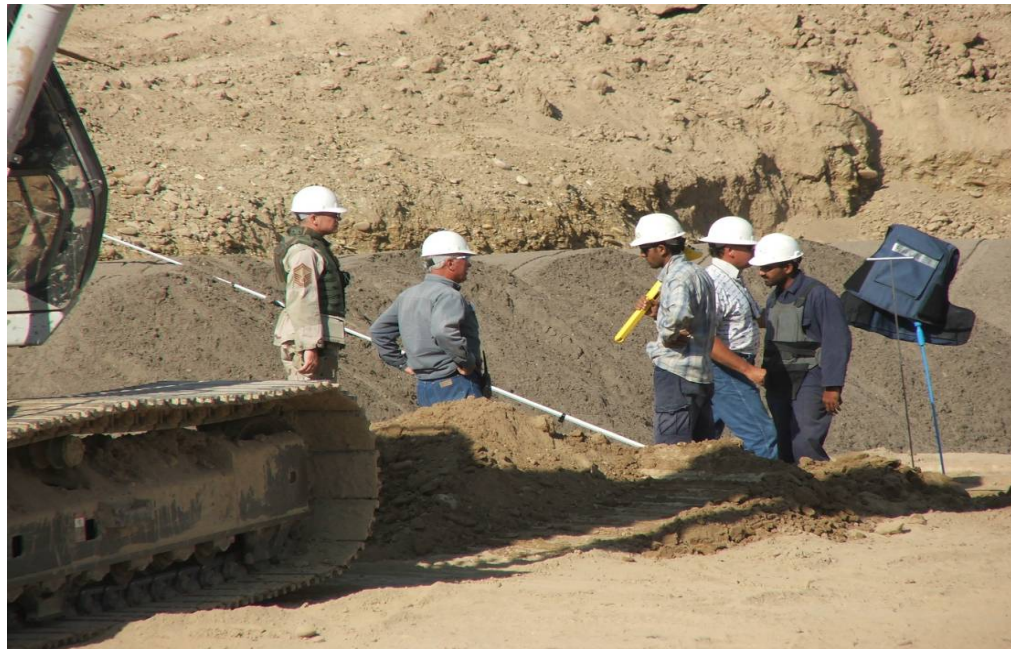
**Site Photo 9: Government Construction Representative and Contractor Supervisors Assessing the Source of a Liquid Petroleum Gas Smell**

- **Supervisor Field Presence:** The assessment team observed that line level construction supervisors were on-site 100 percent of the time, while QC and QA personnel were on site frequently enough to effectively perform their duties. In addition, contractor and government personnel shared a local communications (walky-talky) net. Accordingly, events that needed the attention of a supervisor or the QM team were known to all. Site Photo 9 shows contractor managers and a U.S. Government Construction Representative discussing whether a leak in an unknown pipe or soil contamination caused the smell of liquefied petroleum gas.
