**FOLLOW-UP ON THE NASSRIYA
PRISON FACILITY
NASSRIYA, IRAQ**

**SIGIR PA-08-131
APRIL 17, 2008**

SUBJECT: Report on Project Assessment of the follow-Up on the Nassriya Prison
Facility, Nassriya, Iraq (Report Number SIGIR PA-08-131)

Follow-up on the Nassriya Prison Facility, Nassriya, Iraq

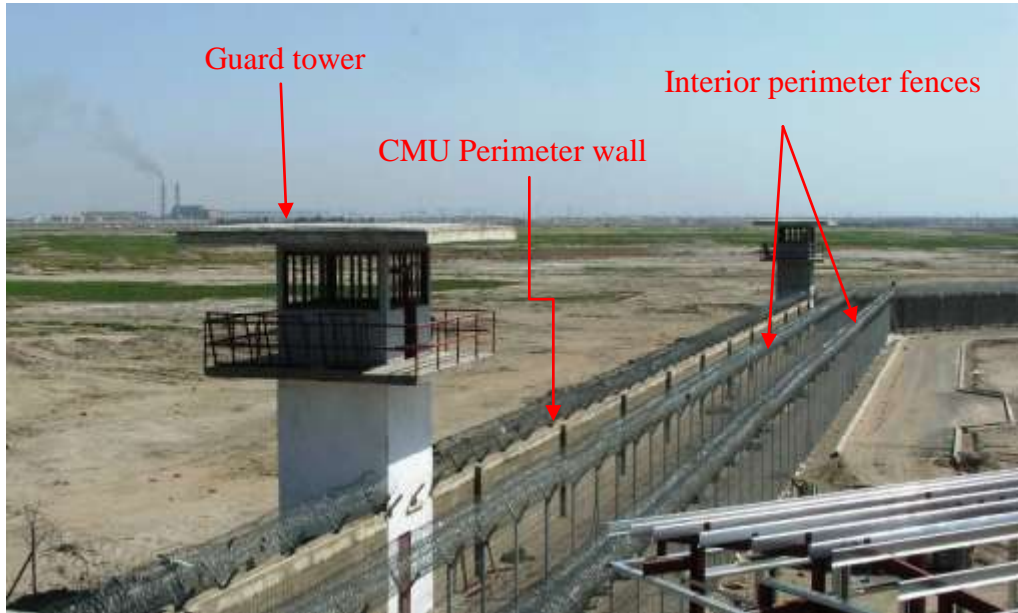
Site Photo 1. Guard tower, perimeter wall and interior chain link fences along prison perimeter.

Site Photo 1 provides an example of the guard tower, the perimeter wall and the perimeter fence construction. During our site visit, we observed that the guard towers were in place, the perimeter walls were constructed, and the coils of wire were located on top of all perimeter walls. In addition, the interior perimeter fences were in place, as designed, with the three coils of razor wire on top of the fences, and the sully gate was installed (Site Photo 2).

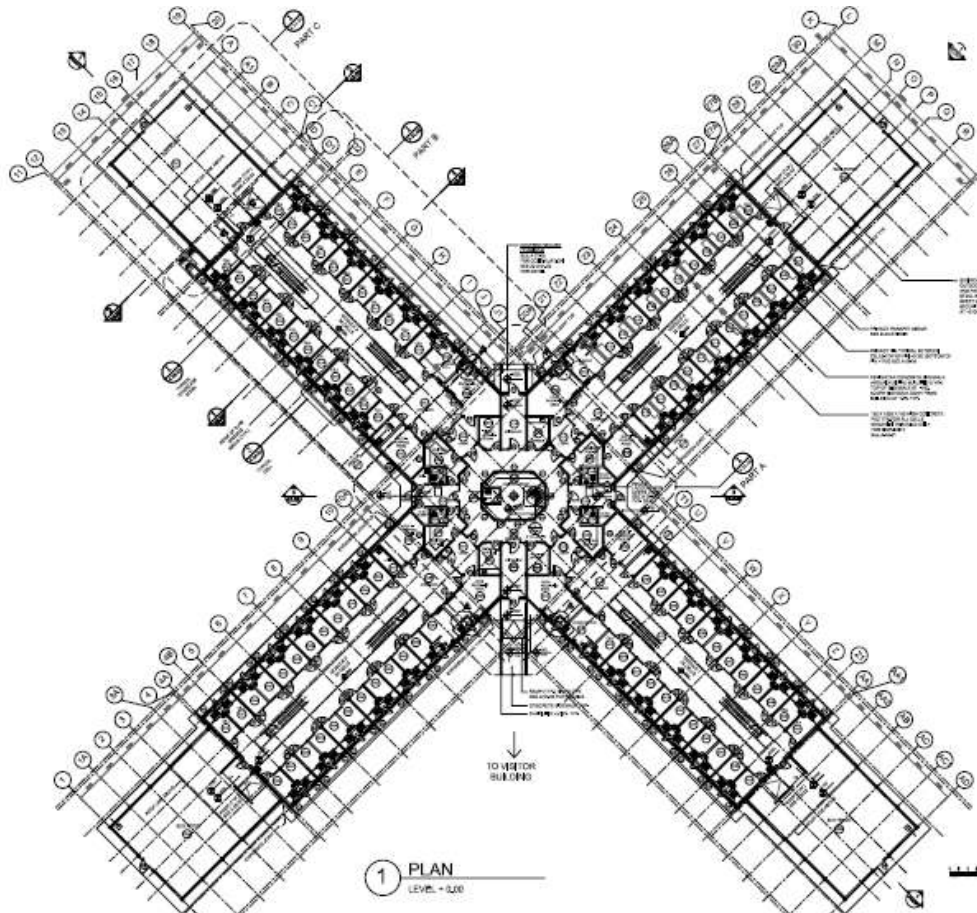
Figure 4. Inmate housing design (Figure courtesy of the USACE)

each of the four wings for a total of 200 cells per building (Figure 4). Site Photo 3 shows the exterior walkway leading into the entrance of one inmate housing unit.

The four wings of each inmate housing unit were connected to a central core area located on the ground level. The central core area contained a control room and control stations for each wing, a medical office, a pharmacy, as well as rooms for a barber shop, and a commissary for prisoners. Site Photo 4 shows the central core area leading to one wing of the inmate housing unit. The quality of workmanship exhibited in the inmate housing areas was satisfactory.

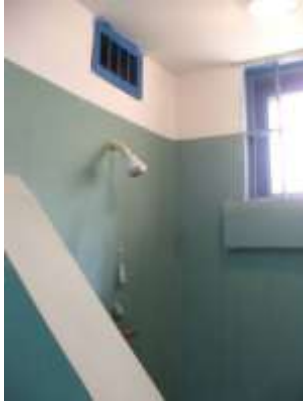
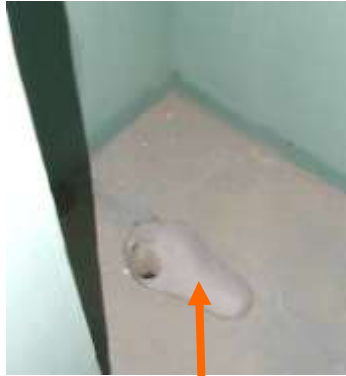
Site Photos 5 and 6. Prison cell shower and toilet

Each inmate cell is designed for two persons (Figure 5), with a shower (Site Photo 5), an eastern style toilet (Site Photo 6), sink (Site Photo 7), prison cell door and two beds, a wall mounted 750-mm x 1800-mm steel bed frame (Site Photo 8), and the other one consisting of a 750-mm by 1800-mm concrete pad on the cell floor (Site Photo 9). The design also required an exercise area at the end of each wing, partially covered with a pre-engineered metal roof structure. Site Photo 10 shows the sunroom without any noticeable defects.

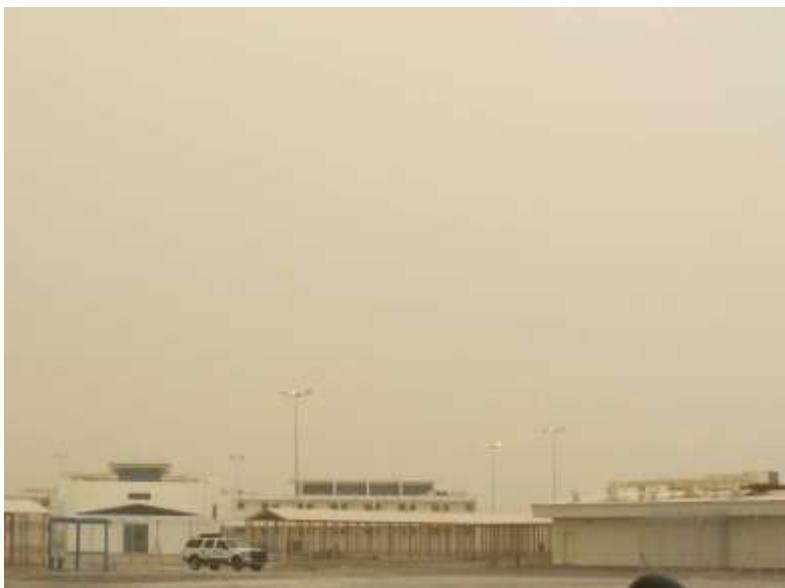
Site Photo 11. Intake/release/medical building

The structural design required a foundation that consisted of isolated reinforced concrete pad footings (2-m x 2-m) supporting reinforced concrete column pedestals (400-mm x 400-mm) and reinforced concrete grade beams. The structural frame of the building included columns, roof joists, and purlins. During our site assessment, we inspected the foundation work and structural steel frame, both of which were complete (Site Photo 11). We were unable to inspect the inside of the building because the doors were locked and the contract workers were unable to locate the keys; however, the construction appeared to meet design requirements.

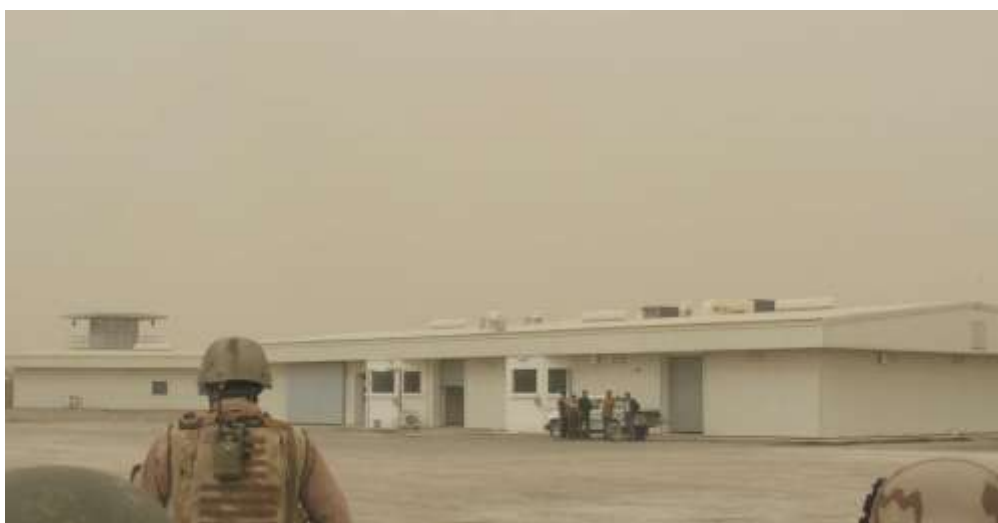
Site Photo 12. Maintenance building

The maintenance building is another pre-engineered building with a similar foundation and structural design as the intake/release/medical building. The 38-m x 17.1-m maintenance building includes a vehicle maintenance area, workshops, and equipment and material storage rooms. Site Photo 12 shows the exterior of the maintenance building. Due to time restrictions, we were unable to inspect the interior of the building. However, the exterior work observed appeared to be consistent with the design requirements.

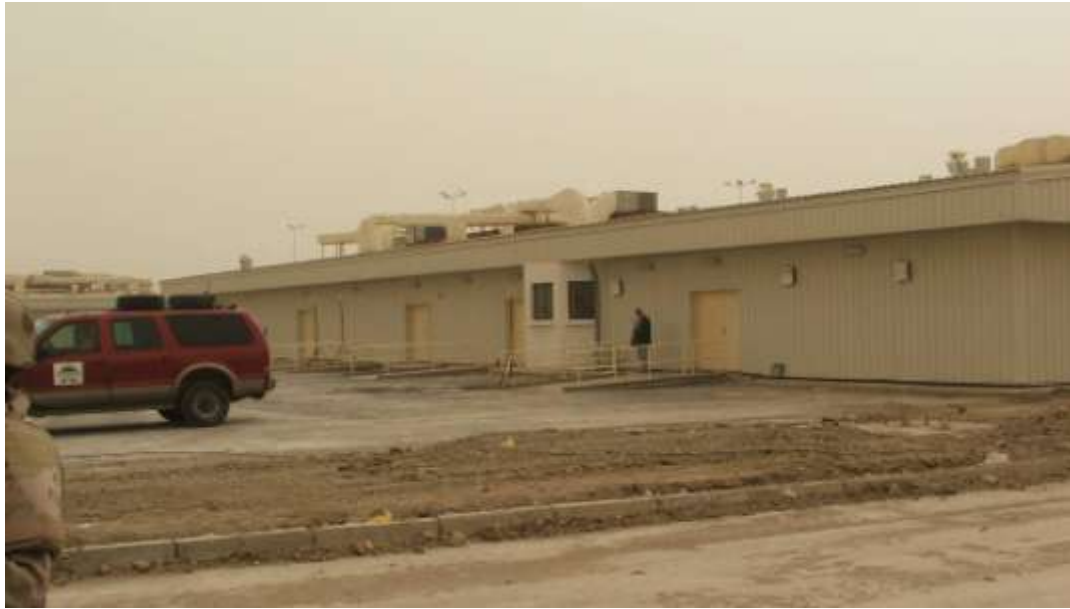
Site Photo 13. Kitchen and laundry building

At the time of our site visits, the kitchen and laundry building was constructed. However, furnishings such as washers, dryers, and ovens were not yet in place. The contractor turned on the electricity during our inspection of the buildings interior. The building's exterior and interior appeared to be consistent with the design requirements.

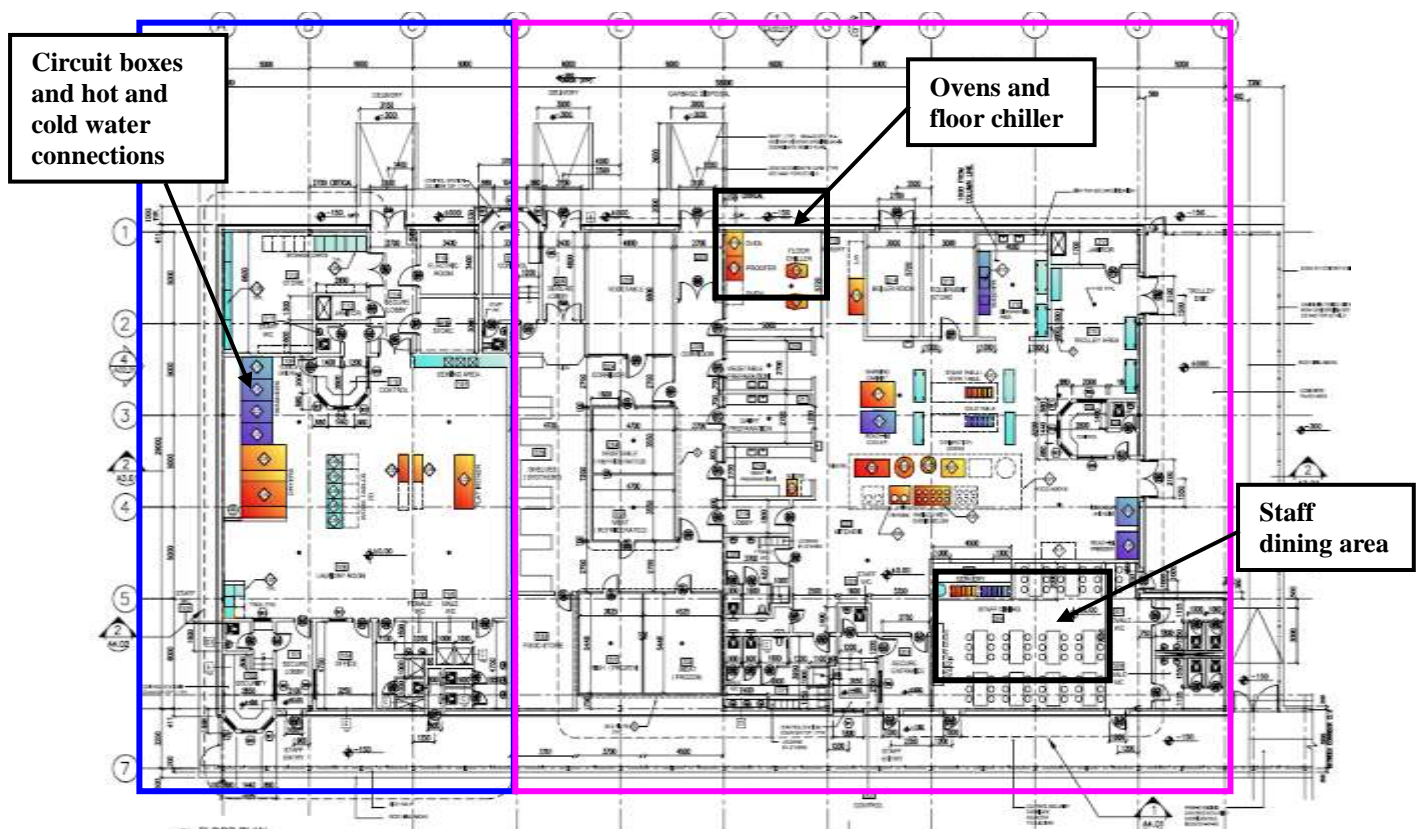
Figure 6. Laundry and kitchen layout (Figure courtesy of the USACE)

The kitchen area floor plan included refrigerated and dry food storage rooms, food preparation and cooking areas, and a dishwashing room (Figure 6). The kitchen building also includes a dining area. According to GRS representatives, this dining area will be used only by prison staff members; while prisoners will only be allowed to dine in their cells.

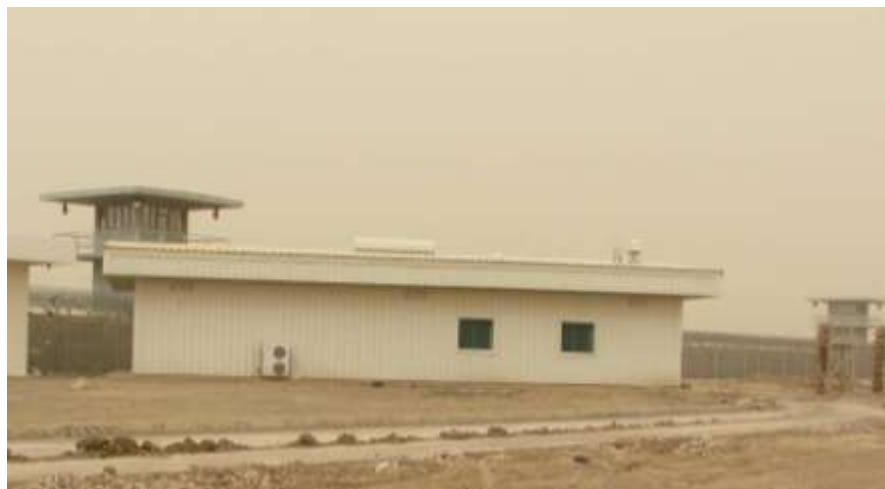
Site Photo 15. Exterior frontal view of prayer building

Site Photo 15 shows the exterior of the prayer building. The 18-m x 10.2-m prayer building architectural design included prayer rooms and ablution facilities (Figure 7). The building is the smallest sized pre-engineered building at the prison. In keeping with the local Iraqi tradition of not entering the prayer room with dirty feet, the contractor provided a separate restroom (ablution unit), which will allow prison staff the opportunity to wash their feet prior to entering the prayer room. At the time of our site visit, the prayer building was complete. However, in order to not disturb the prayer room, we did not enter the facility. The building's exterior appeared to be consistent with the design requirements.

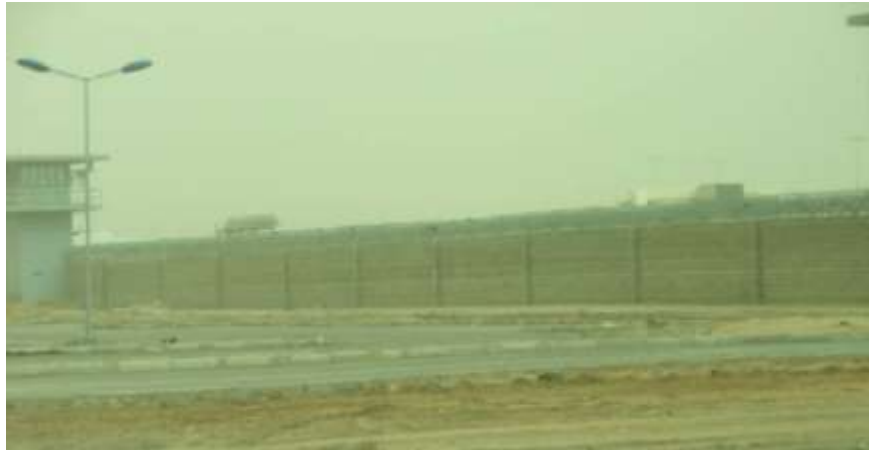
Site Photo 21. Prison parking lot

The other prison facilities that we viewed were the access road, the visitor/employee parking lot (Site Photo 21), and the covered search pit (Site Photos 22 and 23). The 160-space parking lot was complete with traffic islands, curbing, and pavement base constructed. At the time of our inspection, the covered search pit had a foundation, and the structural steel cover was completed.

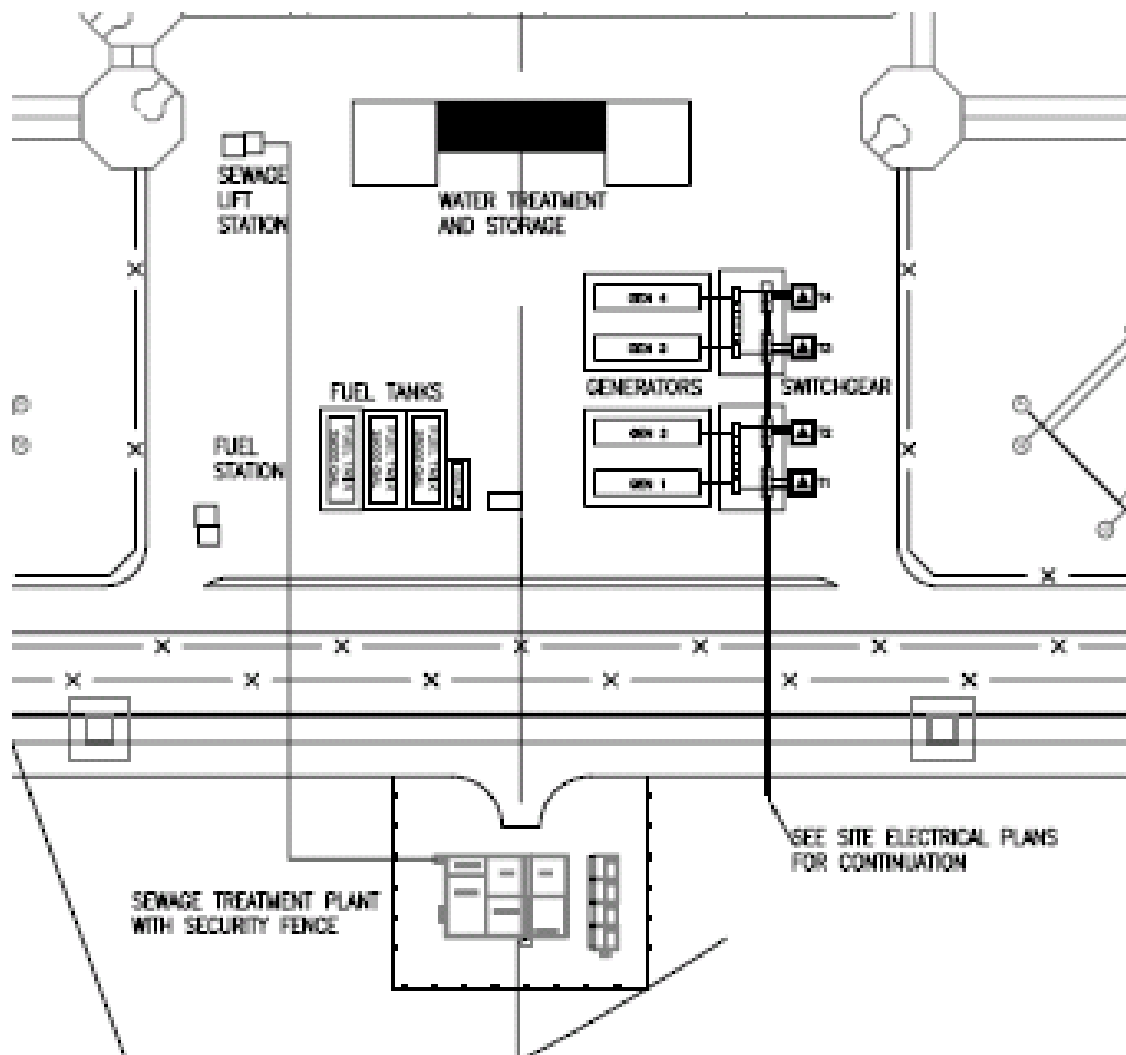
Figure 9. Prison utilities

Figure 9 shows the design layout for the Nassriya Prison utilities. The utilities are centrally located inside the prison grounds except for the sewage treatment plant (STP). The STP is located outside the prison grounds because there was inadequate space to achieve proper drainage. The STP is surrounded by a security fence. The sewage from the prison site is designed to be collected by a sewage system and treated on site before the effluent is disposed of off site. The sewage system consisted of pipes ranging from 200-mm to 110-mm and laid to gradients from 0.5 percent to 1.5 percent. There was a provision for sanitary manholes at sewer intersections, and at regular intervals along the direction of flow. Figure 10 illustrates the STP placement outside the prison grounds surrounded by its own security fence, and Figure 11 shows the close-up of the plant. The STP (Site Photo 24) consists of an administration building (Site Photo 25), pump station, pretreatment unit, aeration tank, clarifier (Site Photo 26), filter, chlorination unit, and sludge drying bed.

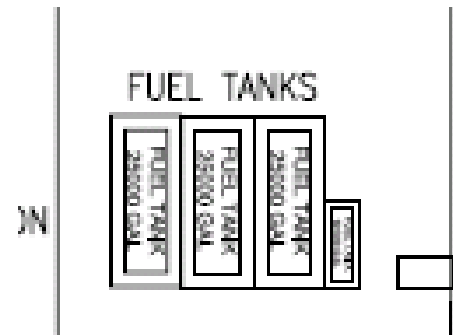
Figure 14. Prison fuel tanks

According to GRS representatives, the Nassriya Prison will run primarily off the local power grid. However, the Nassriya Prison was designed to have four stand-by generators that would supplement the supply from the local power grid (Figure 13). During our site visit, we viewed the prison generators, Site Photo 31. In addition, Site Photo 32 shows the cables connected to the observed generators. Site Photo 33 shows the four prison fuel tanks. Three fuel tanks will store 25,000 gallons each and one fuel tank will store 12,000 gallons (Figure 14).

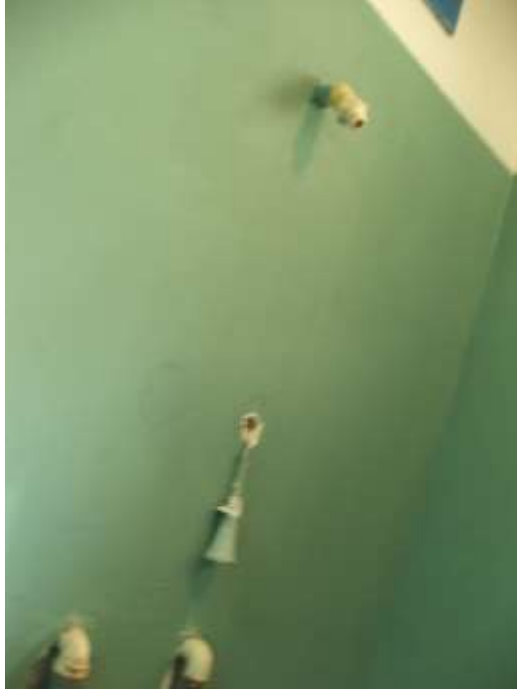
Site Photo 34. Punch list item – missing shower head

Since the overall project was reported as 91 percent complete at the time of the assessment, the majority of the remaining work consists of punch list items. For example, during our site visit, we identified the following deficiencies: the inmate housing unit had a few cells with missing shower heads (Site Photo 34); a crack in the plaster of the inmate housing sunroom (Site Photo 35); exposed cables from the generator running to the switchgears that need to be covered (Site Photo 36); and electric wire going to the STP, which needs to be covered and properly housed, instead of exposed to the elements (Site Photo 37). GRS representatives noted the deficiencies and stated they would be corrected prior to the issuance of final payment to the contractor.

The contractor was performing pre-final checks on the water distribution lines, electrical distribution network, sewage treatment plant, and the prison buildings. Although the SIGIR inspection team did not observe any problems with the water distribution lines, upon our return to the International Zone, we were informed that the International Narcotics and Law Enforcement Affairs (INL) had noted some deficiencies with the Nassriya Prison. When the SIGIR inspection team discussed the issue with the INL representative, he agreed the deficiencies he was referring to were typical punch list items. We followed up with GRS representatives who stated that after our site visit, the water had been turned on to test the plumbing within the prisoners' cells. During the water testing, some leaks were discovered and were being repaired. Again, the GRS representatives stated that all deficiencies would be addressed prior to the issuance of final payment to the contractor.

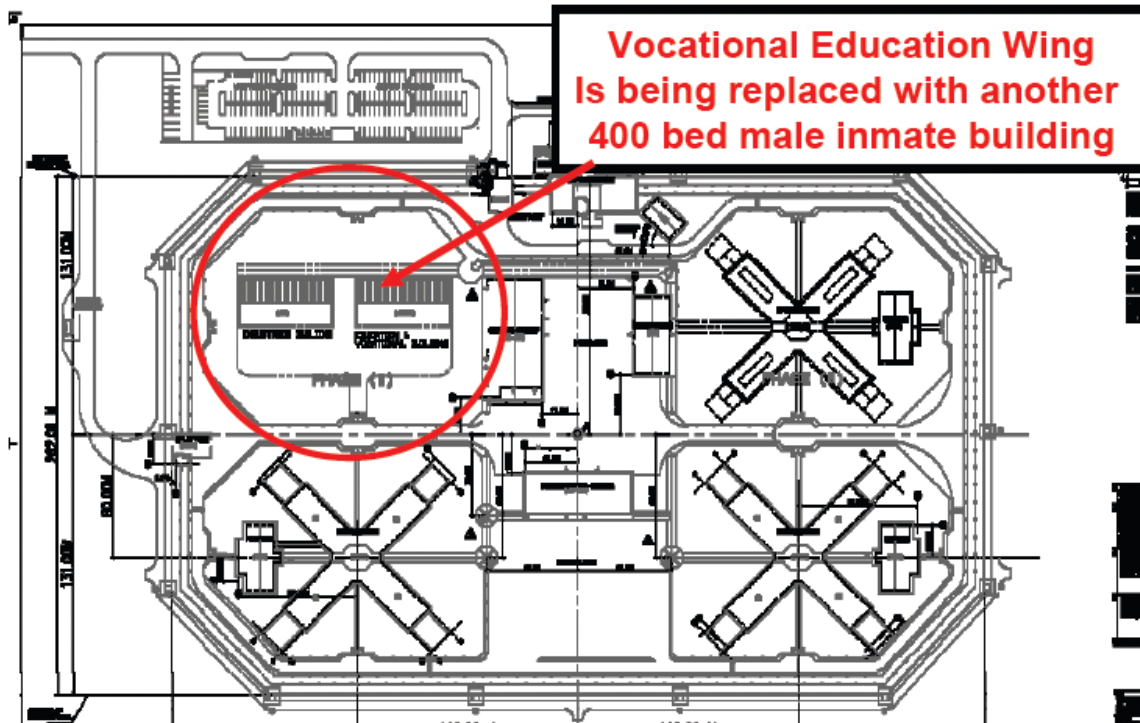
Figure 16. Phase III future construction area (Figure courtesy of the USACE)

Figure 16 shows Phase III where the educational wing is being replaced with another 400 male inmate building. This will bring the total population of the prison facility to 1600.
