2010 FATALITIES AT SMALL AGGREGATE OPERATIONS 23% OF TOTAL 2010 MNM FATALITIES (as of 12/21/2010)

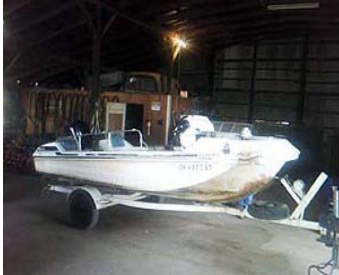
Two miners were pulling a small boat from a dredge pond onto a boat trailer attached to a pickup truck. One miner drowned when he attempted to retrieve the boat after it slipped back into the water.

- Securely attach the trailer winch rope to the boat before removing the boat from the water.

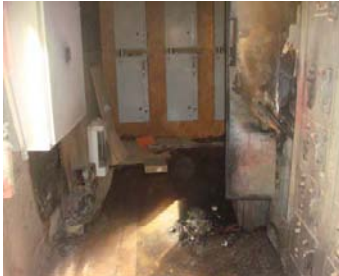
One miner was killed and two were seriously injured when they came into contact with a bottom feed circuit breaker as they were installing ground fault indicator lights in a circuit breaker enclosure.

- De-energize ALL electrical components in an enclosure.
- Ground ALL phase conductors to the equipment grounding medium with properly rated grounding equipment.
- Install warning labels on the terminal covers of bottom feed circuit breakers stating the "Bottom terminal lugs remain energized when the circuit breaker is open."

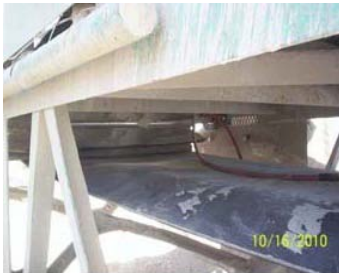
A miner was using an air-powered hammer/chisel to clean hardened material on a belt conveyor tail pulley. He was positioned on top of the return side of the belt conveyor, facing the tail pulley, when the belt conveyor was energized, entangling him in the tail pulley leading to his death.

- De-energize and block belt conveyors against motion before working near a drive, head, tail, and take-up pulley.
- Lock-out/tag-out all energy sources to belt conveyors before working on them.

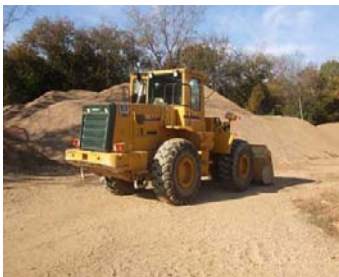
A miner was working underneath a front-end loader with the engine running, checking a hydraulic fluid leak, when the machine moved and rolled over him. The machine was parked on a slight grade, the bucket was raised off the ground, and no wheel chocks were in place.

- Perform repairs on mobile equipment only after the machine is turned off and blocked against motion.
