NUREG-2119

Mechanical Behavior of Ballooned and Ruptured Cladding

Office of Nuclear Regulatory Research

Prepared by
Michelle Flanagan

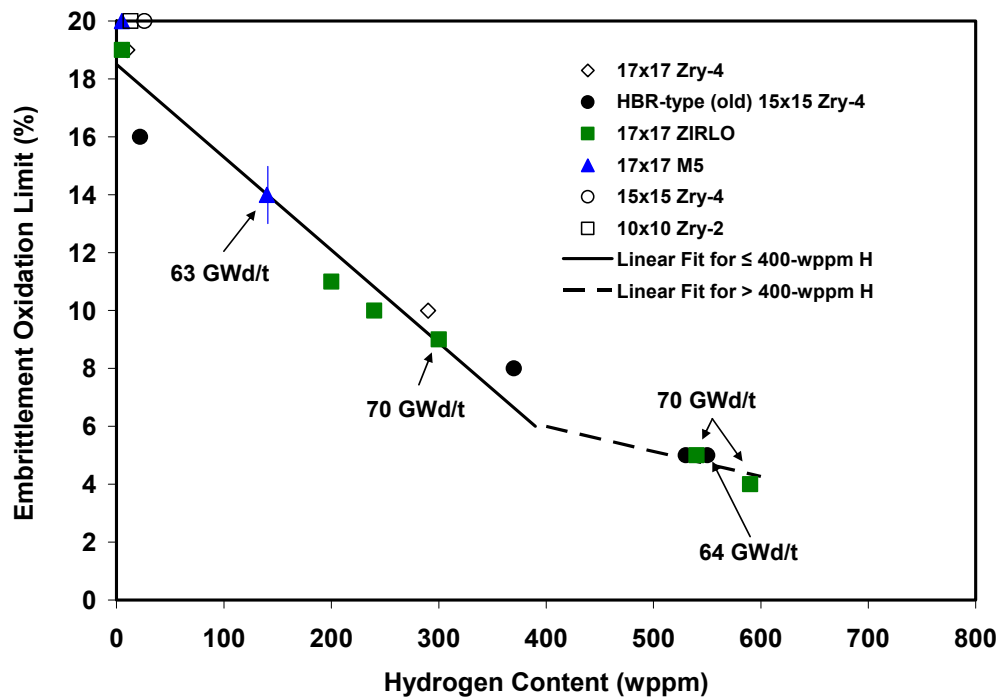
Figure 1 Embrittlement oxidation limit (CP-ECR in %) as a function of metal hydrogen content for as-fabricated, prehydrided, and high-burnup cladding alloys oxidized at a peak temperature of 1,200 °C, quenched at 800 °C, and ring-compressed at 135 °C. Oxidation values above data points and trend lines resulted in brittle behavior. For hydrogen contents in the range of 540–600 wppm, peak cladding temperatures (1,130–1,180 °C) occurred during the heating ramp at <1,200 °C (Ref. 6).

trend lines mark the transition from ductile to brittle behavior, as observed in RCTs, of oxidized as-fabricated, prehydrided, and high-burnup cladding materials.

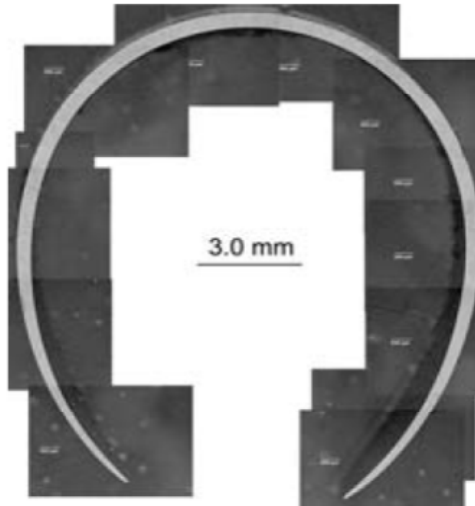
Figure 2 Ballooned and ruptured ZIRLO cladding (ANL)

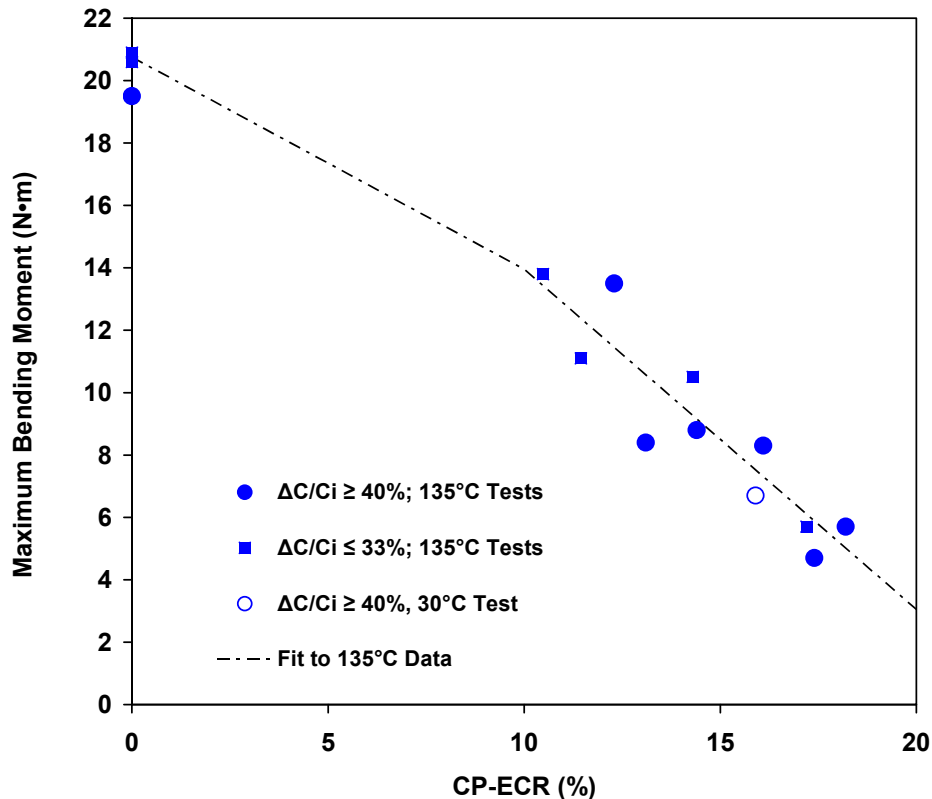
Figure 3 Maximum bending moment as a function of maximum oxidation level (CP-ECR) for post-LOCA samples subjected to 4-PBTs with the rupture region in tension for all tests but one. Bend tests were performed at 135 °C and 2 or 1 mm/s to 14-mm maximum displacement. One bend test was performed at 30 °C and 1 mm/s.

$$M_{max} = 13.96 - 1.090 (\text{CP-ECR} - 10\%), \text{ N}\cdot\text{m} \quad (1)$$

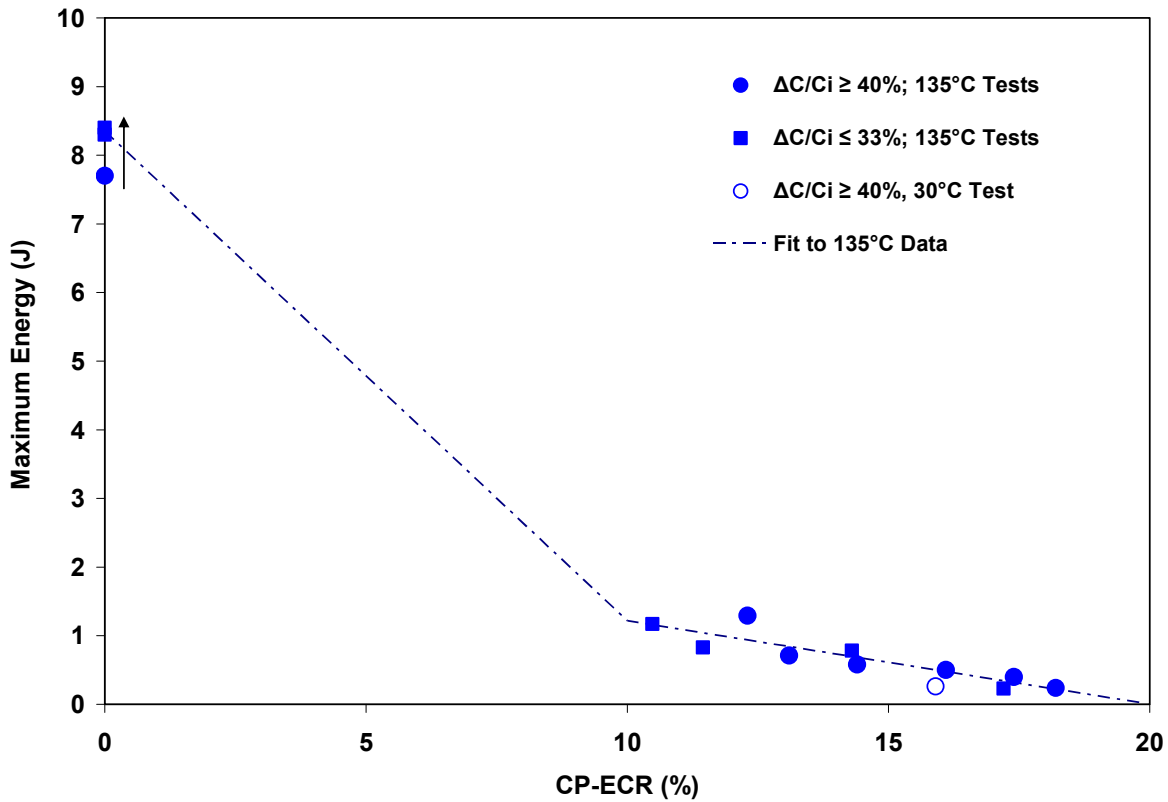
Figure 4 Maximum (for 0% CP-ECR) and failure (for ≥10% CP-ECR) energy as a function of oxidation level (CP-ECR) for post-LOCA samples subjected to four-point bending with the rupture region in tension for all tests but one. Bend tests were performed at 135 °C and 2 or 1 mm/s to 14-mm maximum displacement. One bend test was conducted at 30 °C and 1 mm/s.

although without data in this region, the details of this decrease are not clear. The decrease in failure energy is more gradual for increasing oxidation levels from 10 to 18 percent.

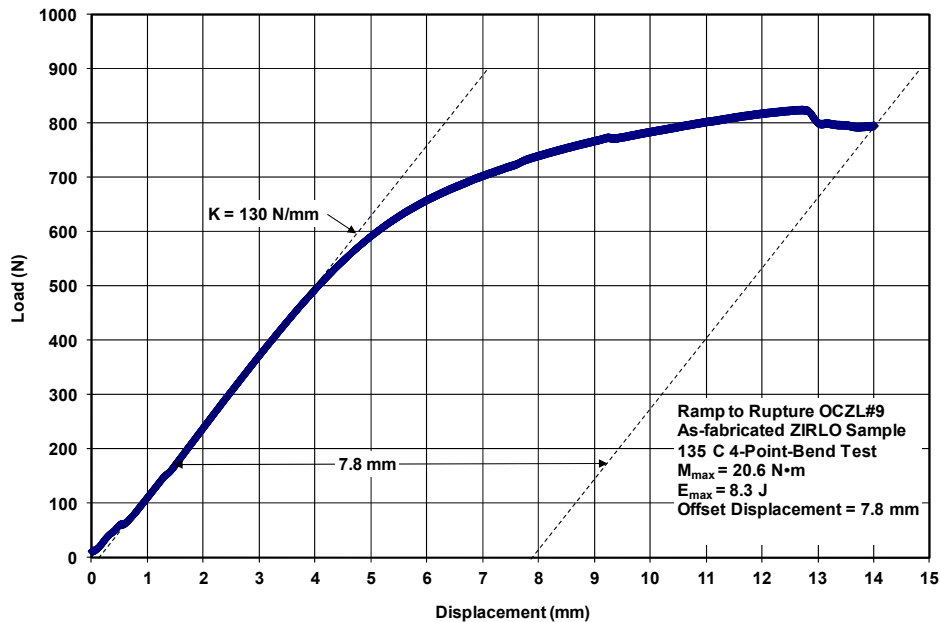
Figure 5 Four-point bend test load-displacement curve for ramp-to-rupture sample OCZL#9. The as-fabricated ZIRLO sample ruptured at 875 ± 15 °C with a mid-wall rupture strain of 33%. The 4-PBT was conducted at 135 °C and 2 mm/s displacement rate to 14-mm maximum displacement.

For the ramp-to-rupture samples (zero percent CP-ECR), there was a smooth transition between the constant load-displacement slope in the elastic bending regime and the decreasing slope after initiation of plastic flow in the axial direction, as can be seen in Figure 5. Measured offset displacements were in the range of 7 to 8 mm for these ductile samples. The loading stiffness values were reasonably close, but they appeared to increase somewhat with decreasing rupture strain: 120 N/mm for 69 percent rupture strain, 130 N/mm for 33 percent rupture strain, and 135 N/mm for 21 percent rupture strain.

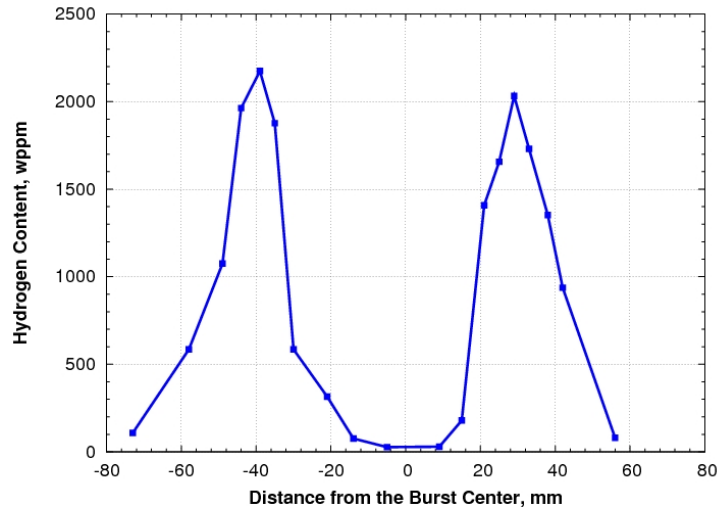
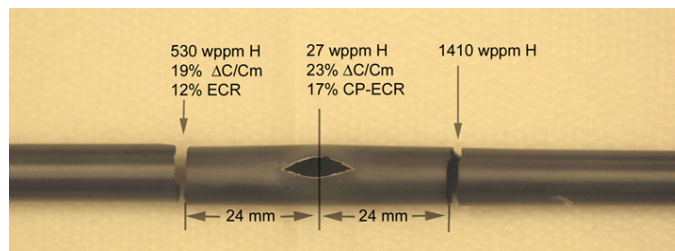
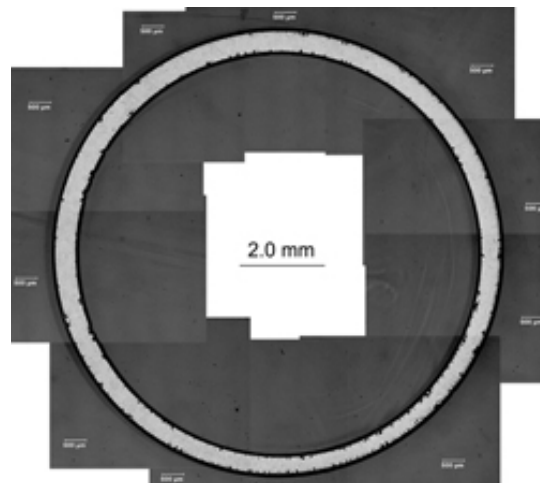
(a) Hydrogen-content profile

(b) Measured values at failure locations

(c) Low-magnification image of severed cross section at -24 mm

Figure 6 Post-bend characterization of the OCZL#19 sample that was subjected to bending at 135 °C with the rupture region under maximum tensile stress: (a) hydrogen-content profile, (b) measured values at failure locations, and (c) low-magnification image of severed cross section at 24 mm below rupture midspan.

The two samples that severed in the rupture node with zero offset strain had rupture strains greater than or equal to 40 percent and CP-ECR values of 12 and 18 percent. Figure 7 shows (a) the hydrogen distribution, (b) the severed sample, and (c) the cross section at the severed location for the OCZL#18 sample. The average CP-ECR was only 12 percent, and the hydrogen pickup at the failure location was negligible. For a ring with no rupture-opening flaw and uniform oxidation around the circumference, the sample would have exhibited high ductility (30 to 50 percent). However, the local oxidation for this sample varied from much greater than 35 percent at the rupture tips (see Figure 8a) to 10 percent at the thick back region 180° from the center of the rupture opening (see Figure 8b). Under tensile bending stress, the crack initiated at the brittle rupture tips and propagated rapidly through the cross section with no indication of offset displacement. Although it required a relatively high bending moment and energy to sever this sample, the "ductile" regions of the cladding did not have enough fracture toughness to blunt crack growth.

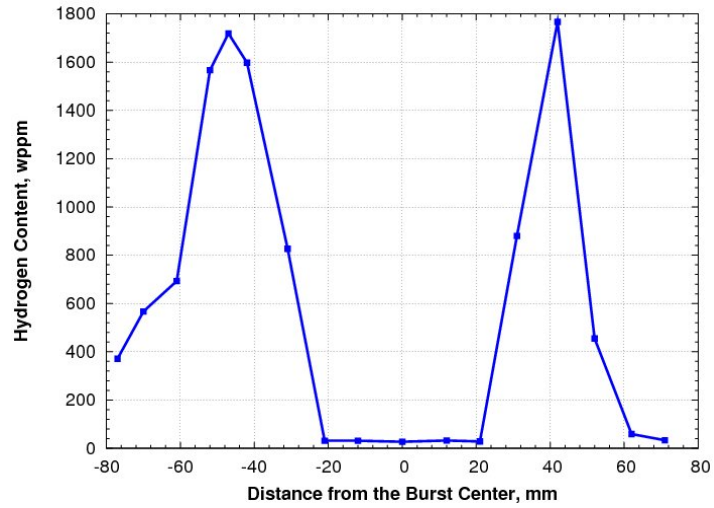
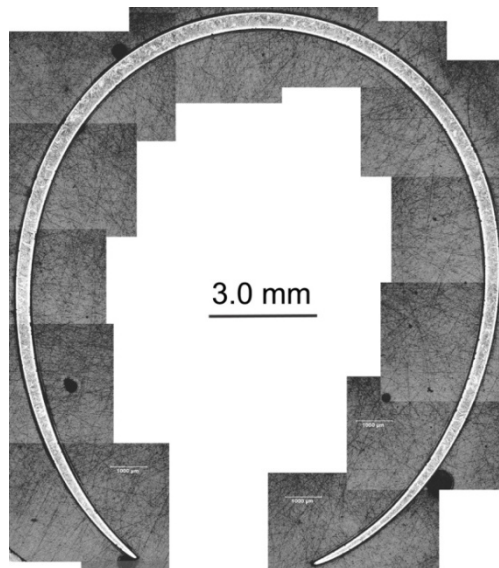
(a) Hydrogen-content profile

(b) Failure location

(c) Low-magnification image of severed cross section

Figure 7 Post-bend characterization of the OCZL#18 sample oxidized to 12% CP-ECR, quenched, and subjected to bending at 135 °C with the rupture region under maximum tensile stress: (a) hydrogen-content profile, (b) failure location, and (c) low-magnification image of the severed cross section.

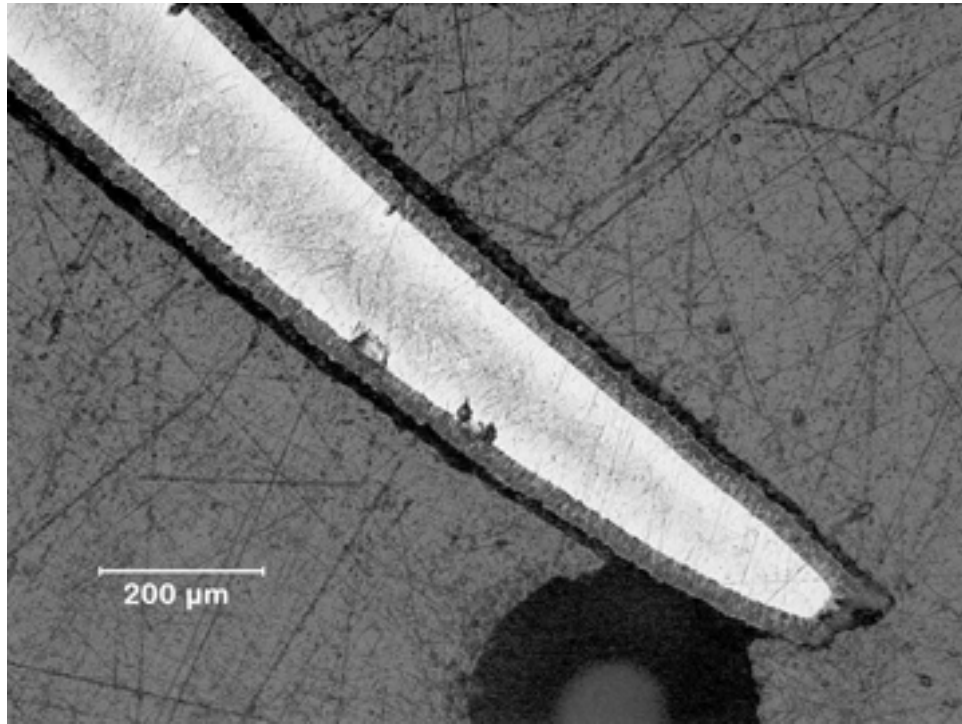
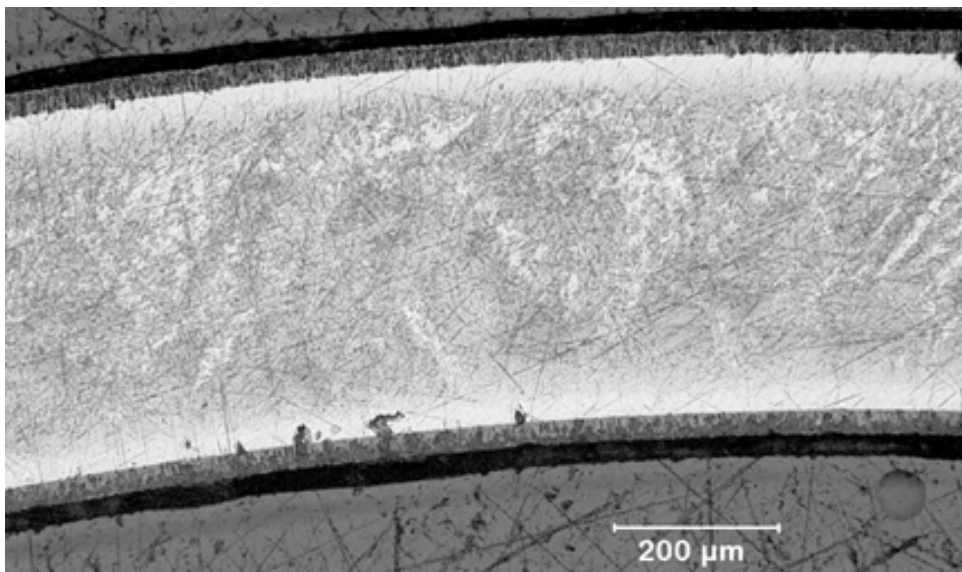
(a) Rupture tip

(b) Back side of rupture node cross section

Figure 8 Metallographic images for the OCZL#18 severed cross section following oxidation to 12% CP-ECR, quench, and bending at 135 °C with the rupture region under maximum tension: (a) rupture tip with 0.14-mm average metal wall and (b) back side of cross section with 0.44-mm metal wall thickness.

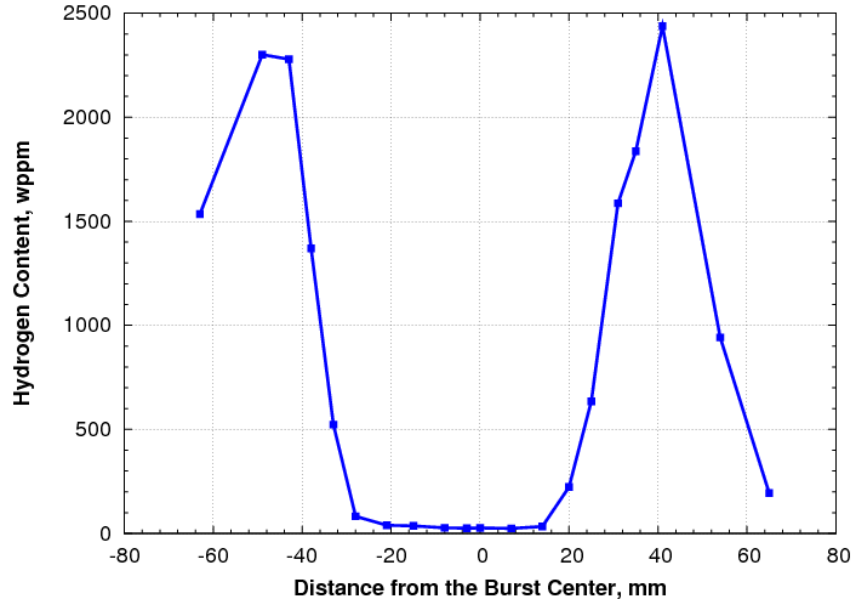
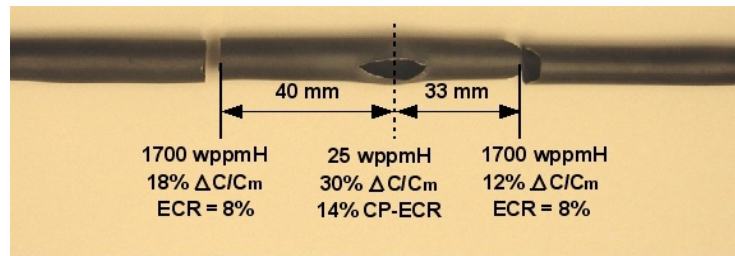
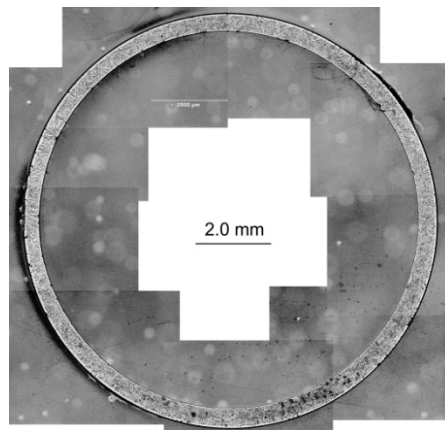
(a) Hydrogen-content profile

(b) Measured values at failure locations

(c) Low-magnification image of severed cross section at -40 mm

Figure 9 Post-bend characterization of OCZL#12 sample that was subjected to bending at 135 °C with the rupture region under maximum compressive stress: (a) hydrogen-content profile, (b) measured values at failure locations, and (c) low-magnification image of severed cross section at 40 mm below rupture midspan.

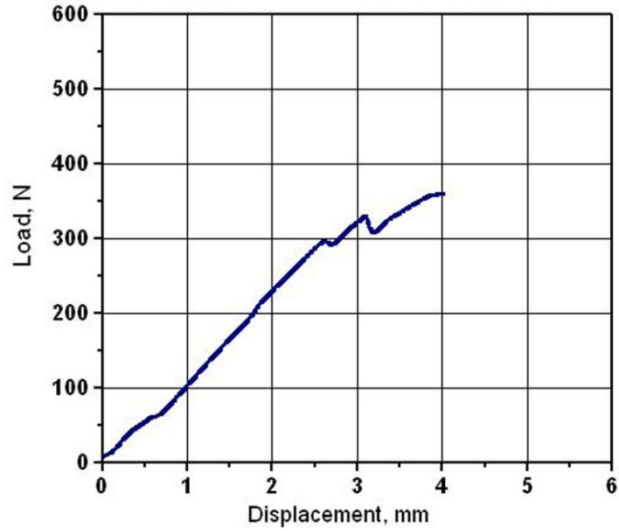
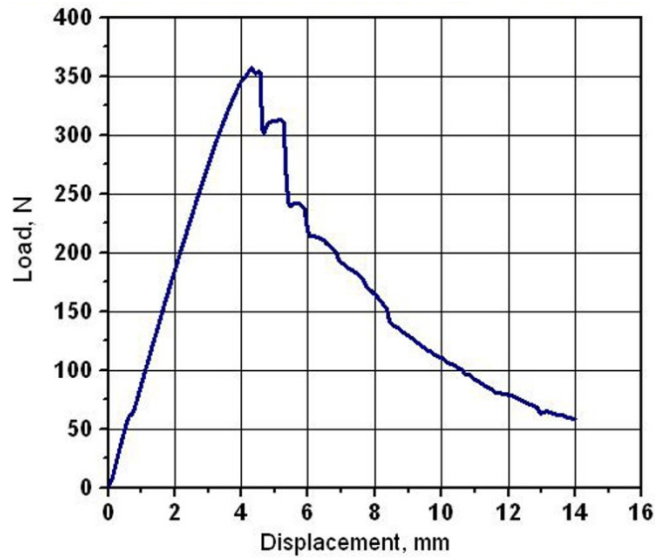
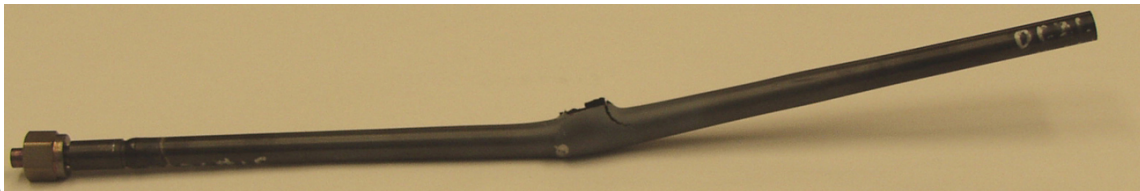
(a) First loading

(b) Second loading

(c) Sample appearance after second loading

Figure 10 Post-bend results for the OCZL#15 sample (18% CP-ECR and quench) with rupture node in compression (reverse bending), 135 °C test temperature and 2 mm/s displacement rate: (a) load-displacement curve for first loading and (b) load-displacement curve for second loading.

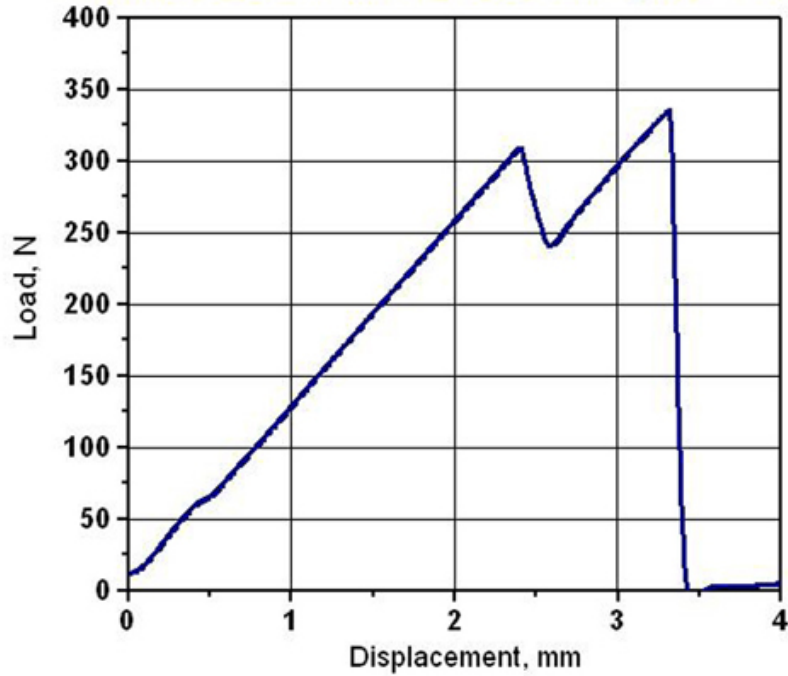
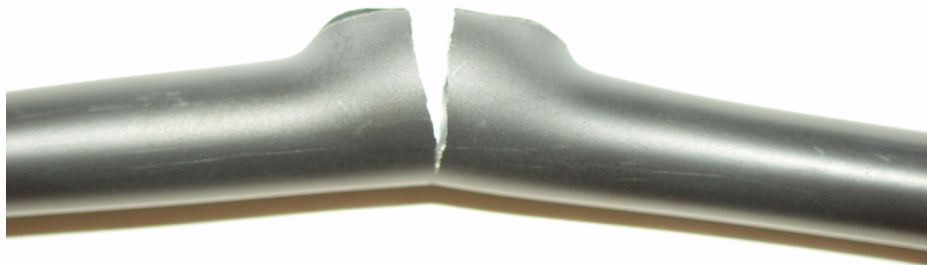
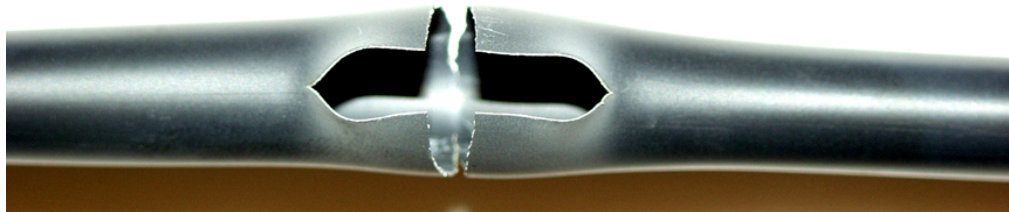
(a) Load-displacement curve for first 4-mm displacement

(b) Posttest image of side view

(c) Posttest image of rupture view

Figure 11 4-PBT results for Test Sample OCZL#17 oxidized to 13% CP-ECR, quenched, and tested at 135 °C and 2 mm/s displacement rate: (a) load-displacement curve for first 4-mm displacement (out of 10-mm total displacement), (b) posttest image of side view, and (c) posttest image of rupture view.

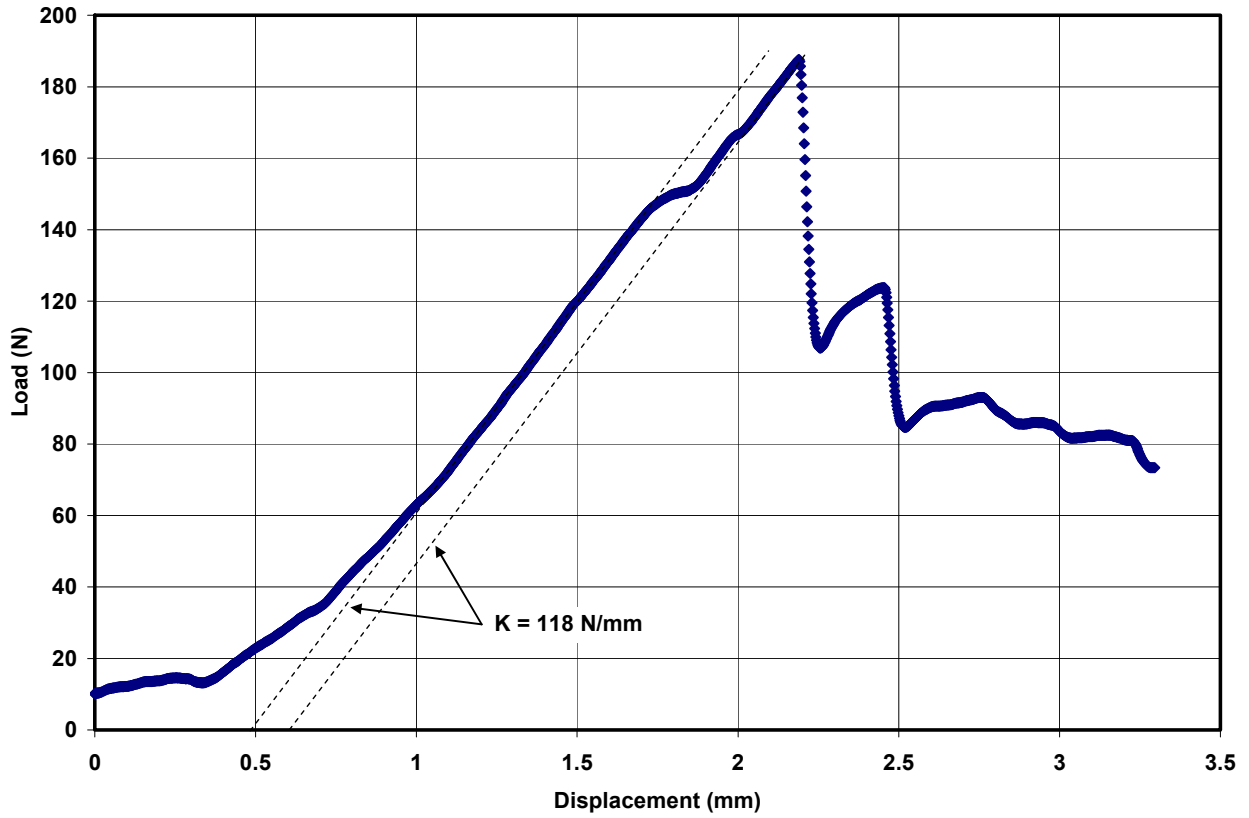
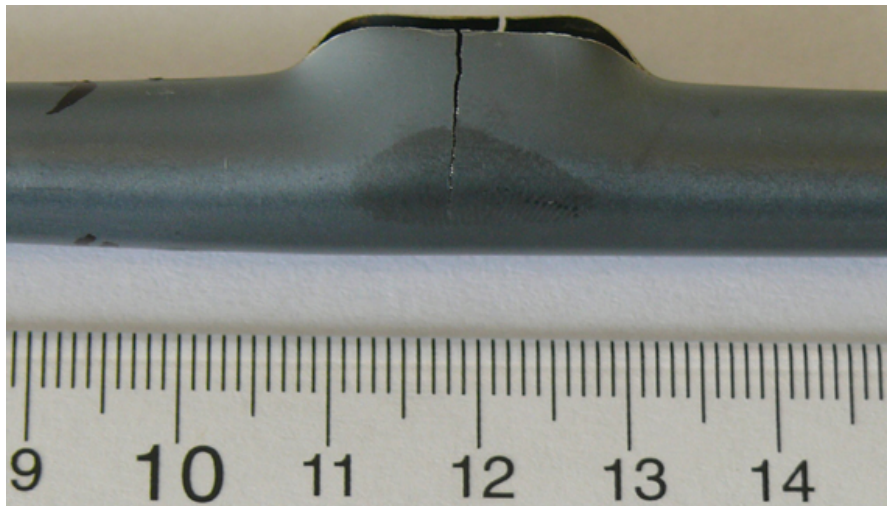
(a) First loading-unloading sequence

(b) Side view after first loading-unloading

Figure 12 Test Sample OCZL#29 oxidized to 17% CP-ECR, quenched, and subjected to 4-PBTs at 135 °C and 1 mm/s displacement rate: (a) load-displacement curve for first loading-unloading sequence and (b) sample appearance after first loading-unloading.

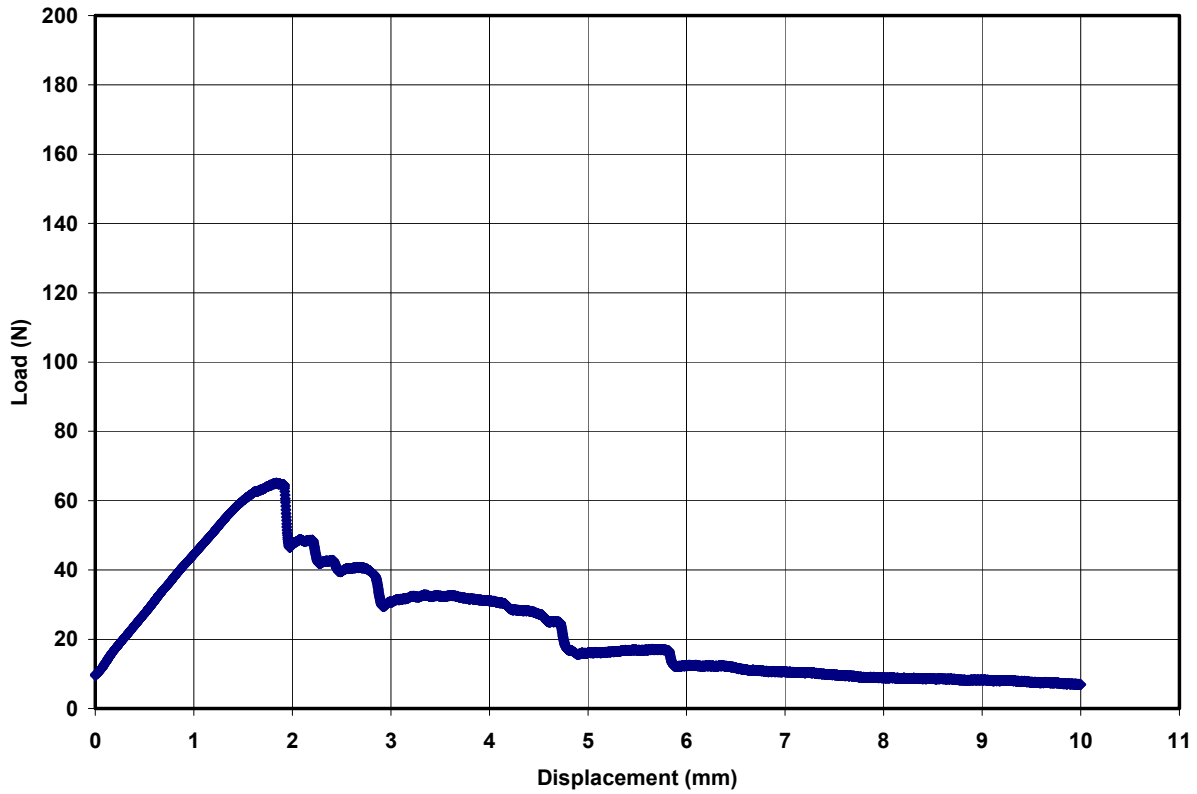
(a) Second loading-unloading

(b) Rupture view after second loading-unloading

Figure 13 Test Sample OCZL#29 oxidized to 17% CP-ECR, quenched, and subjected to 4-PBTs at 135 °C and 1 mm/s displacement rate: (a) load-displacement curve for second loading-unloading sequence and (b) sample appearance after second loading-unloading.

In principle, Equation 5 can be used for samples that severed in the rupture node (e.g., OCZL#29 at 17 percent CP-ECR). However, the severed cross section for the OCZL#29 sample (49 percent rupture strain) would be similar to the one shown in Figure 7c for the OCZL#18 sample (43 percent rupture strain). The equivalent area and area moment of inertia would have to be calculated numerically for this case. Although the maximum bending moment for the OCZL#29 sample (4.7 N•m) was less than for the OCZL#19 sample (5.7 N•m), the sample did exhibit plastic flow following the first significant load drop and did not sever into two pieces. This adds additional complexity to the determination of the axial load needed to sever the sample at this location.

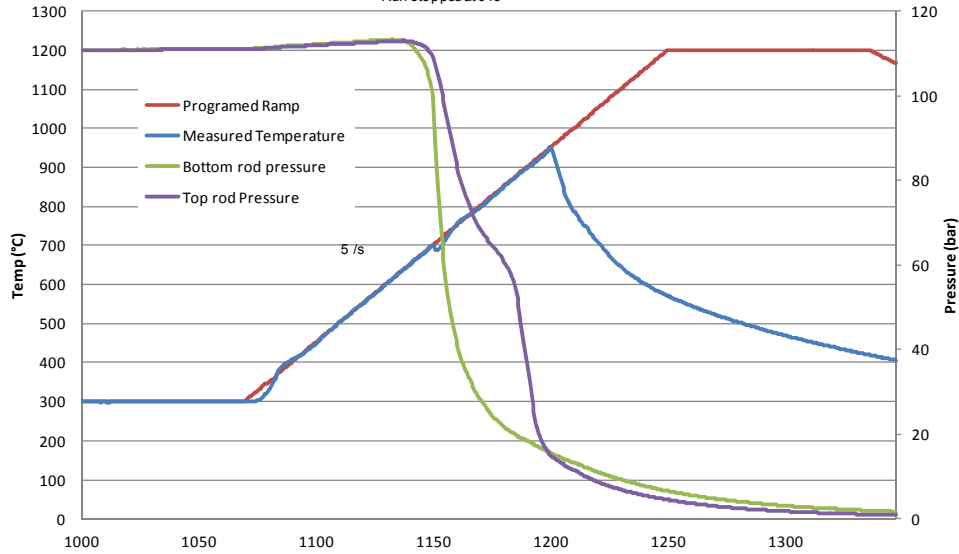
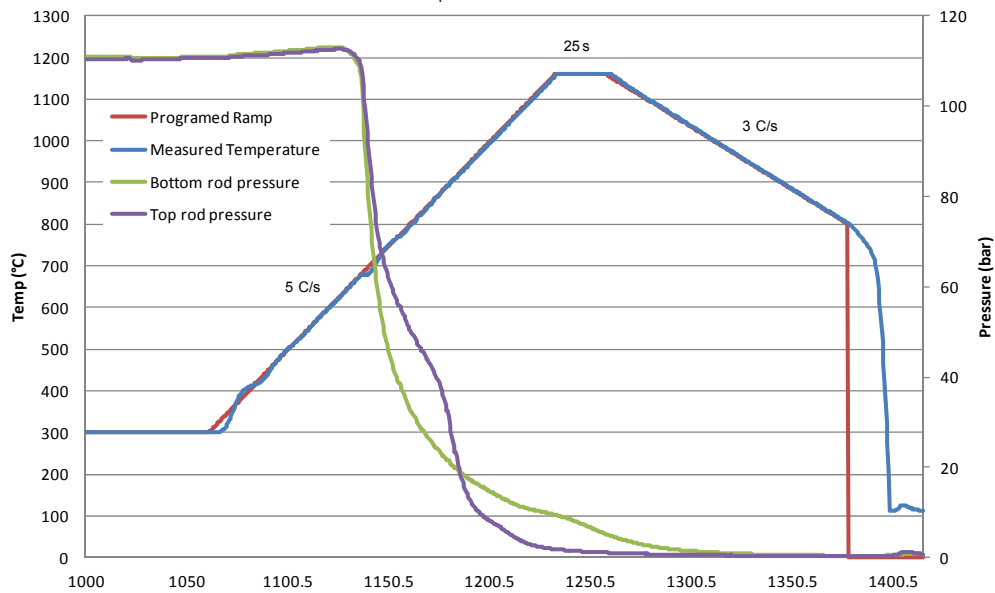
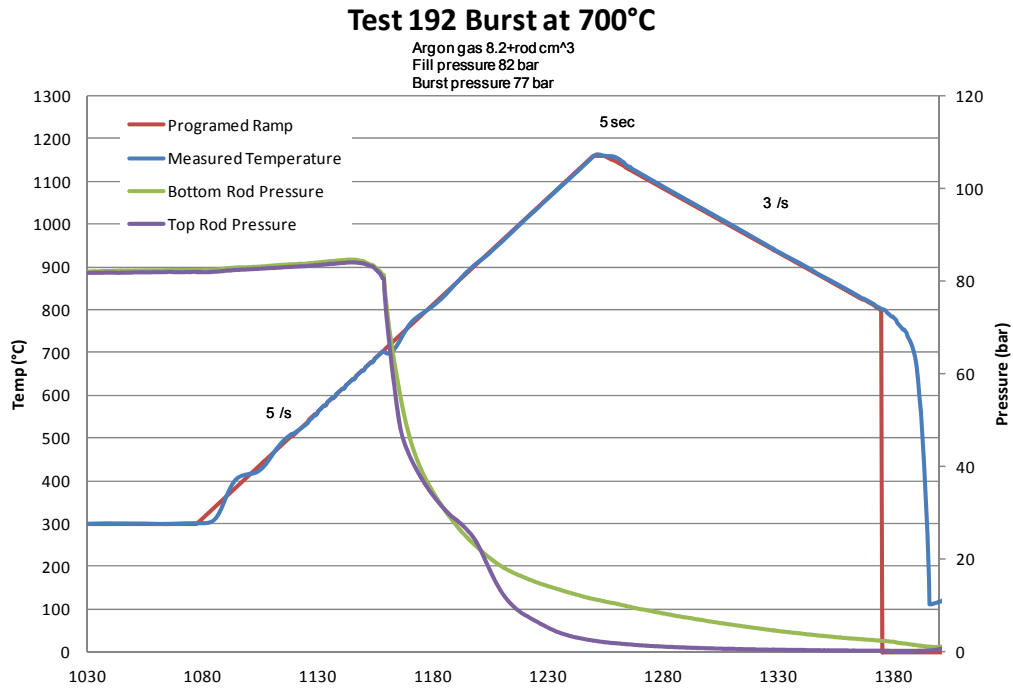
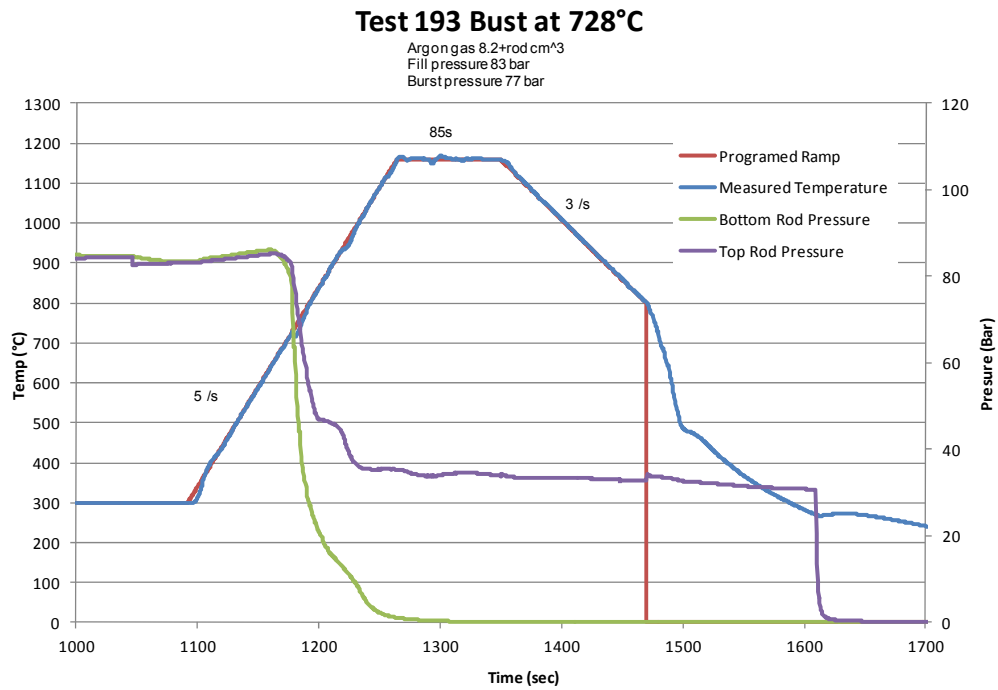
Test 189 Burst at 700°C

Argon gas 8.2+rod cm³
Fill pressure 111 bar
Burst pressure 113 bar
Run stopped at 945

Test 191 Burst at 680°C

Argon gas 8.2+rod cm³
Fill pressure 110 bar
Burst pressure 104 bar

Figure 14 Temperature and pressure history for Test (a) 189, (b) 191, (c) 192, and (d) 193.

Figure 14 indicates the time history of temperature and pressure. Rupture pressure and temperature are indicated in the title of each component of the figure.

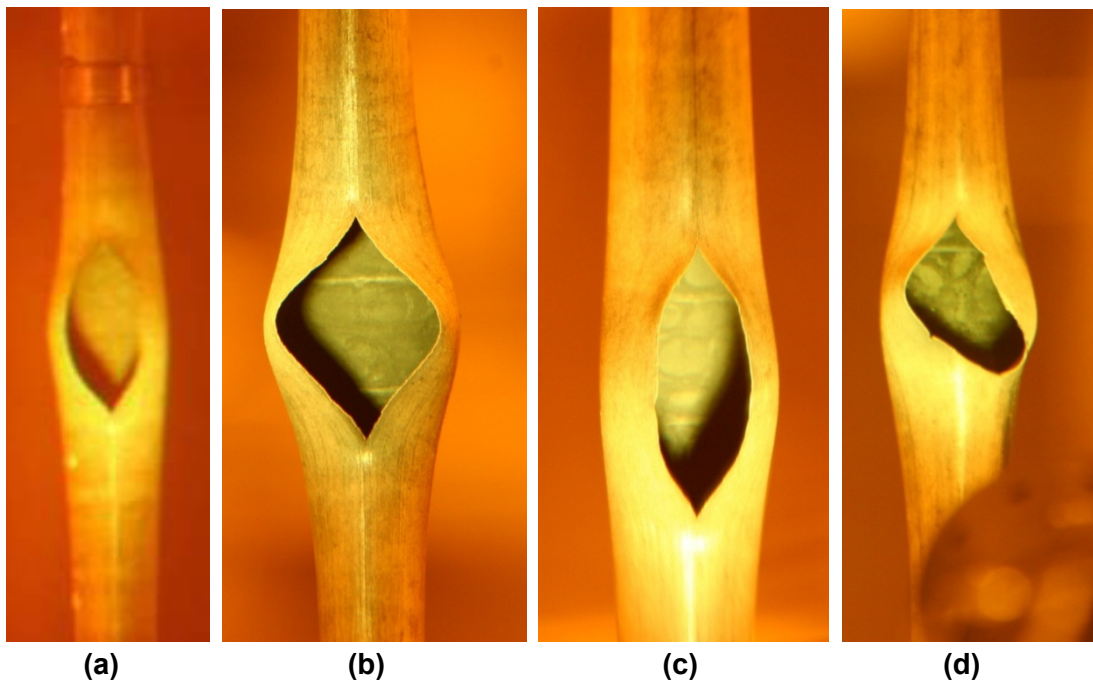
Figure 15 A closeup of the rupture opening after the simulation on rod segment from Test (a) 189, (b) 191, (c) 192, and (d) 193.

Test 189	Test 191	Test 192	Test 193
Comments	Ramp to rupture test	Ramp to PCT, held for 25 s at PCT	Ramp to PCT, held for 5 s at PCT	Ramp to PCT, held for 85 s at PCT
Burnup (GWd/MTU)	≈ 72	≈ 71	≈ 72	≈ 71
PCT (°C)	950 ± 20	1185 ± 20	1185 ± 20	1185 ± 20
Calculated ECR (%)	≈ 0	13	11	17
Fill Pressure (bar)	110	110	82	82
Rupture Pressure (bar)	113	104	77	77
Rupture Temperature (°C)	700	680	700	728
Rupture Opening Width (mm)	10.5	17.5	9.0	13.8

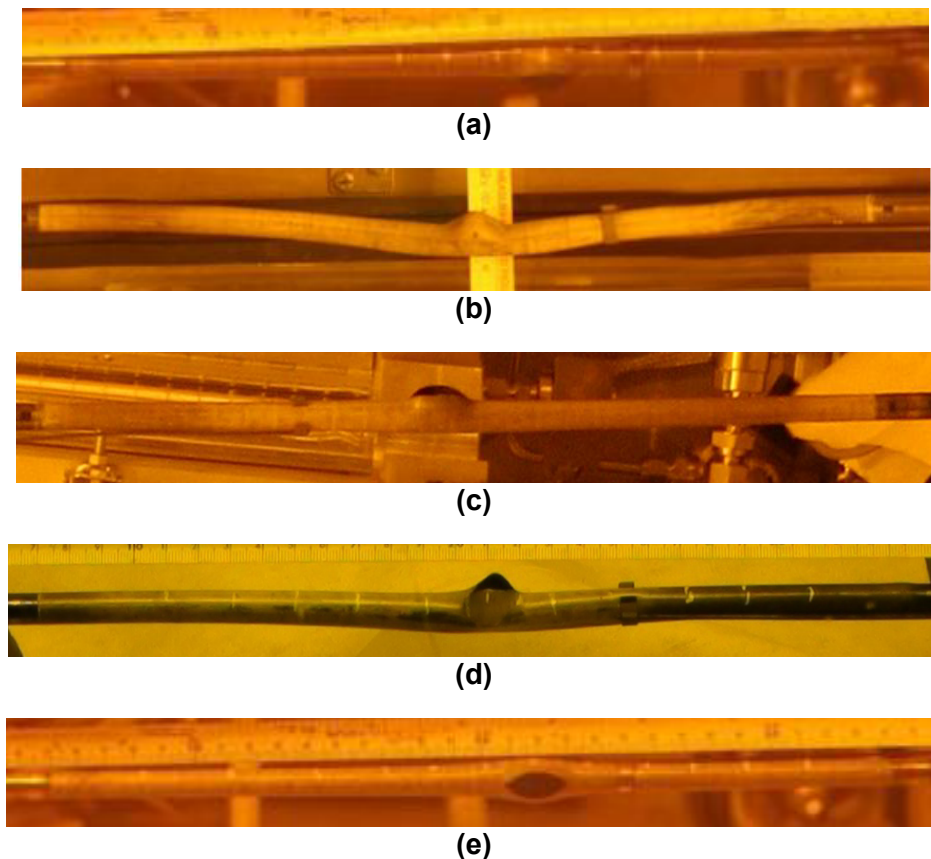
Figure 16 Image of rod segment showing any distortion out of plane, with the rupture from (a) Test 189, (b) Test 191, (c) Test 192, and (d) Test 193. (e) is an image of rod segment 189 taking in-plane of the rupture, showing no significant rod bending that is characteristics of all other tests.

During the LOCA simulation, one of the rod segments (the segment used in Test 191) experienced significant distortion in plane with the rupture opening. Another, from Test 193, experienced minor distortion in plane with the rupture opening. In both cases, the distortion seen in these tests is thought to be related to fuel fragments from previous tests that remained in the test train and around the o-ring and bottom plug. The presence of these fuel fragments increased the friction coefficient at this location and interfered with free expansion of the rod segment. None of the rod segments experienced distortion out of plane with the rupture, and the rod segments used in Tests 189 and 192 did not experience any distortion or bending during the LOCA simulation. Figure 16 provides images of any distortion present out of plane with the rupture for each test, in addition to one image taken of rod segment 189 in plane with the rupture, which is representative of all four tests.

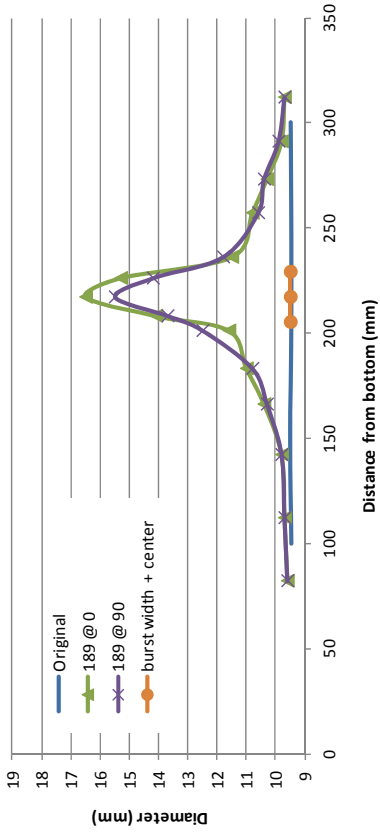
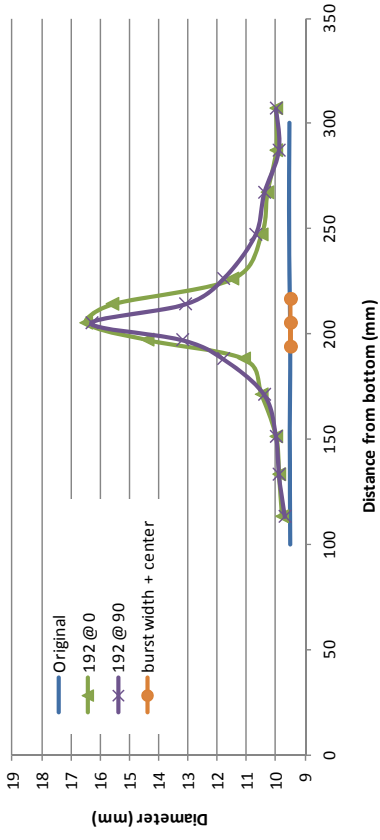
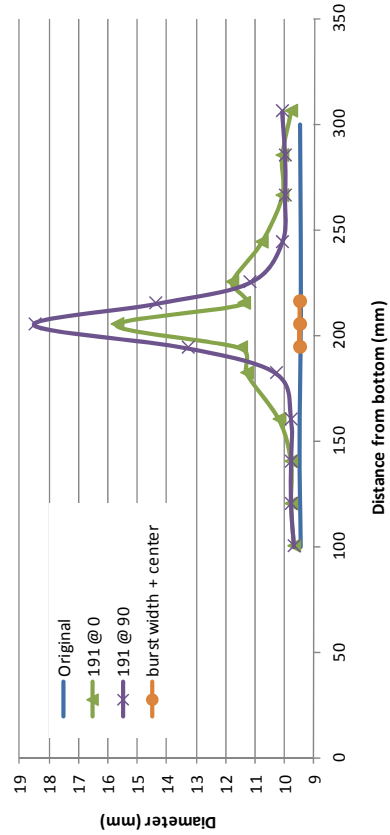
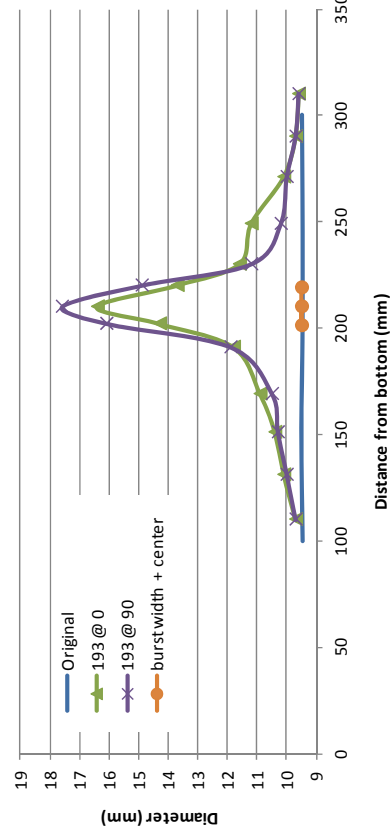
Profilometry measurements were made of each rod segment following the LOCA simulation; they are shown in Figure 17. Figure 17 also indicates the initial diameter and burst length. See Table 3 above for the value of the midwall rupture strain calculated based on these data.

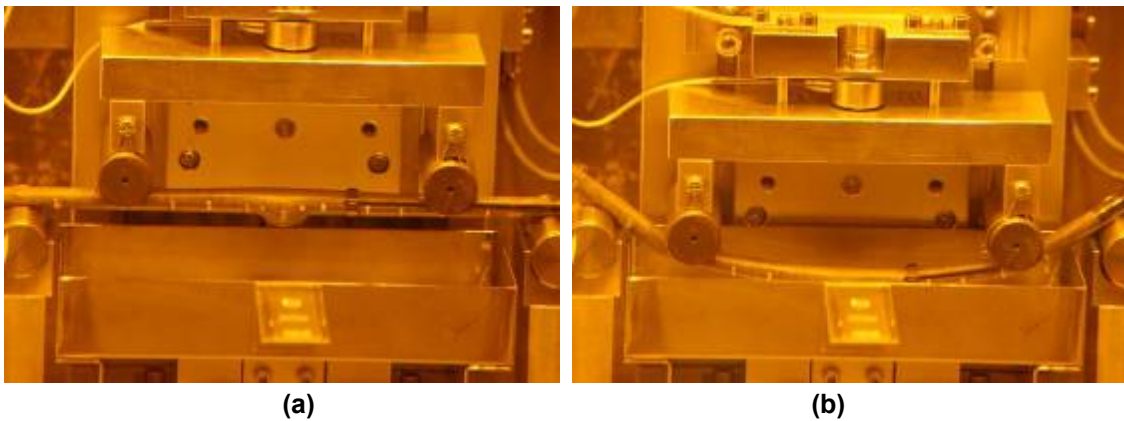
Figure 18 Rod segment 189 (a) before and (b) after four-point bending.

Figure 18 shows images before (a) and after (b) bending of test segment 189. The rod displayed highly ductile behavior and remained intact even after significant bending. Figure 19 illustrates the total displacement (a) by superimposing the initial and final images of the bent rod and (b) by revealing the entire segment length. It can be seen that the rod was able to bend nearly to a 90° angle without breaking. The deflection in this test was limited by the displacement range of the four-point bend device, and therefore it is possible that the rod would have been able to bend even further without breaking.

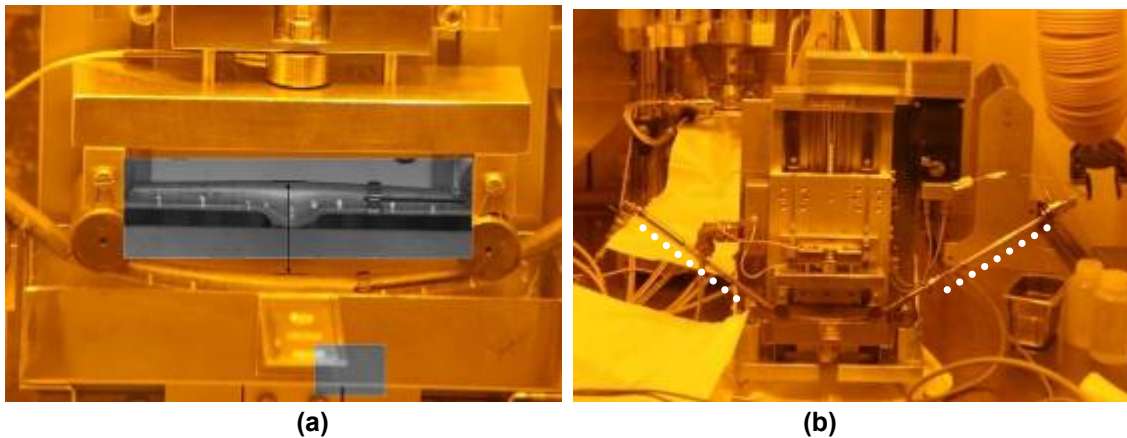
Figure 19 Illustrations indicating (a) the total displacement and (b) total bending of rod segment 189. Note that the deflection was limited by the bend device displacement range.

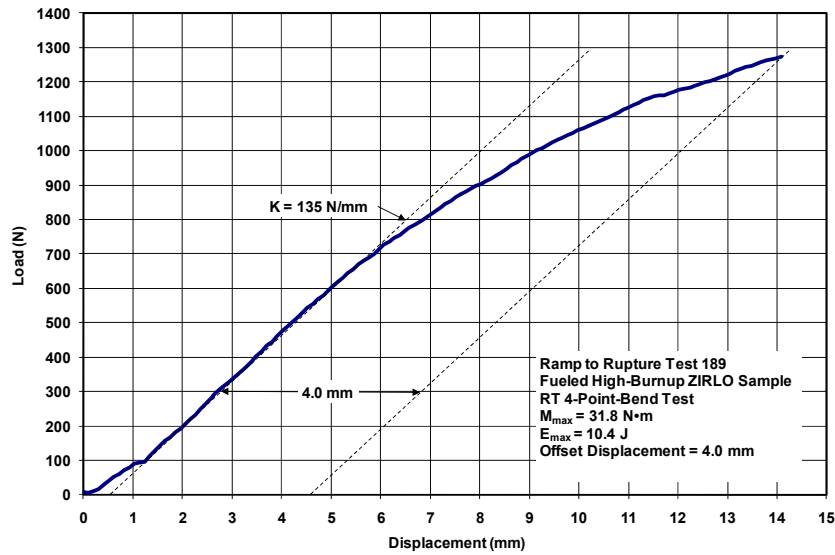
Figure 20 Load-displacement curve for the four-point bend test on segment 189.

loading pins. The displacement at the segment center is derived from this measurement. From the load-displacement curve, through 14.1-mm displacement, maximum values of load, bending moment, offset displacement at the loading pins, and energy were calculated to be 1,273 N, 31.8 N•m, 4.0 mm, and 10.4 J, respectively.

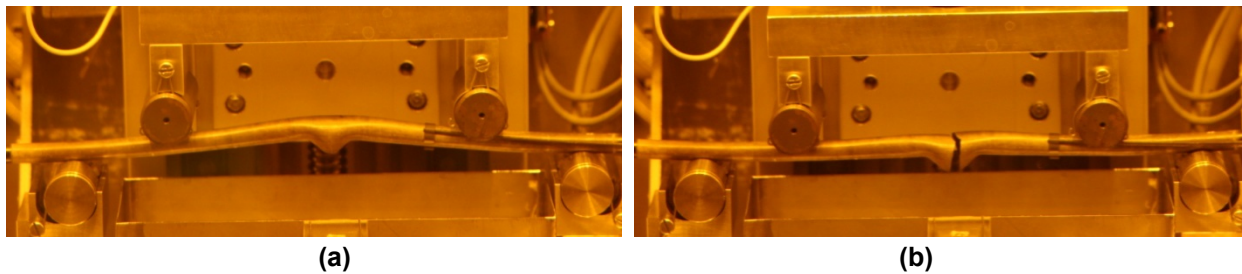
Figure 21 Segment 191 (a) before and (b) after four-point bending.

Figure 21 shows images before (a) and after (b) the bending and breaking of segment 191. The rod displayed fairly brittle behavior. Figure 22 shows the fracture profile for the fractured segment. It can be seen that the fracture path changed directions at the back, and that the original crack path extended after the main fracture path changed directions. It is significant to note that the fracture occurred near the center of the rupture region, at the location of maximum oxidation and minimum wall thickness. One of the objectives of this test series was to investigate if fracture occurred within the rupture region or in the highly hydrided “neck regions” Failure in the highly hydrided “neck regions” would indicate that these regions were more brittle and weaker than the highly oxidized rupture center.

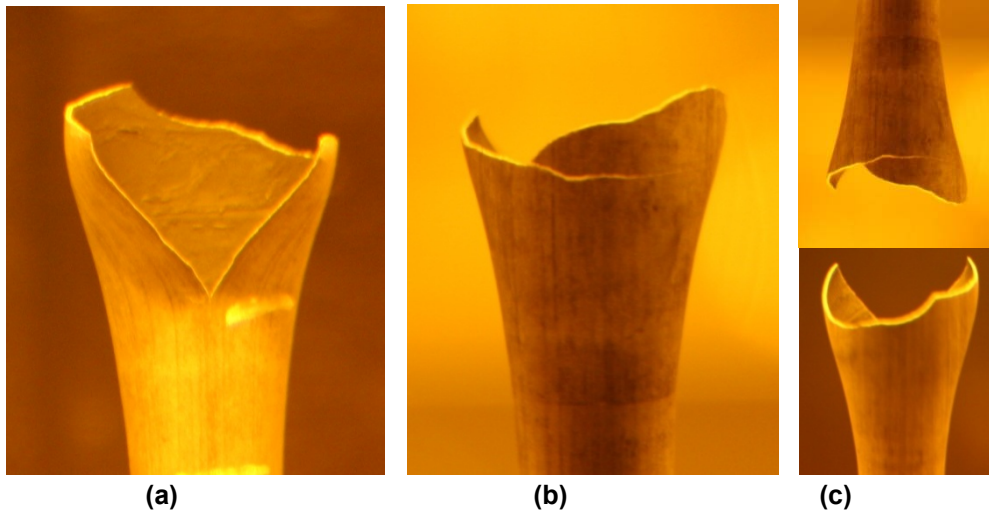
Figure 22 Images of the fracture profile from segment 191 after the four-point bend test: (a) the bottom half, (b) the top half, and (c) an illustration of the back side of the two halves put together. In (b) a second crack propagation path can be seen.

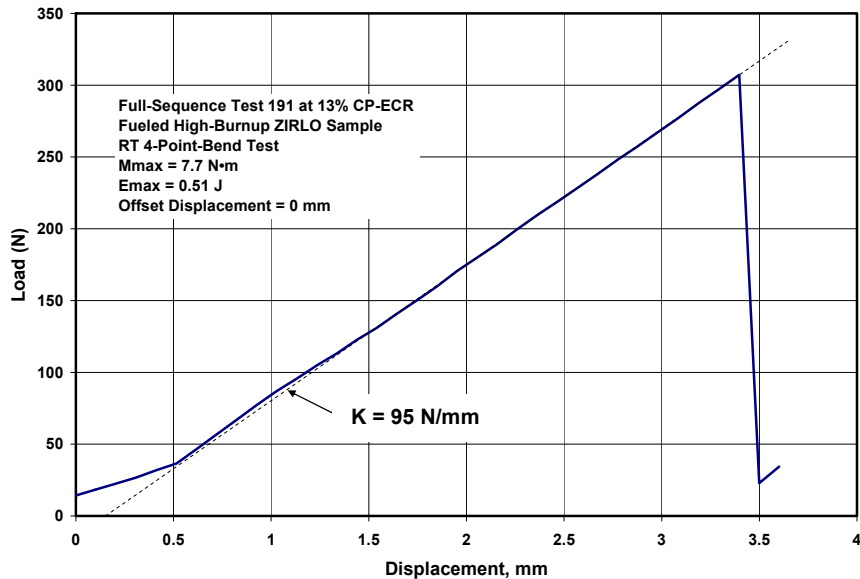
Figure 23 Load-displacement curve for the four-point bend test on segment 191.

Figure 23 provides the load-displacement curve. The segment withstood over 300-N flexural load before breaking. The x-axis is flexural extension and indicates the displacement of the loading pins. From the load-displacement curve, values of maximum load, failure bending moment, offset displacement at the loading pins, and failure energy were calculated to be 307 N, 7.7 N•m, 0 mm, and 0.51 J, respectively.
