NUREG-2119

Mechanical Behavior of Ballooned and Ruptured Cladding

Office of Nuclear Regulatory Research

Prepared by
Michelle Flanagan

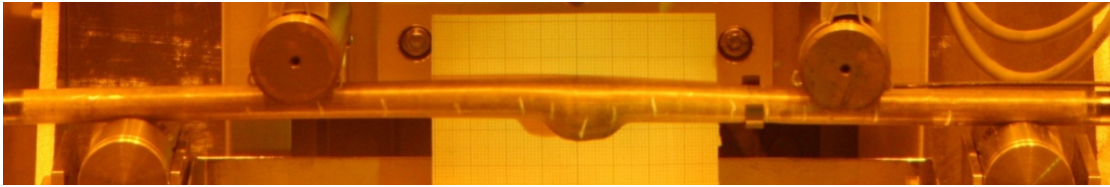
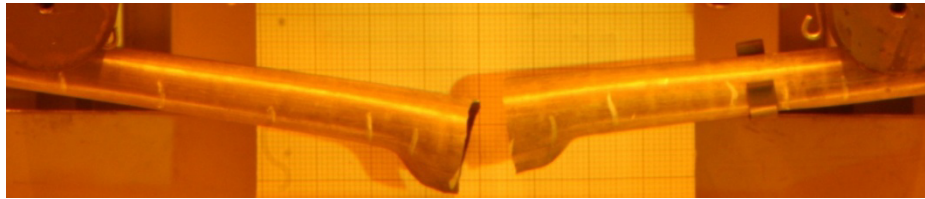
Figure 24 Segment 192 (a) before and (b) after four-point bending.

Figure 24 shows images (a) before and (b) after bending and breaking of rod segment 192. The rod displayed fairly brittle behavior. Figure 25 shows the fracture profile for the fractured segment. As in Test 191, the fracture occurred near the center of the rupture region, at the location of maximum oxidation and minimum wall thickness.

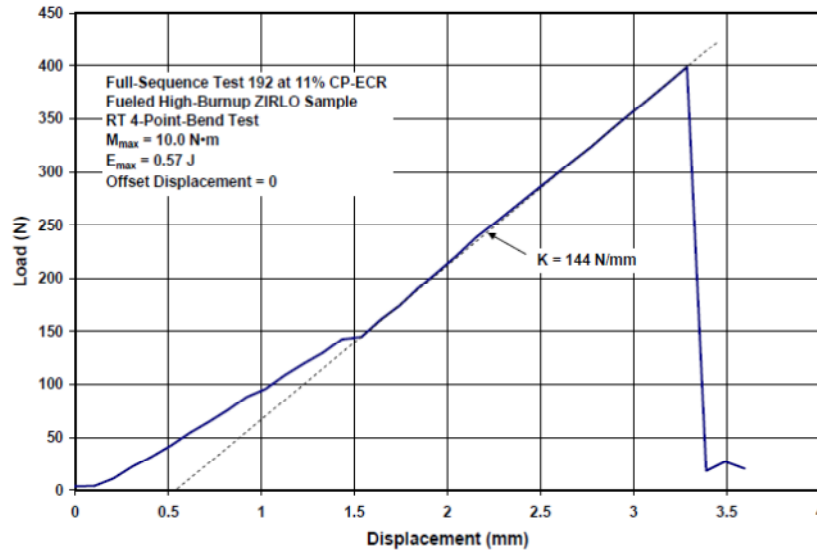
Figure 26 Load-displacement curve for the four-point bend test on segment 192.

Figure 26 provides the load-displacement curve. The segment withstood almost 400-N flexural load before breaking. The x-axis is flexural extension and indicates the displacement of the loading pins. From the load-displacement curve, values of maximum load, failure bending moment, offset displacement at the loading pins, and failure energy were calculated to be 400 N, 10.0 N•m, 0 mm, and 0.57 J, respectively.

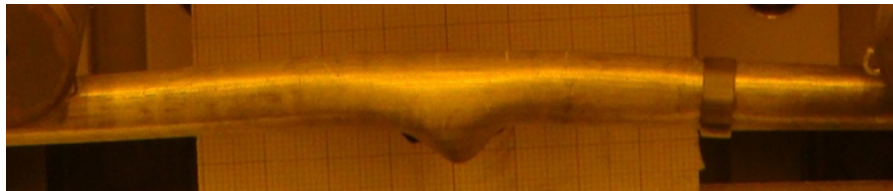
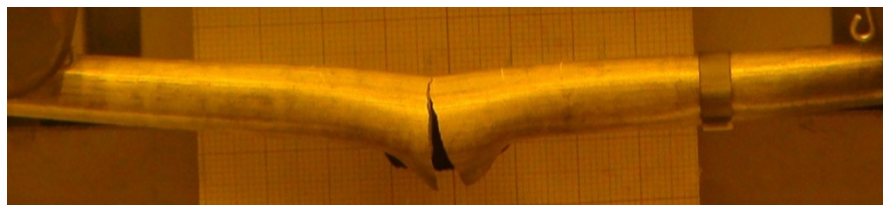
Figure 27 Segment 193 (a) before and (b) after four-point bending.

Following the LOCA simulation, the fuel rod was loaded in four-point bending. Figure 27 shows images before (a) and after (b) bending and breaking. The rod displayed brittle behavior. Figure 28 shows the fracture profile for the fractured segment. As in Tests 191 and 192, the fracture occurred near the center of the rupture region, at the location of maximum oxidation and minimum wall thickness.

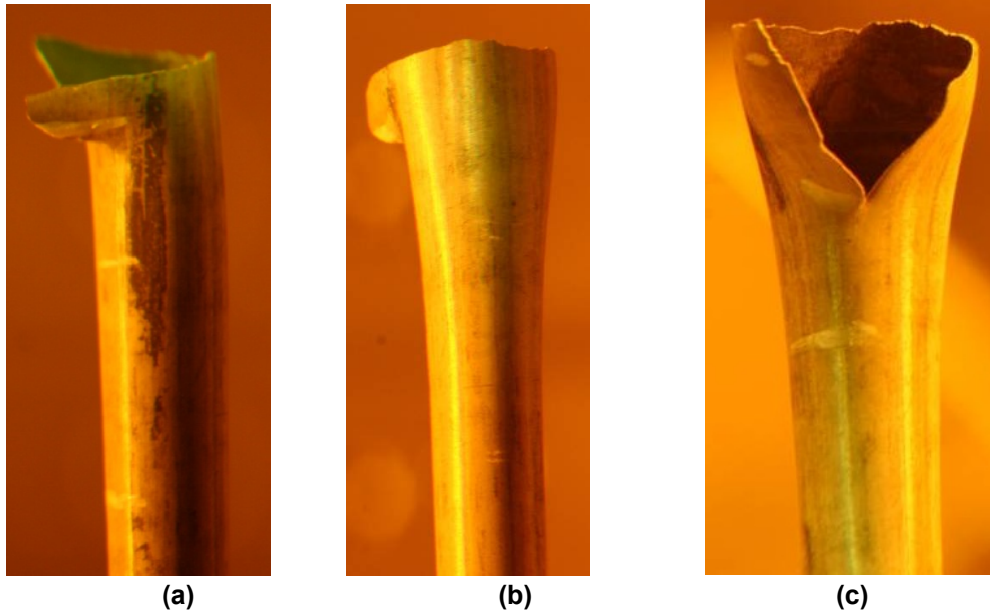
Figure 28 Images of the fracture profile from segment 193 after the four-point bend test of (a) and (b) the bottom half and (c) the top half.

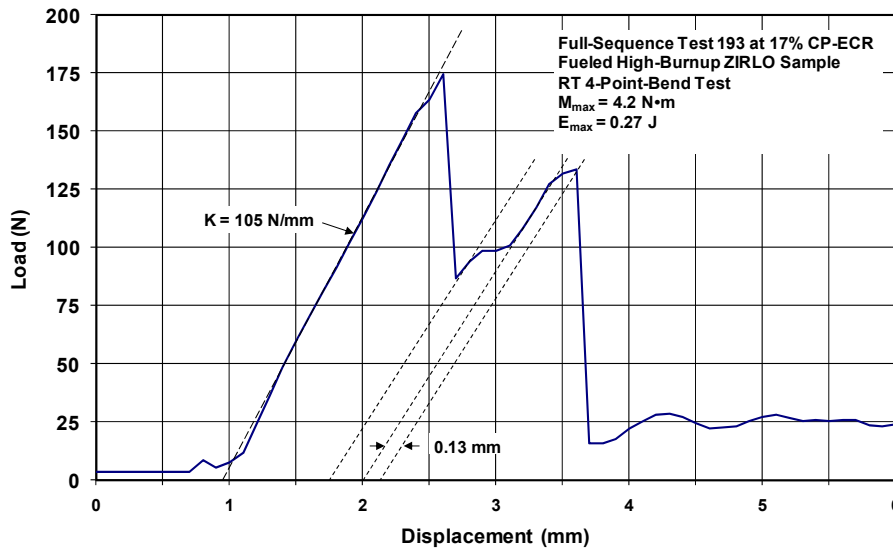
Figure 29 Load-displacement curve for the four-point bend test on segment 193.

Figure 29 provides the load-displacement curve. The segment withstood a 175-N flexural load before breaking. The x-axis is flexural extension and indicates the displacement of the loading pins. From the load-displacement curve, values of maximum load, failure bending moment, offset displacement at the loading pins, and failure energy were calculated to be 175 N, 4.2 N•m, 0.13 mm, and 0.27 J, respectively.

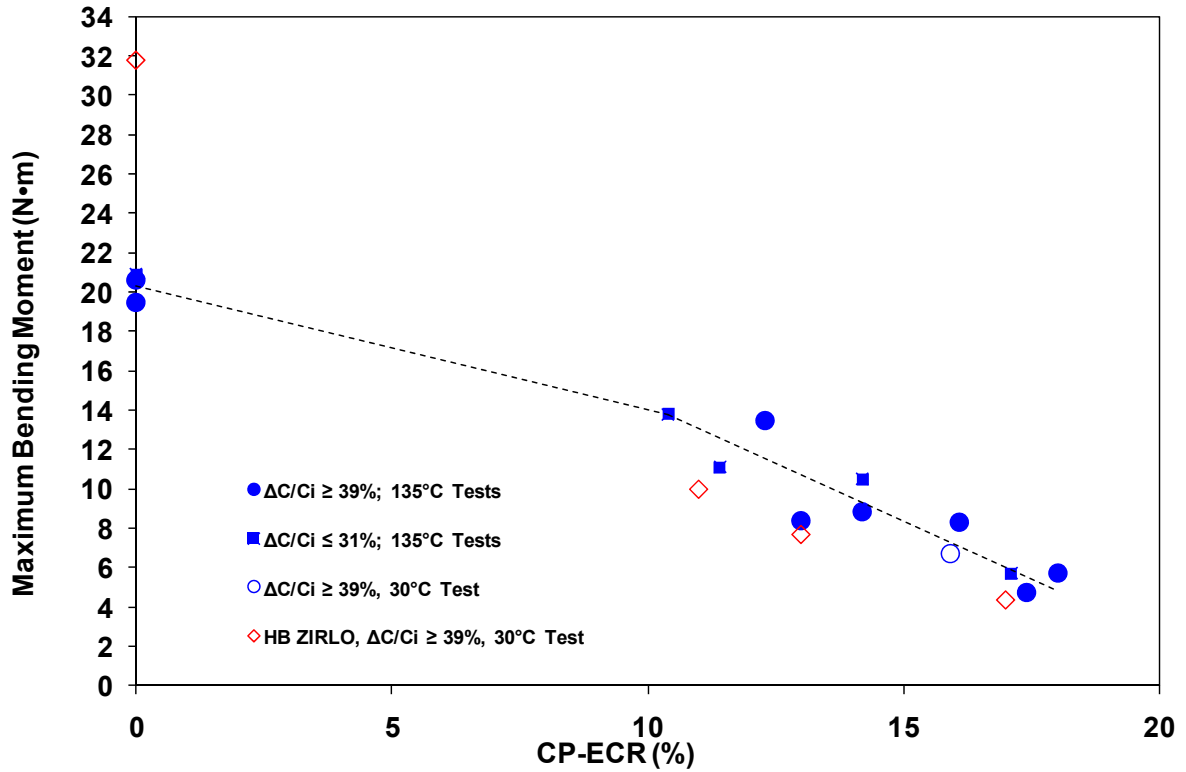
Figure 30 Maximum bending moment as a function of oxidation level for post-LOCA-oxidation samples subjected to four-point bend tests at 1–2 mm/s and either 135 °C or RT (30 °C). For samples at 0% CP-ECR, which did not fail, values are plotted for 14-mm displacement. Argonne data for AF ZIRLO are plotted with blue symbols and Studsvik data for high-burnup ZIRLO samples are plotted with red symbols. The trend line is a best fit to Argonne four-point bend test data at 135 °C.

The results presented in sections 4.1 and 4.2 for as-fabricated and irradiated testing have been combined and plotted below in Figure 30 and Figure 31.

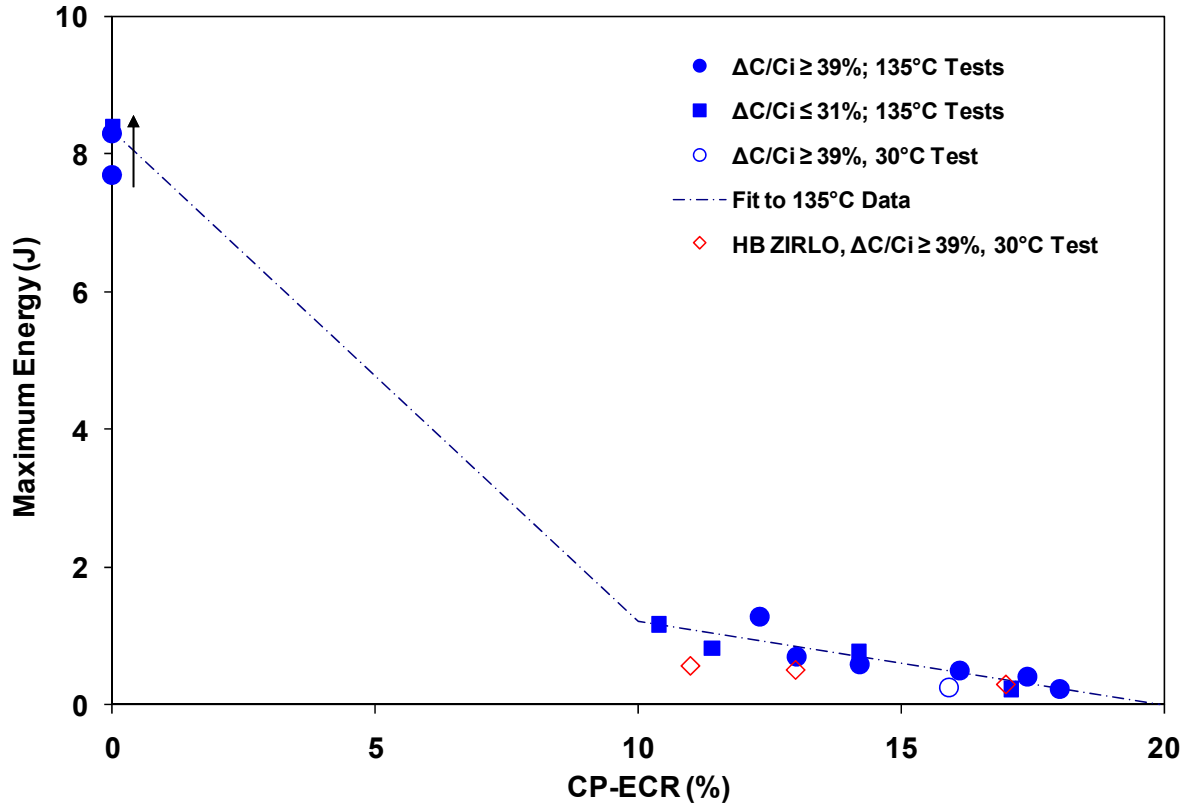
Figure 31 Maximum energy as a function of oxidation level for post-LOCA-oxidation samples subjected to four-point bend tests at 1–2 mm/s and either 135 °C or RT (30 °C). For samples at 0% CP-ECR, which did not fail, maximum energies through 14-mm displacement are plotted. For samples with >10% CP-ECR, data points represent failure energy. Argonne data for AF ZIRLO are plotted with blue symbols and Studsvik data for high-burnup ZIRLO samples are plotted with red symbols. The trend line is a best fit to Argonne four-point bend test data at 135 °C.

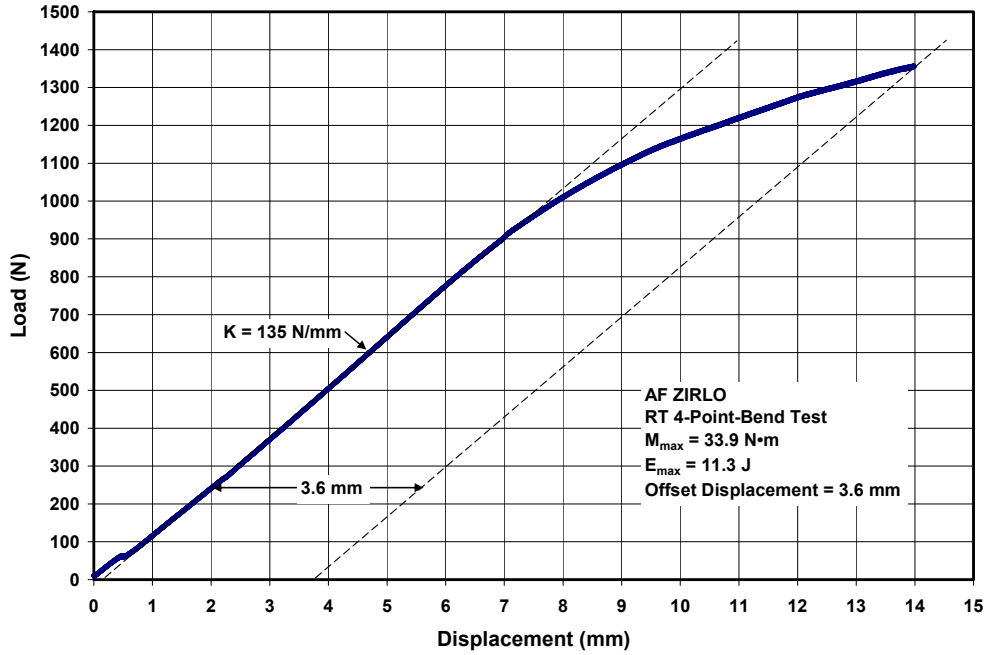
Figure B-1 Load-displacement curve for Argonne National Laboratory four-point bend test benchmark conducted with AF ZIRLO-2003 at RT and 1 mm/s.

4-PBT	Calculated K , N/mm	Measured K , N/mm	M_{max} , N•m	E_{max} , J	Offset Displacement, mm
Argonne	133	135	33.9	11.3	3.6
Studsvik	138	149	36.1	12.6	3.7

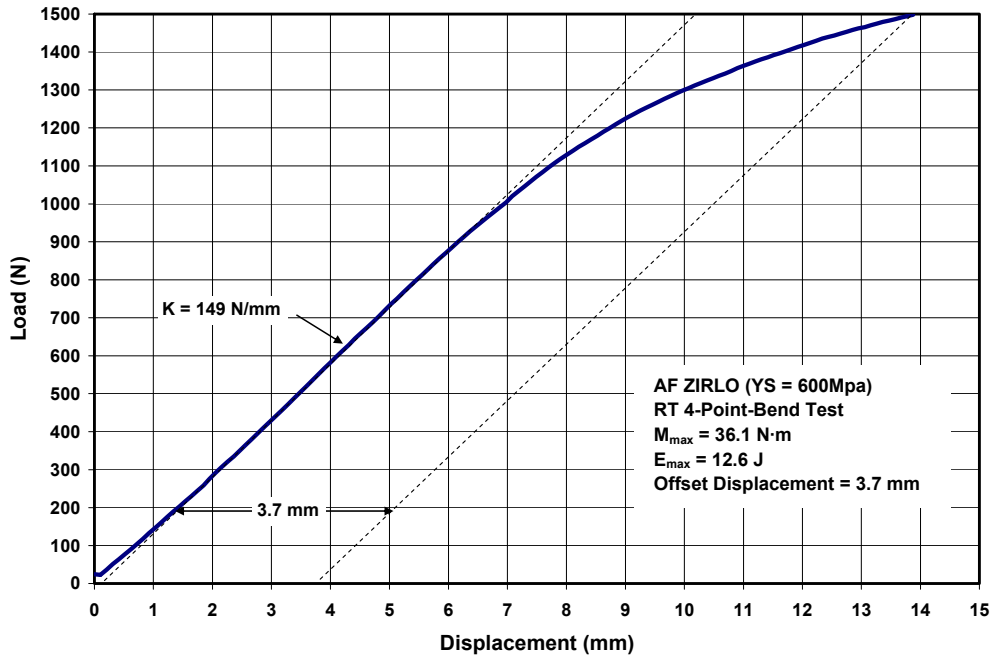
Figure B-2 Load-displacement curve for Studsvik four-point bend test benchmark conducted with AF ZIRLO at RT and 1 mm/s.

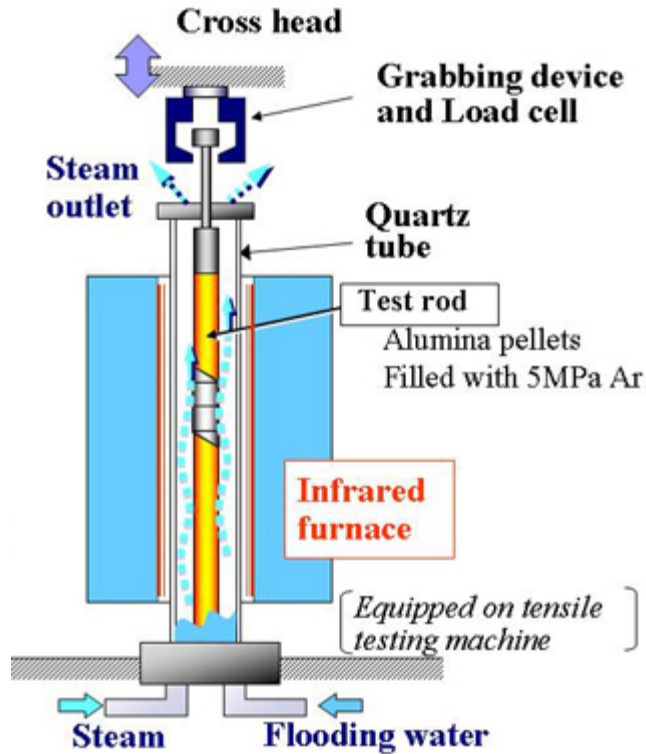
(a) JAEA LOCA apparatus

Rather than pulling the sample to failure, the JAEA LOCA integral samples were restrained from axial contraction during the quench in the integral experiment. Both full and partial axial-restraint tests were conducted during cooling from the oxidation temperature to less than 100 degrees C. Figure a shows the gripping mechanism used to restrain the cladding. Figure b shows typical axial load versus time results for fully restrained and partially restrained cases that were limited to maximum axial loads of 735 newtons (N), 540 N (reference JAEA case), and 390 N.

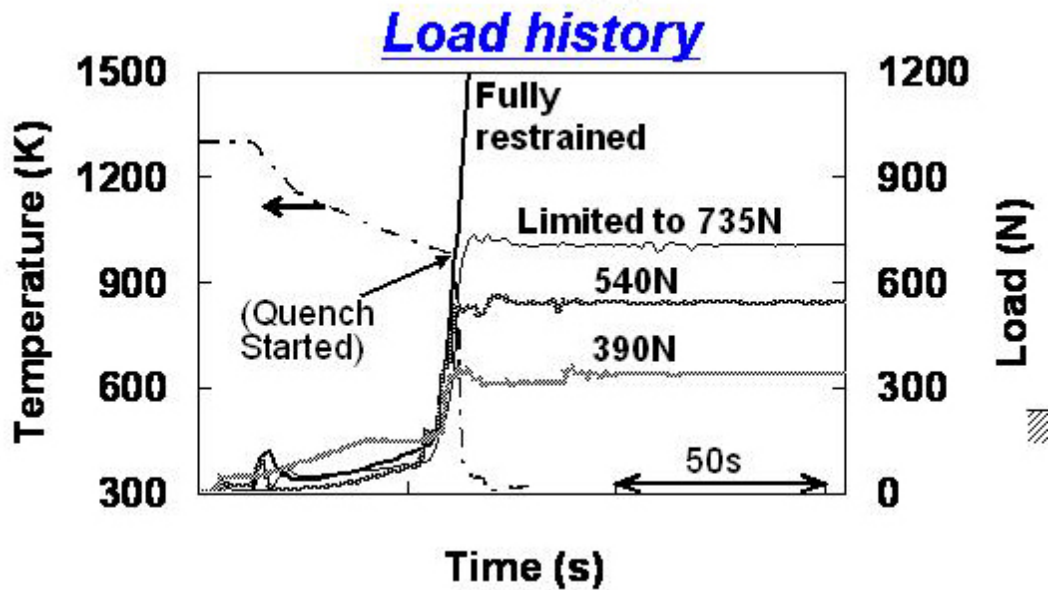
(b) Axial tensile loads vs. time for several constraint conditions

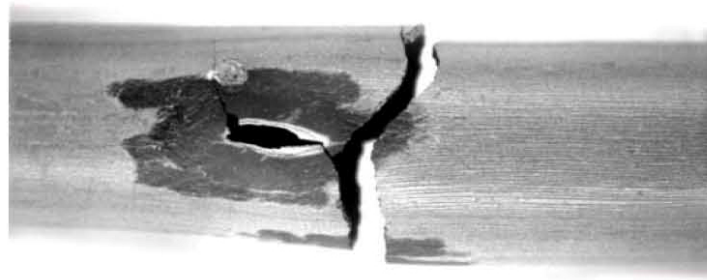
For the sample that fractured at 498 N, posttest imaging (see Figure , taken from Figure 5 in Ref. 19) indicated that failure occurred near the edge of the rupture opening. JAEA interpreted this as a rupture-node failure. However, the results are open to interpretation. In particular, the high hydrogen concentrations near the fracture are indicative of regions outside the rupture opening, which have high hydrogen pickup from inner-surface oxidation. Consistent with JAEA interpretation, the crack may have initiated at the edge of the rupture opening, but it clearly propagated into the high-hydrogen zone outside the rupture opening.
