# Catch Tank 241-C-301 Retrieval Feasibility Study

Prepared by **J. J. Elsen, Columbia Energy and Environmental Services, Inc.** for  
**Washington River Protection Solutions, LLC**  
Richland, WA 99352  
U.S. Department of Energy Contract DE-AC27-08RV14800

Abstract: This document compiles information pertaining to catch tank 241-C-301. The report is intended to be a collection point of information to support potential retrieval and closure of catch tank 241-C-301.

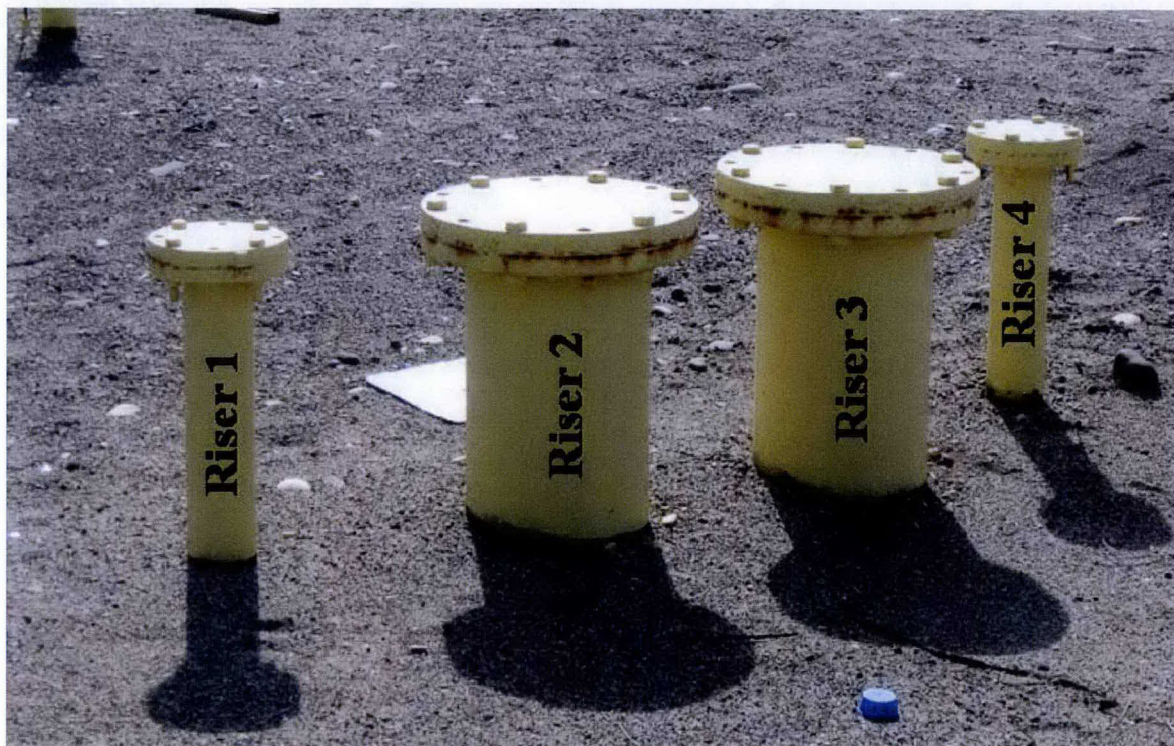
**Figure 5. Catch Tank Risers 1 Through 4.**

A field walk down was performed on March 9, 2010 of the 241-C-301 catch tank above grade area. The walk down revealed no local above-grade equipment or structures near the catch tank. The edge of the catch tank is located approximately ten feet from the exterior fence that restricts access to the 241-C tank farm complex. Figure 5 shows the above grade configuration for Risers 1 through 4. Risers 1 and 4 are four inches in diameter and covered with blind flanges. Risers 2 and 3 are twelve inches in diameter and covered with blind flanges.

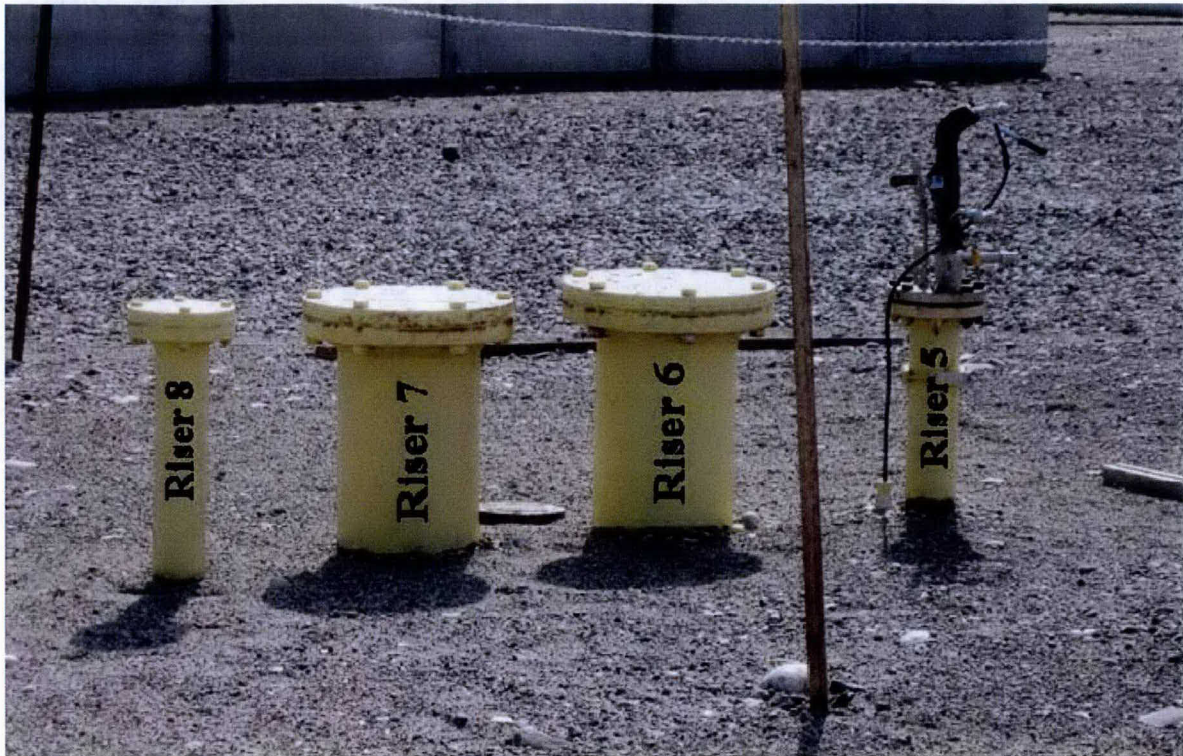
Figure 6. Catch Tank Risers 5 Through 8.

Figure 6 shows the above grade configuration for Risers 5 through 8. Riser 8 is four inches in diameter and covered with a blind flange. Risers 6 and 7 are twelve inches in diameter and covered with blind flanges. Riser 5 is four inches in diameter and contains an abandoned vapor tube assembly. The vapor tube assembly was used to collect vapor and gas samples from the catch tank on September 29, 1995. The results from this sample are not discussed in any detail in this report but are noted for informational purposes. Specific information regarding the sample can be found in (WHC-SD-WM-RPT-198, *Vapor and Gas Sampling of Single-Shell Tank 241-C-301 Using the Vapor Sampling System*).
