Coffee Break Training - Fire Protection Series

Means of Egress: Recognizable Doors

No. FP-2009-4 January 27, 2009

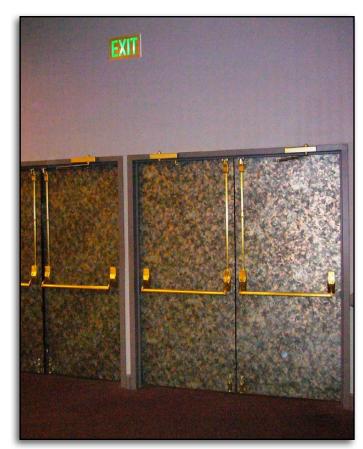
The pattern on these doors provides a clear contrast to the adiacent wall.

In the illustrated example, the designer applied colorful and visually contrasting wallpaper to the door leaves. There is no way that the doors would be confused with the adjacent wall finishes.

There is one concern with this solution, though. The wallpaper that was applied must meet the appropriate flame spread requirements for the place of assembly where these doors are located. In this example, since the building in which it is located is protected by an automatic sprinkler system; the wallpaper must have a Class C flame spread rating. In fact, all of the wall finishes in this space must have a Class C flame spread rating.
