PROJECT 01-109

Investigation of the Confederate Commerce Raider *CSS Alabama* - 2001

Institute for International Maritime Research, Inc.
CSS Alabama Association
Association *CSS Alabama*

November 11, 2001

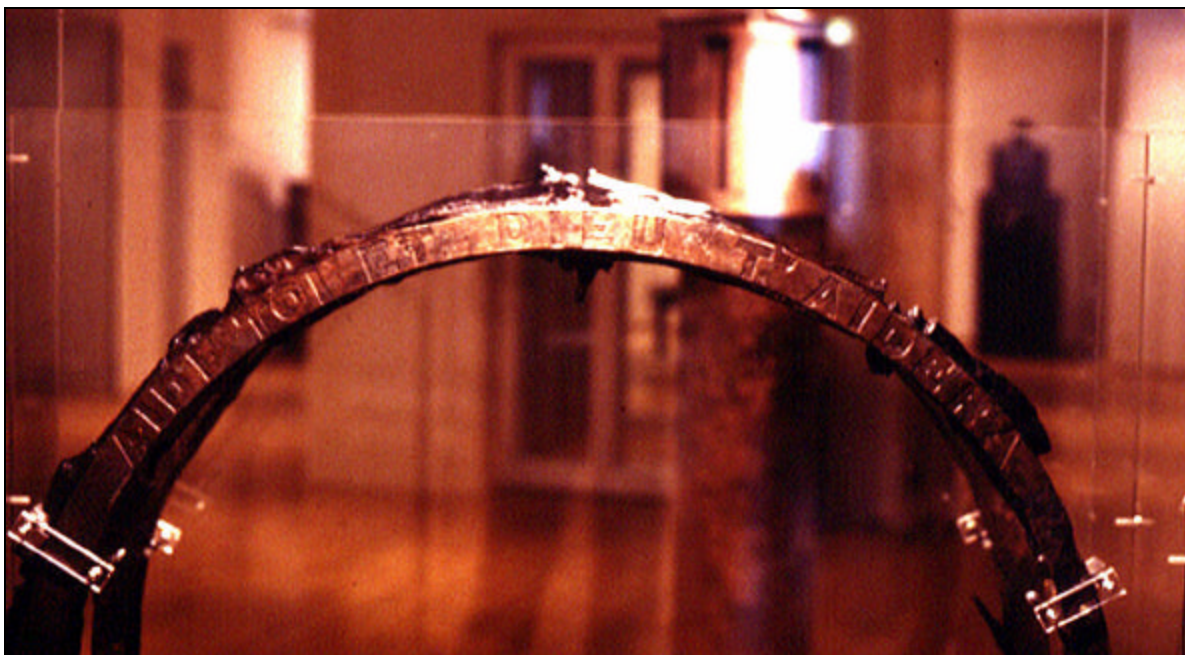
Figure 1. Remains of the ships wheel.

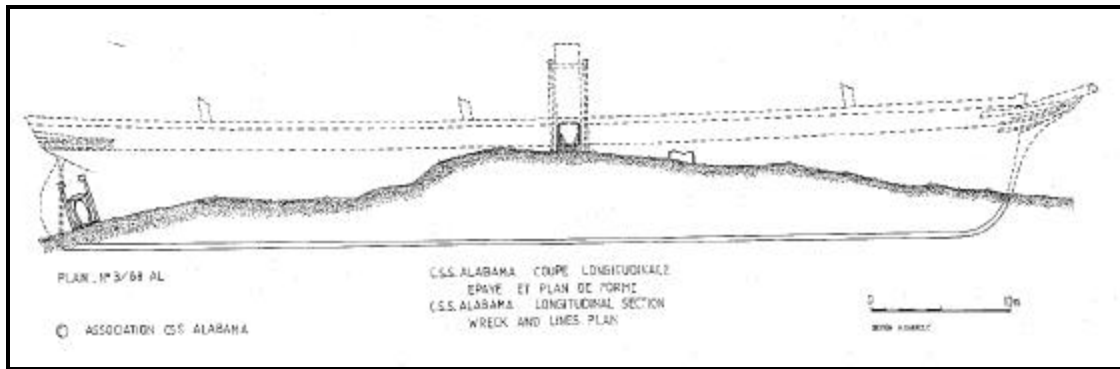
Figure 4. Projection of the surviving hull remains (Guérout, 1994).

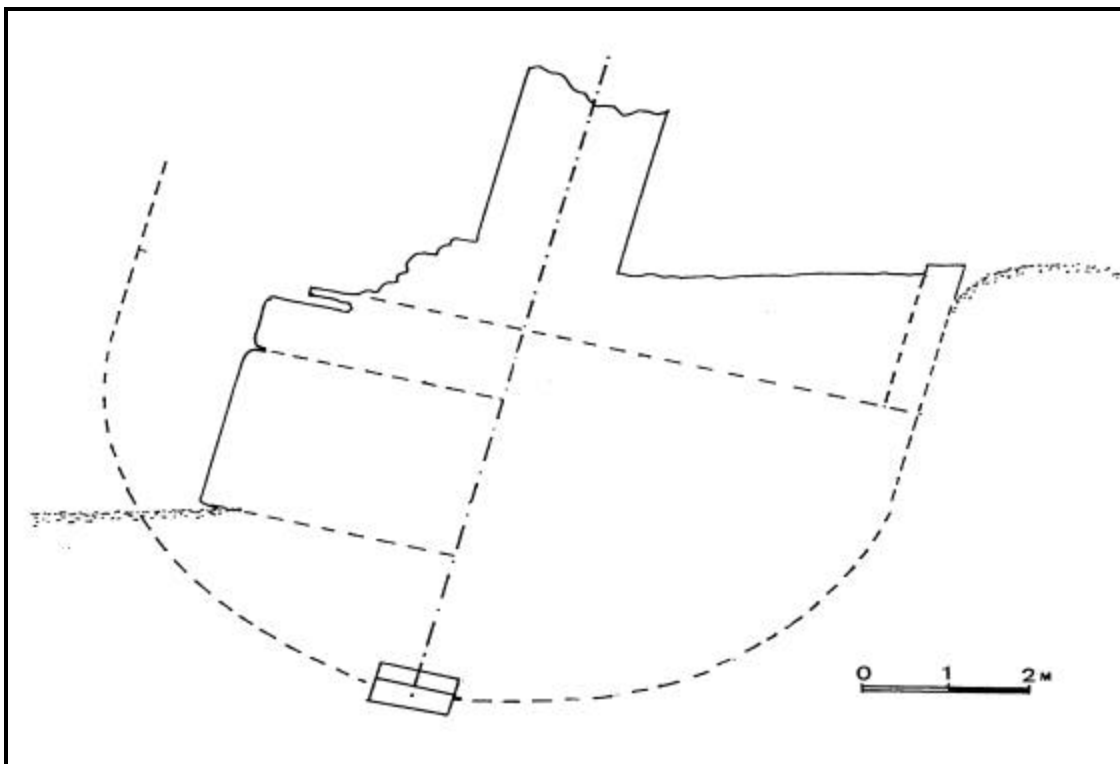
Figure 5. Projection of the degree of starboard list (Guérout 1994).

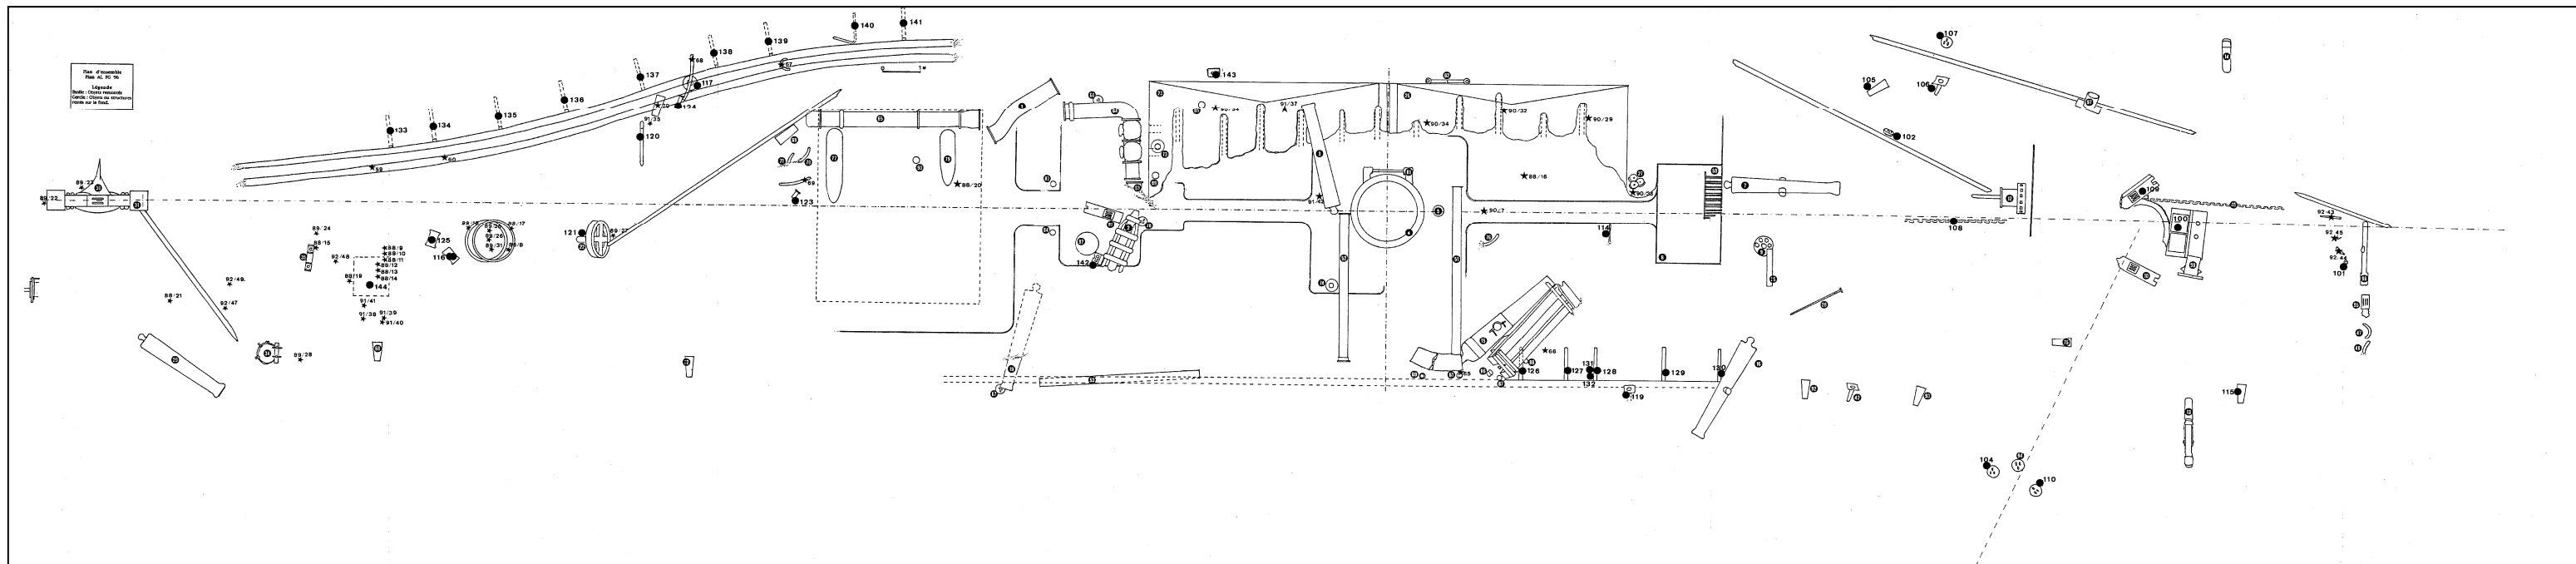
Figure 6. Site Plan of the CSS *Alabama* prepared by Max Guerot.

A preliminary site map was prepared by Guérout and the ASAM divers in 1988 and has been improved by subsequent investigations (Figure 6). To control mapping, a baseline was deployed from the propeller in the stern to the approximate location of the stem. Using the baseline as a reference, exposed wreck structure and associated material was recorded. The most dominant structural features of the wreck were found to be the boilers and smoke pipe, sections of the hull amidships, and propeller and elevating frame. The partially exposed port boilers each measured approximately 20 feet (6 m) in length and 10 feet (3 m) in height. Their shape is rectangular and each is connected to the smoke pipe by a common flue system.

Although most of the hull of the *Alabama* has been destroyed by the elements, sediment accumulating in the vicinity of the steam machinery appears to have preserved a portion of the starboard side of the ship. Adjacent to the boilers the starboard hull could survive up to the level of the weather deck clamp. Although the 30° list documented by divers suggests that more of the starboard side of the ship may be preserved fore and aft of the machinery, it does not appear to be much beyond the turn of the bilge. In the stern the exposed propeller and elevating frame confirm that the hull has deteriorated to the level of the propeller shaft and hub. Forward of the machinery, perhaps even less hull fabric remains.

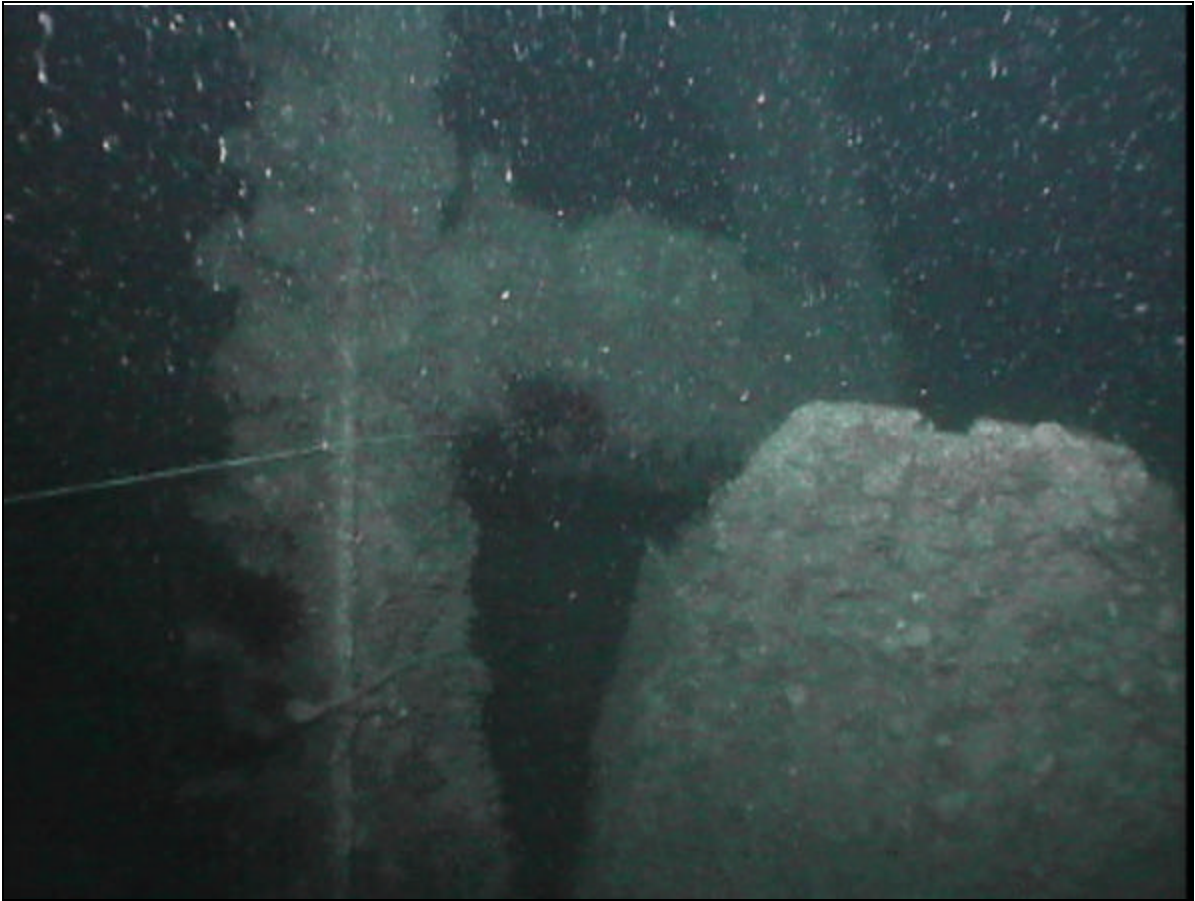
Figure 7. Propeller and lifting frame.

The propeller identified the stern of the Alabama. A single blade of the brass propeller and the top of its lifting frame are exposed above the bottom surface (Figure 7). While no evidence of the bow was identified, portions of two Trotman's patent anchors confirm its proximity. One anchor lies along the starboard extremity of the hull structure and the second lies to port of the wreck (Figure 8). Development of the site plan also revealed the iron main mast step, a capstan, several sets of bitts, a hawse hole throat, and anchor chain. Three unique toilets were also found in the vicinity of the ship's engineering space. Each contained an English porcelain bowl with a transfer-printed scene inside.

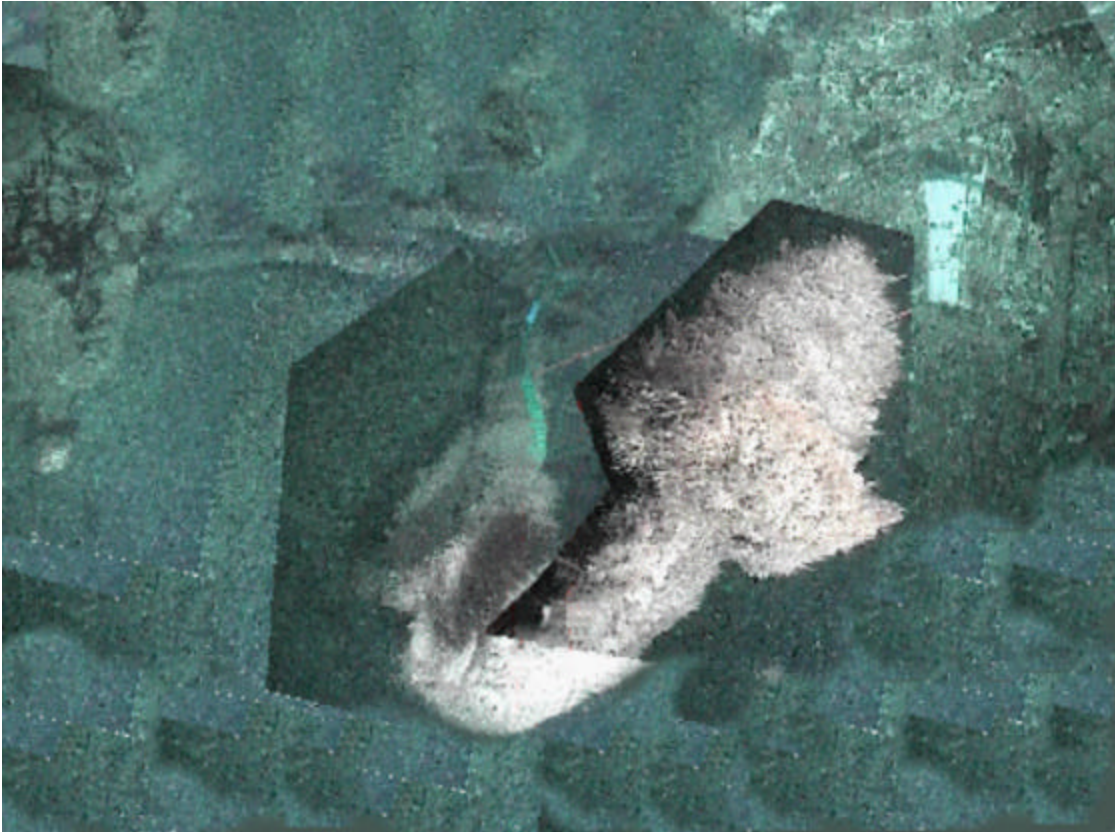
Figure 8. Starboard Trotman patent anchor in-situ.

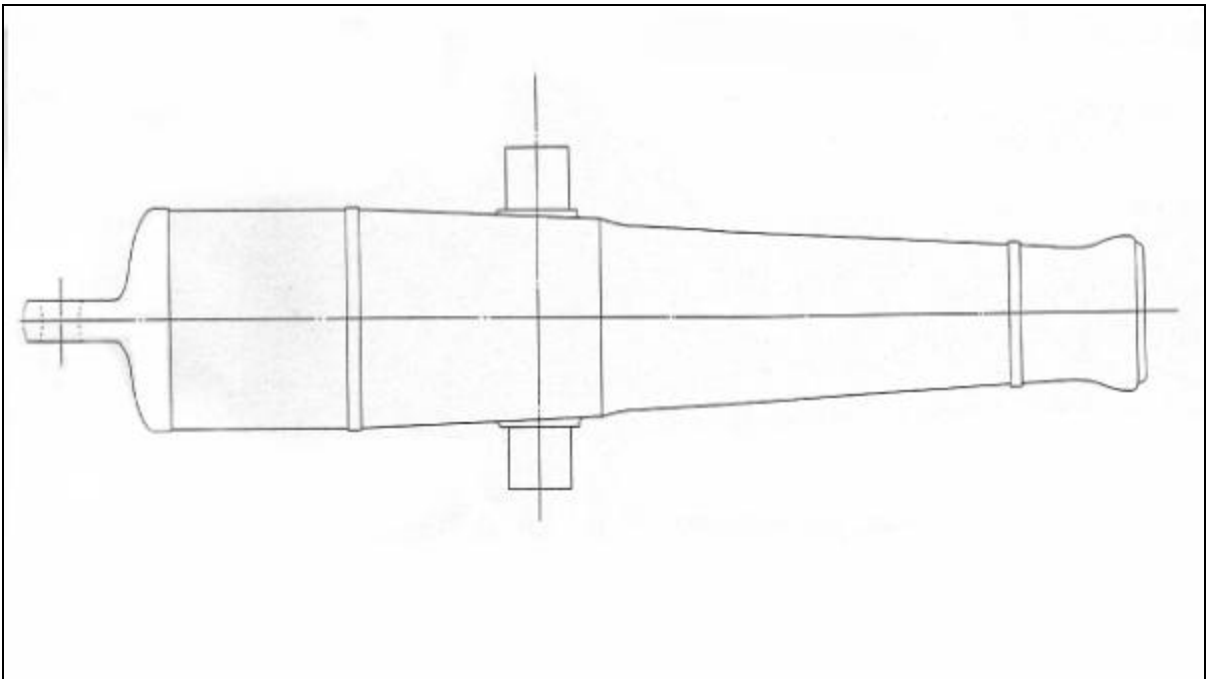
Figure 19. Blakely designed British Royal Navy pattern 32-pounder (A. Bowcock).

Historical research confirmed that the CSS *Alabama* carried six 32-pounders. Two of those were Blakely designed British Royal Navy pattern guns (Figure 19) and the remaining four were a more modern Blakely design (Figure 20) specifically cast for the CSS *Alabama* by Fawcett, Preston & Company. Historical photographs and research carried out by Andrew Bowcock helped archaeologists identify one of those for recovery in 2000. Subsequent examination of that 32-pounder confirmed it had indeed been produced by Fawcett, Preston & Company in Liverpool (Figure 21). Bowcock's research and historic photographs of the CSS *Alabama* provided design criteria that made it possible for archaeologists to identify the heavily concreted British Royal Navy pattern guns at the site (Figure 22). One of those was selected for recovery by the *Vulcain*.

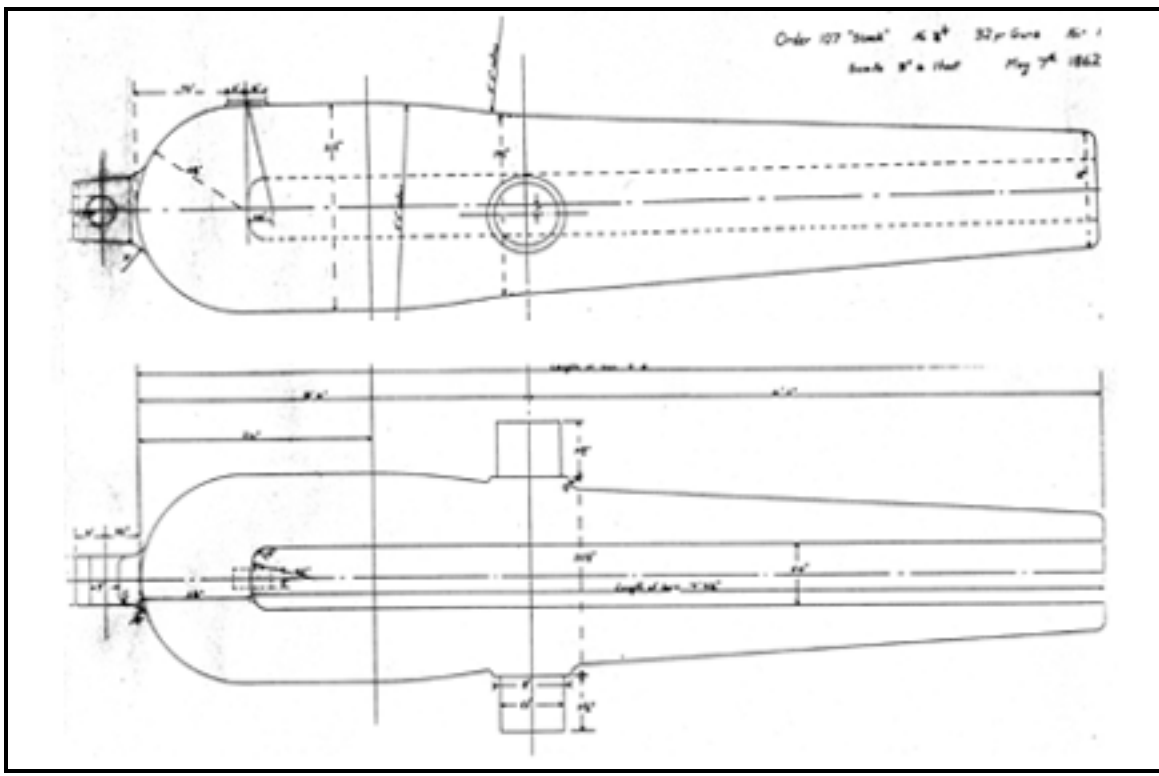
Figure 20. Design of the Fawcett, Preston & Company 32-pounder (A. Bowcock).

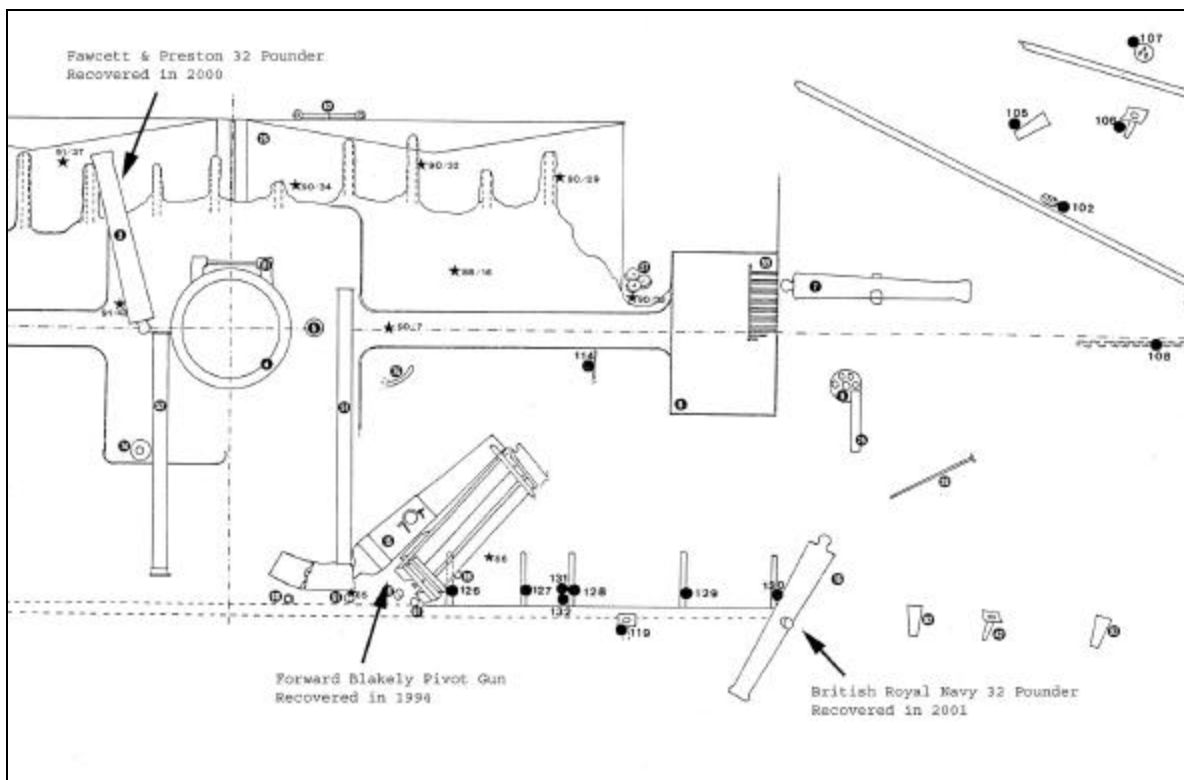
Figure 22. Locations of cannon recovered from the CSS *Alabama*.

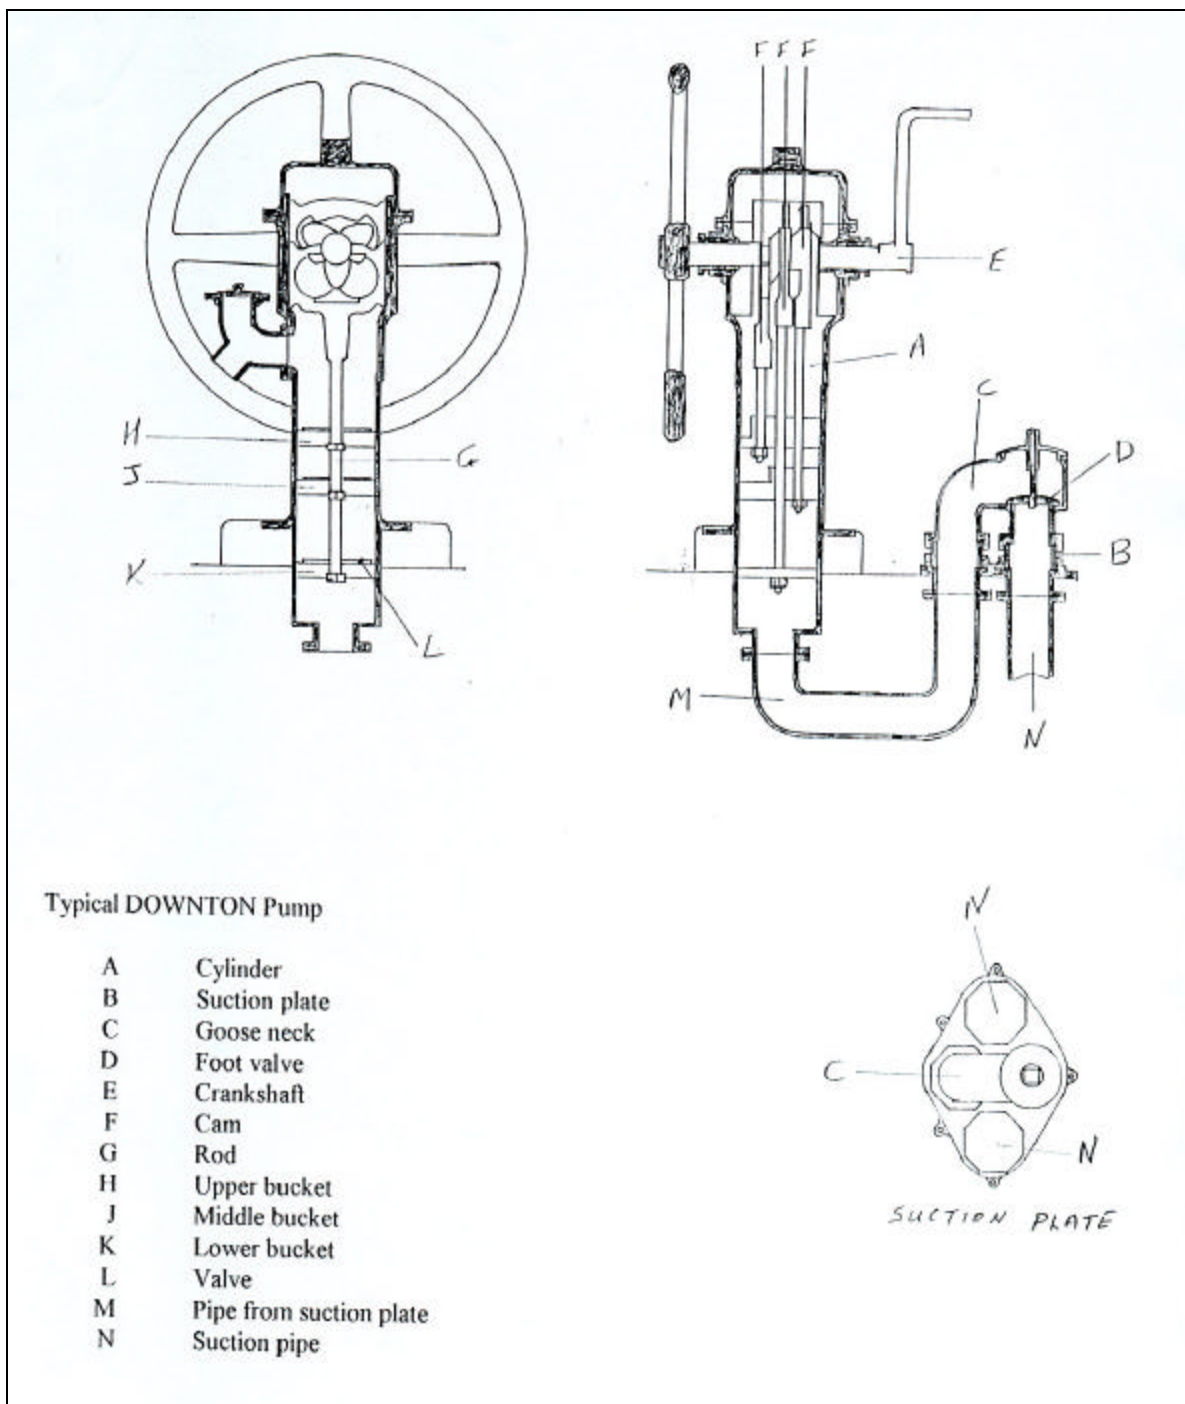
Figure 30. Schematic of the Downton pump (A. Bowcock).

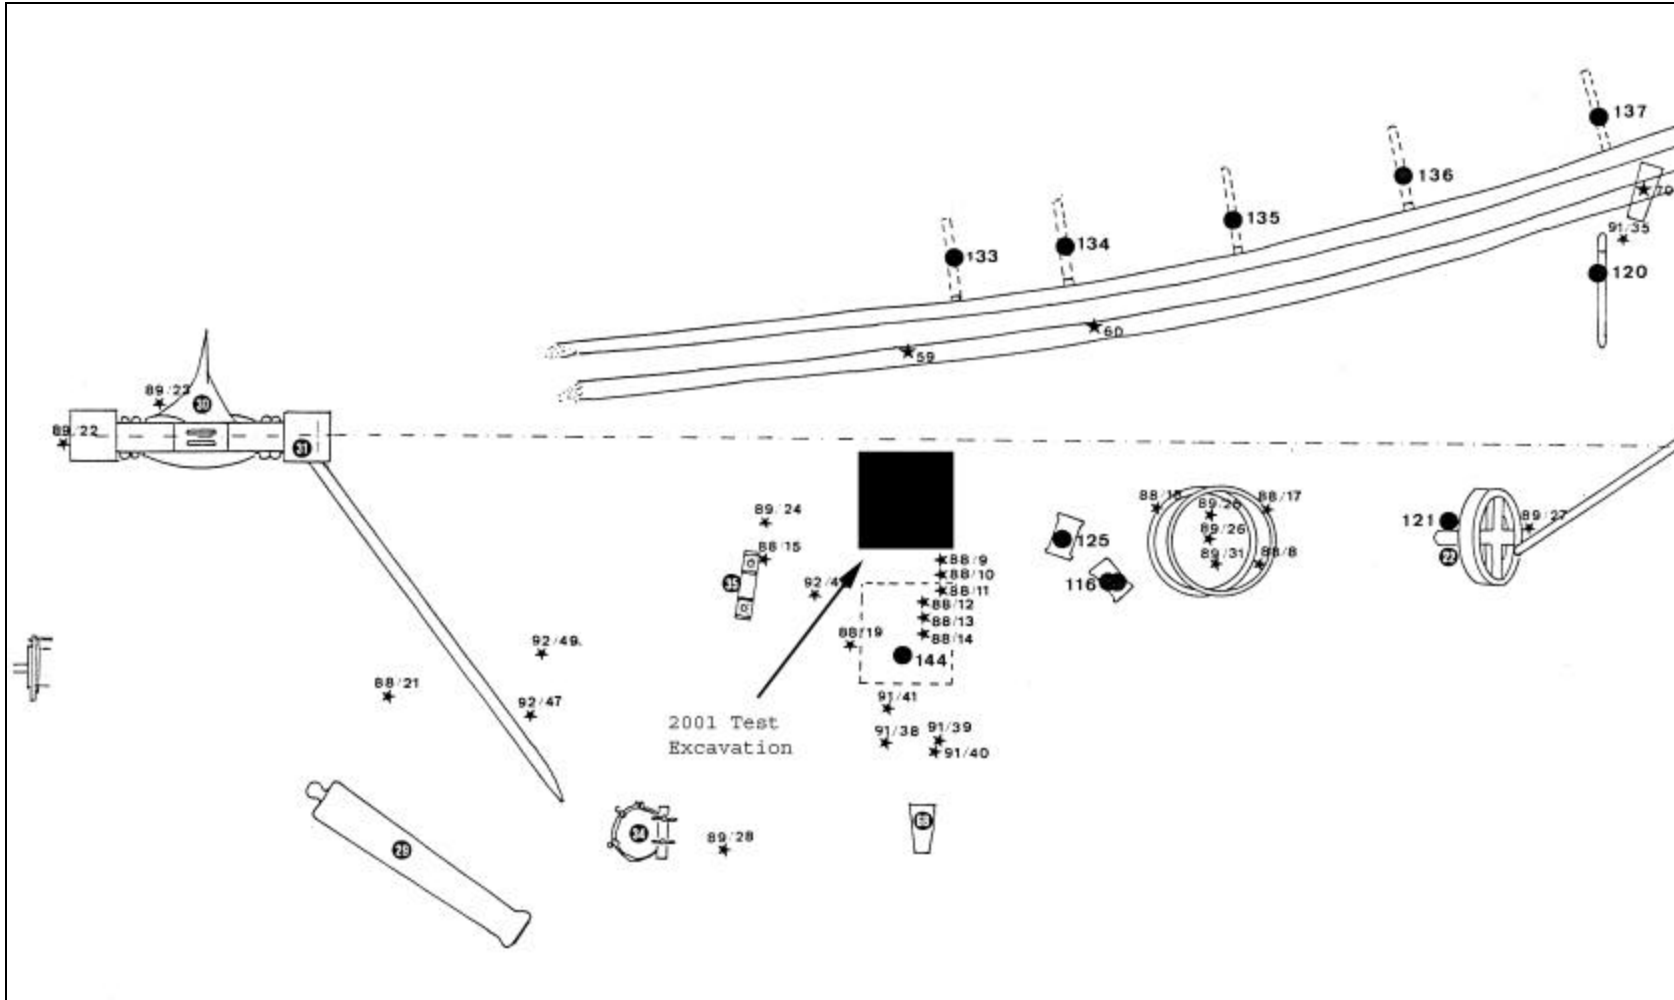
Figure 32. Location of test excavation for 2001.

As neither the *Vulcain* nor the French Navy divers would be available during the second period, on-site operations were refocused on a test excavation in the stern. A 2-meter by 2-meter grid structure was fabricated from PVC pipe (Figure 31). Line run through two parallel sides of the grid structure made it possible for the grid to be attached to the CSS *Alabama's* hull remains yet still be repositioned along an athwartship corridor identified for investigation (Figure 32). The grid structure was to be deployed over a pre-selected site in the stern that corresponded with previous test excavation. Video from the first period of diving was used to determine the best position for the grid structure.

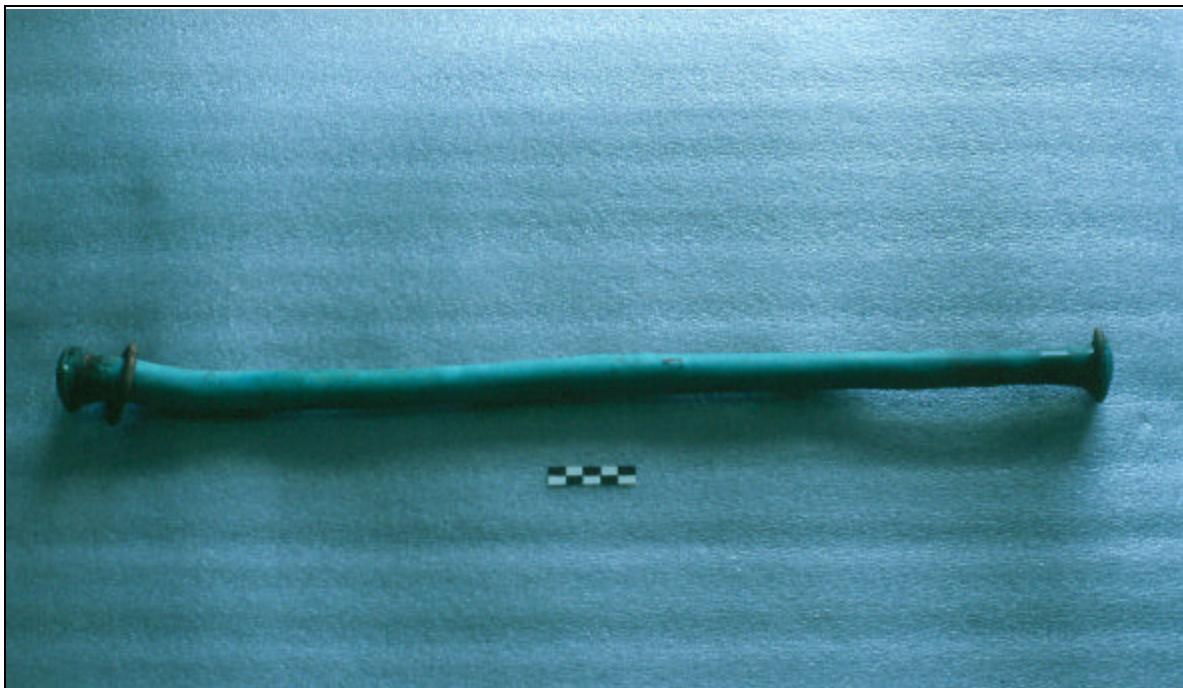
Figure 40. ALS-236 Drift pin with rove.

Artifact ALS-236 is a copper drift pin with rove. The ends of the drift pin have been peened over the roves. Both of the peened over ends are at nearly 90 degrees to the pin itself. This would indicate that the pin came from an area where the interior and exterior surfaces were parallel, such as the side of the hull or in joining interior futtocks. On this piece, one of the roves is loose.

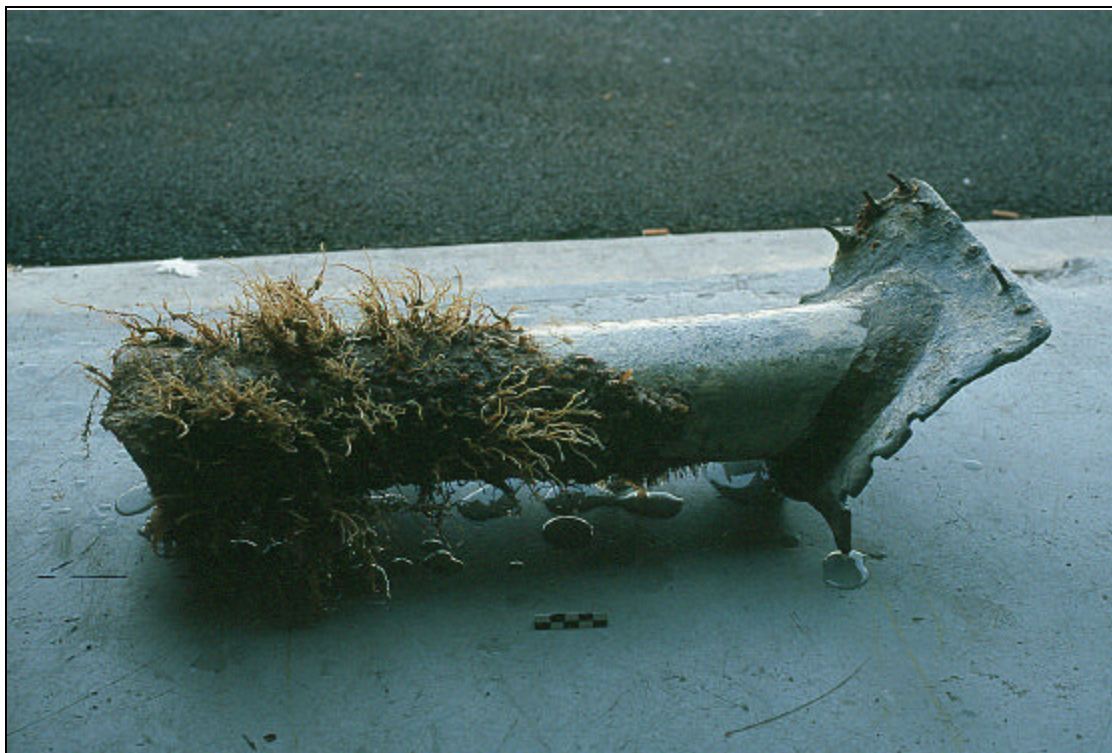
Figure 42. ALS-238 Scupper with fasteners.

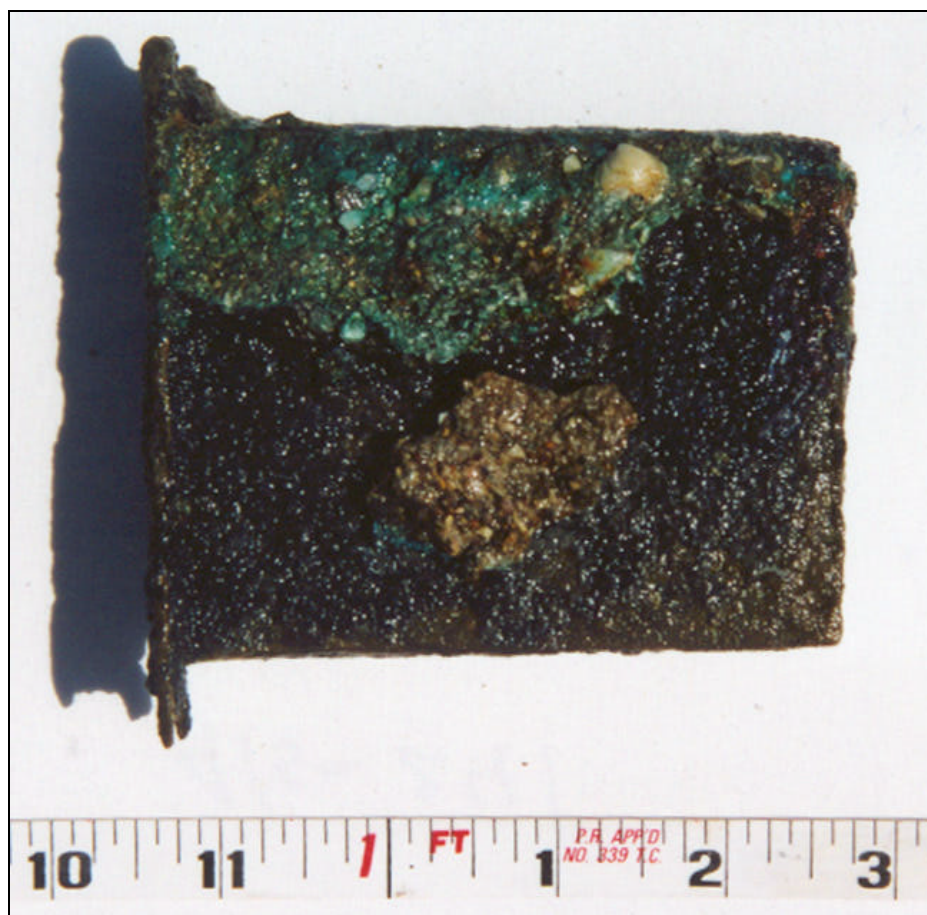
Figure 45. ALS-241 Lock.

Artifact ALS-241 is a quadrangular lock mechanism. The interior of the lock has corroded away, but from the design and dimensions, it was probably used for an interior door aboard the vessel. One of the sides has eroded away, so the interior mechanisms are visible. The presence of sulfides inside the lock indicates that a part of the internal mechanism was made of iron and has deteriorated to an irreversible extent. What remains indicate the bolt was moved via a hollow-stemmed key.

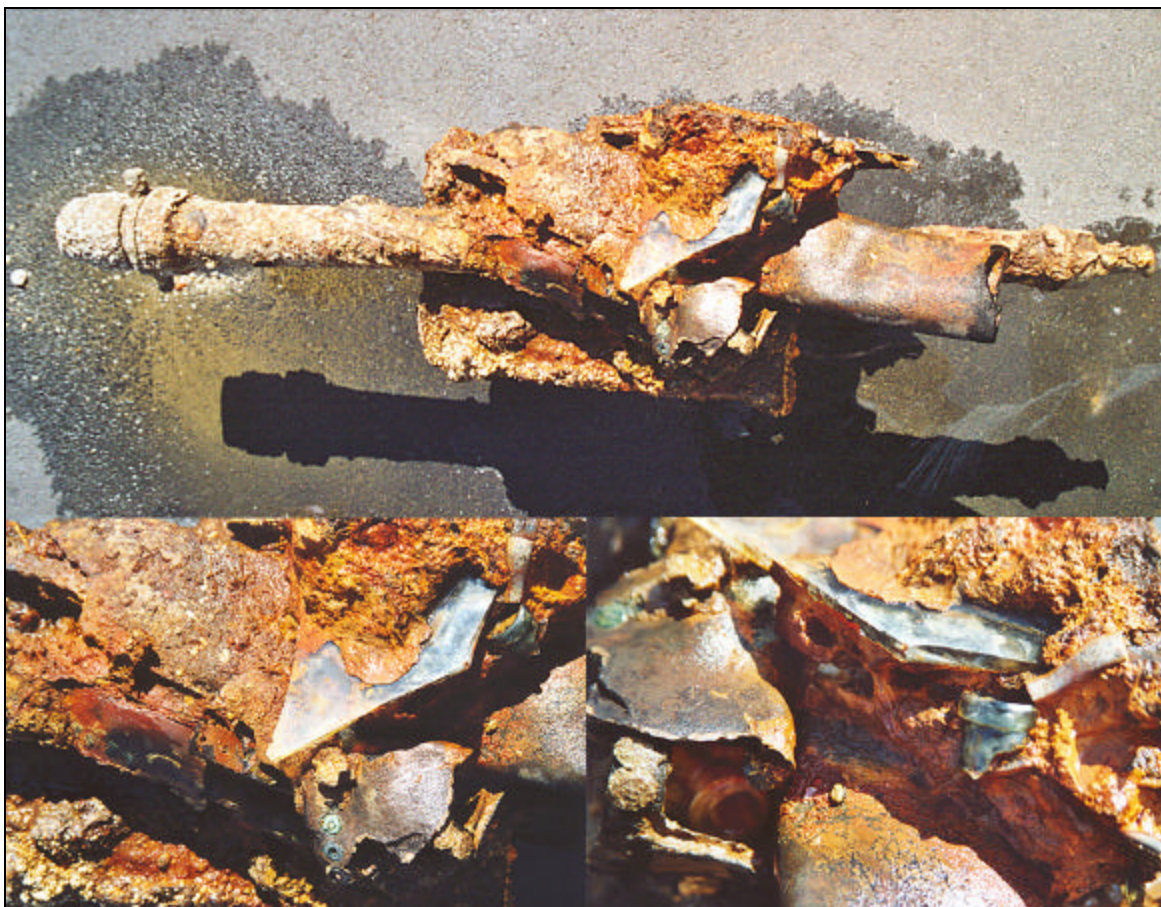
Figure 66. ALS-251 Fire Nozzle, Box, and artifacts in concrete.

Length max :	44.09 inches	1120 mm
Height max :	15.74 inches	400 mm
Width max :	11.81 inches	300 mm
Box Length :	15.35 inches	390 mm
Box Width :	10.23 inches	260 mm
Box Height :	9.05 inches	230 mm

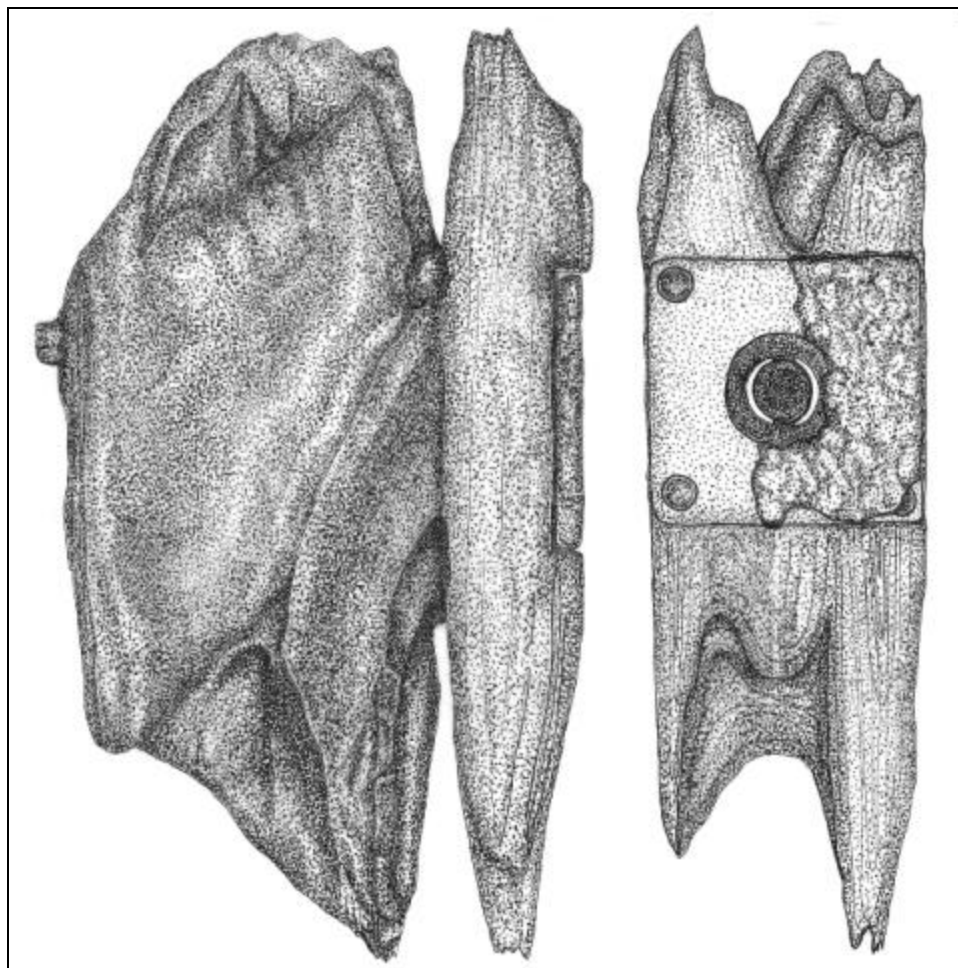
Figure 81. ALS-266 Cannon Pivot with wood and fasteners.

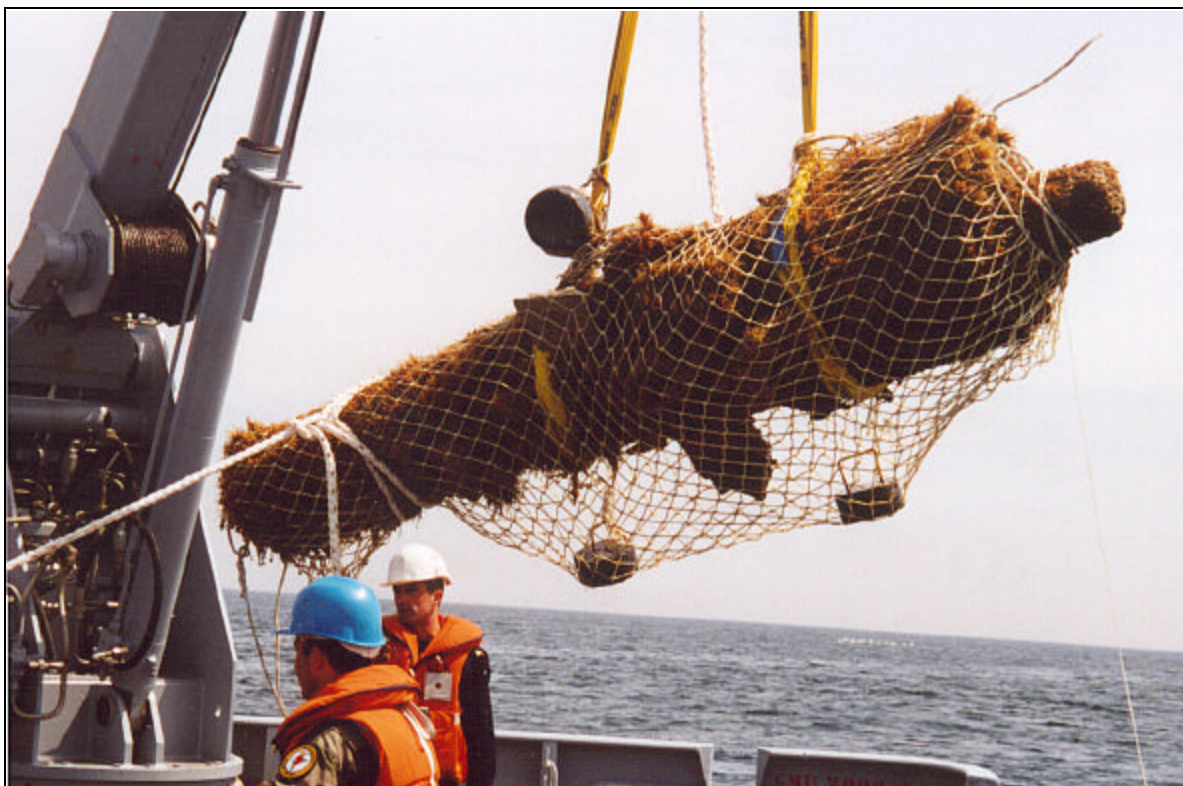
Figure 99. ALS-284 British Royal Navy Pattern 32-Pounder Cannon.
