Department of Defense Legacy Resource Management Program

Investigation of the *CSS Alabama*

November 7, 2000

**Gordon P. Watts, Jr., Ph.D.
Institute for International Maritime Research, Inc.
P. O. Box 2494
Washington, North Carolina 27889**

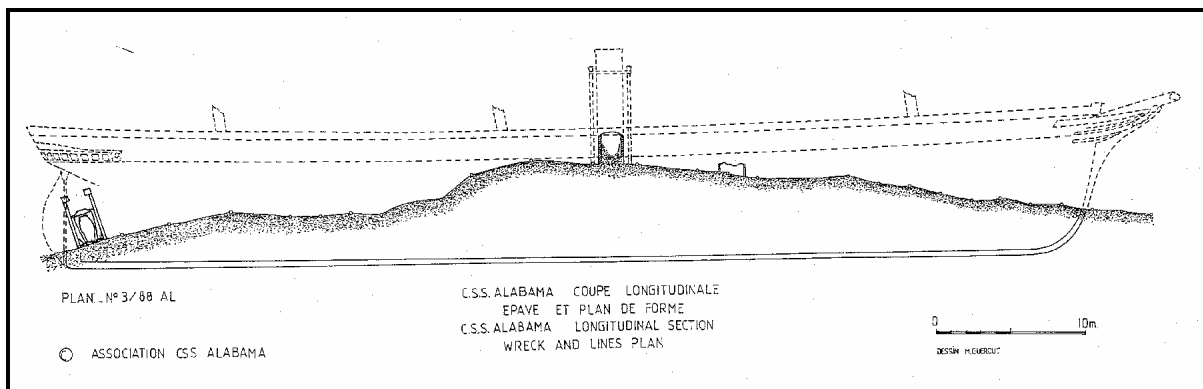
Figure 2. Projection of the surviving hull remains (Guérout, 1994).

the propeller shaft. At the stern, a little less than half of the propeller is exposed along with its brass lifting frame. No evidence of the stem was observed making it difficult to determine the amount of sediment accumulation forward. It is also possible that the hull may not lie on an even keel fore and aft and the amount of surviving structure is considerably less. Very little of the surviving hull structure is exposed at the site. The majority of exposed hull fabric is on the starboard side amidships and adjacent to the boilers.

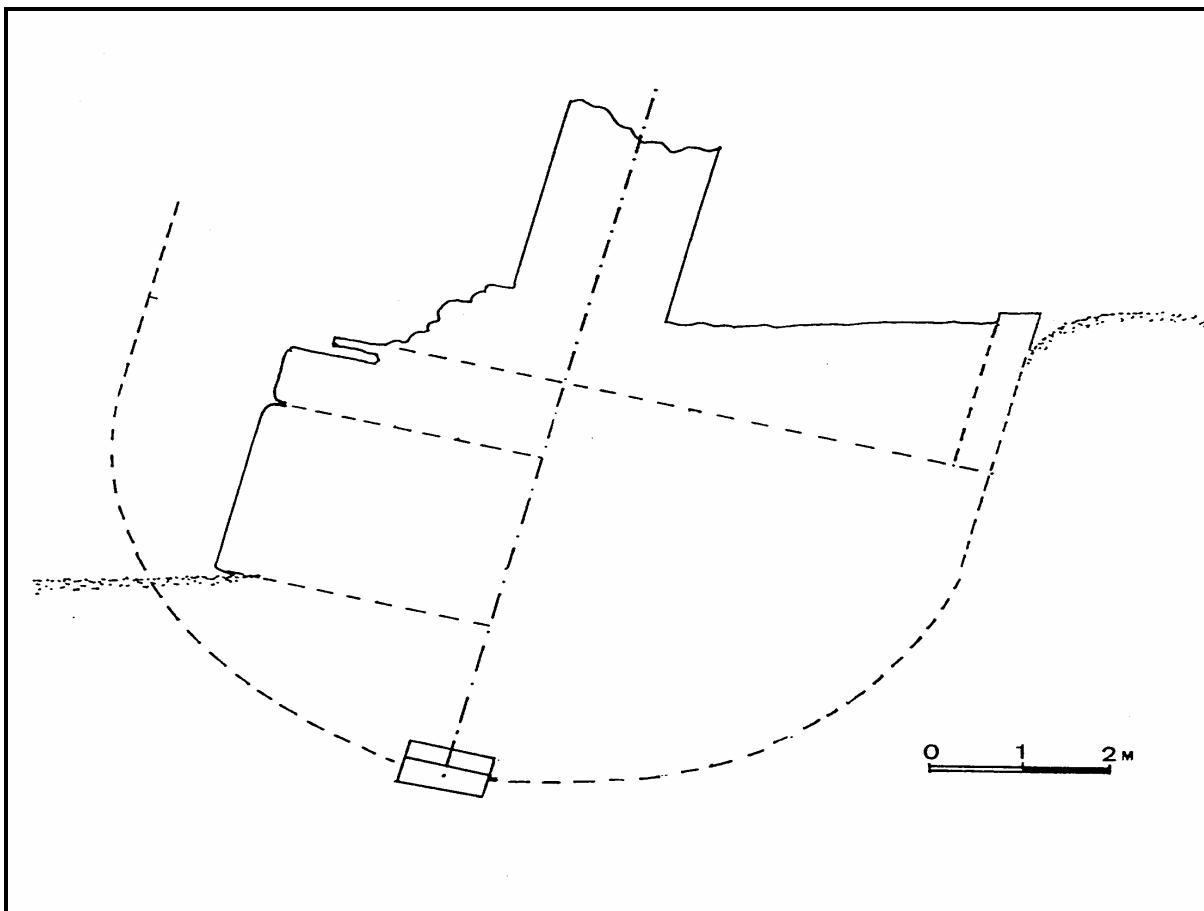
Figure 3. Projection of the degree of starboard list (Guérout 1994).

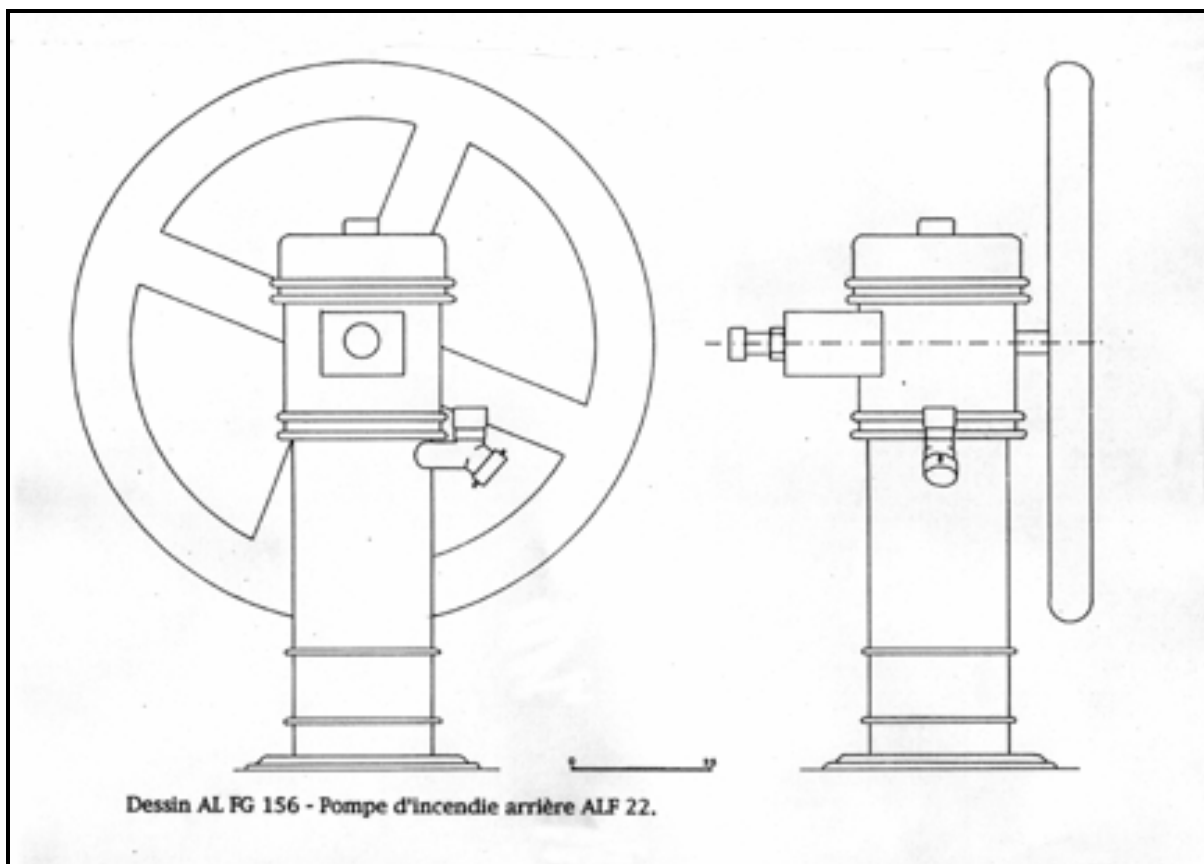
Figure 5. Drawing of the aft fire pump (Guérout, 1995).

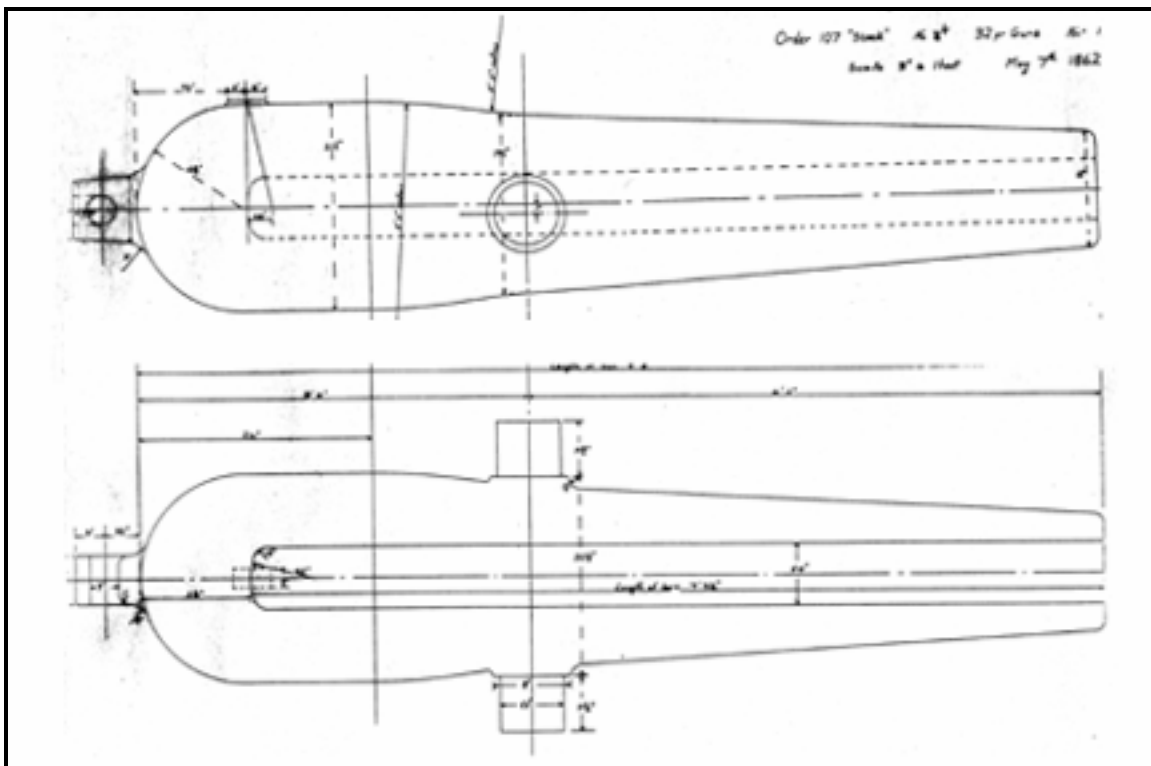
Figure 6. Design of the Fawcett, Preston & Company 32-pounder (A. Bowcock).

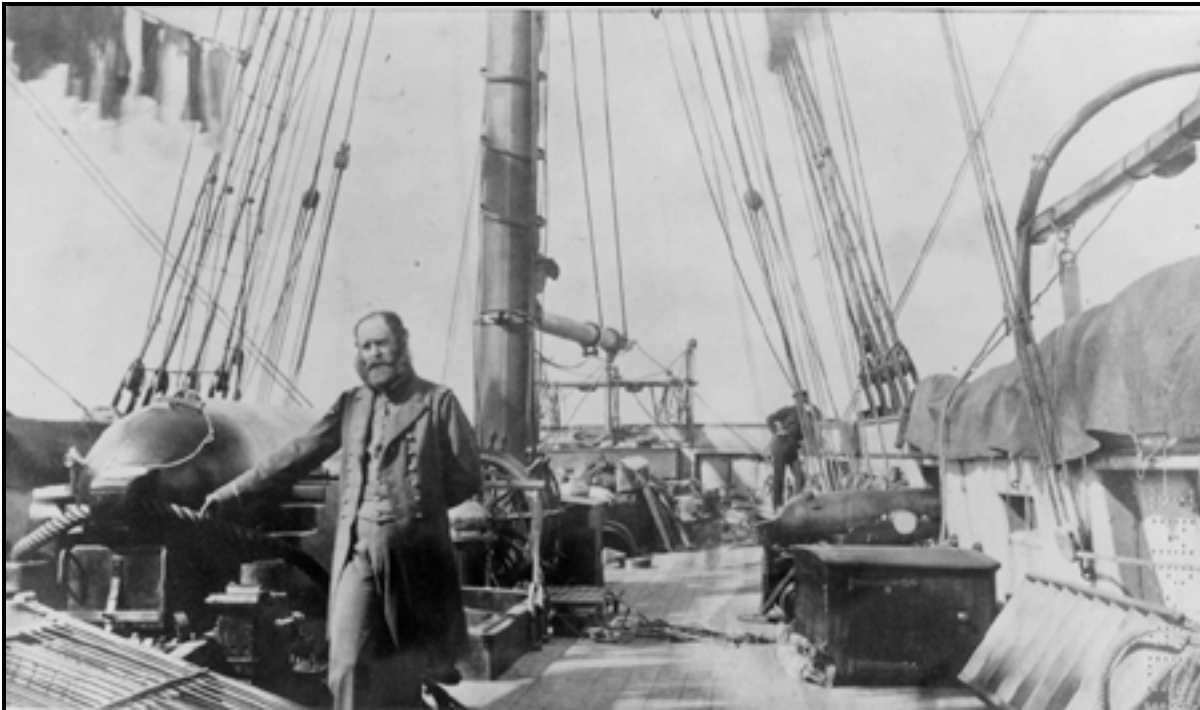
Figure 7. Historic photograph illustrating a Fawcett, Preston & Co. 32-pounder, an ordnance chest and the tangent sight on the breech of the stern pivot gun of the CSS *Alabama*.

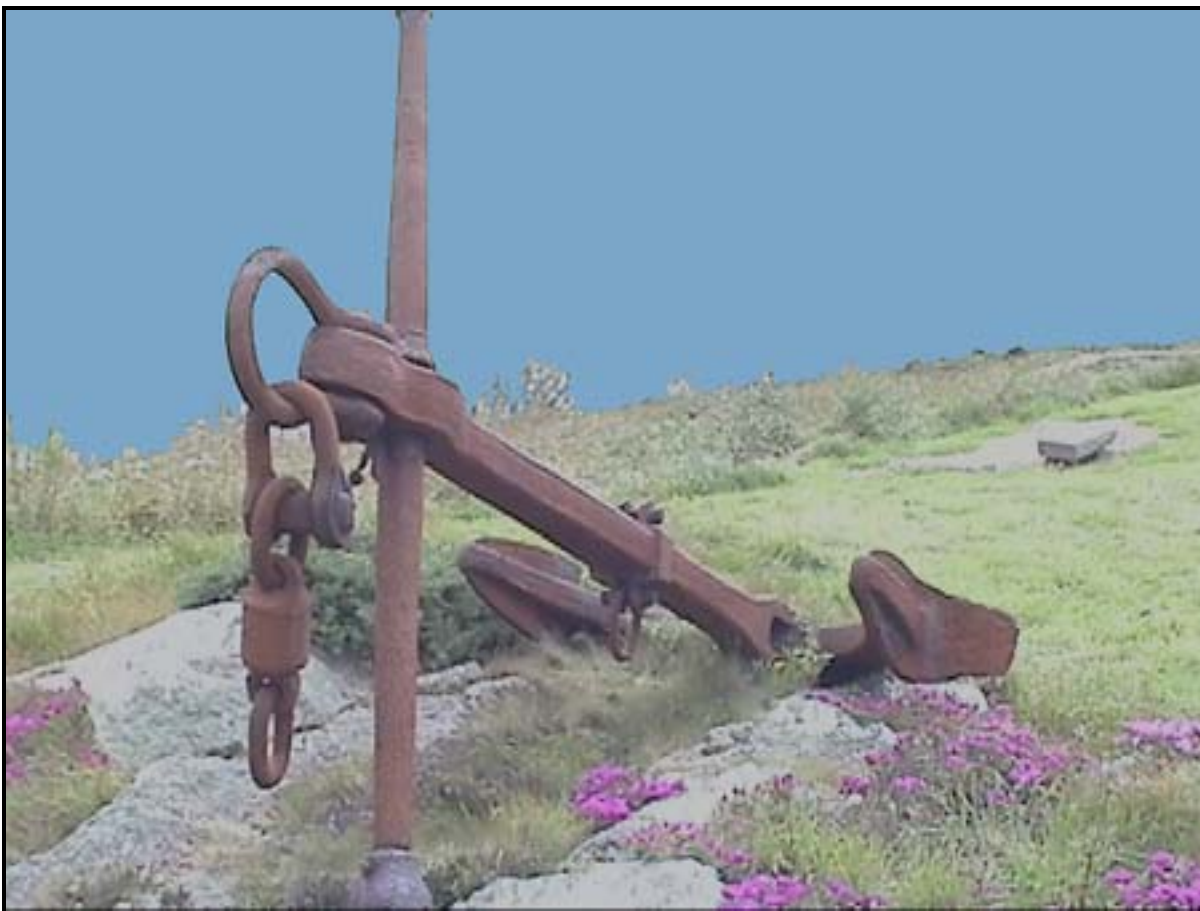
Figure 9. Example of a Trotman anchor similar to those of the CSS *Alabama*.

Before the end of the first dive period, considerable effort was focused on excavations at the base of the aft fire pump and around the starboard Trotman anchor (Figure 9). French Navy divers using an airlift excavated the anchor shank to a depth of almost two meters. At that point consolidated sediment frustrated excavation and the stock was not exposed. Efforts to move the anchor proved entirely unsuccessful by the time the first dive period came to an end on 29 June. Although excavation was to continue during the second dive period in July, recovery of the anchor was abandoned as French Navy assistance was unavailable. A subsequent examination of the anchor indicated that the stock and chain lay under the surviving remains of the starboard bow and extensive excavation would be required to clear it for lifting.

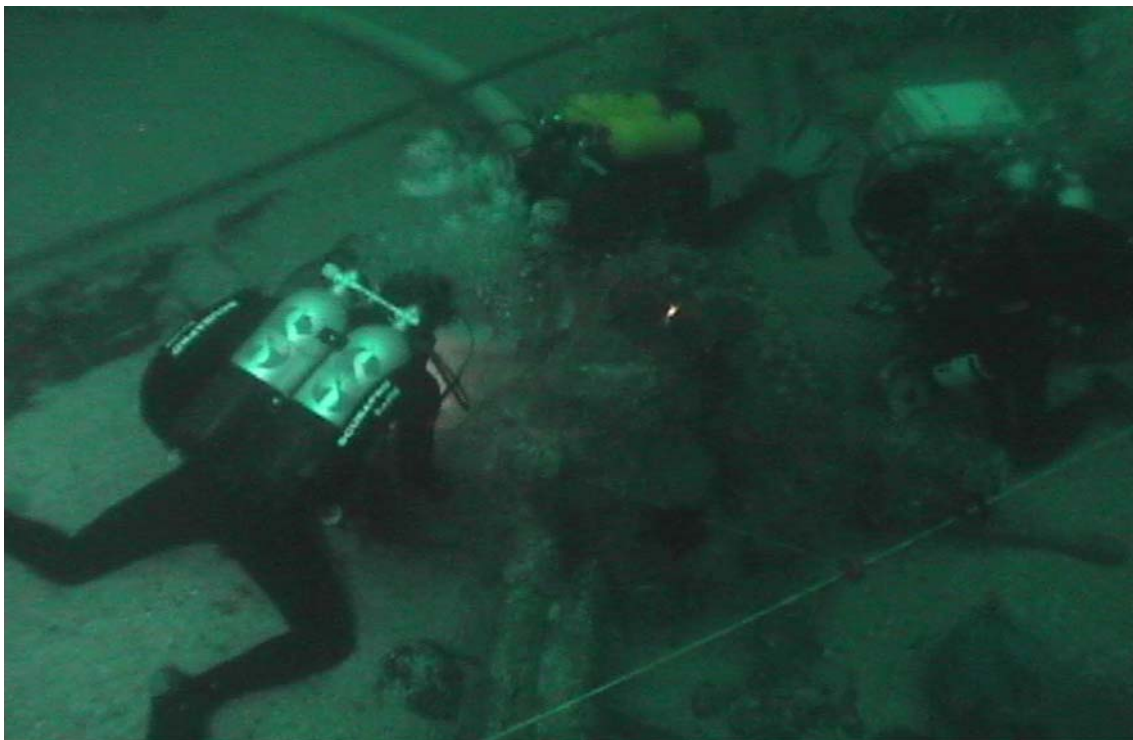
Figure 10. Excavation at the base of the aft fire pump.

In addition to the 32-pounder and anchor, French volunteer divers and American archaeologists worked to clear the base of the aft fire pump (Figure 10). Excavation at the base of the pump was carried out using an induction dredge powered by a pump in one of the inflatable boats and the propwash from diver propulsion vehicles (Figure 11). Neither the scooter nor the induction dredge had sufficient power to excavate beneath the plate that attached the pump to the *Alabama*'s deck structure. Below that plate, a brass pipe extended into the sediment (Figure 12).

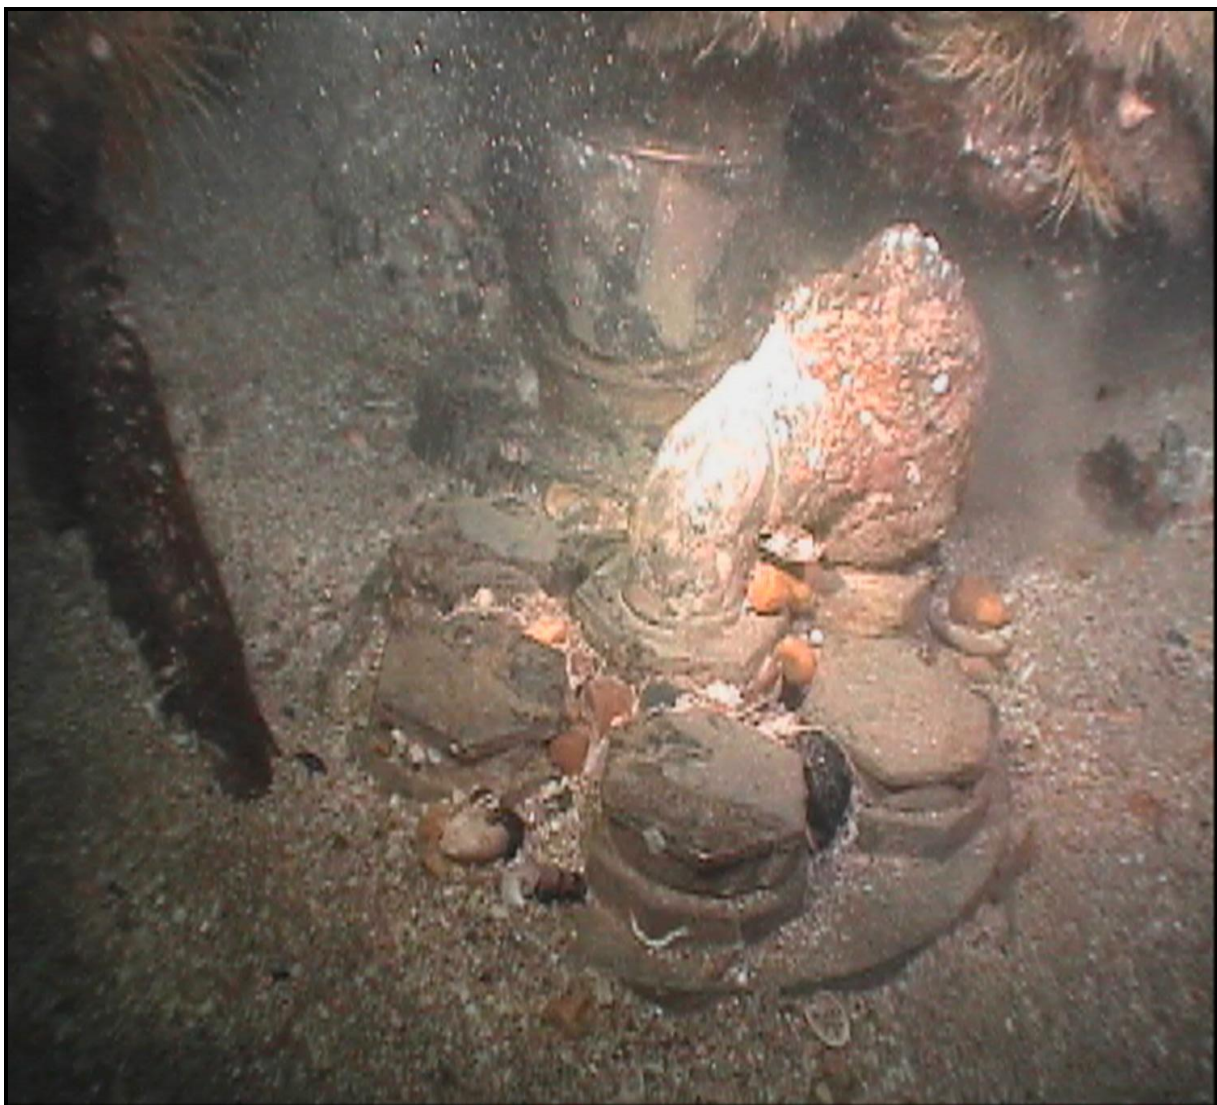
Figure 12. Base of the aft fire pump and an associated valve chest.

That pipe probably served as the pump intake and extended into the bilge. It became readily apparent that the pump either remained attached to the unexposed hull structure or the intake was buried in consolidated sediment and could not be cleared for lifting. Rather than risk damaging the pump, efforts to recover it were abandoned until the second period of diving.

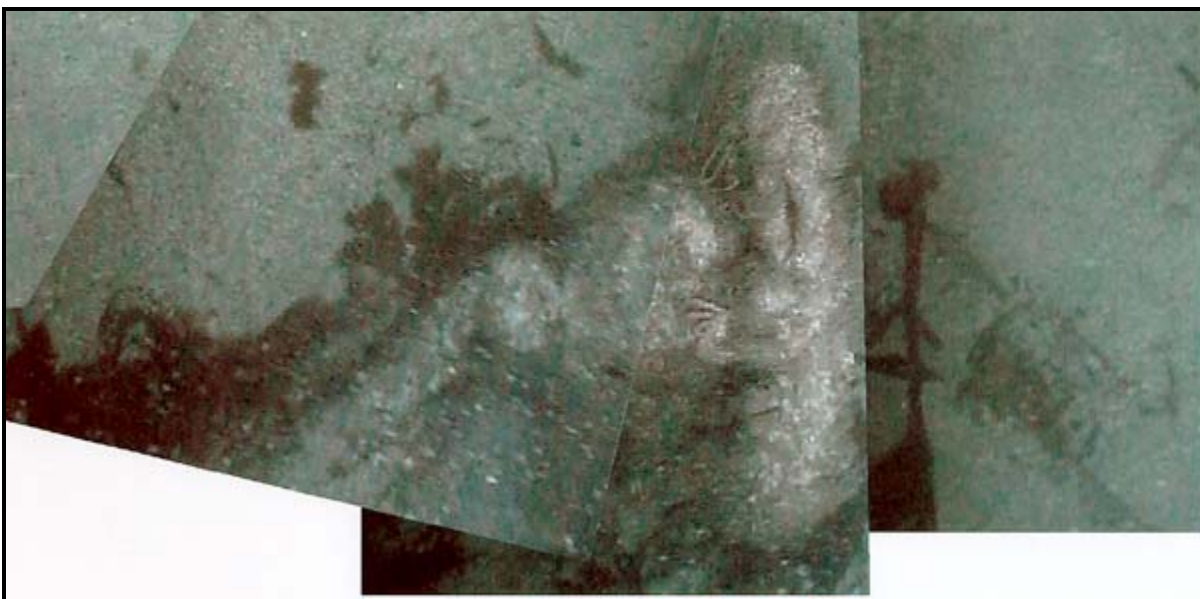
Figure 13. Example of a mosaic illustrating the aft fire pump.

During the first period of on-site activity, underwater television was used to record the exposed wreck structure and underwater activity. Documentation of the on-site activity was designed to provide illustrations for reports and publications. Documentation of the wreck structure was designed to provide images of the features being cleared for recovery and collect sufficient digital data to produce mosaics of the wreck site. Documentation of the underwater work provided a graphic record of excavation of the aft fire pump. However, producing images for the mosaic was frustrated by video equipment problems. Efforts to record the wreck structure in plan view produced a very limited amount of usable imagery (Figure 13).

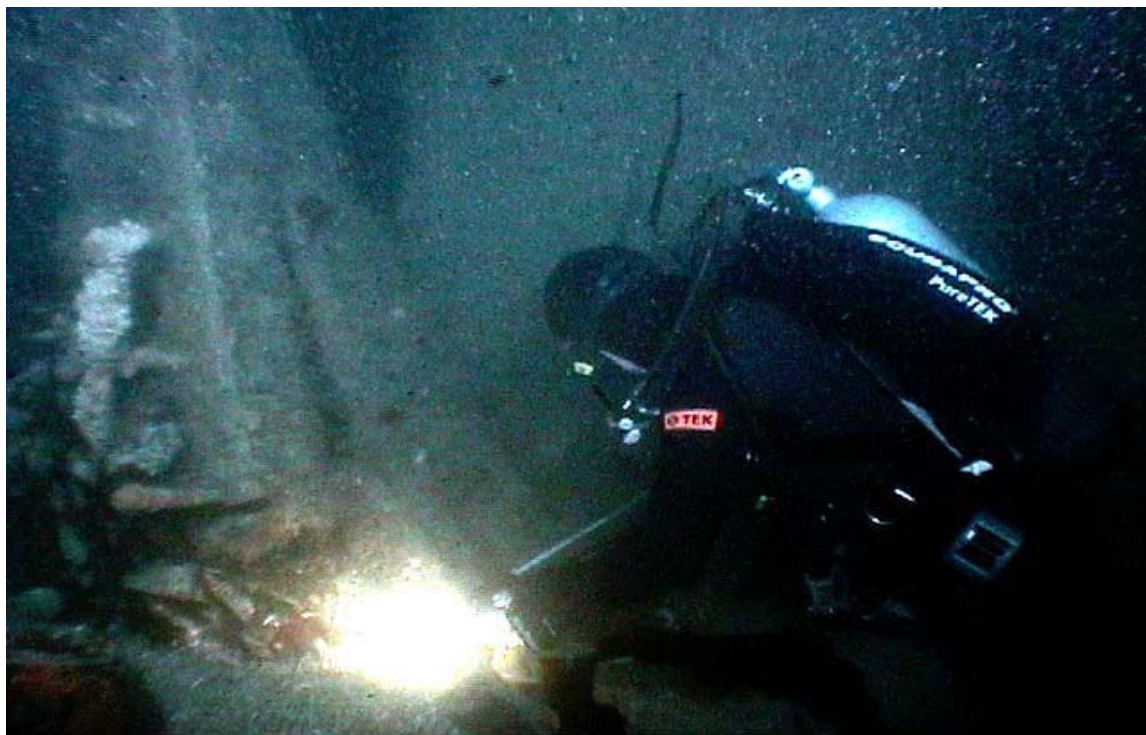
Figure 18a. Documenting the *Alabama's* lifting frame.

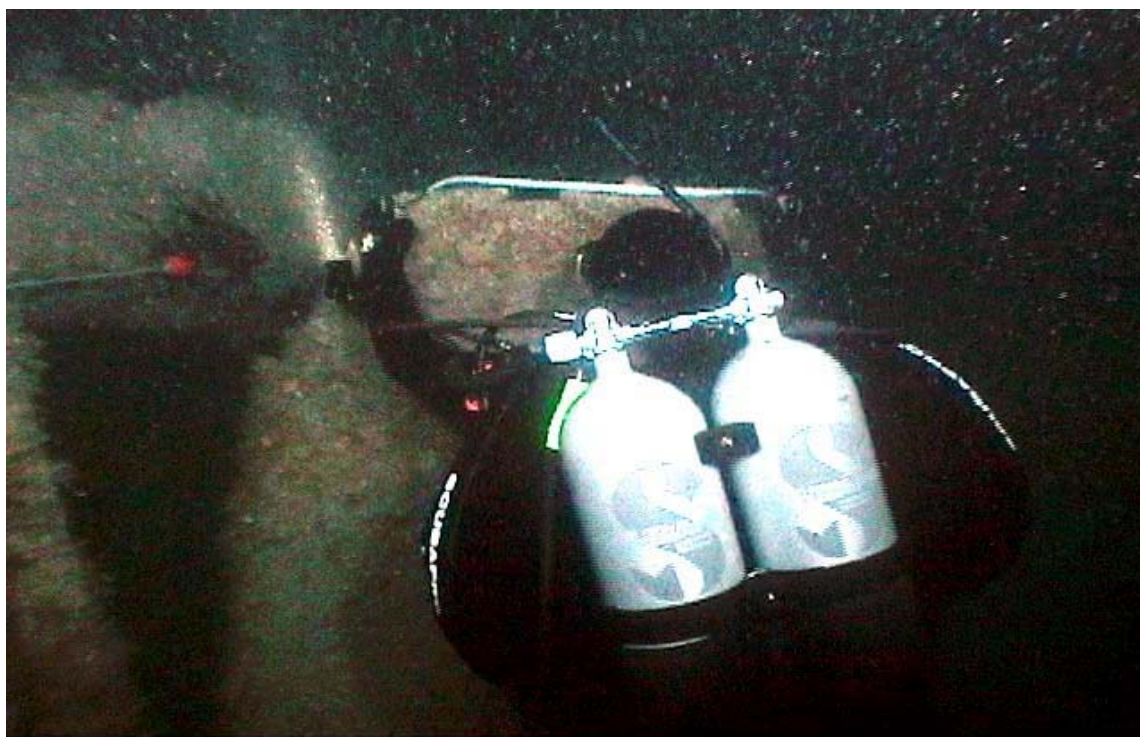
Figure 18b. Documenting the *Alabama's* propeller.

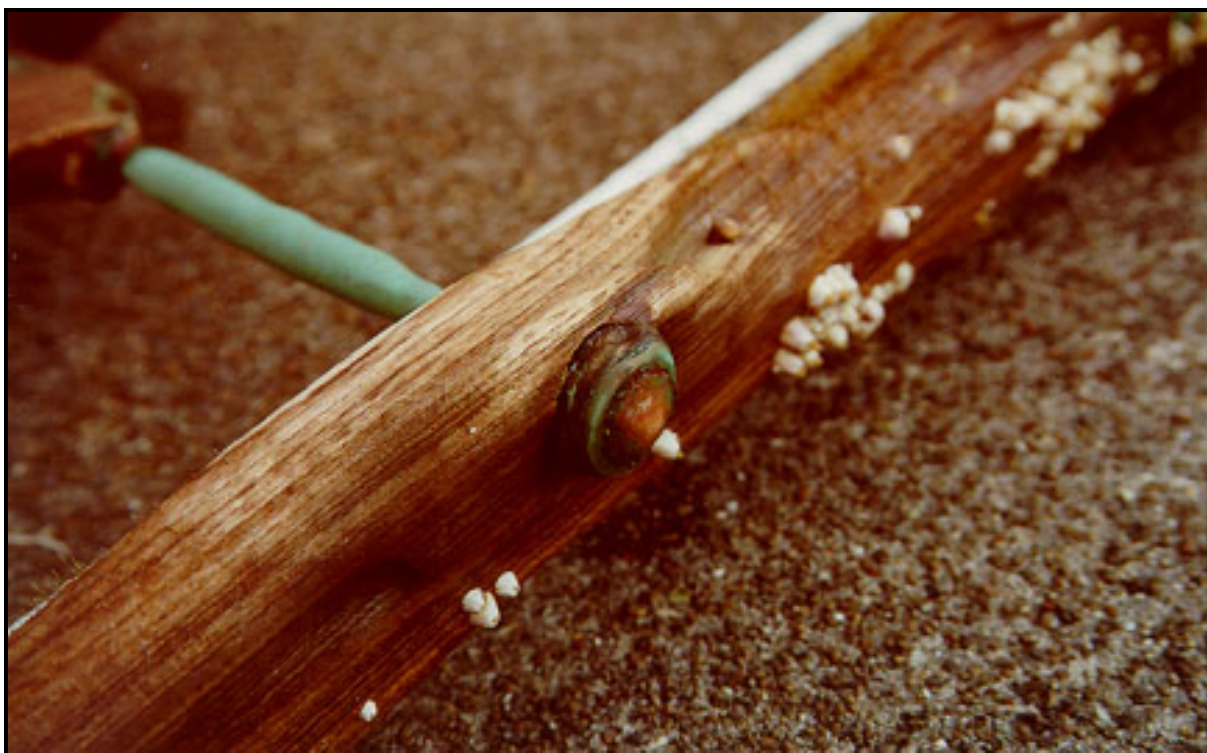
Figure 20

ALS-215 Hull Fragment with Fasteners

Artifact ALS-215 is a large fragment from the hull of the CSS *Alabama*. Although it is impossible to determine its exact location in the vessel structure the wood and fasteners suggest that it consisted of a section of deck clamp, hull planking and futtock. The multi-component artifact is made up of three different wood species. The outer portion is teak that represents hull planking. The middle section appears to be white oak and represents remnants of a futtock. The inner portion is mahogany and represents the remains of a deck clamp. Copper fasteners run through each piece and are corroded away on the inner side. The pins are peened over roves outside the teak planking.

Length:	87.5 inches	222.25 cm
Width of Oak:		
Width of Teak:	3.6 inches	9.1 cm
Width of Mahogany:		
Pin Diameter:	.75 inches	1.9 cm
Rove Diameter:	1.5 inches	3.8cm

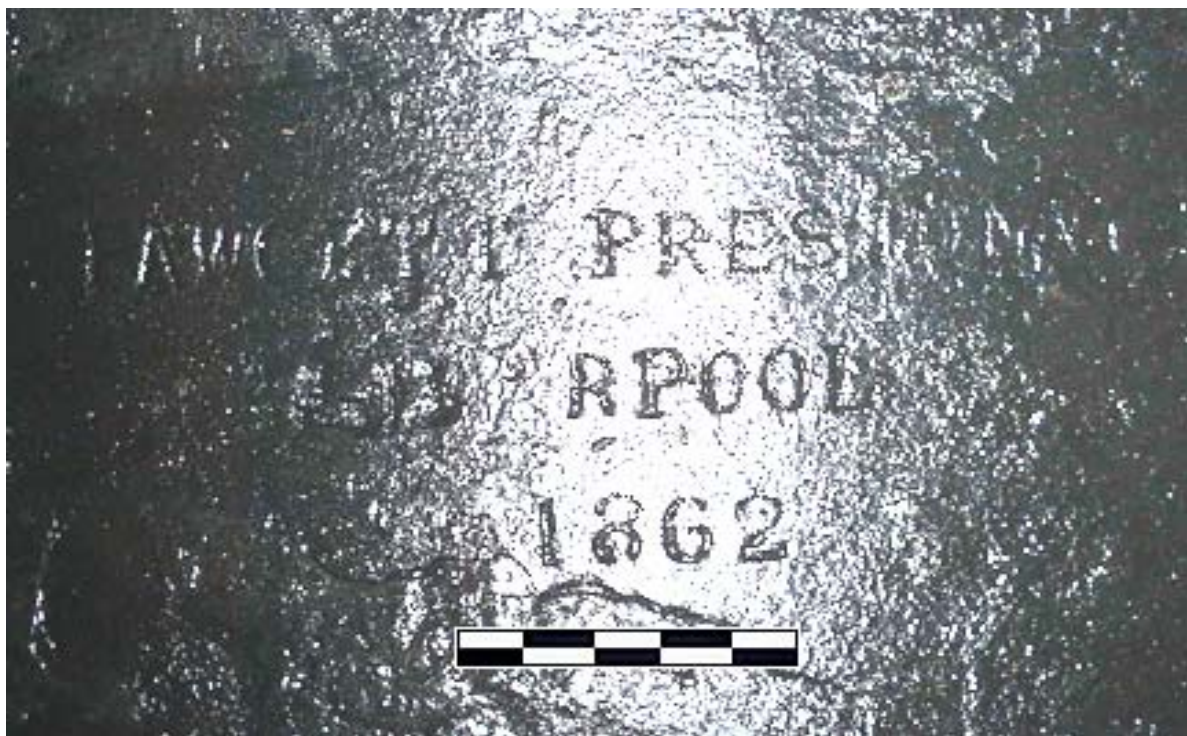
Figure 23

ALS-217 Makers Mark on the 32-pounder Cannon

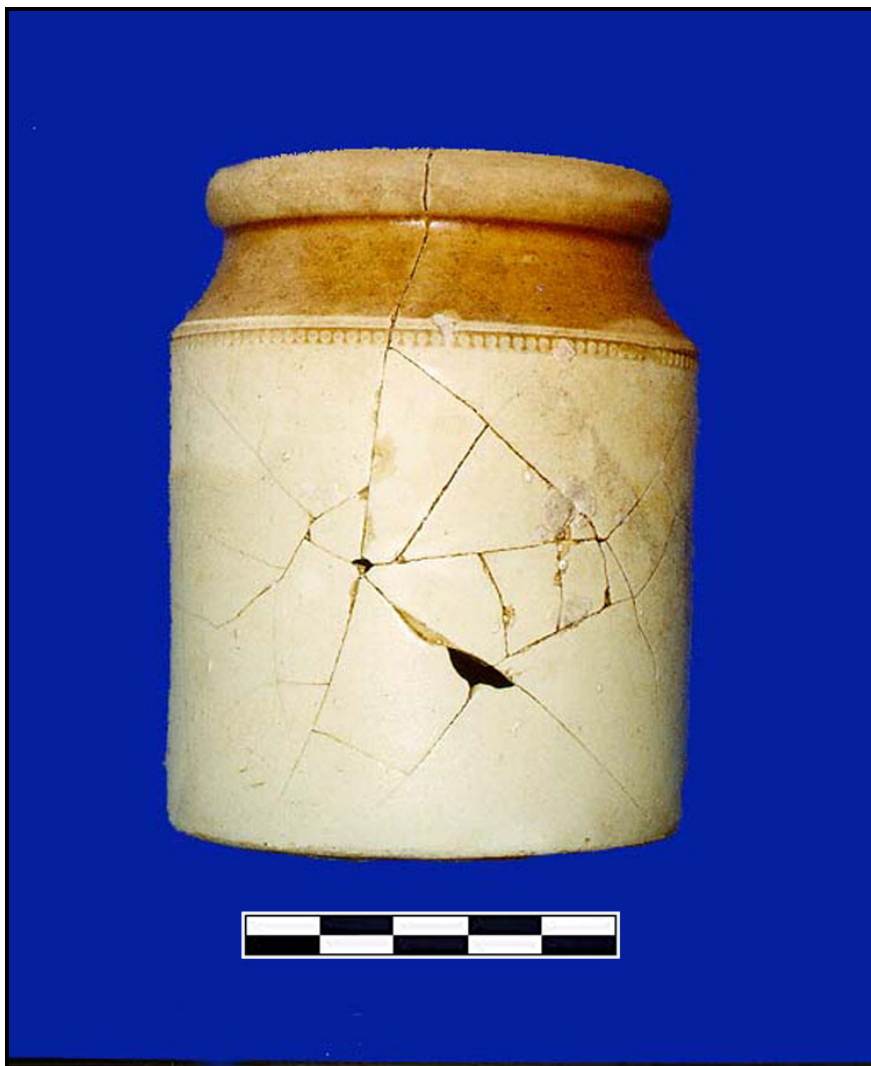
Figure 31

ALS-225 Stoneware Jar

Artifact ALS-225 is an stoneware jar. The lower body is cylindrical and cream colored. The top narrows in a concave style above the stamp decorated shoulder. A heavy lip forms the mouth of the vessel. Above the shoulder and inside the vessel light brown slip has been applied under a salt glaze. One side of the jar contains an impact break. Only a few of the fragments associated with the impact break are missing and it is possible that the break has been partially repaired.

Body Diameter:	6.19inches	15.7 cm
Height:	7.63inches	19.4 cm
Rim Diameter:	5.50 inches	14 cm

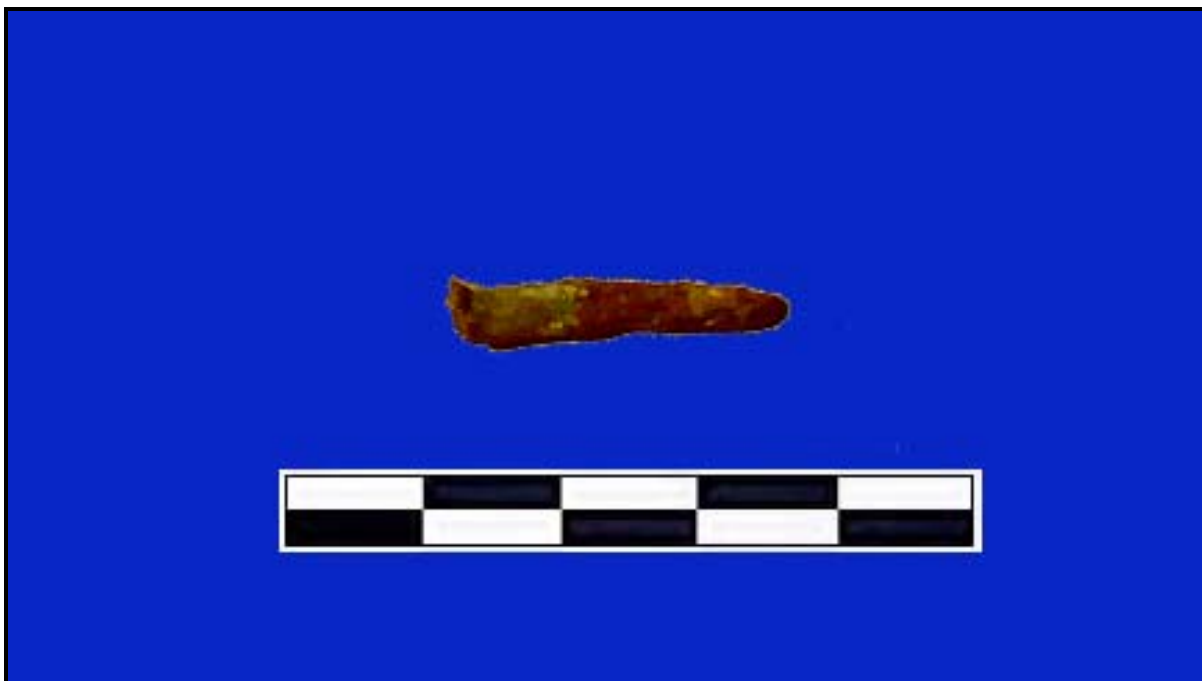
Figure 32

ALS-226 Tack

Artifact ALS-226 is a square brass tack that was used to fasten the rectangular flange of the lead scupper to the deck. Little can be ascertained about the shape of the head as it is badly corroded. However, the tack appears to be a common sheathing tack of the type used to attach copper sheathing to the hull of ships.

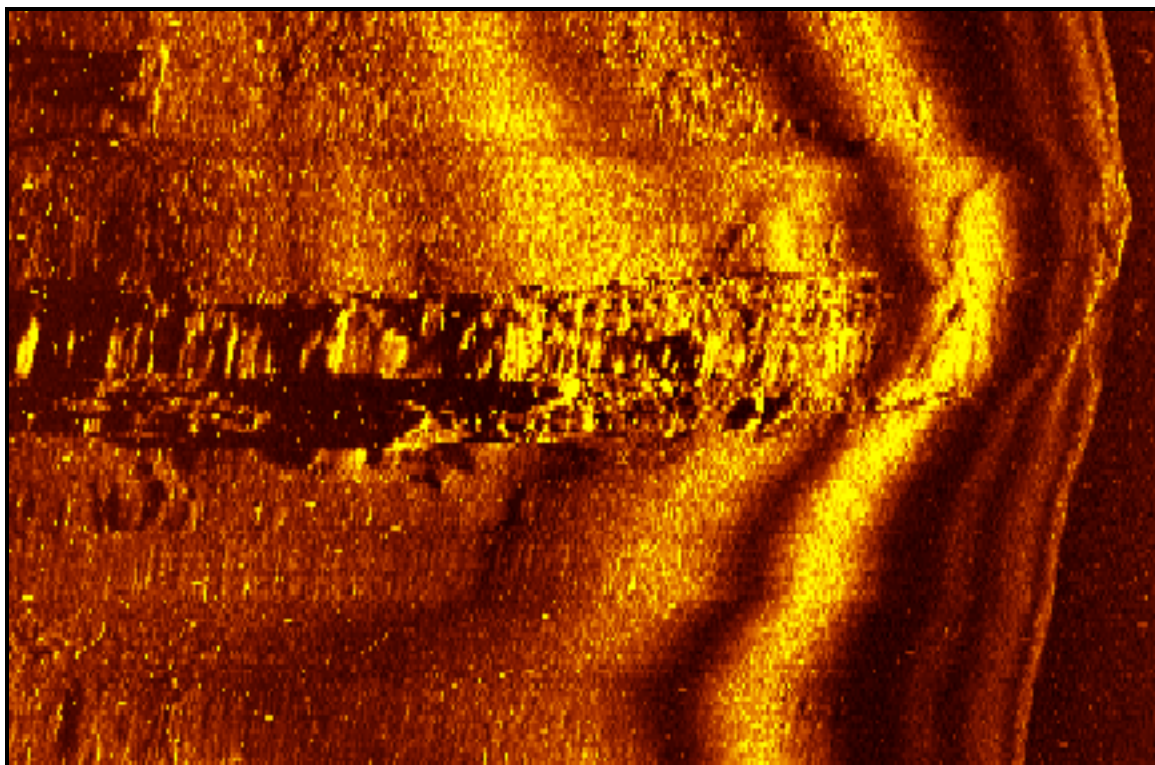
Figure 41. *Robo* sonar image of the CSS Alabama.

Although that objective was also compromised by the last minute cancellation of the support vessel *Robo*, that vessel did subsequently make several passes over the wreck with sonar. The images were produced by a 600kHz Marine Sonics sonar. Unfortunately, the range scale used, the direction of the survey transects, and the height of the transducer in the water column combined to produce images which revealed little of the exposed wreck structure of the wreck site environment (Figure 41). Thus, the imagery could not be used to enhance the site map or identify additional exposed wreckage for diver identification and assessment.

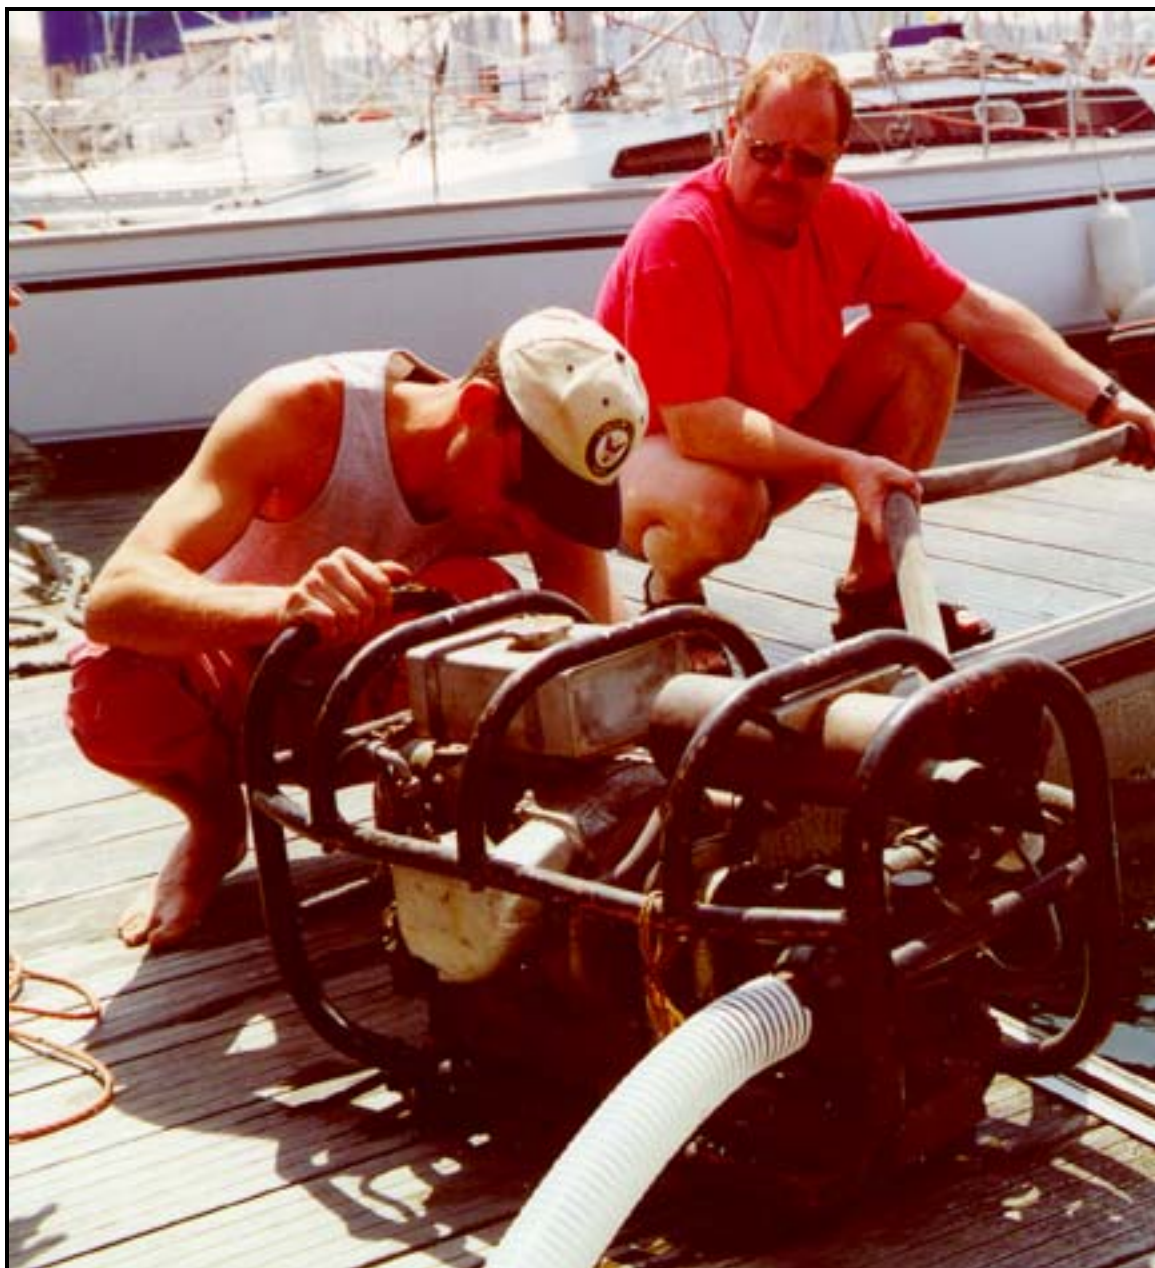
Figure 43. Water pump used to power the induction dredge.
