Evaluation of Fiber-Reinforced Unbonded Overlay

Initial Report
RI97-015

**EVALUATION OF FIBER-REINFORCED
UNBONDED OVERLAY**

MISSOURI DEPARTMENT OF TRANSPORTATION
RESEARCH, DEVELOPMENT AND TECHNOLOGY

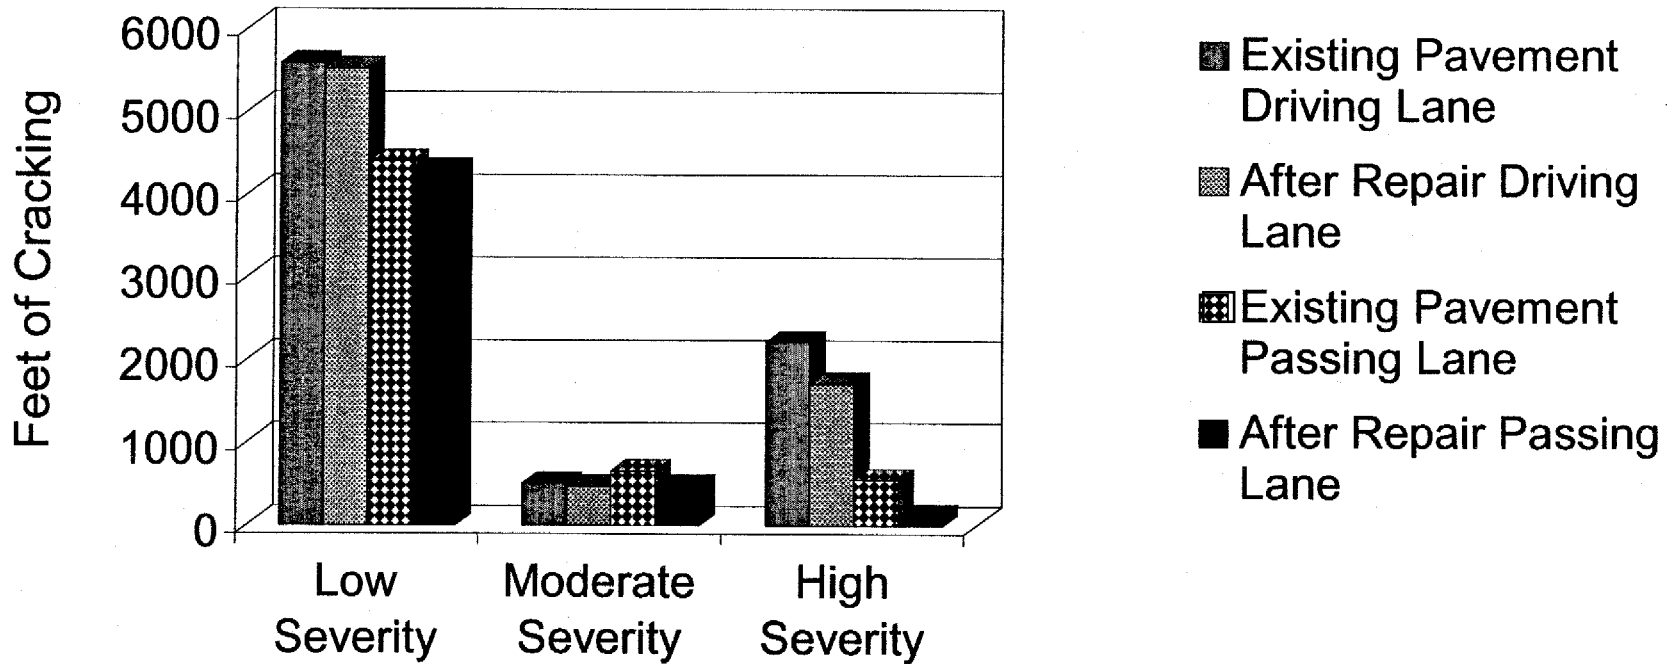
Transverse Cracking Before and After Pavement Repair

Between April 13 and May 12, 1998, full depth pavement repair was performed by the contractor on the existing pavement to prepare the pavement for the unbonded overlay. *Appendix D* shows the number of transverse cracks in the pavement before and after repair. Approximately 2% of the low severity transverse cracks were repaired, with 9,816 feet of low severity cracks remaining. Roughly 20% of the moderate severity

cracks were repaired, leaving 942 feet of moderate severity cracks. Almost 35% of the high severity transverse cracks were repaired but 1,826 feet remained unrepaired. In addition to the repair of some transverse cracks, 17 out of 330 transverse joints were partially or entirely replaced.

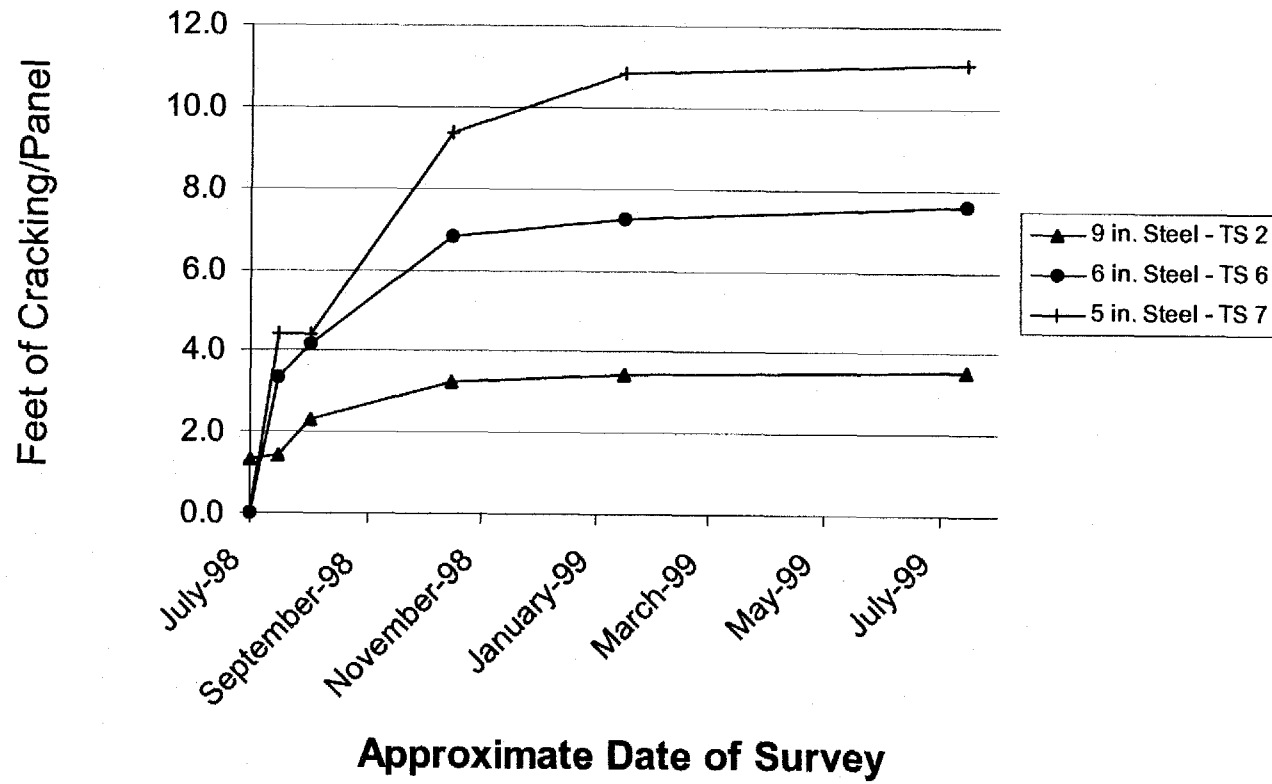
Transverse Cracking of Steel Fiber-Reinforced Test Sections

The progression of cracking in the steel fiber-reinforced and polyolefin fiber-reinforced sections can be seen on pages F-3 and F-4 of *Appendix F*, respectively. The steel fiber-reinforced concrete has developed more cracking overall, than the polyolefin fiber-reinforced concrete. At the one-year survey, the 5" steel fiber-reinforced section had about 11 feet of transverse cracking per panel, while the 5" polyolefin fiber-reinforced section had about 5 feet/panel. Similar trends are present for the 9" and 6" sections. The largest difference in amount of cracking between the steel fiber-reinforced and polyolefin fiber-reinforced concrete is present in the 6" sections. The 6" steel fiber-reinforced section has nearly 8 feet of transverse cracking/panel, while the polyolefin fiber-reinforced section has less than 2 feet/panel. During the cold temperatures (30 – 35 °F) of the 6-month survey in January 1999, the cracks in the steel fiber-reinforced sections were approximately 1/16" wide. The width of the cracks in the polyolefin fiber-reinforced sections was approximately 1/8".
