# MNMM Fatal 2004-25

- Machinery
- December 9, 2004 (Texas)
- Alumina Plant
- Technician/Operator
- 46 years old
- 26 years experience

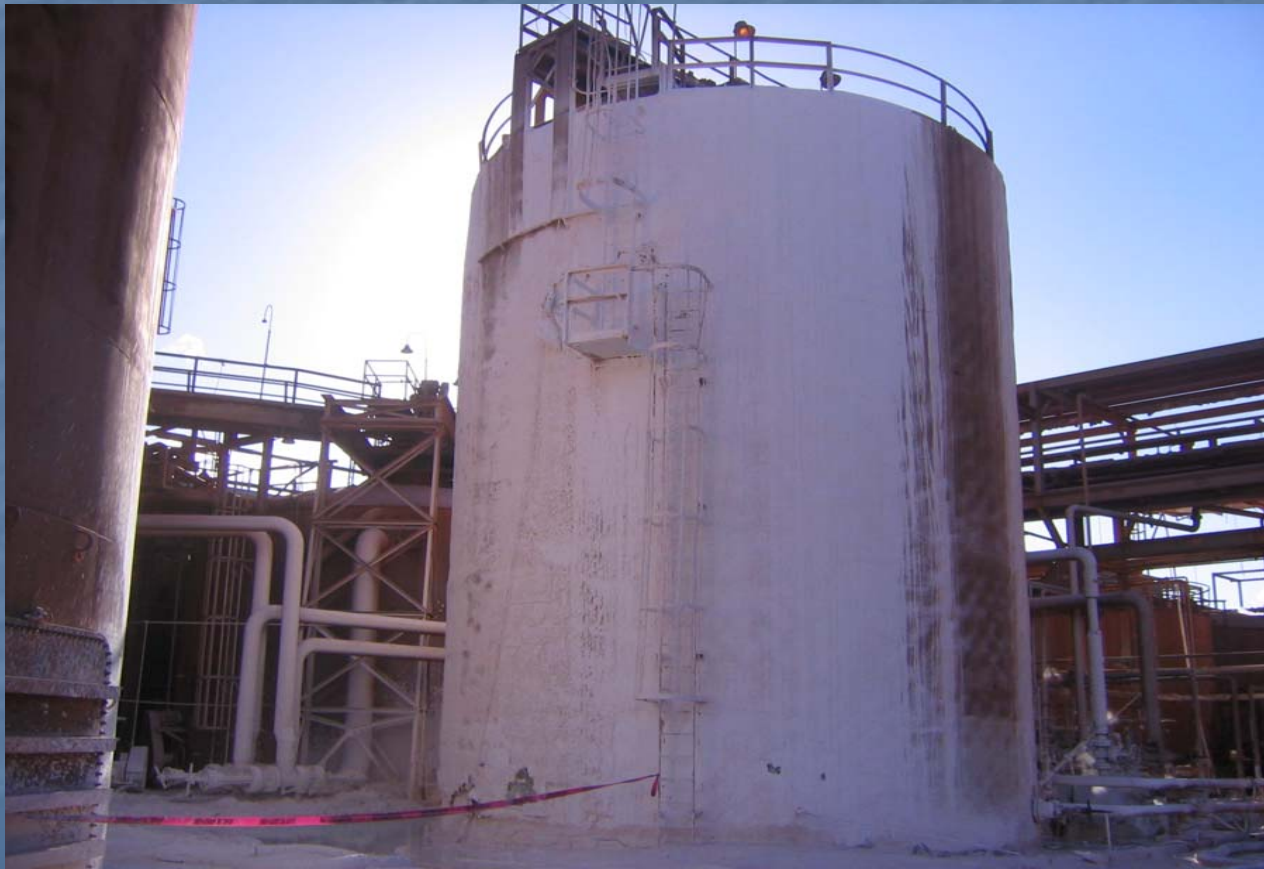
**Slaked lime surge tank involved in accident.  
Tank was 30 feet in diameter and 38 feet high.**

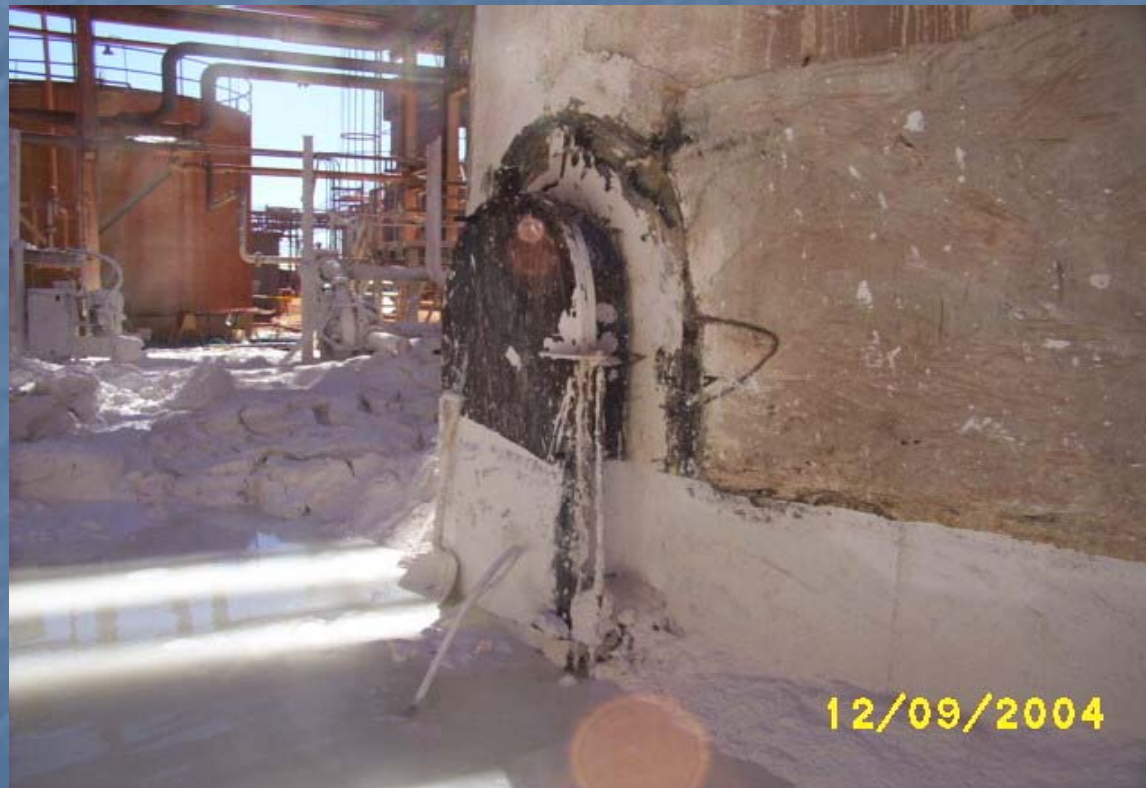
- The victim was standing outside an open access door attempting to flush material from a slaked lime surge tank. The lime slurry rushed from the tank as the victim was hydro-blasting through crusted material just inside the open door.

The victim was standing in front of this access door located at the bottom center of the lime surge tank.

- The accident occurred because the mine operator did not ensure that effective procedures were utilized to protect persons from entrapment by materials from within the surge tank. The amount and consistency of material in the surge tank were not determined before the tank access door was removed and the hydro-blasting work began.

- Management policies and controls were inadequate and failed to implement safe work procedures to ensure miners were not exposed to entrapment hazards created by material remaining in the slaked lime surge tank.

- Ensure that tanks, bins, or silos have been thoroughly examined and materials that could be hazardous to personnel have been removed or diverted prior to opening or activating access doors, valves, feeders, or gates.
- Ensure that miners jointly discuss the safe job procedures, identify all possible hazards, and take all precautions to safely perform the task before the work begins.
