Technical Memorandum No. 86-68220-07-05

## Inspection and Cleaning Manual for Equipment and Vehicles to Prevent the Spread of Invasive Species

2012 Edition

June 2012

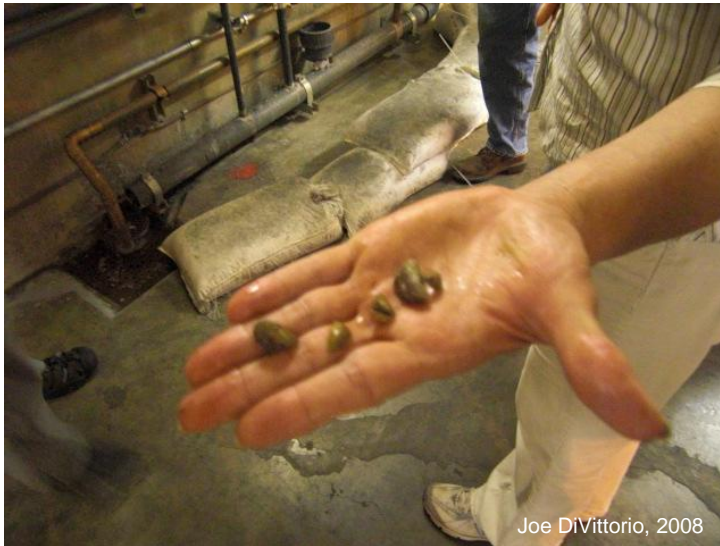
**Live adult quagga mussels taken from a wet well at a Lower Colorado River facility (photo courtesy of Joe DiVittorio, 2008).**

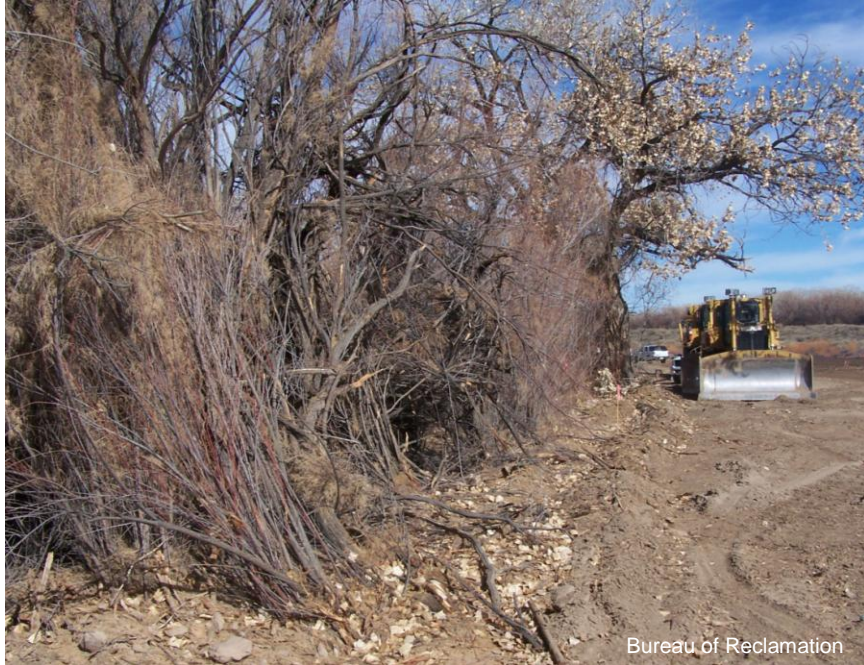
**Figure 3. Dozing operations taking place in Socorro, New Mexico, in an area occupied by the invasive species saltcedar (Bureau of Reclamation photo).**

Watercraft, vehicles, earth-moving equipment, pumps, trailers, and other equipment are particularly troublesome avenues of spread (figure 3). Clothing, shoes, waders, and diving gear can become vectors of spread when personnel leave infested areas that contain soil or mud laden with seed or plant fragments (figure 4). Invasive species can also be deposited on fuel tanks, wheel wells, and behind the bumpers of vehicles (figure 5). Pathogens, insects, and other animals can be transported in the same manner.

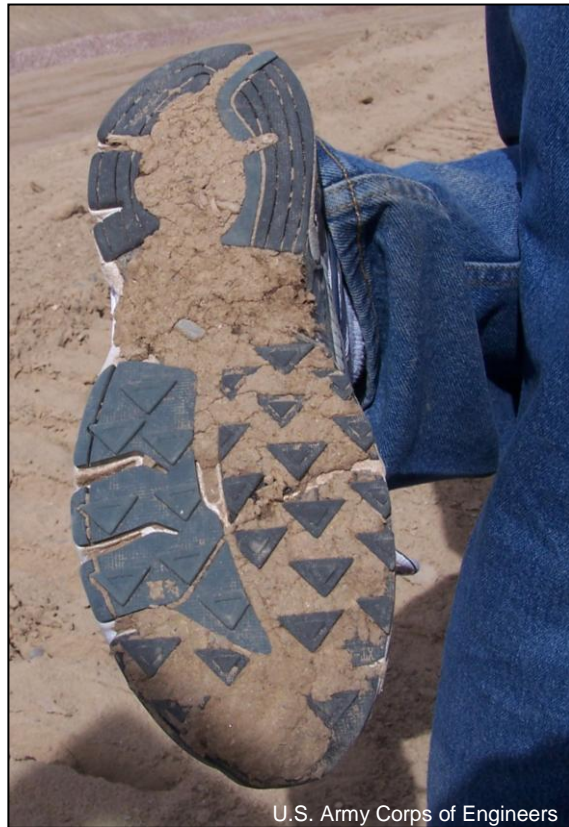
**Figure 4. Mud encrusted on a shoe sole (U.S. Army Corps of Engineers photo).**

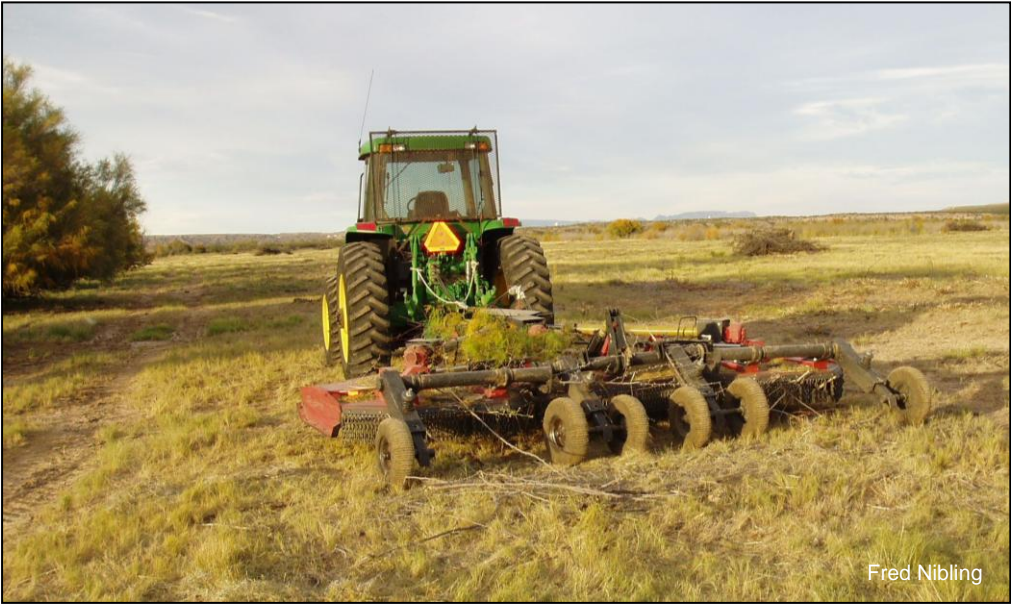
**Figure 6. Plant material carried on brush mowing equipment (photo courtesy of Fred Nibling).**

Tractors and mowers collect plant materials during operations in the field (figure 6). Tracked vehicles pick up large amounts of soil, mud, and debris, making them more of a challenge to clean than smaller vehicles and other equipment. Similarly, drivetrain belly pans of bulldozers accumulate large amounts of soil and debris, which might require physical removal of foreign material before washing. Physical removal of accumulated material (precleaning) before washing operations can help reduce water demand when cleaning certain equipment (figure 7).

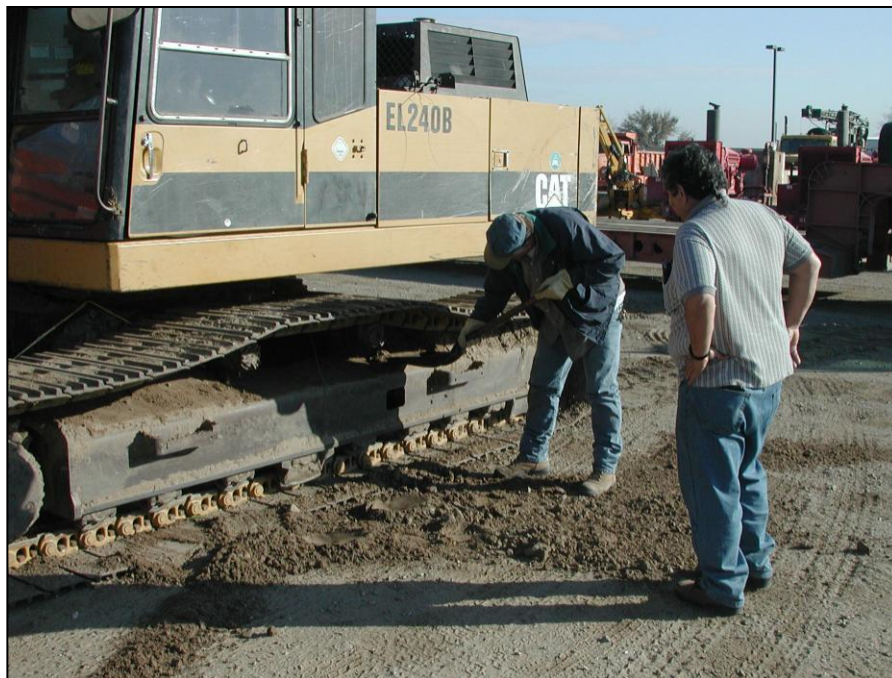
**Figure 7. Precleaning heavy accumulations can help reduce water use when washing. Working in certain areas may require a safety lookout (photo courtesy of Fred Nibling).**

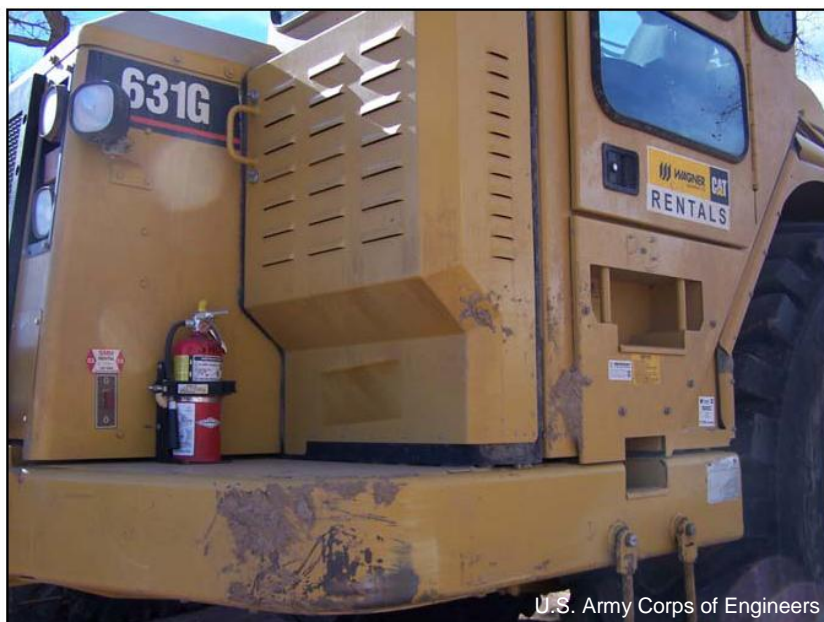
**Figure 8. Rental equipment may be delivered to a worksite with mud accumulations. Consider including equipment cleaning in the equipment rental contract (U.S. Army Corps of Engineers photo).**

Equipment use might involve not only Reclamation-owned equipment, but also rented equipment and equipment used by contractors and subcontractors (figure 8). Equipment also is brought in from other areas of the United States and may be transferred out to locations where new invasions may inadvertently accompany contaminated equipment.

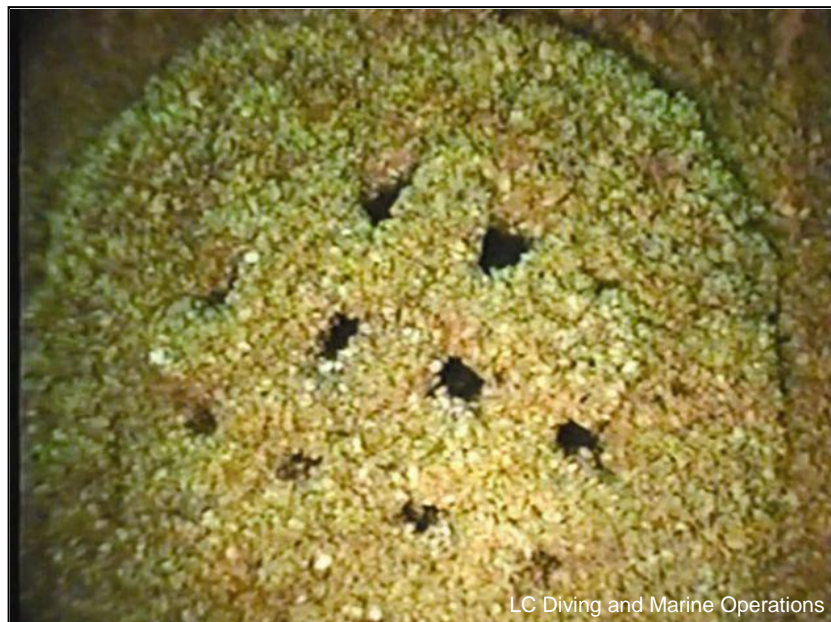
**Figure 9. Underwater photo showing mussels covering the Davis Dam domestic water intake grate (photo courtesy of LC Diving and Marine Operations, 2008).**

Many facilities throughout Reclamation share common designs and components. Where these components have the potential of being used interchangeably at facilities from one location to another, there is a pathway of invasive species spread, particularly by zebra or quagga mussels. Any parts, components, or equipment being considered for use at another facility must be fully inspected for invasive mussels and thoroughly decontaminated before transport to the new location. Gates, valves, pumps, and structural components are examples of such items (figure 9).

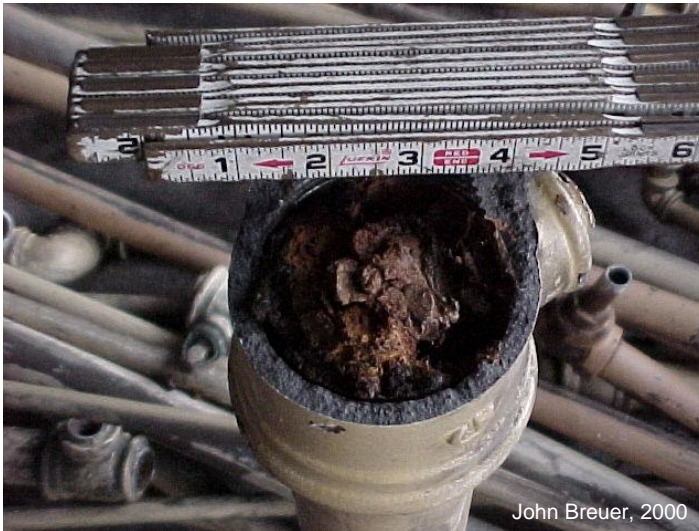
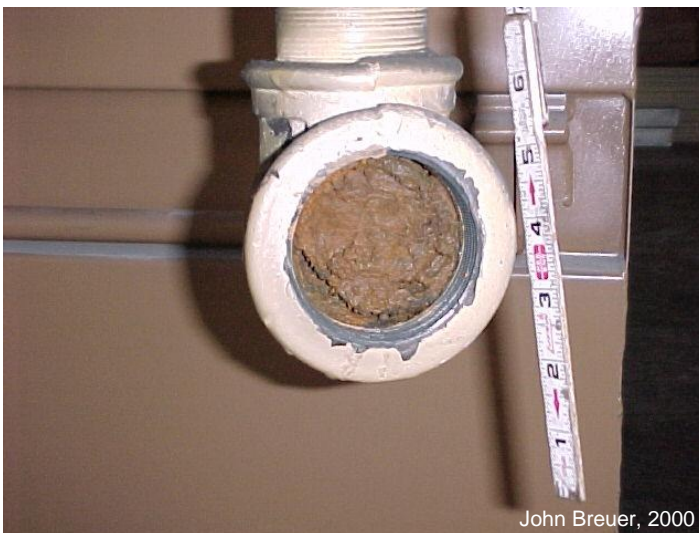
**Figure 10.** This raw water fire protection sprinkler system, located on the former Philadelphia Naval Shipyard, is contaminated with aquatic organisms and debris. Raw water that contains zebra or quagga mussels can enter a sprinkler system intake, where the mussels can grow and clog the sprinkler heads (photos courtesy of John Breuer, 2000).

Although not contaminated with either zebra or quagga mussels, figure 10 provides an unusual glimpse of a contaminated dry-pipe fire protection sprinkler system discovered after disassembly. The contamination seen is composed of dead aquatic organisms and silt. In this case, the contamination is so great that portions of the system may not have operated during a fire emergency.

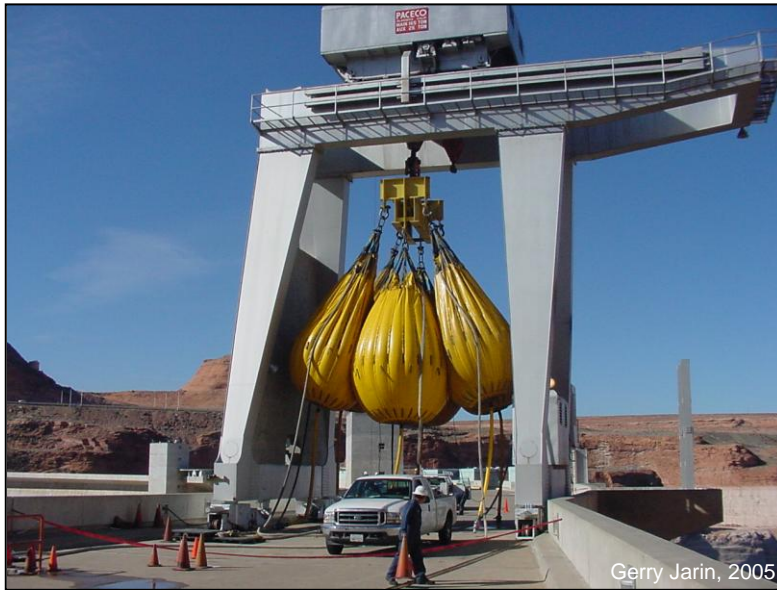
**Figure 11. Crane testing at Glen Canyon Dam (photo by Gerry Jarin; photo courtesy of Jim Jota, Imes, Inc., 2005).**

In particular, attention should be given to water bags used during crane testing and calibration at various Reclamation facilities (figures 11 and 12). Crane testing companies often use water bags by filling the bag with water to the corresponding weight for the testing process. These bags can be used at various locations across the country and might be filled with untreated raw water at the location of last use. At the end of crane testing, the bag is drained and can be moved to a new location. If not properly handled, water bags can become a pathway of aquatic invasive species spread.

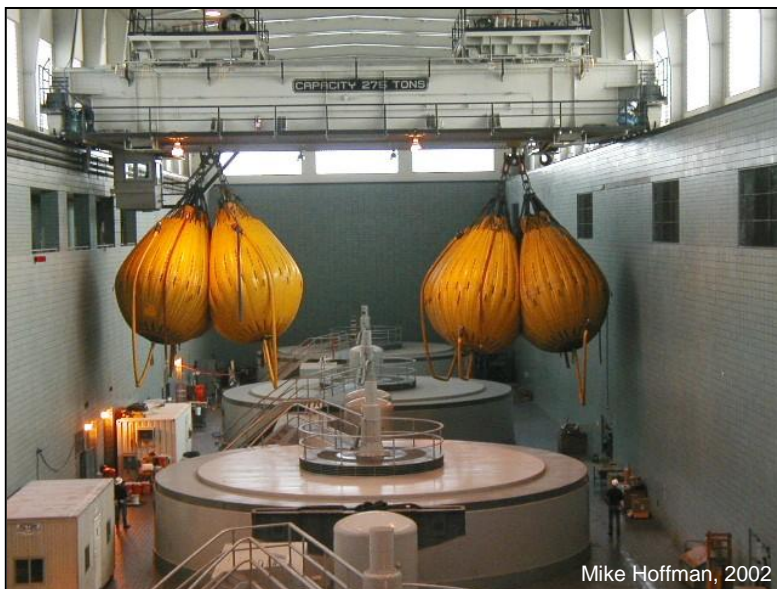
**Figure 12. Crane being tested at a Tennessee Valley Authority powerplant using water weight bags™ (photo by Mike Hoffman; photo courtesy of Jim Jota, Imes, Inc., 2002).**

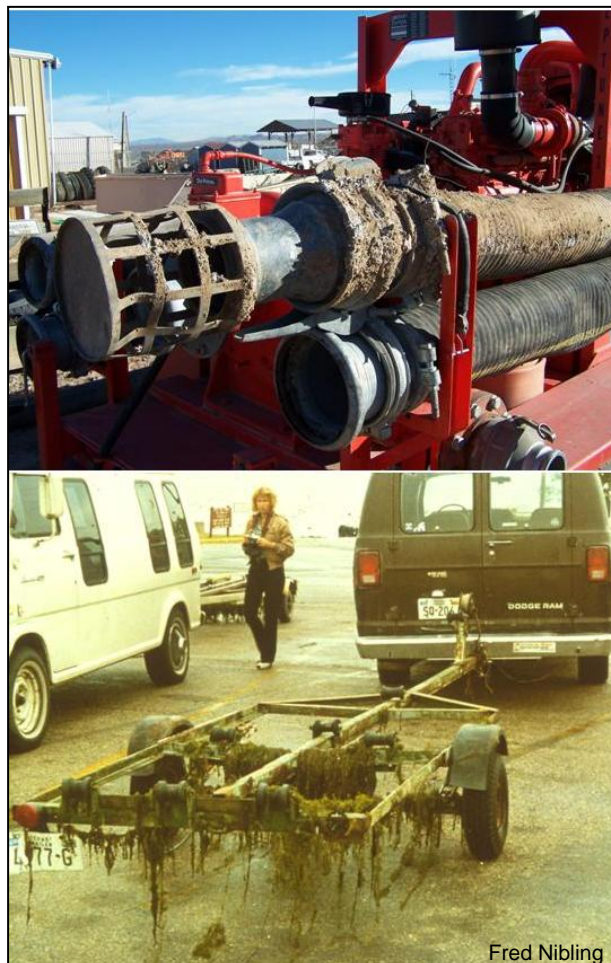
**Figure 13. Mud and debris on pump (above) and hydrilla on boat trailer (below) (photo courtesy of Fred Nibling).**

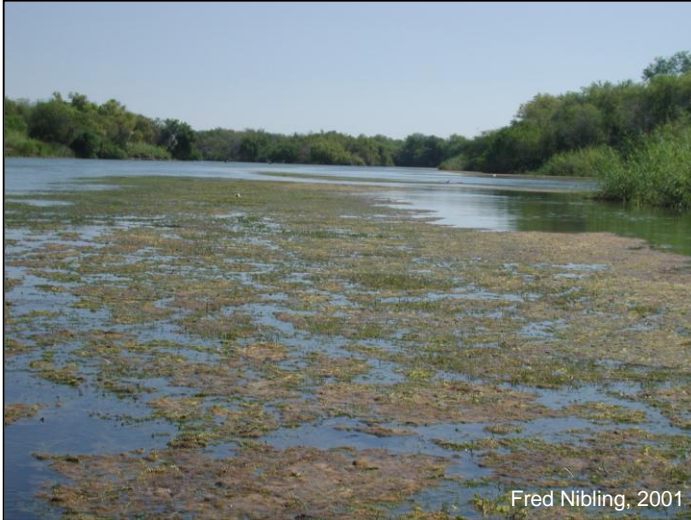
**Figure 14. Hydrilla can block the flow of water in rivers, creeks, and channels. It can be spread to new locales by vegetative fragments and propagules carried on contaminated equipment and watercraft. Lower Rio Grande River (photo courtesy of Fred Nibling, 2001).**

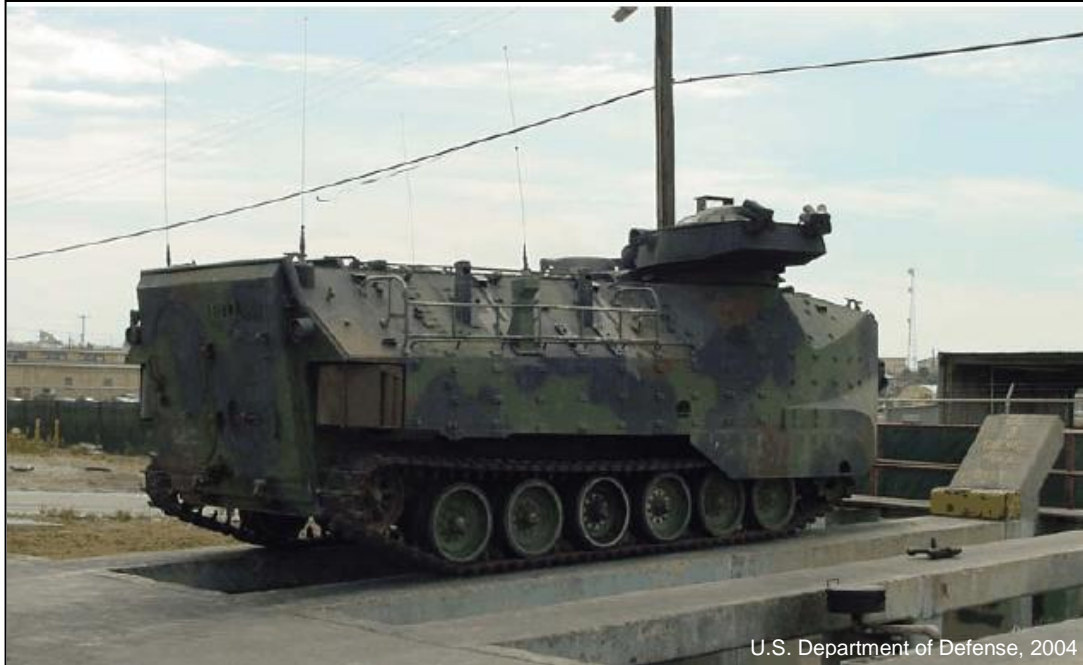
**Figure 15. Tracked military equipment wash bay with hardstand surface and access underneath equipment (U.S. Department of Defense photo, 2004).**

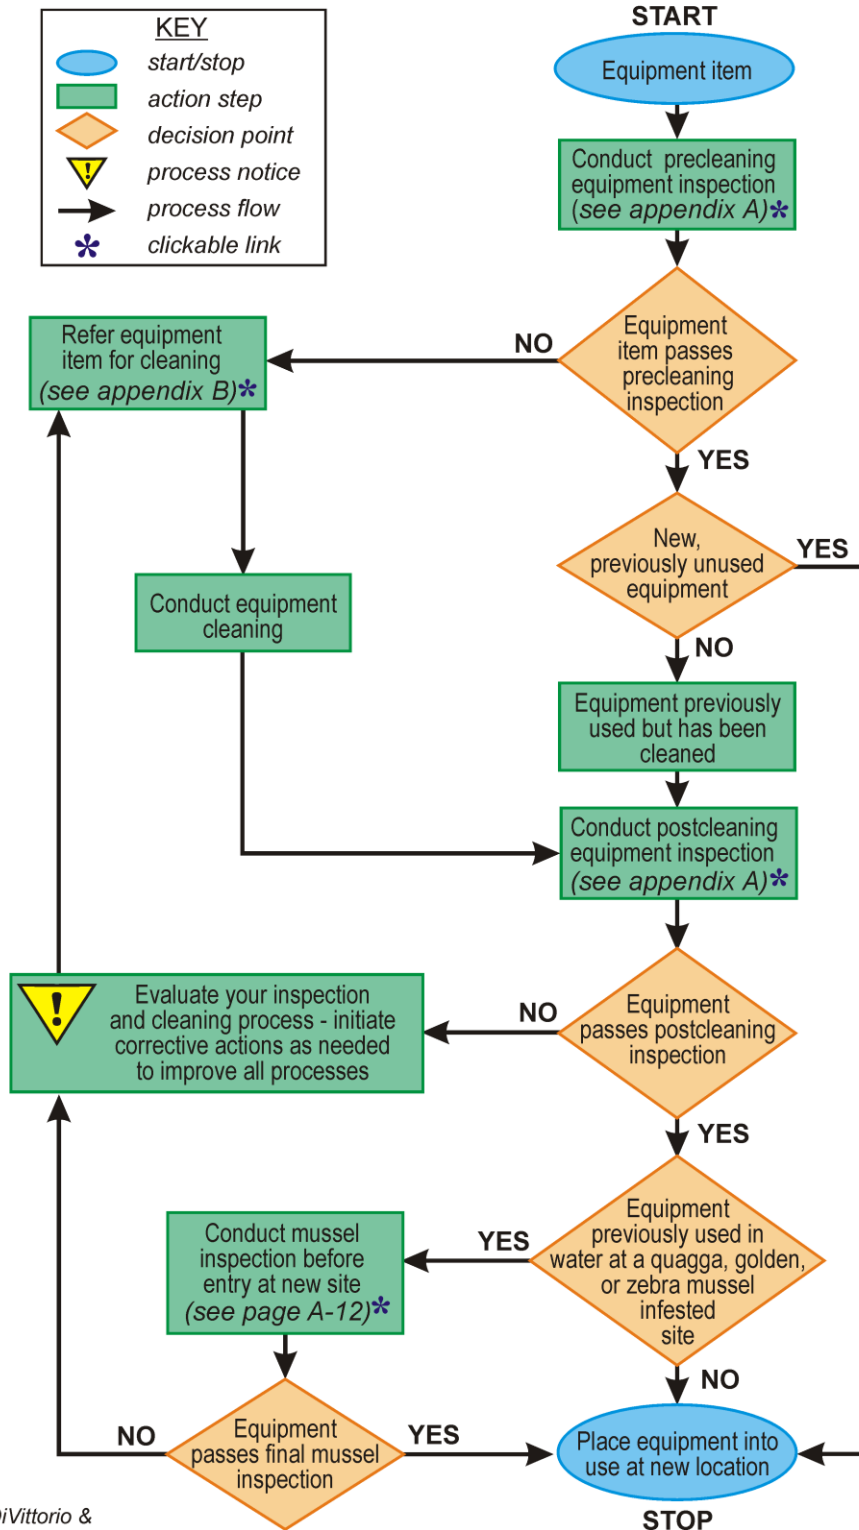
Figure 17. The inspection-cleaning relationship.

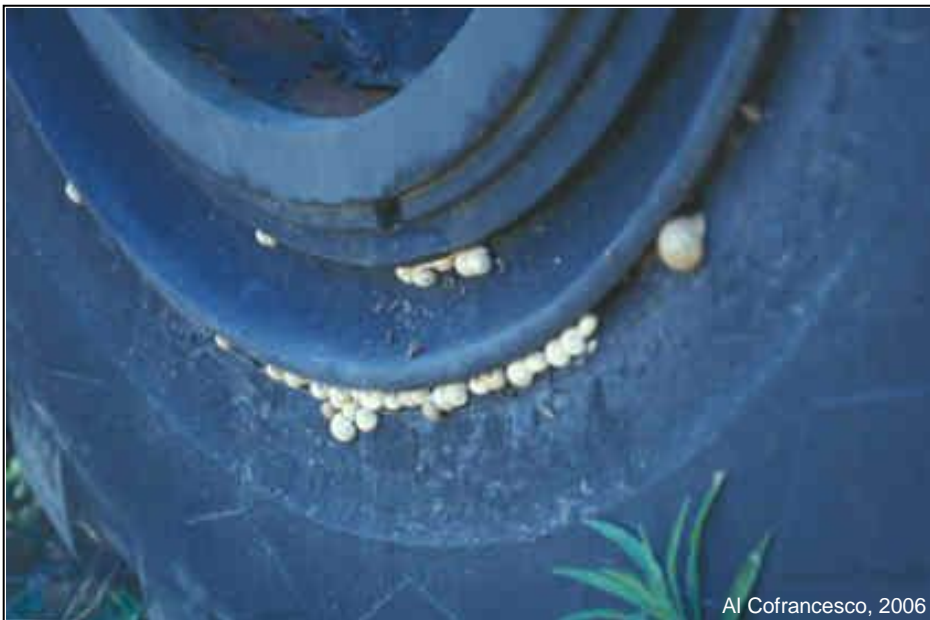
**Figure 18. Snails directly attached to wheel and tire (photo courtesy of Al Cofrancesco, 2006).**

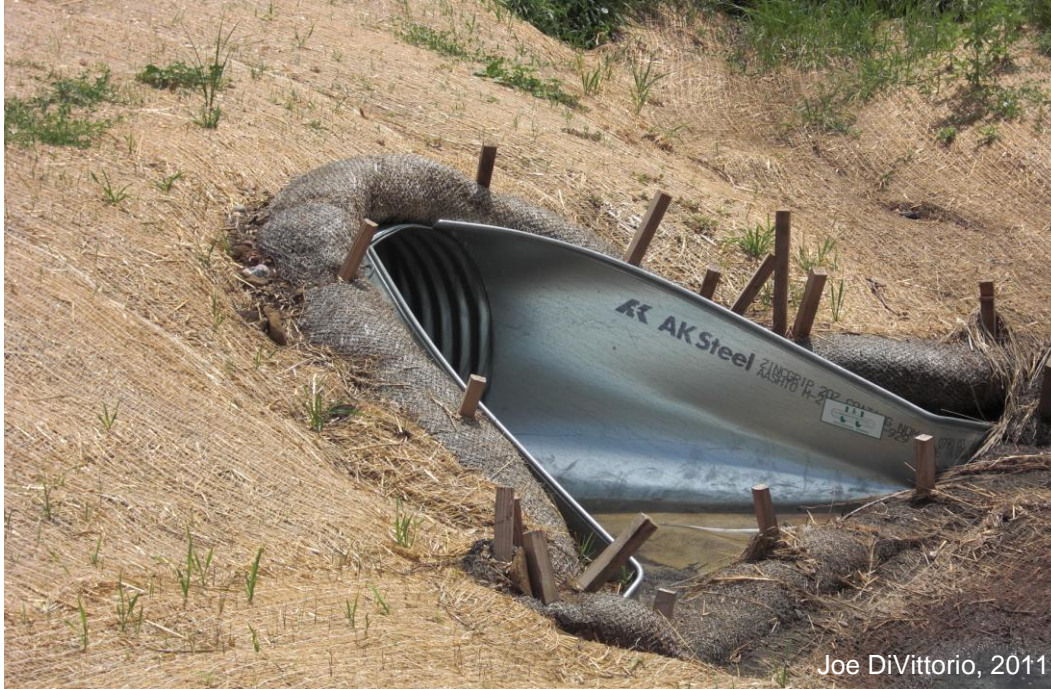
**Figure A-1. Straw is used as a mulch and in sediment logs to control erosion. Here, sediment logs (or wattles) are shown staked around a culvert (photo courtesy of Joe DiVittorio, 2011).**

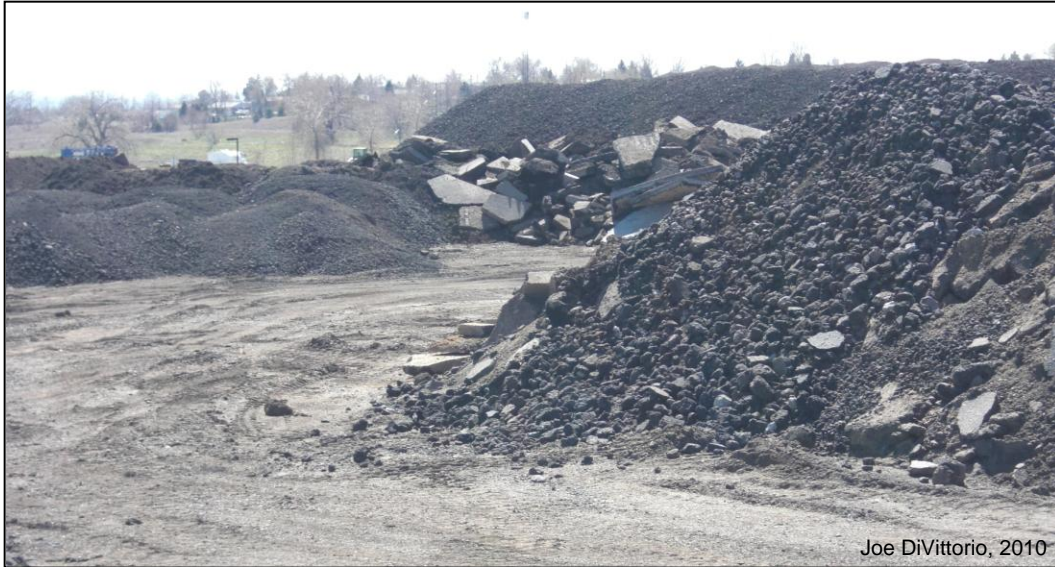
**Figure A-2. Fill materials separated by type – soil, broken concrete, pavements, etc. – temporarily stored at a barrow site (photo courtesy of Joe DiVittorio, 2010).**

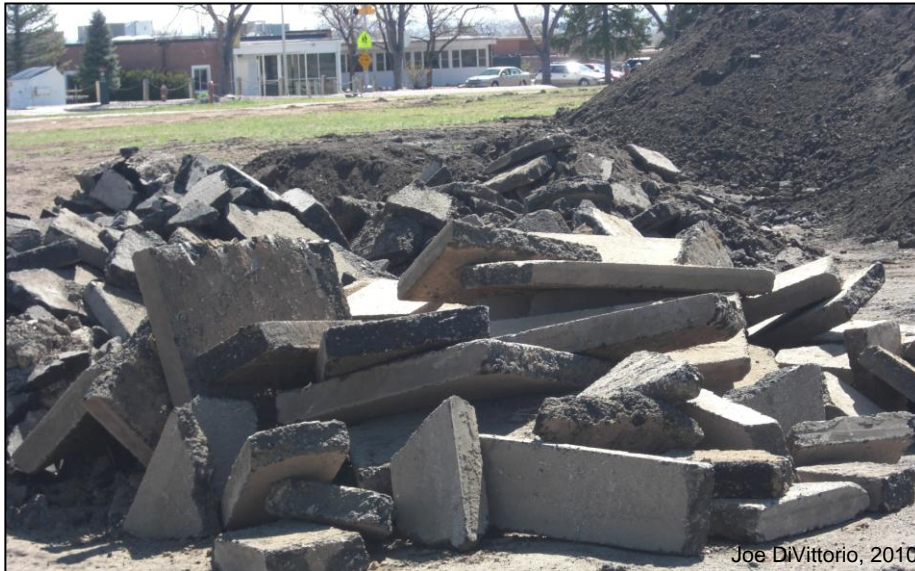
**Figure A-3. Stockpiled broken concrete – note contact surfaces with adhering residue soils. These surfaces can harbor foreign species from the site of previous use (photo courtesy of Joe DiVittorio, 2010).**

- Recycled fill materials, such as broken concrete and pavements, often have adhering residue soils that can harbor foreign species. Prior to transport to the work site, reduce the risk of transporting foreign

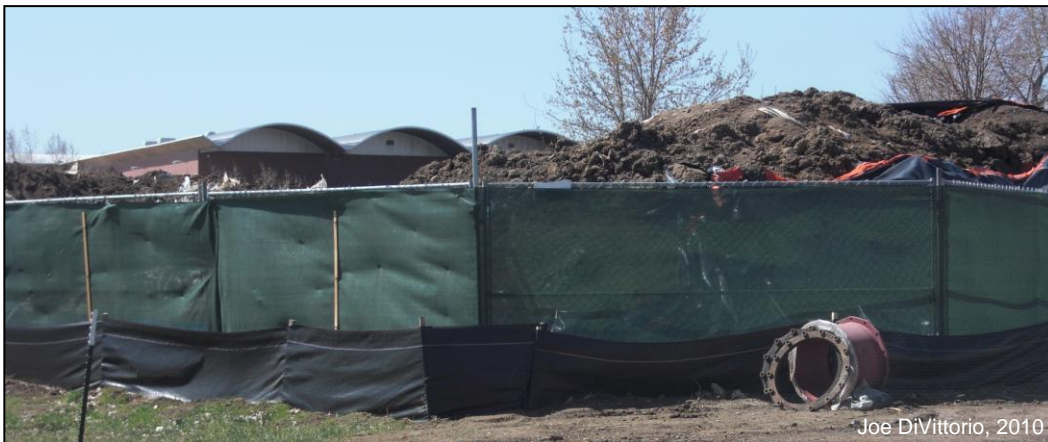
**Figure A-4. Stockpiled fill material at a construction site enclosed by silt fencing to help control soil loss and the potential spread of foreign species. Black plastic covering (seen in upper right corner) has been pulled back to allow machine work (photo courtesy of Joe DiVittorio, 2010).**

- Stockpiled fill materials suspected of harboring foreign species at the work site may be covered by black plastic and enclosed by silt fencing to help control their spread (figure A-4).

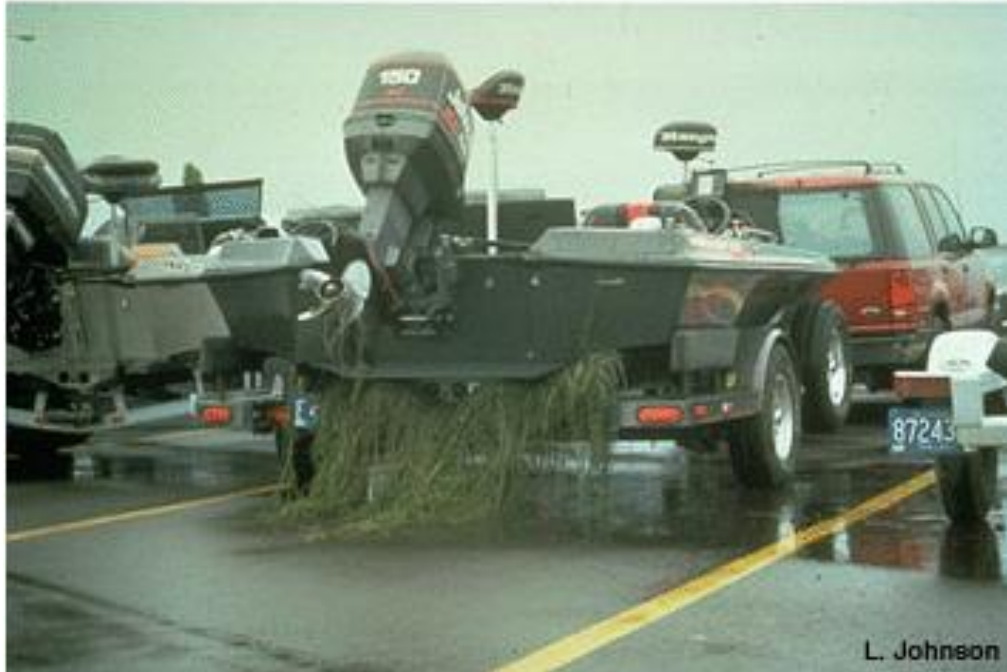
**Figure A-5.** It is possible for mussel juveniles and adults to attach to aquatic weeds; this photo shows aquatic weeds (macrophytes) caught on a boat trailer at a Lake St. Clair boat access.

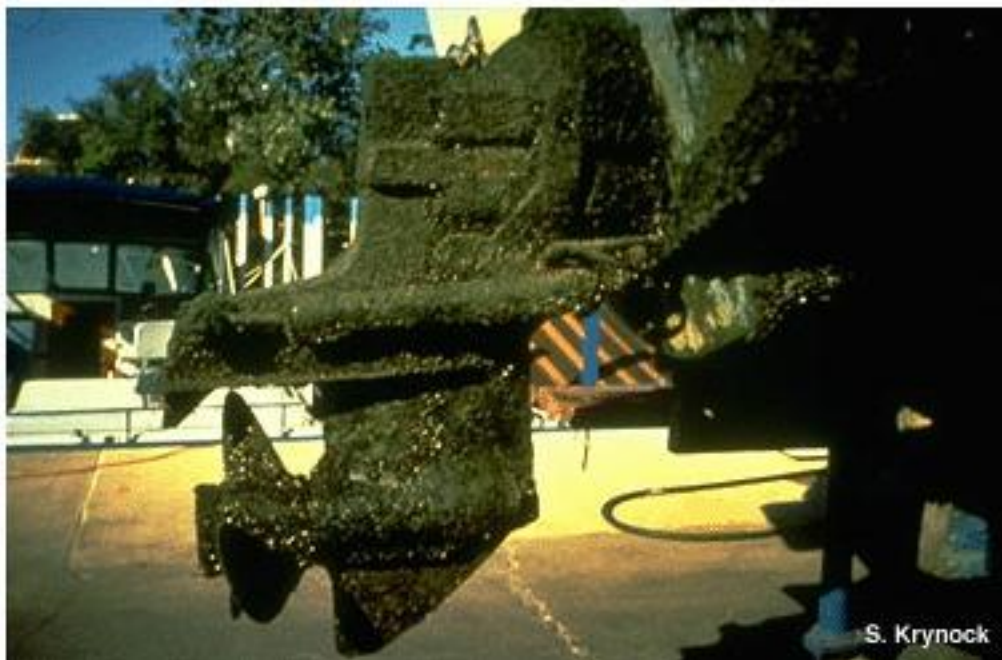
**Figure A-6.** Mussels on the lower unit of an inboard/outboard engine.

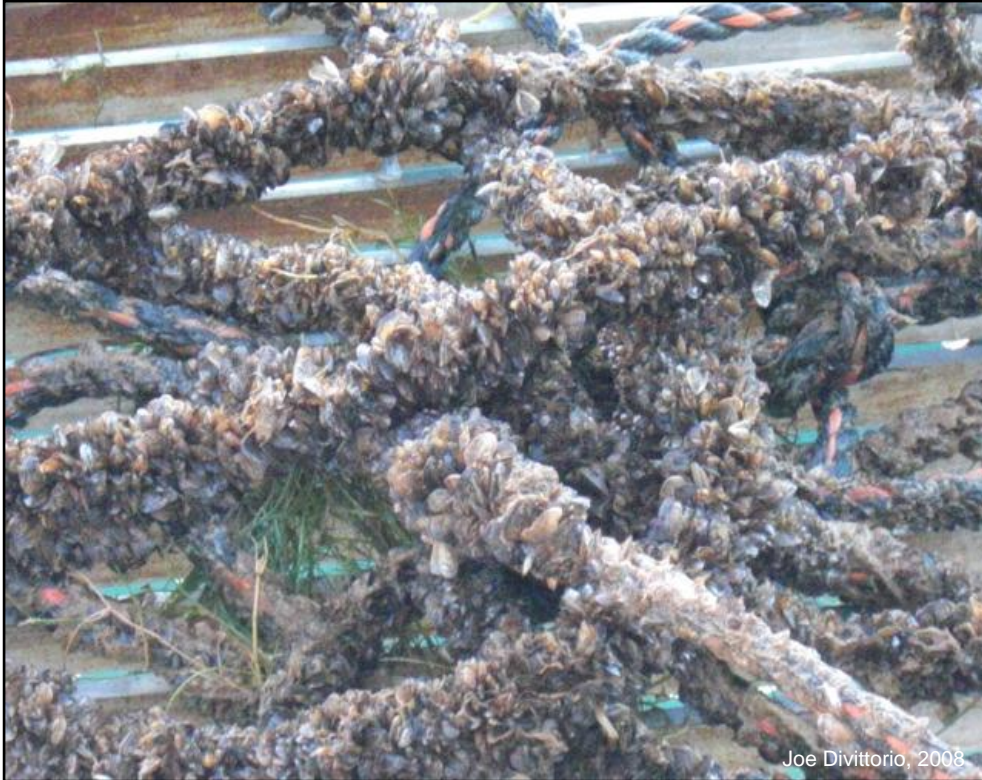
**Figure A-7. Adult quagga mussels can be seen covering a rope used in the Lower Colorado River. More than likely, this rope also has unseen juvenile life stage mussels as well (photo courtesy of Joe DiVittorio, 2008).**

identified. Since the juvenile is microscopic and cannot be seen without laboratory equipment, do not rely on visual inspection alone. Juvenile mussels can attach to a surface when they are “as small as a sesame seed”; therefore, they are detectable only by feeling by hand along all surfaces and inside holes and crevices. On a smooth surface, juvenile mussels will feel gritty, like sandpaper. As the juvenile ages and grows, it may become visible to the unaided eye, appearing as a nondescript speck. Equipment that has been in water for a long period of time can become infested with adult mussels (figure A-7).

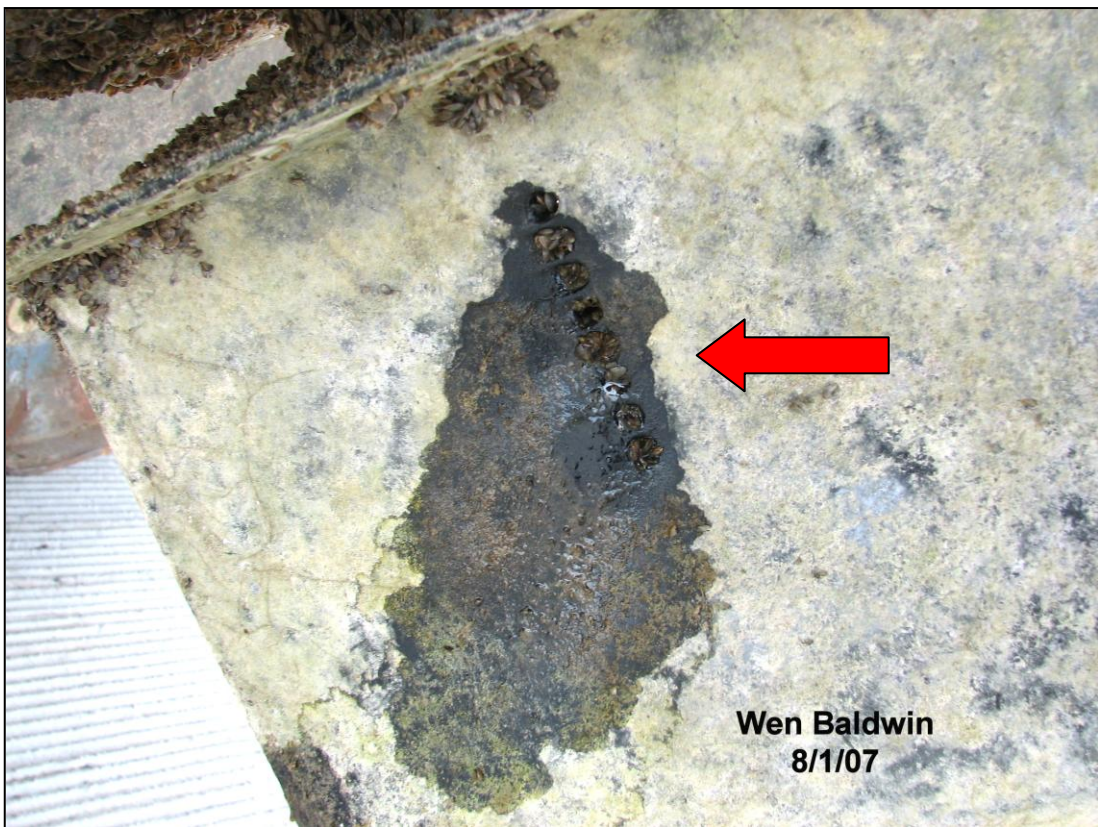
**Figure A-8. Closeup view of outboard motor shaft housing. Adult quagga mussels living inside the engine and plugging the water intake ports of this outboard motor.**

If the watercraft engine is not a closed cooling system configuration (if the engine intakes its cooling water from the environment), the following applies. Although it may seem counterintuitive, it is possible for zebra and quagga mussels to live inside the cooling system of watercraft engines and become a source of contamination when it is operated in un-infested waters. Mussel veligers can enter the engine cooling system through the cooling water intake, become attached inside the system, and grow into the adult (reproductive) life stage mussels. The mussels can survive on the “cool” side of the cooling system—that portion of the cooling system beginning at the water intake ports flowing to the engine’s water jacket (heat exchanger)—for the long term in between uses (figures A-8 and A-9).

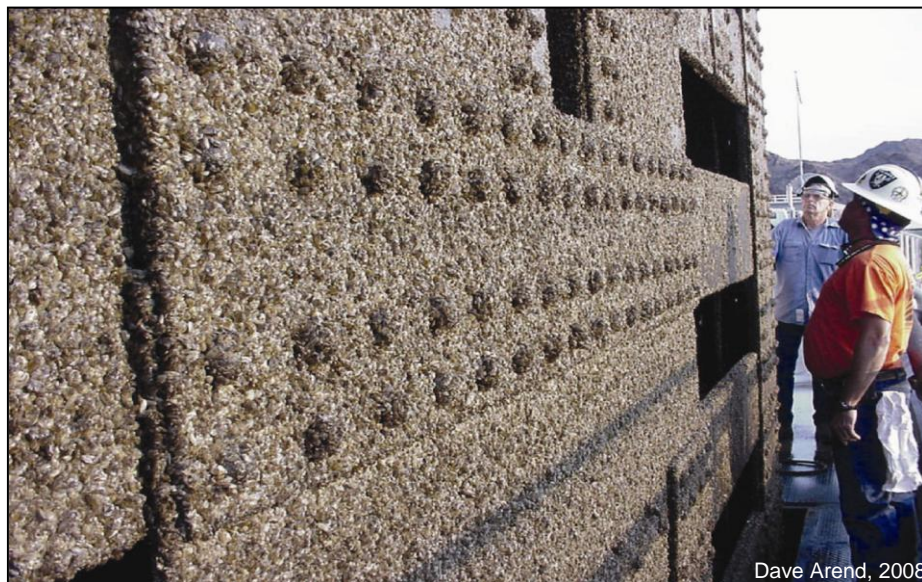
**Figure A-11. Mussels covering a penstock gate at Davis Dam (photo courtesy of Dave Arend, 2008).**

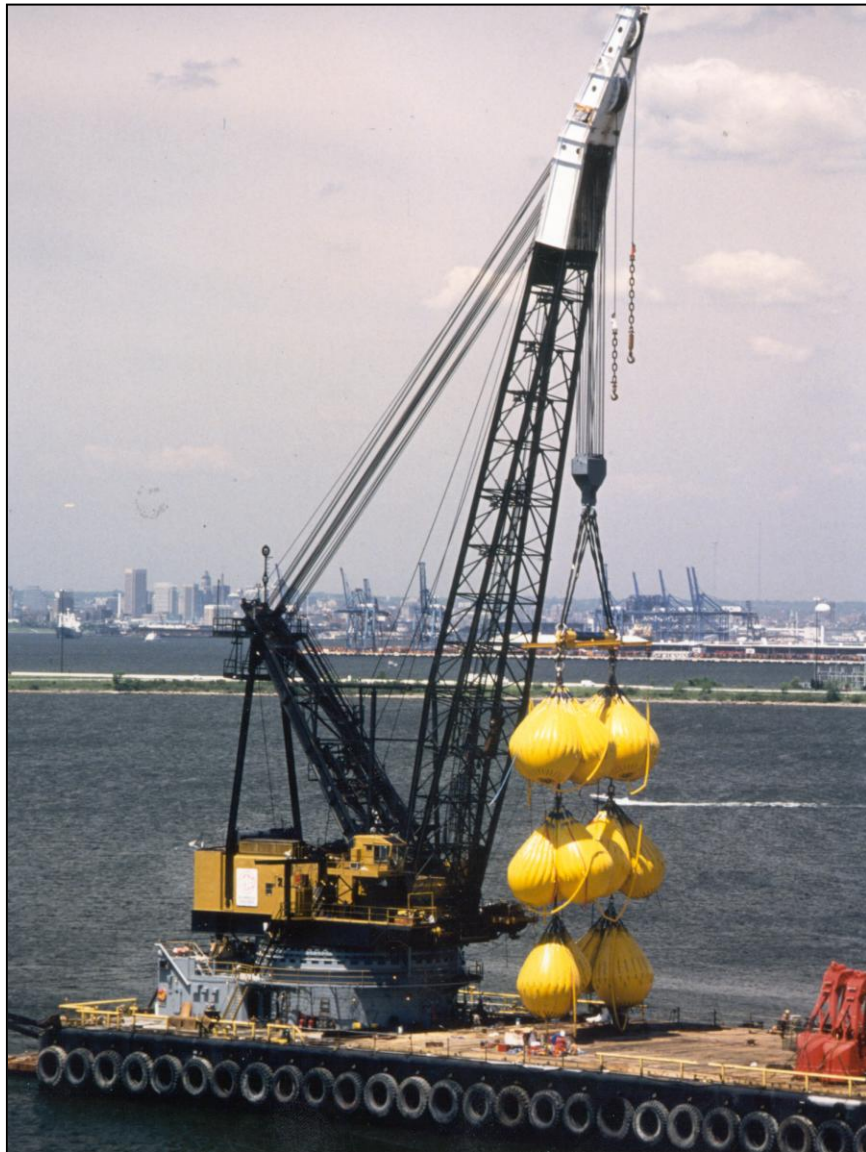
**Figure A-12. The 'Betty L' Barge Crane, Morrison Knudsen Company, during water weight bag™ testing, Baltimore, Maryland (photo courtesy of Jim Jota, Imes, Inc., 1994).**

Water bags used for crane testing generally cannot be easily inspected at the level required to find the mussel veliger life stage. Therefore, rather than inspecting it, if the water bag was filled with raw water during its prior use and was not decontaminated, assume it is contaminated. See appendix B for more information regarding water bag decontamination procedures. If the crane testing company can provide certification that the water bag was filled only with potable water at its last location, or was filled with raw water and properly decontaminated, the bag can be assumed to be free of contamination. However, if there is any doubt, insist upon decontamination of the water bag before allowing its use at the facility.

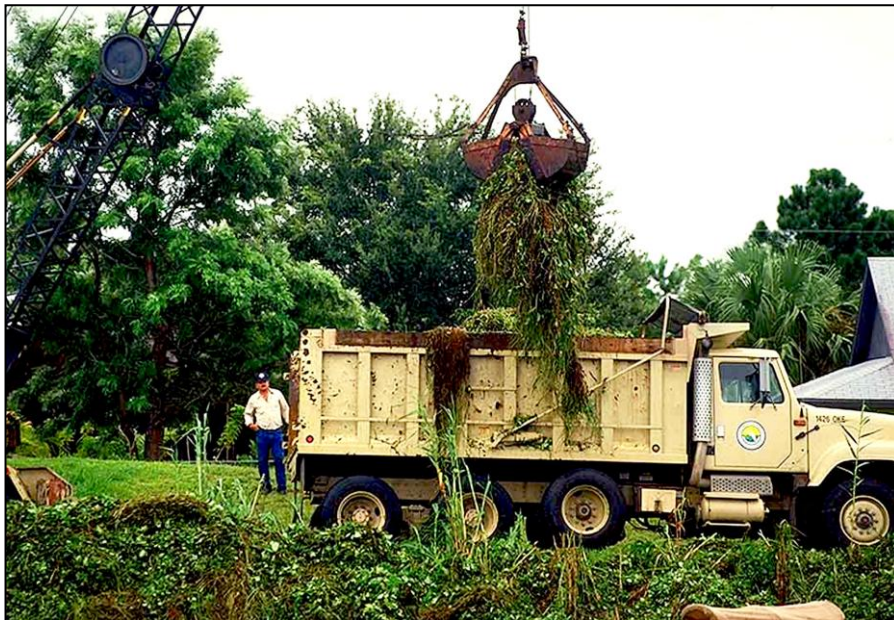
**Figure A-13. Equipment can become contaminated with pest and invasive species during field work. Contaminated equipment can spread these species to uninfested sites. Inspect and clean equipment before moving to a new work location.**

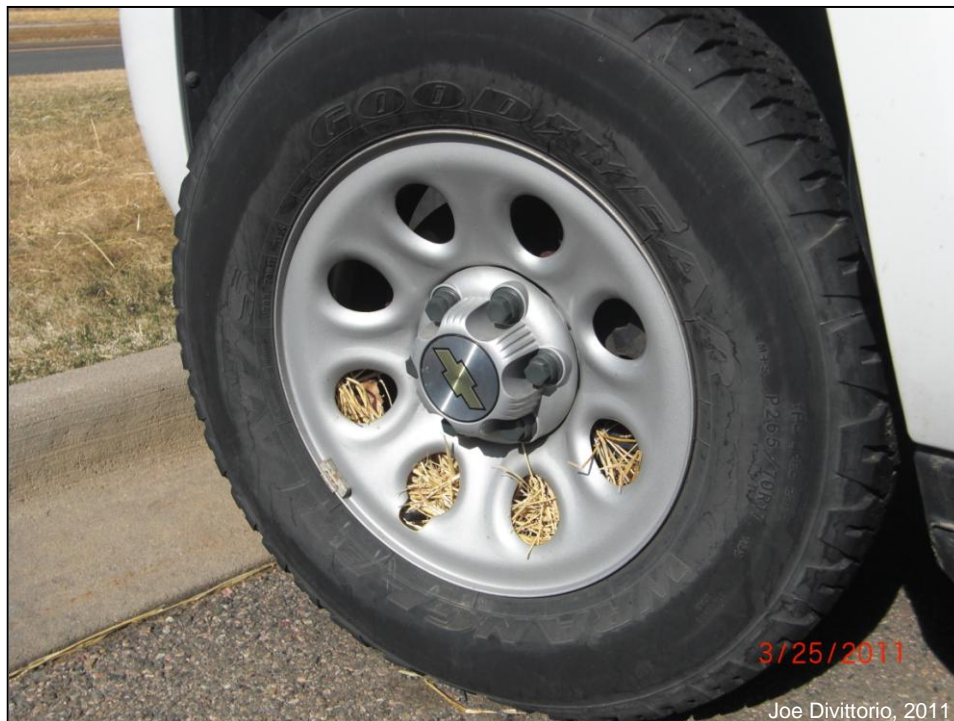
**Figure A-14.** A packrat nest constructed around the disk brake inside the front wheel of a vehicle. The major nest building material is straw, which was being used as a soil erosion control treatment at a nearby construction site (photo courtesy of Joe DiVittorio, 2011).

Particular attention must be given to places where foreign material could become accidentally trapped, such as in cracks and crevices, in undercarriages, and in the treads of tracks or tires (figure A-14). The following is a list of areas that warrant special attention and where plant material could most easily become lodged.

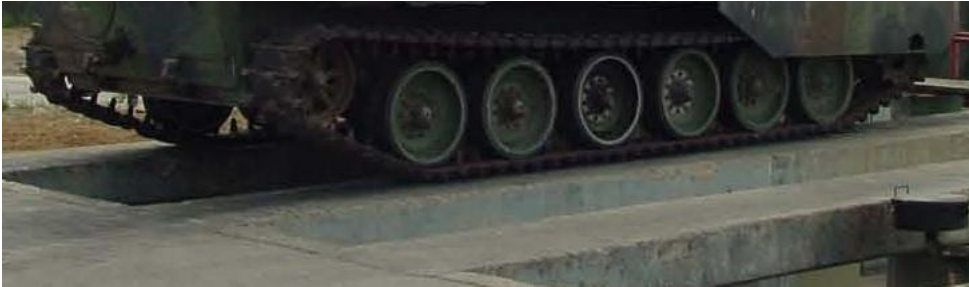
All tracked land vehicles share many common components such as tracks, rollers, idlers, tensioners, and sprockets.

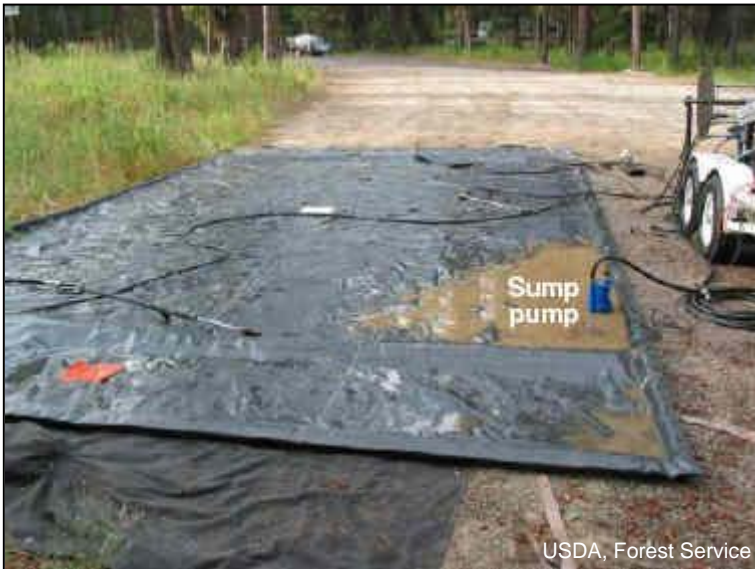
**Figure B-1.**  
**Bermed portable**  
**mat system**  
**with sump pump**  
**for water recycling**  
**(U.S. Department of**  
**Agriculture, Forest**  
**Service site).**

Water runoff carrying soil, seeds, animals, and petroleum contaminants must be managed with the use of berms or other containment (figures B-1 and B-2). Silt fence installed along perimeters of work areas can also aid in preventing spread of contaminated materials outside of the washdown location.

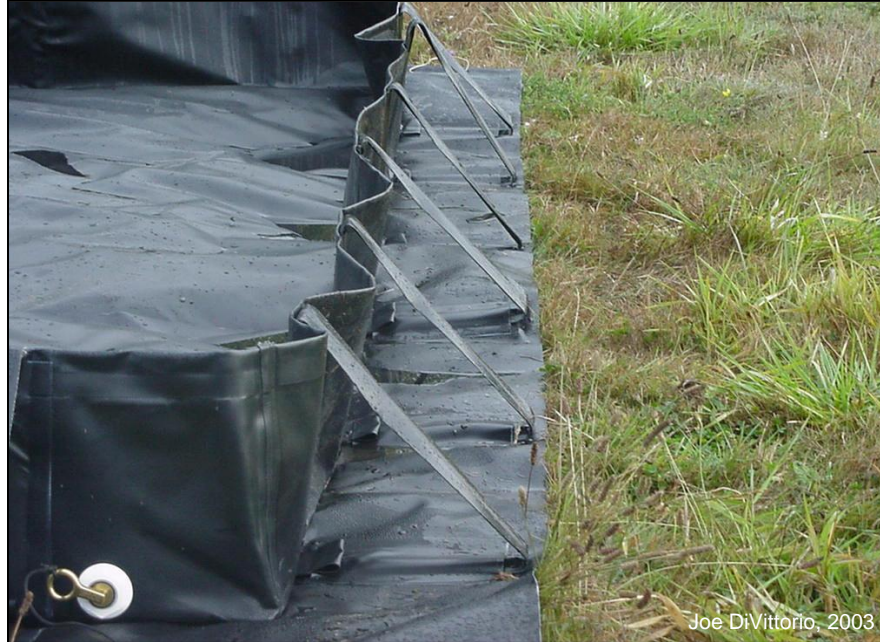
**High-wall portable berm with wall supports in place. High-wall berms might offer better overflow protection when conducting equipment washing. Remove the wall supports on one side to move equipment onto the berm. All wall supports can be removed, and the entire berm rolled up for easy moving and storage. Bung openings can be positioned to fit specific need when ordering from the company (Interstate Products, Inc.).**

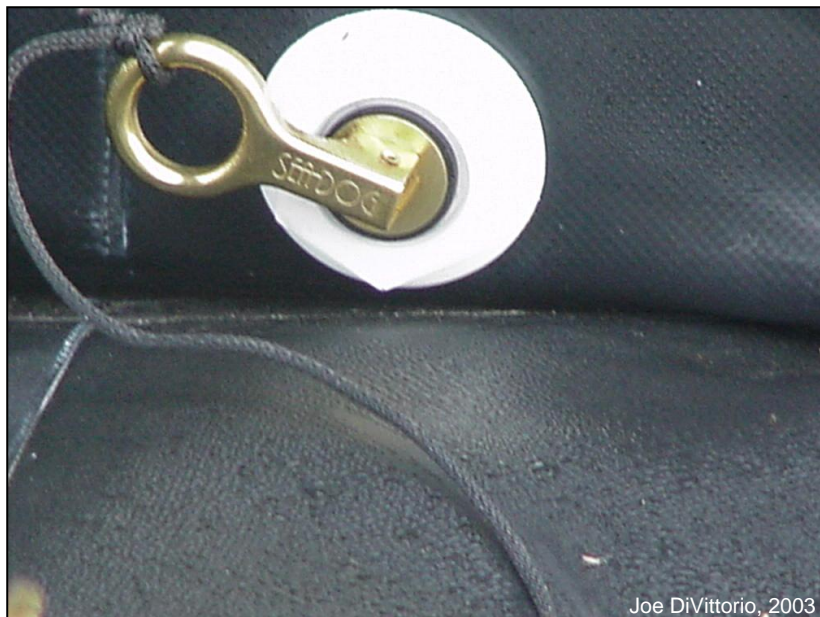
**Secured bungs are tied in place (Interstate Products, Inc.).**

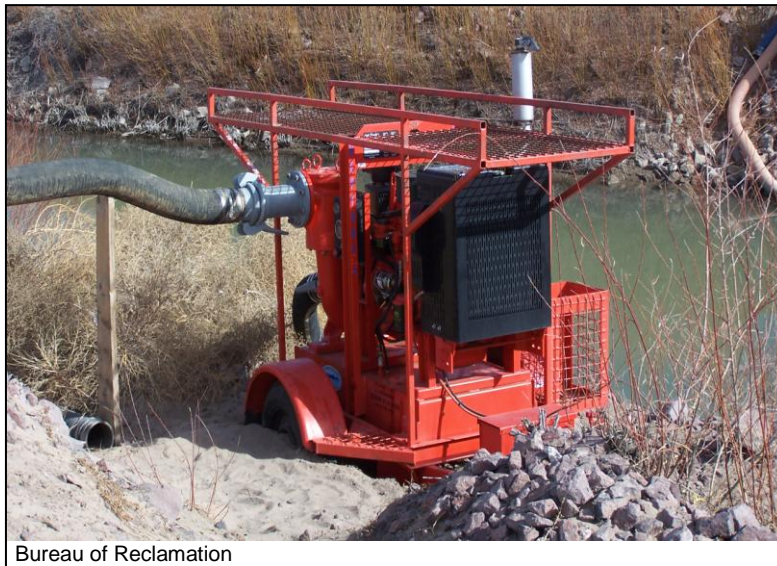
**Figure B-3. Water for vehicle cleaning was pumped from conveyance channel at Socorro, New Mexico field site (Bureau of Reclamation photo).**

Raw water, or even gray water, is sometimes used, but potential health issues may require precautions such as immunizations or specialized safety equipment for personnel (figure B-3). When pumping water from field sources, unintentional movement of exotic plants, problematic algae, or other invasive aquatic species must be addressed. Proper placement of pumps away from aquatic or shoreline vegetation that is known to be invasive is a prudent first step. Heating field source water to 140 °F is required to prevent invasive mussel spread while washing with field source water.
