Technical Memorandum No. 86-68220-07-05

## Inspection and Cleaning Manual for Equipment and Vehicles to Prevent the Spread of Invasive Species

2012 Edition

June 2012

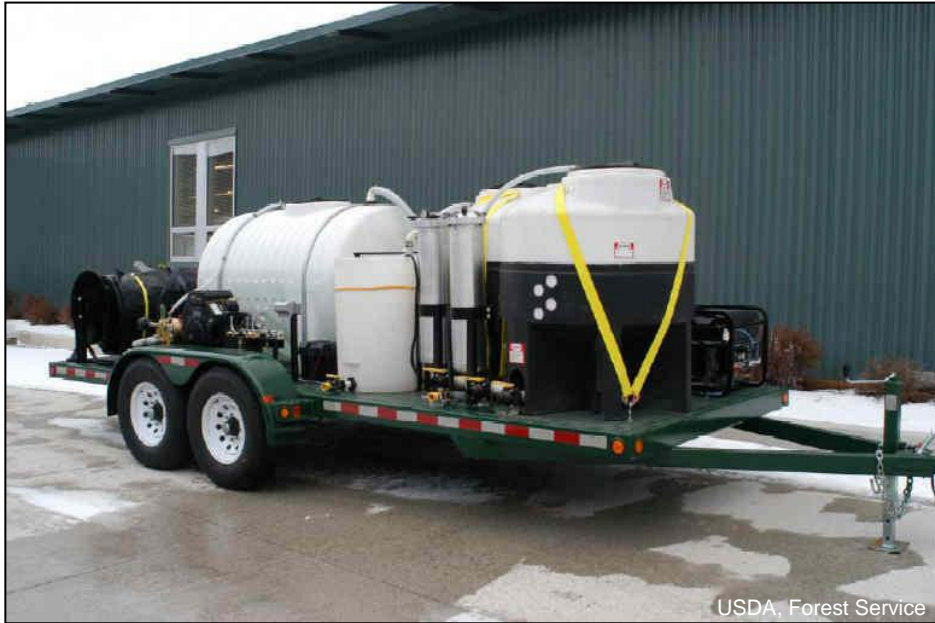
**Figure B-4. Trailer-mounted washing system field tested by Forest Service for cleaning land use vehicles and other equipment (U.S. Department of Agriculture, Forest Service photo).**

The Forest Service has also built and field tested a portable vehicle washer mounted on a flatbed trailer (figure B-4). That system includes two high-pressure wands to wash sides of vehicles, an underbody high-pressure nozzle system, portable rubber mat system with side berms, settling tanks, and filtration system coupled with a 550-gallon holding tank, powered by a 5,000-watt gasoline generator. This portable system can wash at 800 psi, using 20 gallons of water per minute. Field tests demonstrated the ability to wash standard vehicles in 2 to 3 minutes. Further details about this portable vehicle washer can be found in *MTDC Portable Vehicle Washer* (U.S. Department of Agriculture, 2004).

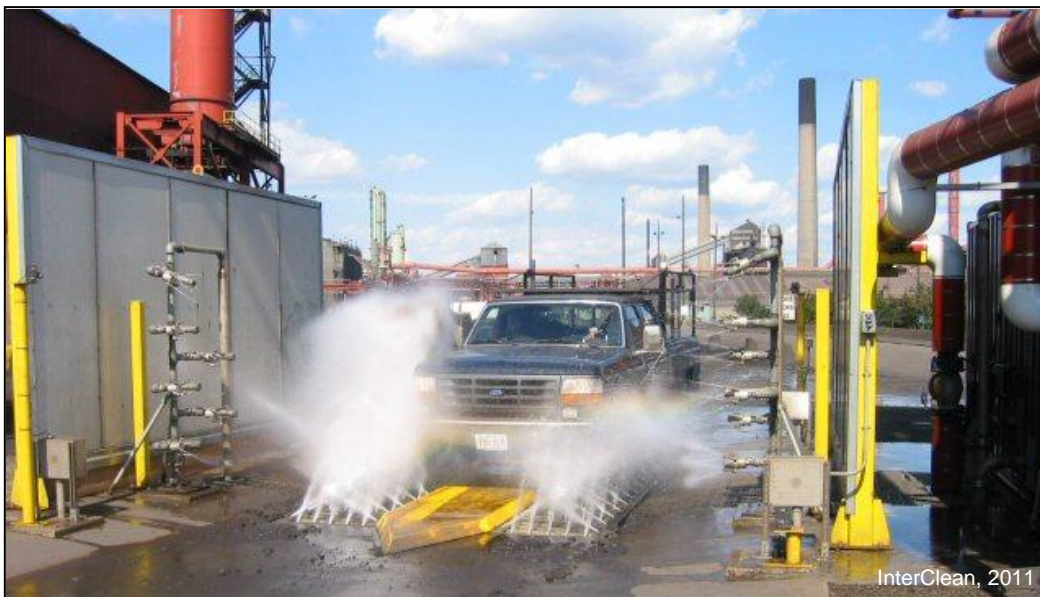
**Figure B-5. InterClean Equipment's heavy duty washing system (InterClean, 2011).**

InterClean Equipment offers several commercially available systems to wash and decontaminate vehicles and heavy equipment (figure B-5). The portable tire wash, “Red Wolf PT-15,” can be installed at remote sites. Ground excavation, water supply, and 70-kilowatt-hour (460-volt) electrical service are required for this installation. Their HT series system includes chassis washing. More information on InterClean’s vehicle washing and decontaminating systems is provided on their Web site: <http://www.interclean.com/Default.htm> (InterClean, 2011).

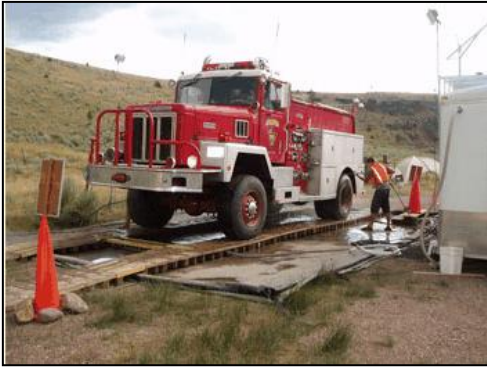
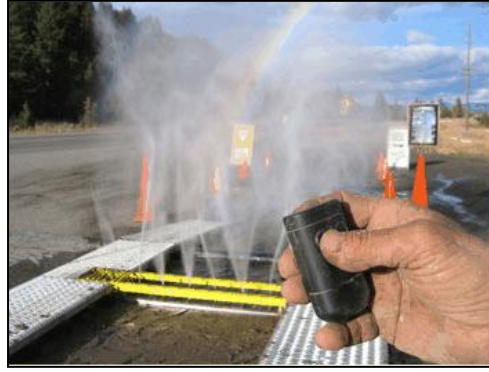
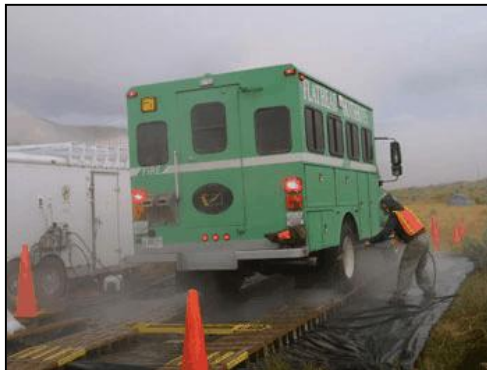
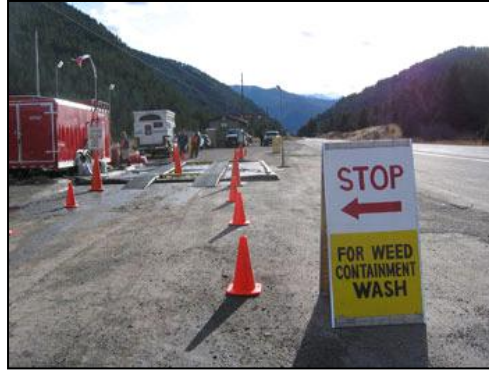
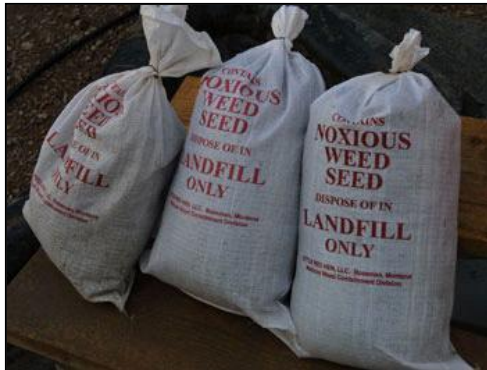
Figure B-6. Little Red Hen, LLC, Bozeman, Montana vehicle washing service. Filtered mud and debris are compacted and packaged for landfill.

Little Red Hen, LLC, is based in Bozeman, Montana, offers onsite services for vehicle and equipment washing (figure B-6), and has worked with the Forest Service on equipment cleaning projects. Further details about Little Red Hen, LLC, services are provided on their Web site: <http://www.rrmobileservices.com/janda/inner.php?PageID=23> (Little Red Hen, 2011).

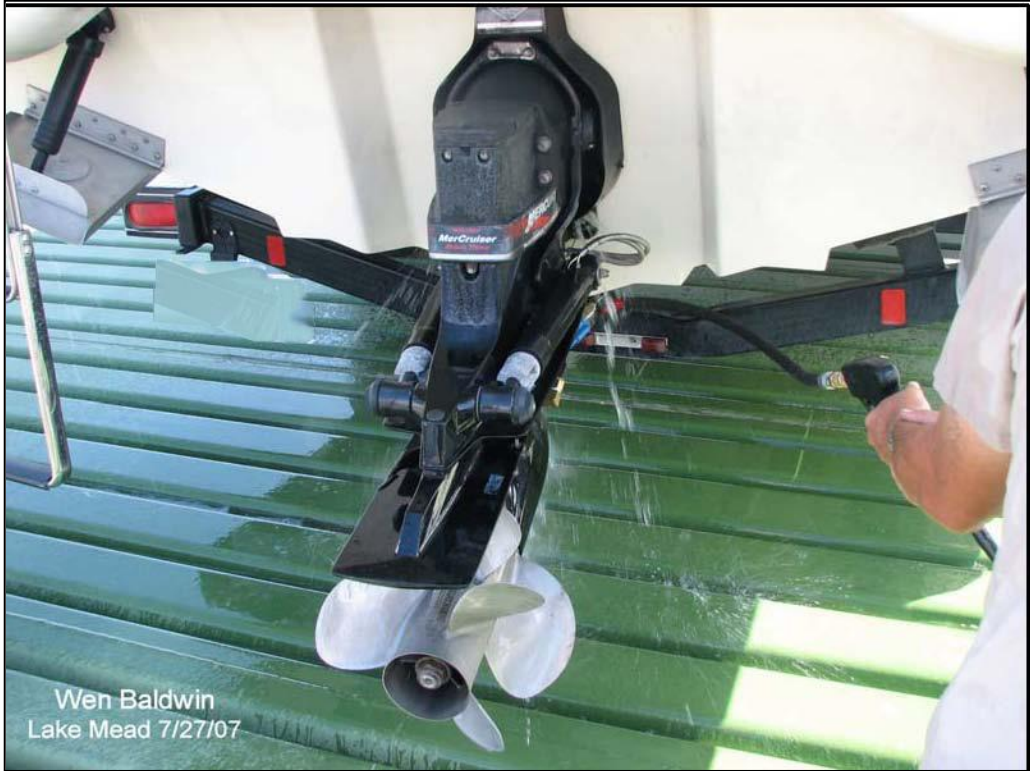
**Figure B-7. Inboard/outboard engine flushing (photo courtesy of Wen Baldwin, 2007).**

**Inboard Engine.** All surfaces of the propeller, driveshaft, driveshaft bearing supports, rudder, and driveshaft bearings must be cleaned to remove any clinging foreign material by washing with hot, high-pressure water. Then, visually inspect, feel by hand, and remove any remaining foreign material. Finally, decontaminate the engine cooling system by using the appropriate flushing attachment. Operate the engine according to the “Engine Decontamination Instructions” below.

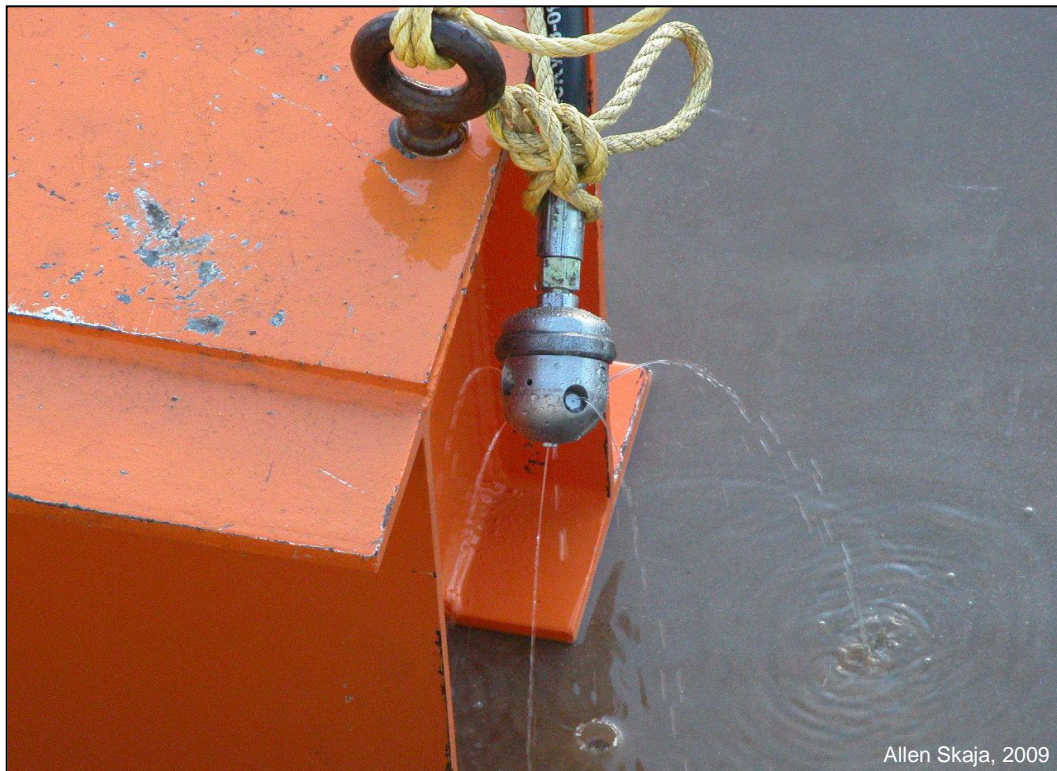
**Figure B-8. Water jetting spin nozzle for cleaning out small diameter pipe infested with quagga mussels (photo courtesy of Allen Skaja, 2009).**

As discussed previously, special attention must be given to inspecting and cleaning construction and facility equipment. Decontaminate construction and facility equipment using much the same approach for watercraft cleaning where a hot water, high-pressure cleaning method is indicated. For cleaning encrusted mussels from the interior of pipes, water jetting systems using high pressure attachments, such as a water jetting spin nozzle can be used (figure B-8). Depending on the equipment item, desiccation or freezing may be the preferred decontamination method. Abrasive sand blasting may also be an appropriate cleaning measure, depending on the particular equipment item, or the coating properties of the item. If desiccation is used, proceed according to the drying time calculated by the 100th Meridian Quarantine Estimator for Zebra-Mussel Contaminated Boats drying schedule located at the following Web site: <http://www.100thmeridian.org/Emersion.asp> (100th Meridian Initiative, 2011).

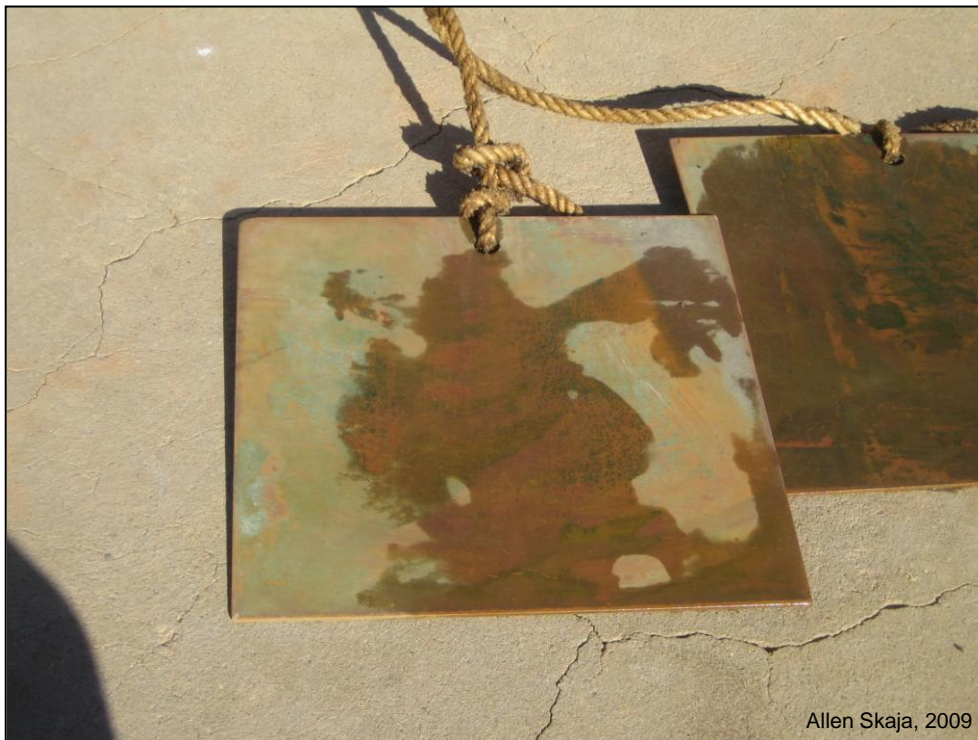
**Figure B-9.** This copper plate has been submerged for 18 months in Lake Havasu, notice there are no mussels on the rope or on the plate (photo courtesy of Allen Skaja, 2009).

*Metals.* Copper and many copper alloys prevent the attachment of mussels due to the toxicity of available copper ions to the mussels (figures B-9 through B-11). In general, as the copper content of an alloy increases, corrosion resistance decreases; and, as the copper content decreases, the effectiveness to repel mussels also decreases due to the lack of copper ions at the metal's surface, as shown by the 90-10 copper-nickel alloy in figure B-12. The gradation of copper ion availability in metals, and their ability to resist mussel infestation, is dramatically illustrated in figures B-9 through B-12. The test panel in figure B-9 has the greatest available copper ions; while figure B-12 has the least. In particular, note that in figures B-9 and B-10, even the ropes attached to the test panels are free of mussels, due to copper ions in solution in the surrounding water. In addition to the corrosion concerns, copper or copper alloy in-water facility components have the tendency to contribute available copper to fresh-water systems that may cause concerns for elevated copper levels. Zinc has also been shown to prevent the attachment of mussels in soft water (U.S. Army Corps of Engineers, 1994), but has been proven ineffective in hard water on the Colorado River (Bureau of Reclamation, 2009). Hard water has a high carbonate concentration which reacts with the zinc ions to form a precipitate zinc carbonate. Thus, the carbonate consumes the zinc ions before they can repel mussel attachment.

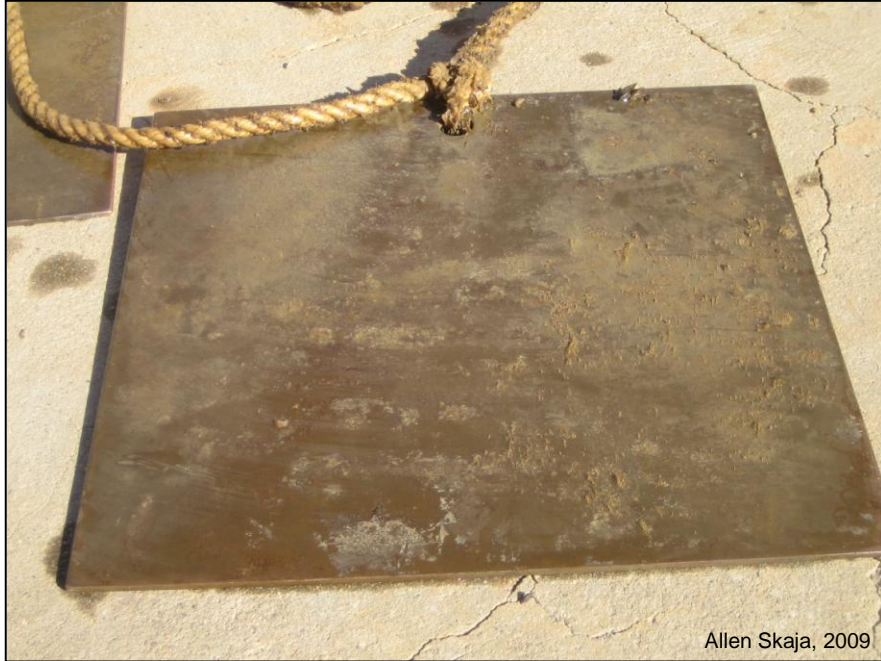
**Figure B-10.** This brass plate has been submerged for 18 months in Lake Havasu; notice there are no mussels on the rope or on the plate (photo courtesy of Allen Skaja, 2009).

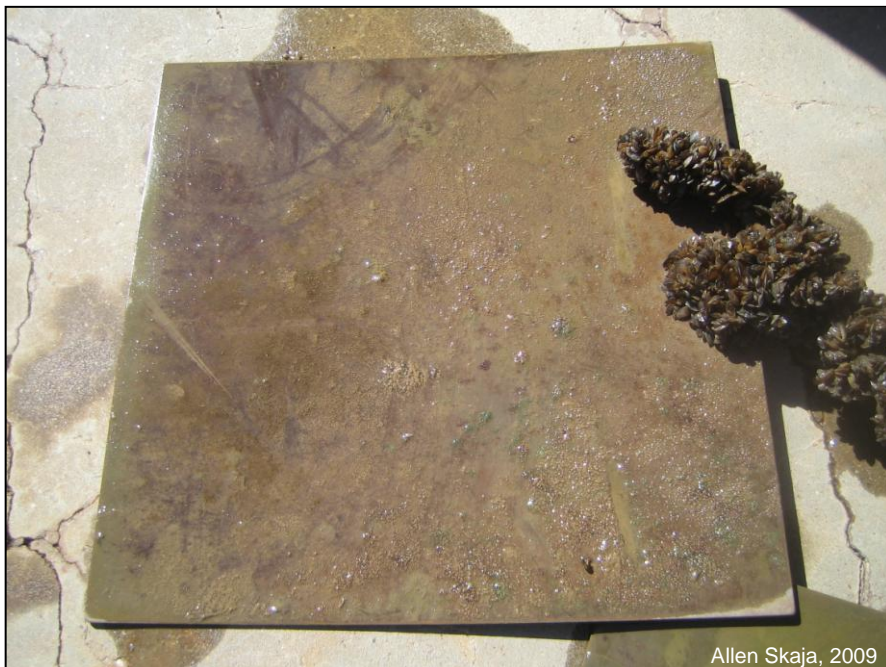
**Figure B-11.** This bronze plate has been submerged for 18 months in Lake Havasu; notice the rope has mussels attached while the plate is mussel free (photo courtesy of Allen Skaja, 2009).

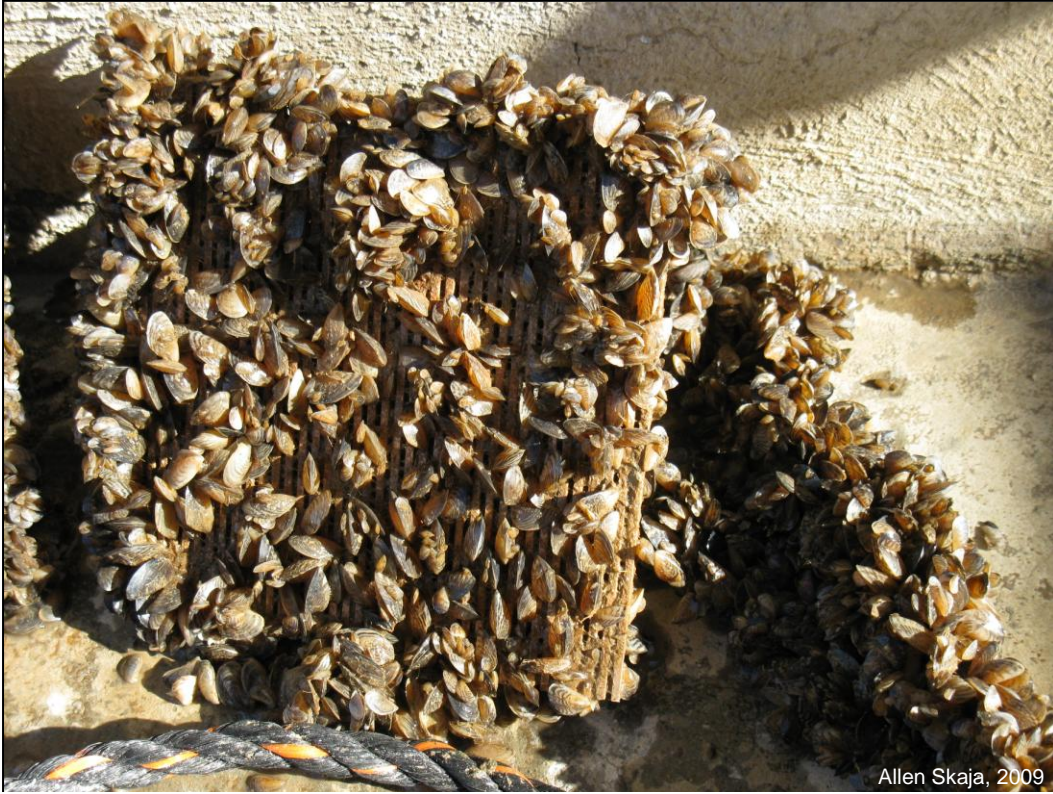
**Figure B-12. This 90-10 copper nickel fish screen has been exposed for 4 months; notice the amount of mussels attached to the surface (photo courtesy of Allen Skaja, 2009).**

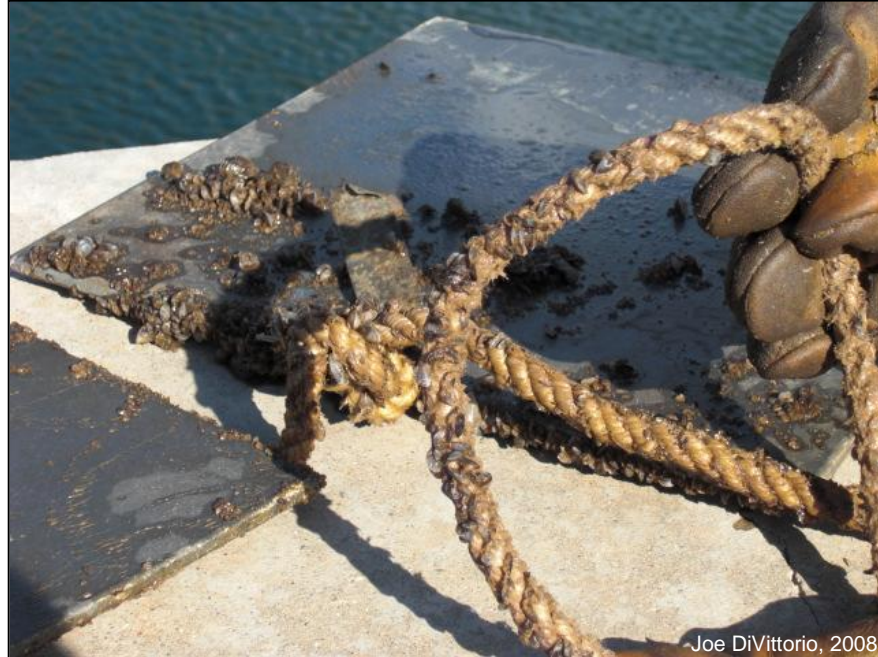
**Figure B-13.** Antifouling coating test panel has been in the Lower Colorado River at Parker Dam for 4 months; notice the attached adult quagga mussels on the test panel and anchoring ropes (photo courtesy of Joe DiVittorio, 2008).

*Coatings.* There are two types of coatings that potentially resist mussel attachment, antifouling and foul release coatings (Hellio and Yebra, 2009). Antifouling coatings rely on the release of a biocide to keep the mussels from attaching (figure B-13). The most common antifouling paint contains copper, but there are some products available that have organic biocides. The service life of these coating systems depends upon flow rates, water chemistry, pH, temperature, and coating thickness. Foul release coatings rely on surface chemistry to form a slick surface to prevent the mussels to attach firmly to the coating (figure B-14). Foul release coatings are nontoxic. In static or low water flowing conditions the mussels will attach, however can easily be cleaned with a garden hose or low pressure waterjetting. In general, the foul release coatings are not as durable as the antifouling coatings and could be damaged by abrasion, gouging, or mechanical cleaning.

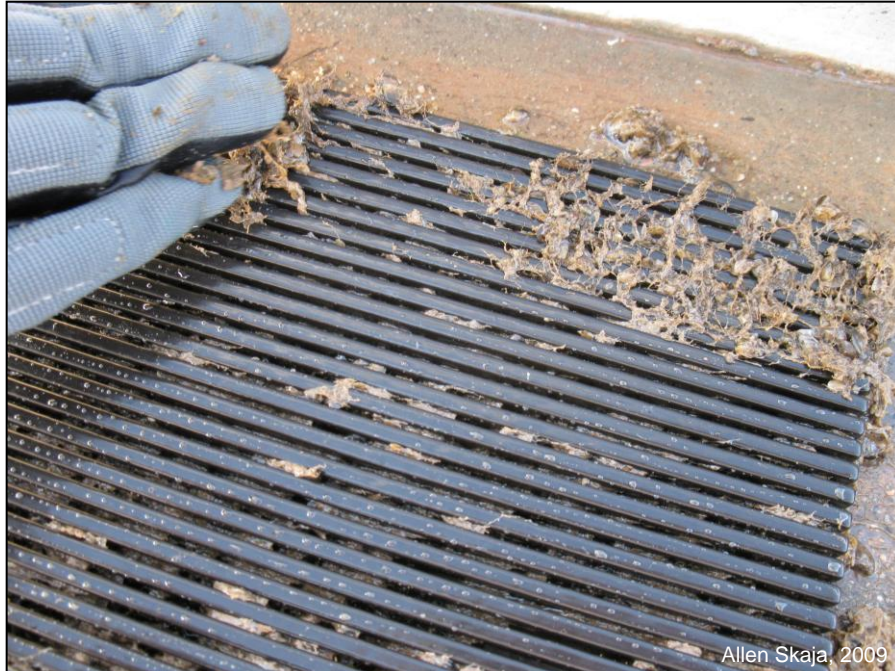
**Figure B-14.** This is an example of a foul release coating that has been in the water for 18 months. Mussels and algae growth may attach to the surface under certain flow rates; however, they are easily removed (photo courtesy of Allen Skaja, 2009).
