Appendices

Appendix 2
Detailed Natural Resource Management
Prescriptions

APPENDIX 3
Summary of projects recommended for implementation at NMCS D

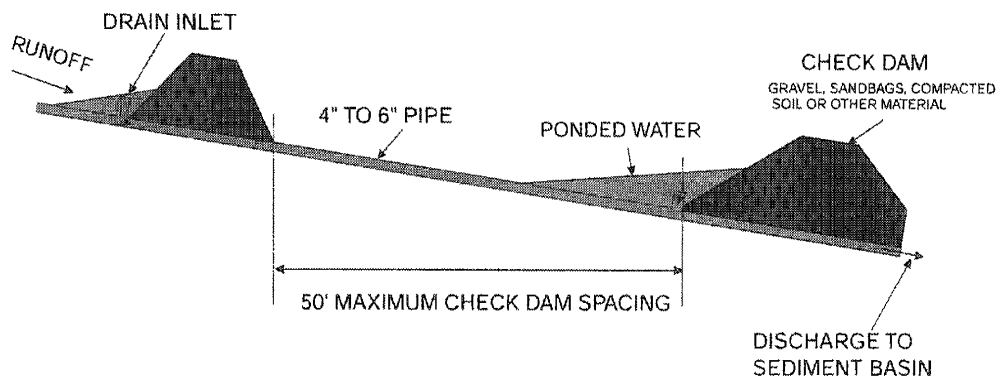
CHECK DAM

- ➡ Inspect check dams periodically before and after storm events to check for undermining.
- ➡ Repair failures by replacing loosed materials (rocks, gravel bags, etc.).

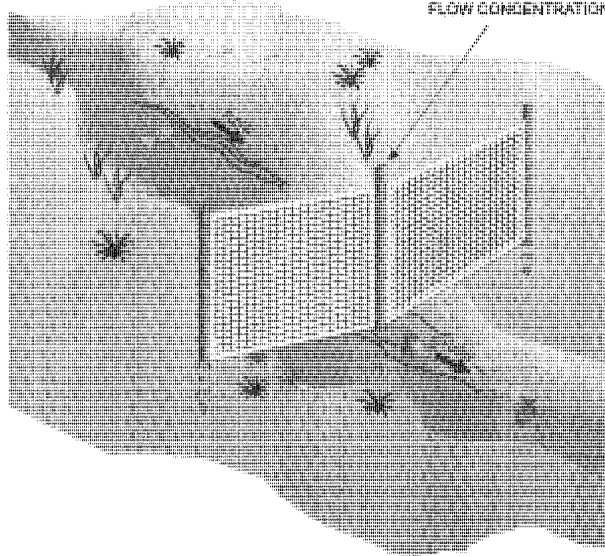
DO NOT PLACE SILT
FENCE OR STRAW
BALES ACROSS
STREAMS OR OTHER
FLOW CONCENTRATIONS

SILT FENCING PLACED ACROSS STREAMS OR OTHER FLOW CONCENTRATIONS IS INEFFECTIVE IN PONDING WATER AND LEADS TO UNDERCUTTING, GULLY FORMATION, AND FENCE FAILURE.

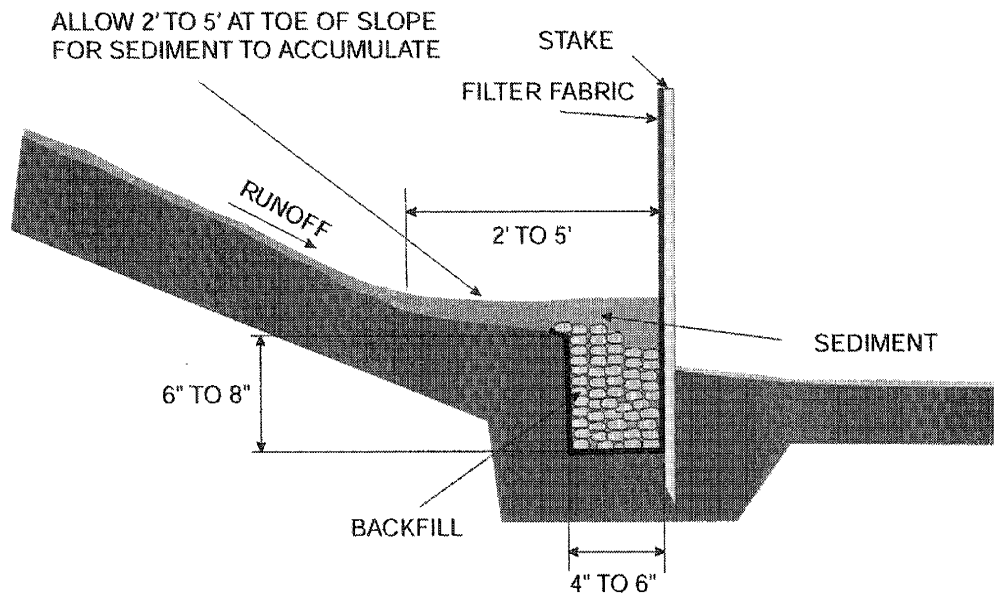
**RECOMMENDED INSTALLATION OF
SILT FENCE**

STRENGTHENING

ANCHORING

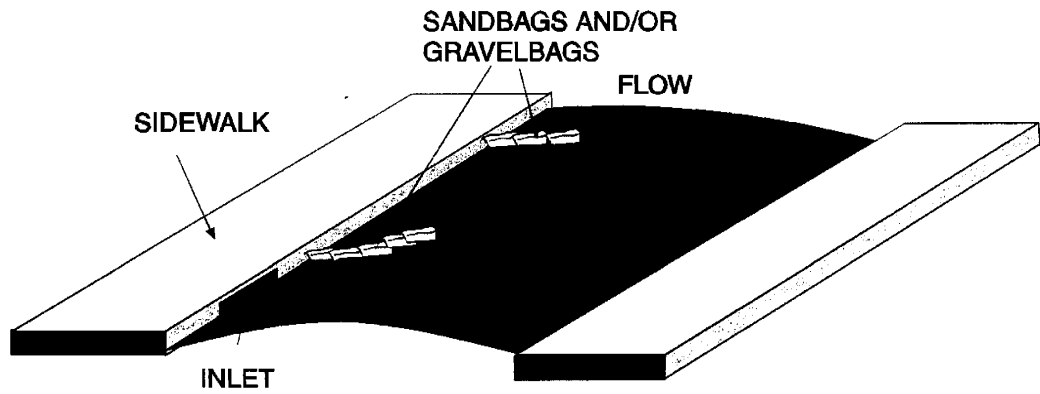
SAND OR GRAVEL BAGS (PREFERRED) USED IN ROADWAYS SERVE TO DIVERT FLOW, SLOW FLOW VELOCITY, AND POND AND FILTER RUNOFF.

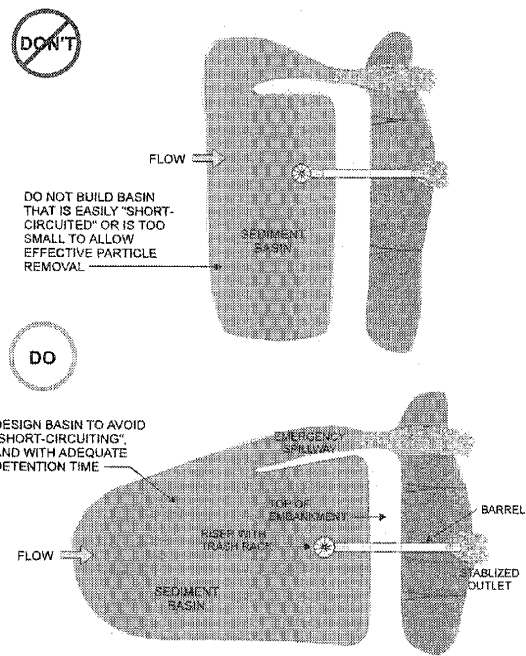
SEDIMENT BASIN SHOULD BE DESIGNED WITH LENGTH IN MIND TO PREVENT SHORT-CIRCUITING.

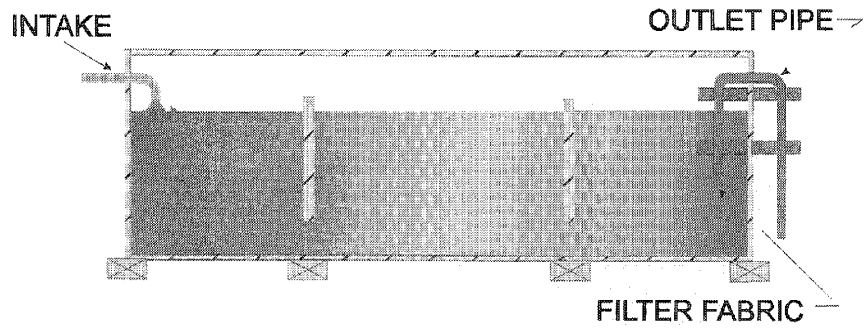
PORTABLE SEDIMENT TANK

- ⇒ The dewatering structure must be inspected frequently during operation and repaired or replaced once sediment build-up decreases the efficiency of the structure design.
- ⇒ When floating suction hoses are used, personnel should be assigned to monitor dewatering operations and effluent to ensure that sediment is not discharged into a stormdrain or into a water of the State (Goal 100 mg/I Total Suspended Solid).

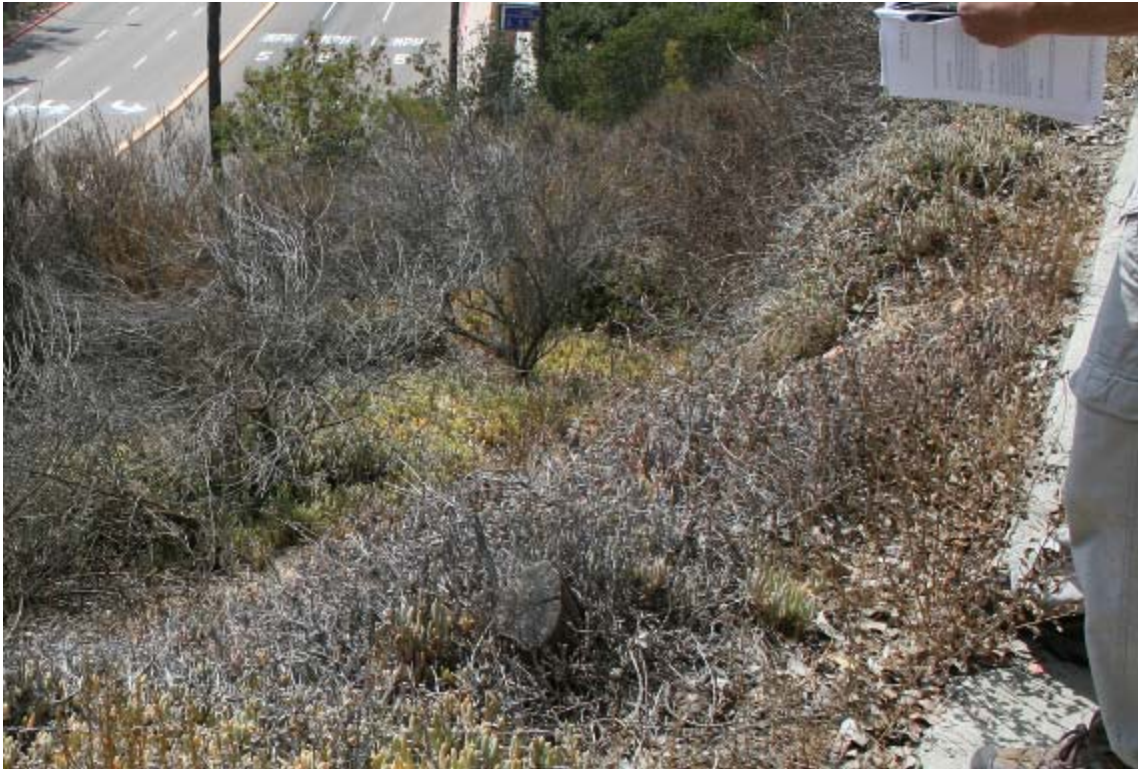
Figure 16. Site 9 - Crib Wall Restoration.

Other: This linear site is adjacent to some moderate quality CSS and restoration will remove a potential non-native seed source. Site must be re-vegetated with natives following non-native removal.

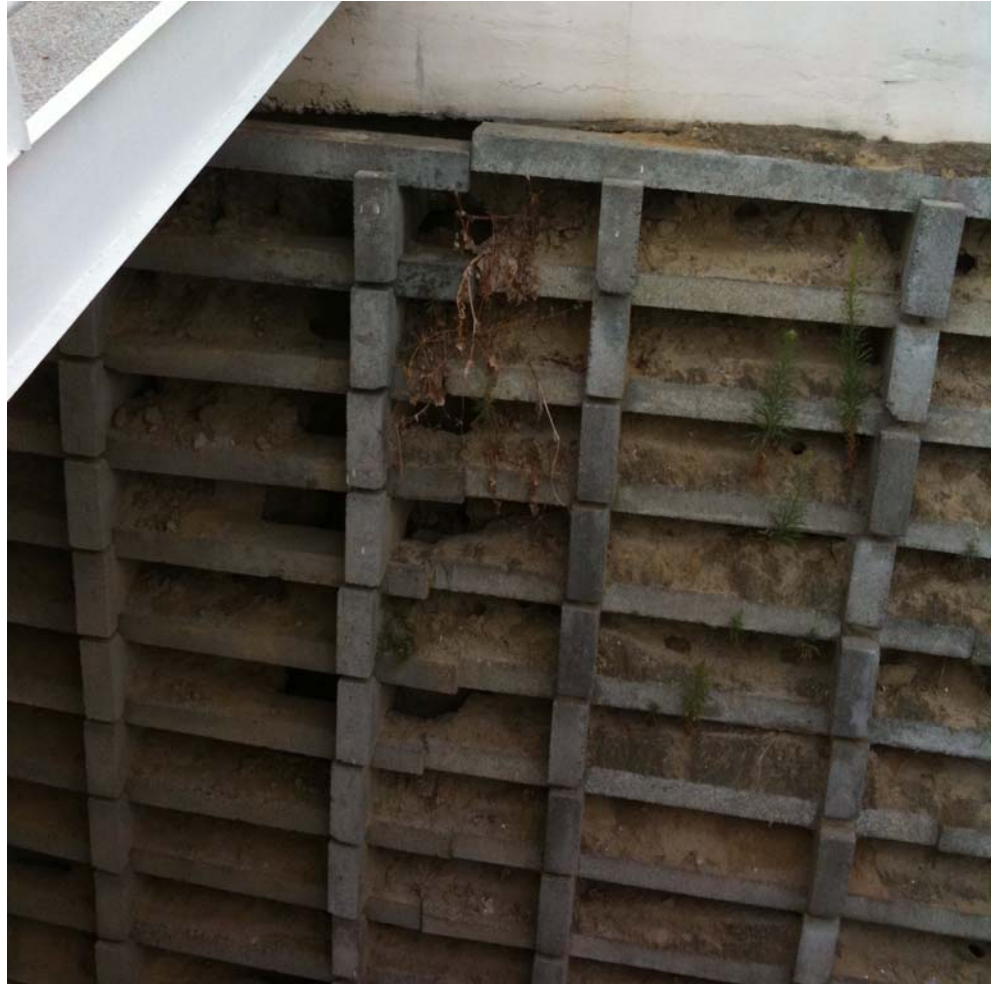
Runoff from walking paths near the helipad are causing the development of large earthen holes inside the crib wall. There is an imminent threat of continued erosion and potential failure of the crib wall if this is not addressed (Photo 3-2). Note that a concrete pathway (Photo 3-3) has settled, presumably due to the erosion of soil beneath it. Note runoff settling near a stair well at the edge of the parking lot (Photo 3-4).

Photo 3-2. Photo showing erosion within crib-wall.

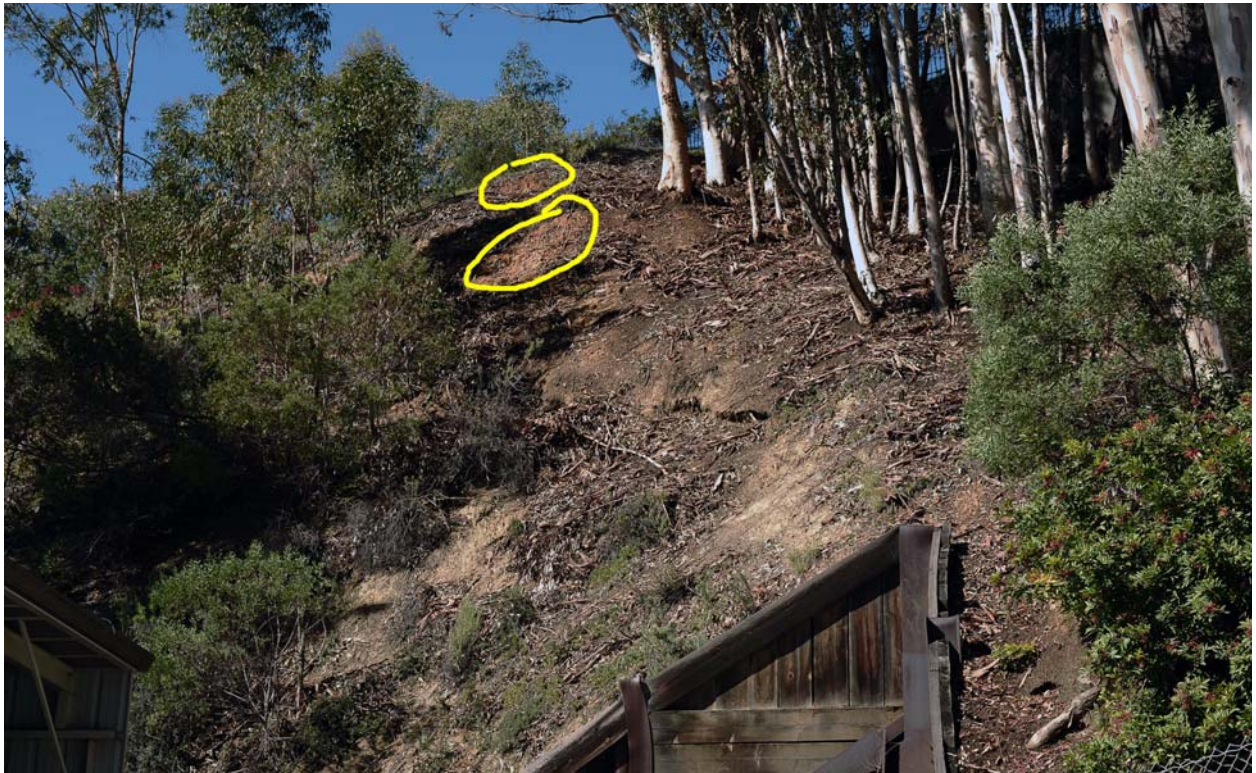
The threat of erosion at this site is rather low as it appears what little erosion has been occurring here has been a feature of this area for many years. Additionally, there are no high value structures (mostly storage sheds) beneath the slope that are threatened in the case of slope failure.

Photo 3-6. Two areas of exposed cobbly subsurface (encircled) above the transportation office, that are outside the cover of the eucalyptus stand.

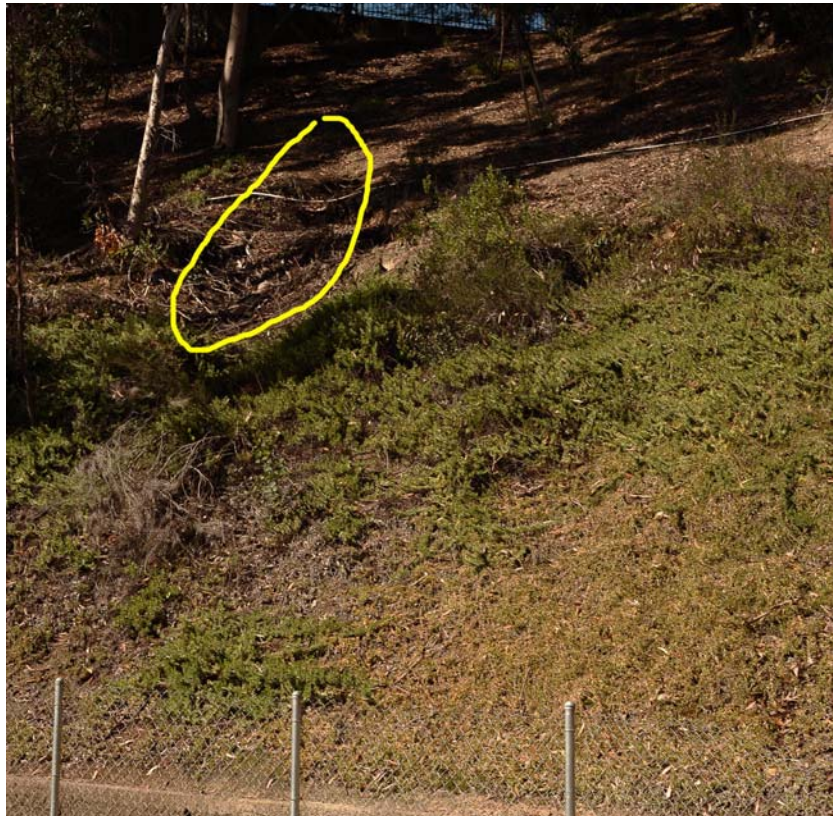
Photo 3-8. Large gully halfway upslope. Note broken PVC pipe (encircled) above and vegetation below.

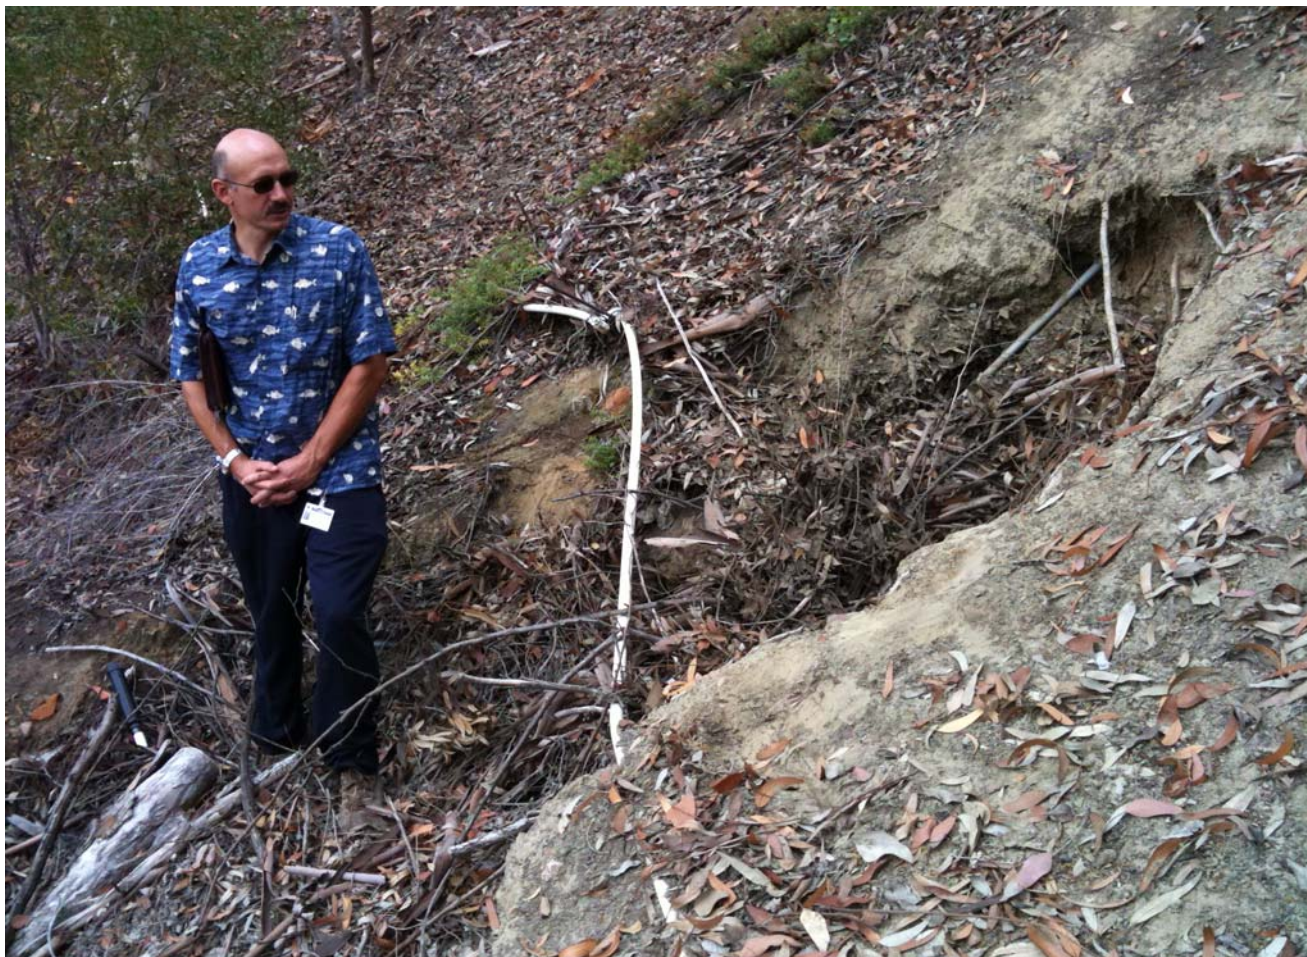
Photo 3-9. Large gully erosion filled with slash. Note irrigation system in disrepair.

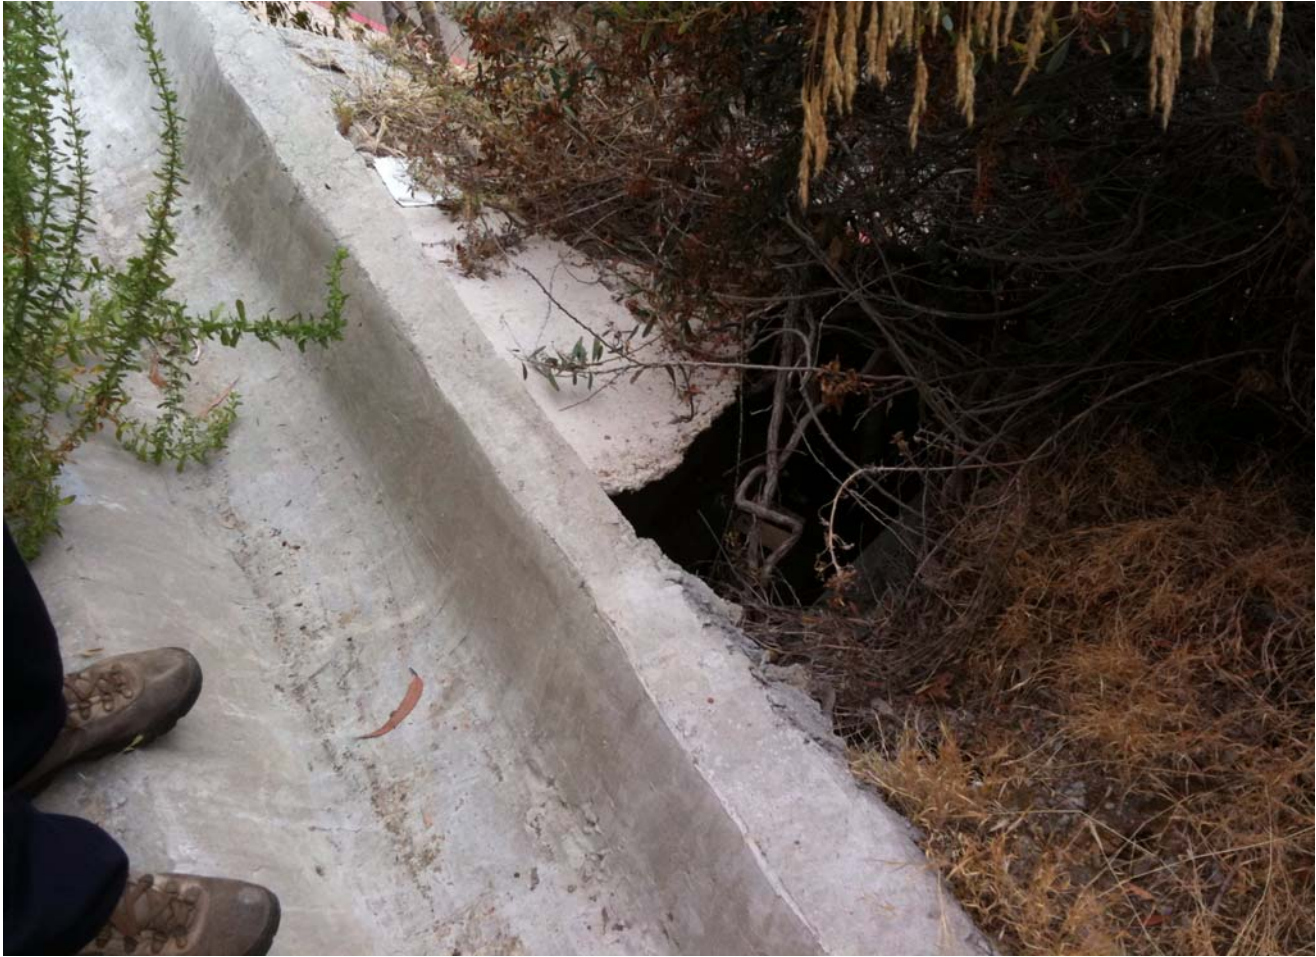
Photo 3-17. Point of entry of water, just outside the concrete drainage ditch.

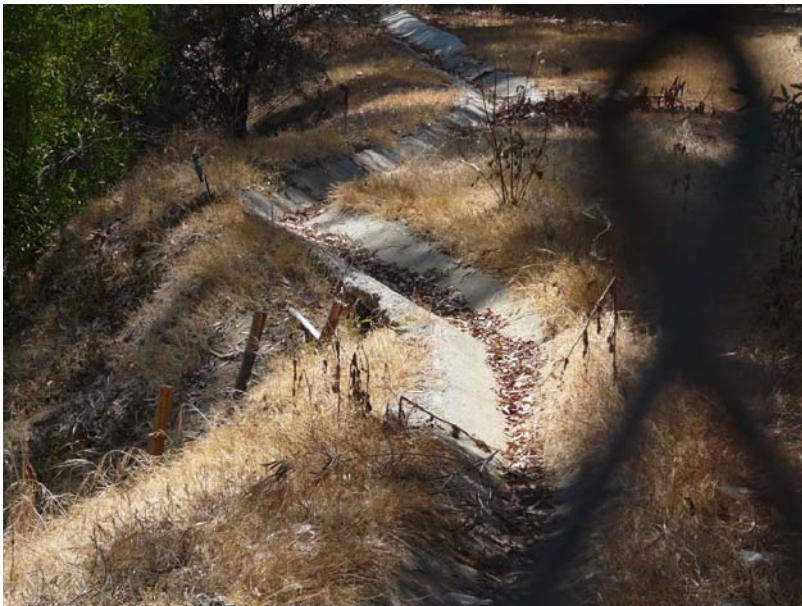
Photo 3-23. Brow ditch with soil eroding downslope.

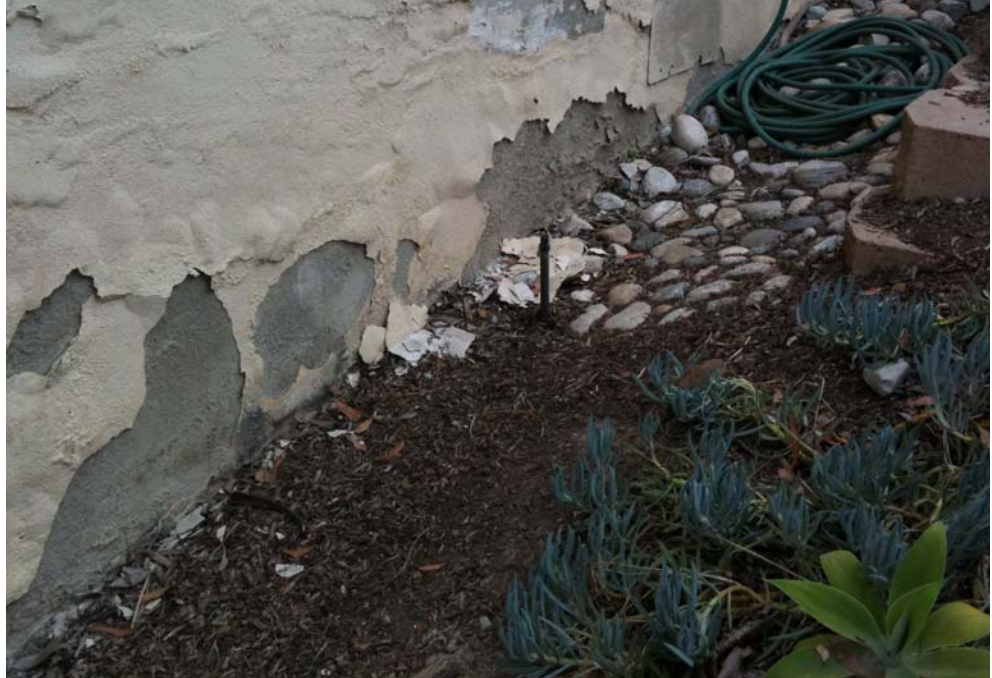
Photo 4-1. Ineffective sprinkler on the north side of the Fischer House directed to the wall (note premature wear on stucco) surrounded by drought tolerant ice plant.

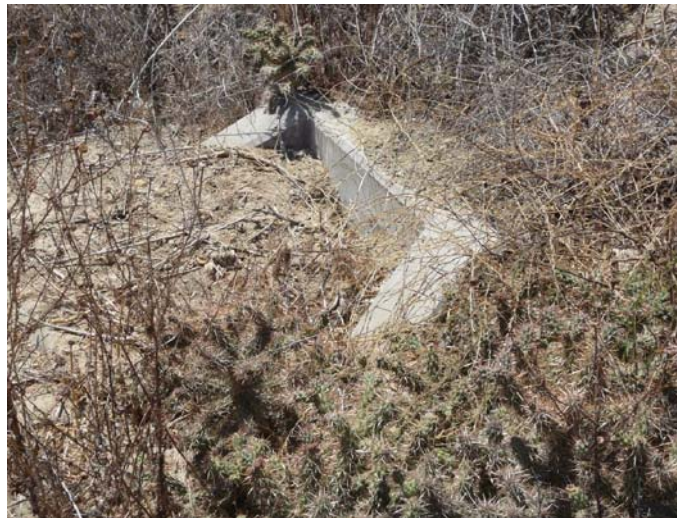
Photo 4-2. The City property to the north drains into Naval Medical Center San Diego property in several places. Some of these structures, like the one pictured above, is not well maintained and could result in future erosion problems.

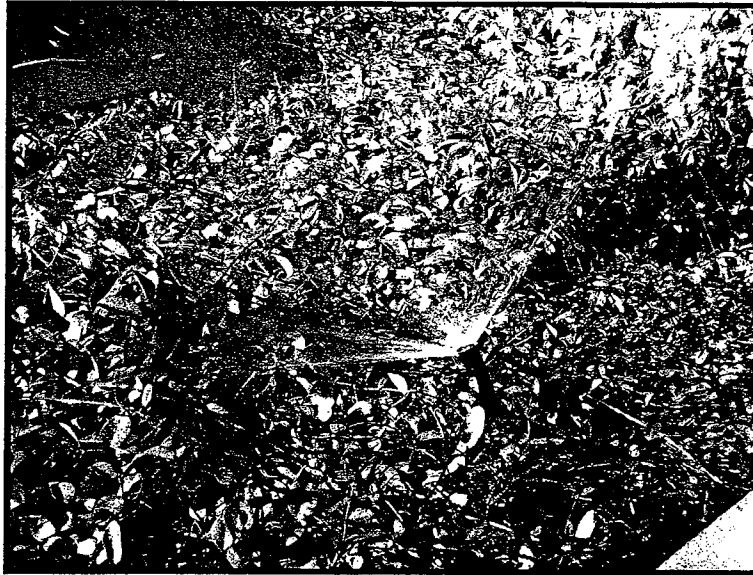
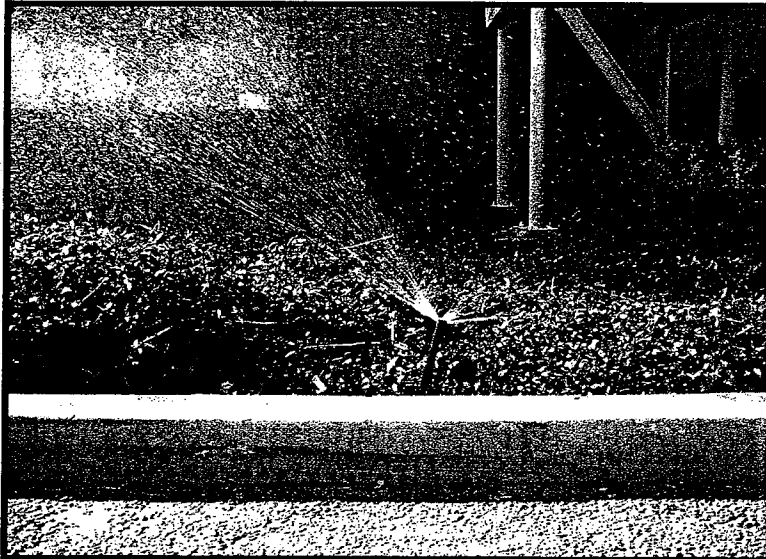
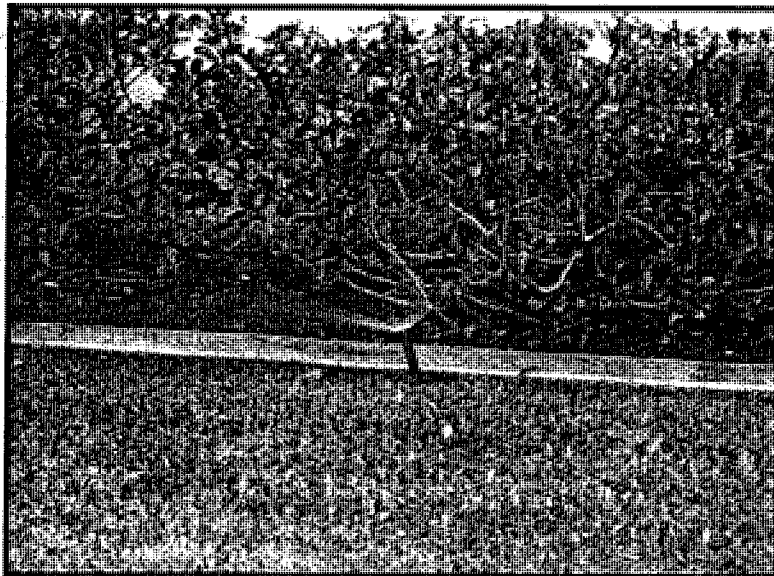
Heads blocked by plant material
