SUBJECT : Electric and Gas Clothes Dryers – Staff Evaluation and Contractor Report

CLOTHES DRYER PROJECT

FINAL REPORT ON ELECTRIC AND GAS CLOTHES DRYERS
February 2000

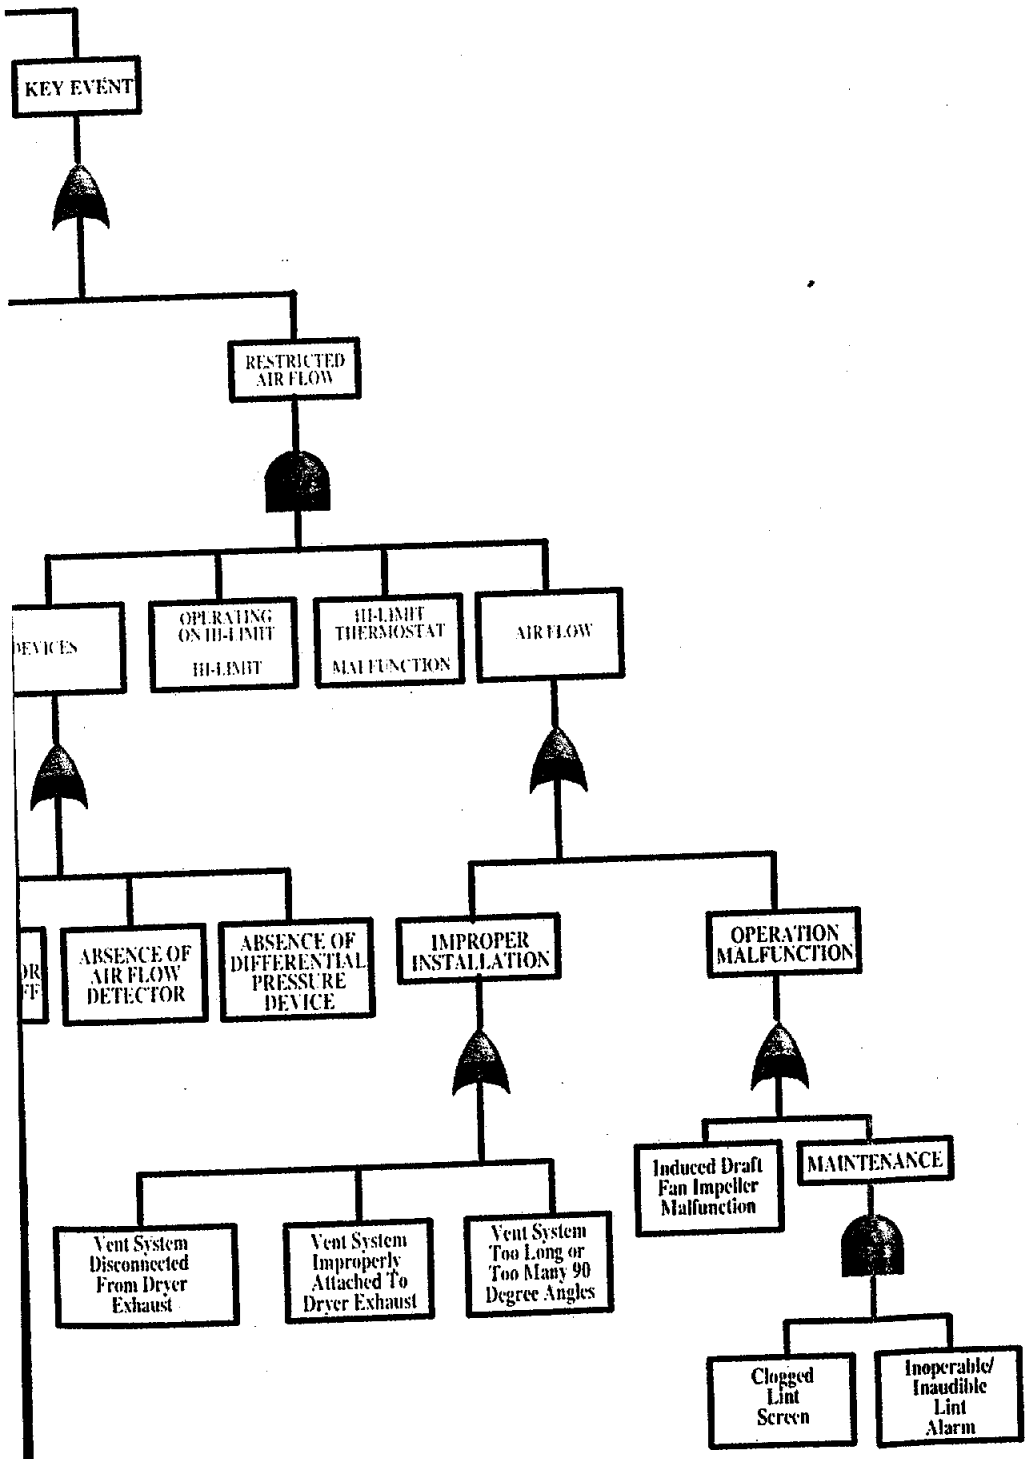
FTI CLOTHES DRYER FAULT

(Data from FTI's report: Engineering Analysis O)

TREE ANALYSIS

(Gas And Electric Clothes Dryer Fires)

Two fault trees were constructed, one utilizing the general failure mode data summarized from the 79 CPSC Epidemiologic Investigation Reports, Figure No. 7, and the other for the drum-drive motor and restricted airflow failure modes analysis conducted by FTI, Figure No. 8 (see *Appendix E*). The overall predictability of the fault tree analysis was hindered by the limited detail in the causation analysis and lack of empirical data.
