NUREG-2121

Fuel Fragmentation, Relocation, and Dispersal During the Loss-of-Coolant Accident

Office of Nuclear Regulatory Research

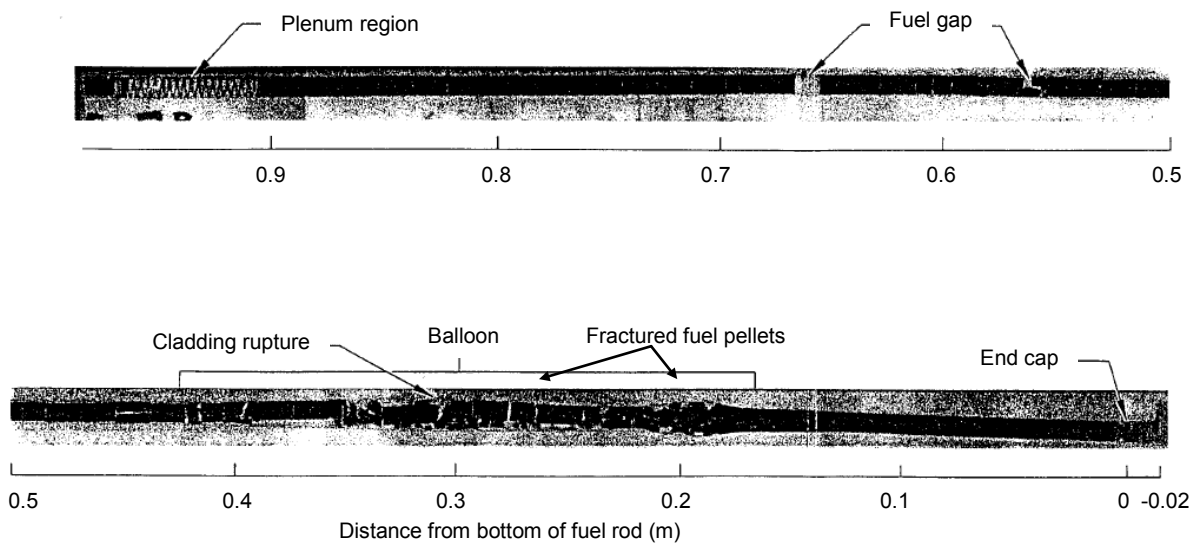
Figure 4-4 Neutron radiograph of test LOC-5, rod 7B, showing axial fuel relocation in a rod with limited fuel fragmentation (pellet fragments were relatively large, but relocation was nonetheless observed) (Ref. 17)

Figure 4-4 and Figure 4-5 are neutron radiographs of LOC-5, rod 7B (fresh fuel), and LOC-6, rod 12 (10.8 GWd/MTU), respectively. It can be seen that both tests resulted in rod ballooning and fuel relocation. The fuel relocation was more pronounced in LOC-6, rod 12, which had a higher burnup and consequently underwent more significant fuel fragmentation. The additional fragmentation in LOC-6, rod 12, compared to LOC-5, rod 7B, combined with the larger ballooning strain (74 percent versus 48 percent), facilitated the movement of fuel particles from the portion of the rod above the ballooning plane into the ballooned region.

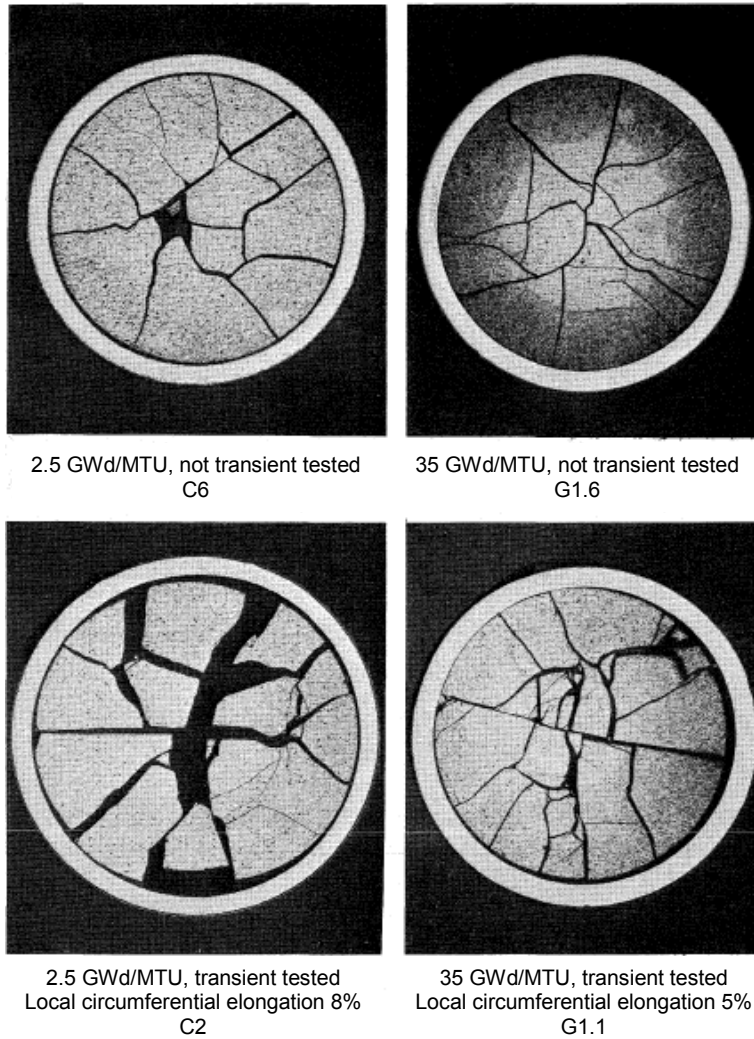
Figure 4-7 Pre (top) and post (bottom) LOCA transient fuel fragmentation for low-burnup rods (2.5 GWd/MTU, left) and medium-burnup rods (35 GWd/MTU, right) (Ref. 19)

The large number of micrographs from PIE of rods tested in the FR-2 program allows for a fairly extensive study of the effects of burnup on fuel fragmentation and relocation. Figure 4-7 shows cross-sections of very-low-burnup (2.5 GWd/MTU) and medium-burnup (35 GWd/MTU) rods that have simply been irradiated to these levels without being transient tested, and others that have gone through a LOCA transient. It can be seen that fuel fragmentation had already occurred before the LOCA transient, and that the transient did not appear to have a marked effect on fuel fragmentation. Regarding fuel relocation, the information in Figure 4-7 indicates that radial relocation increases when rod ballooning occurs, as is particularly visible when comparing the micrographs of the low-burnup rods. It should also be pointed out that the rod irradiated to 35 GWd/MTU and not transient tested shows the signs of rim formation on the outer 50 percent or so of the fuel pellet as a result of irradiation.

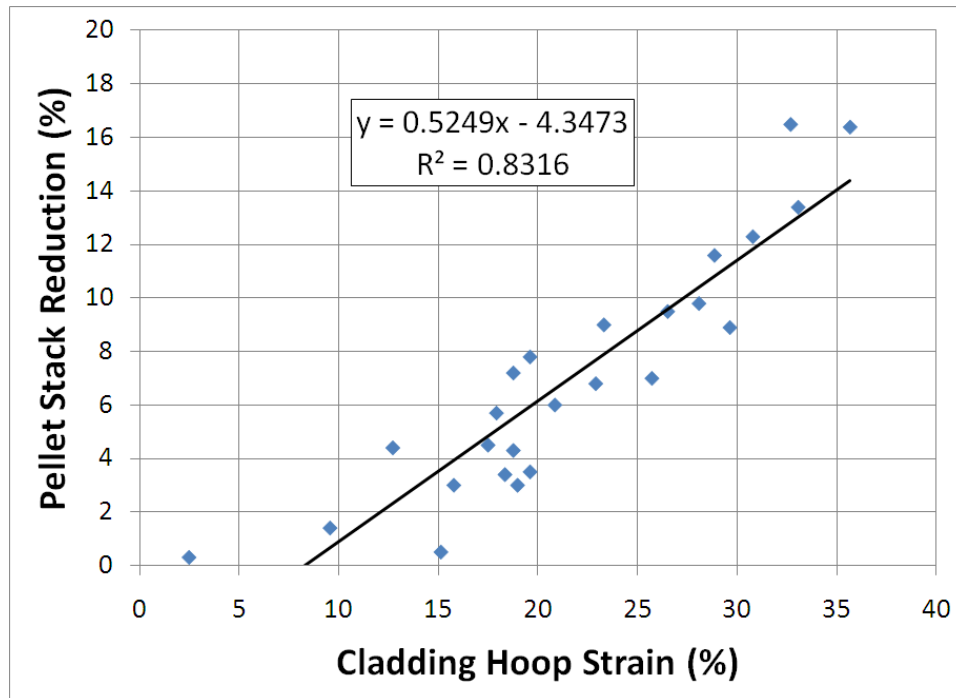
Figure 4-15 Pellet stack reduction as a function of cladding hoop strain for preirradiated fuel rods (based on the increase in volume in cladding balloon with no axial elongation) (Ref. 21)

The model developed for axial fuel relocation reflects the experimental results, as shown in Figure 4-15. In fuel rods ballooning until rod-to-rod contact occurs, the model predicts that axial fuel relocation causes a 35-percent increase in the linear heat generation rate on the ballooned region of the fuel rod.

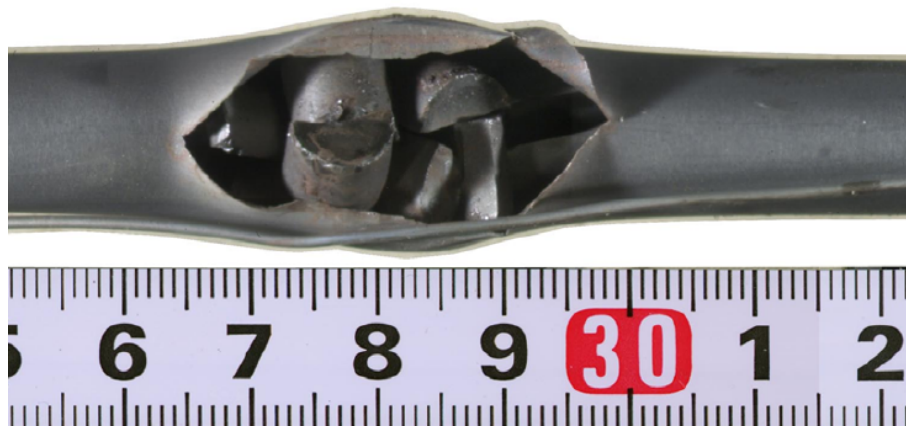
Figure 4-26 Ballooned region with relocated fuel in the Halden IFA-650.2 test (Ref. 61)

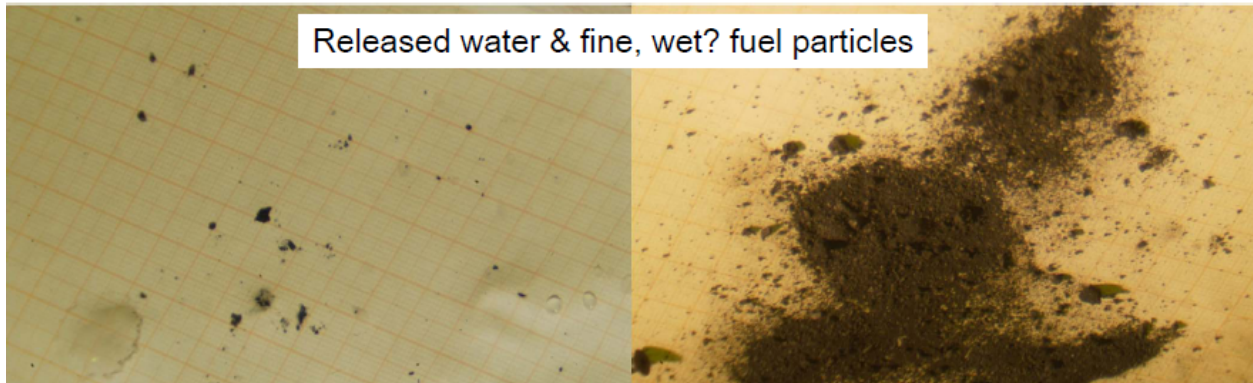
Figure 4-30 Fuel residue from posttest disassembly of IFA-650.9 (Ref. 46)

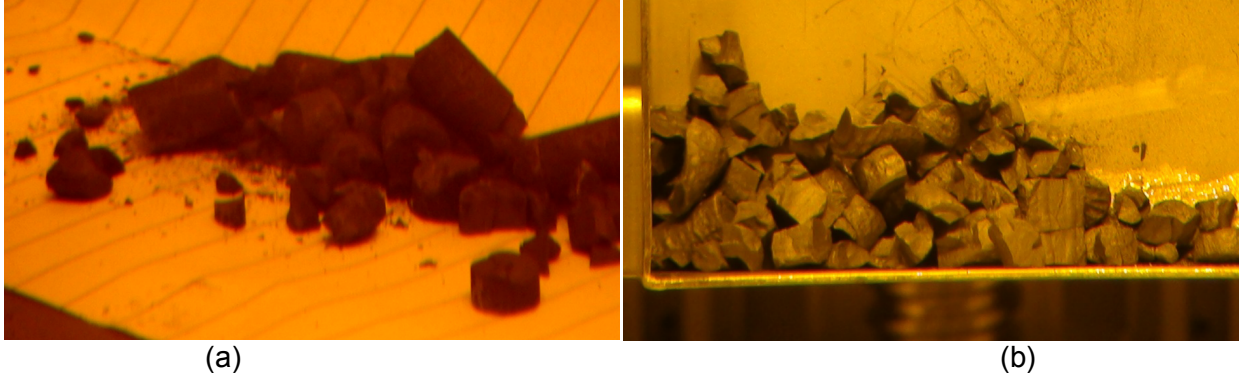
Figure 4-42 Images of fuel particles collected from test rod (a) 196 and (b) 198 revealing large fragments

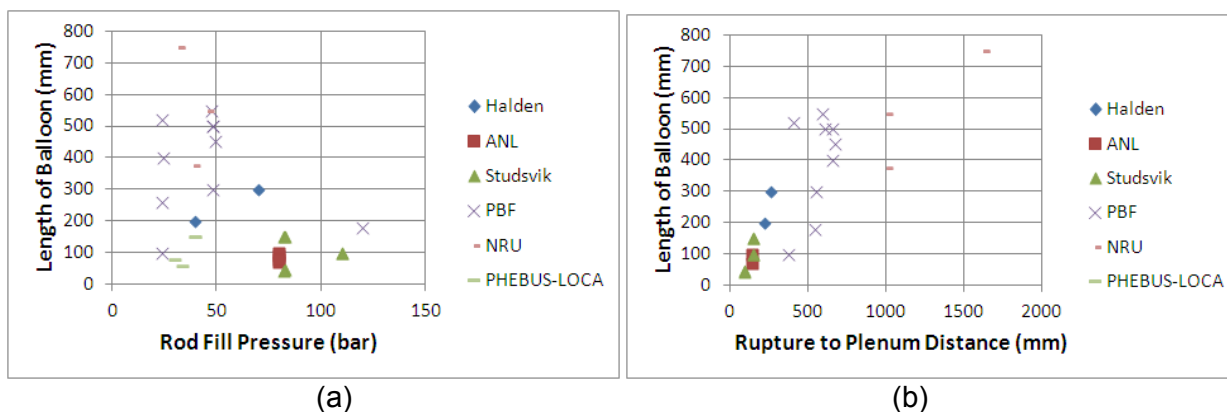
Figure 4-52 Length of ballooned section of the rod as a function of (a) rod fill pressure, and (b) rupture to plenum distance, showing that balloon length decreases with increase rod fill pressure, and increases when the rupture occurs further from the plenum.

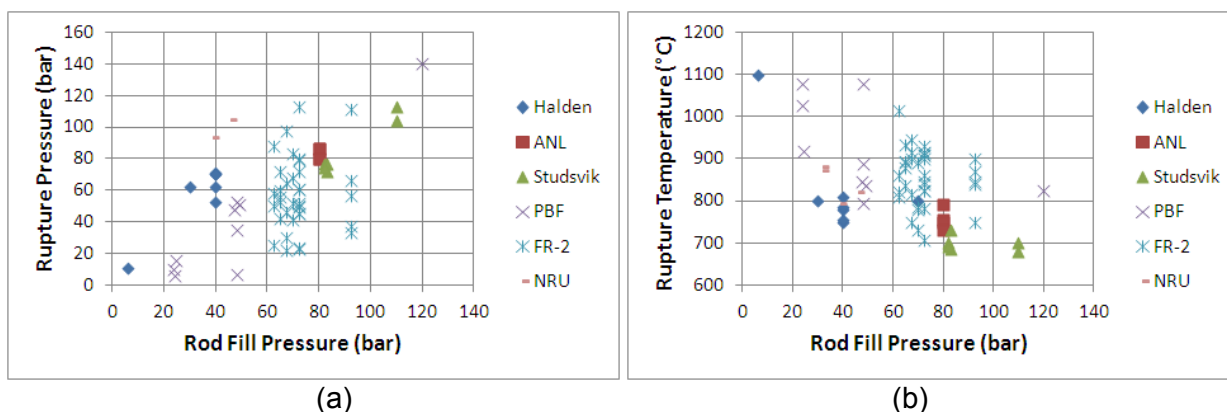
Figure 4-53 Rupture pressure (a) and temperature (b) as a function of rod fill pressure, showing opposite trends, implying that rupture pressure and temperature are inversely correlated, as shown in Figure 4-54

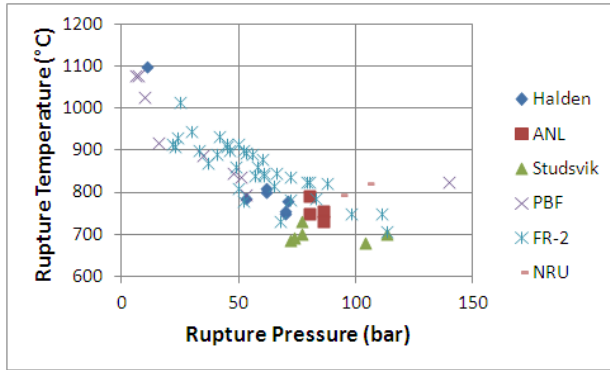
Figure 4-54 Rupture temperature as a function of rupture pressure, showing that rupture temperature decreases as rupture pressure increases

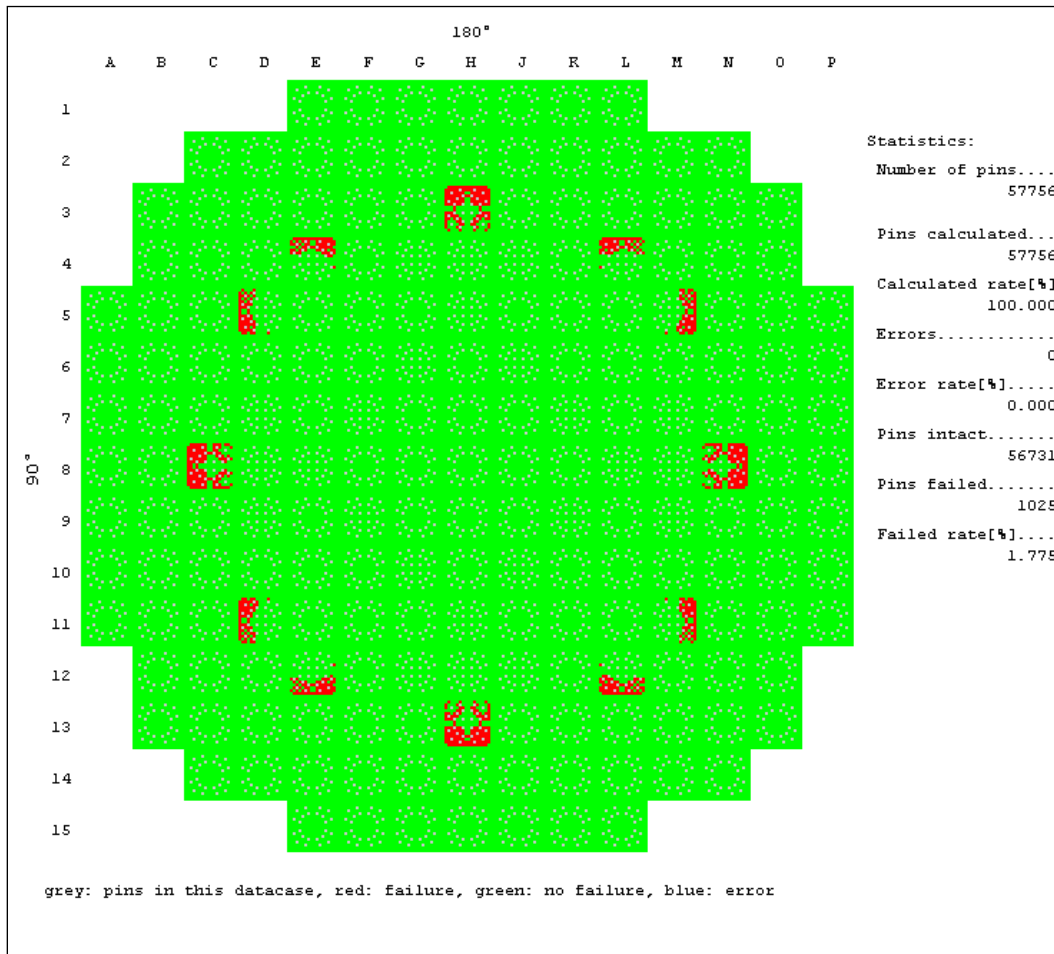
Figure A-8 Number of failed fuel rods/failure rate during LOCA (Ref. A.7)
