# PORTLAND HARBOR

## *Natural Resource Trustee Council*

### **Ecological Restoration Portfolio**

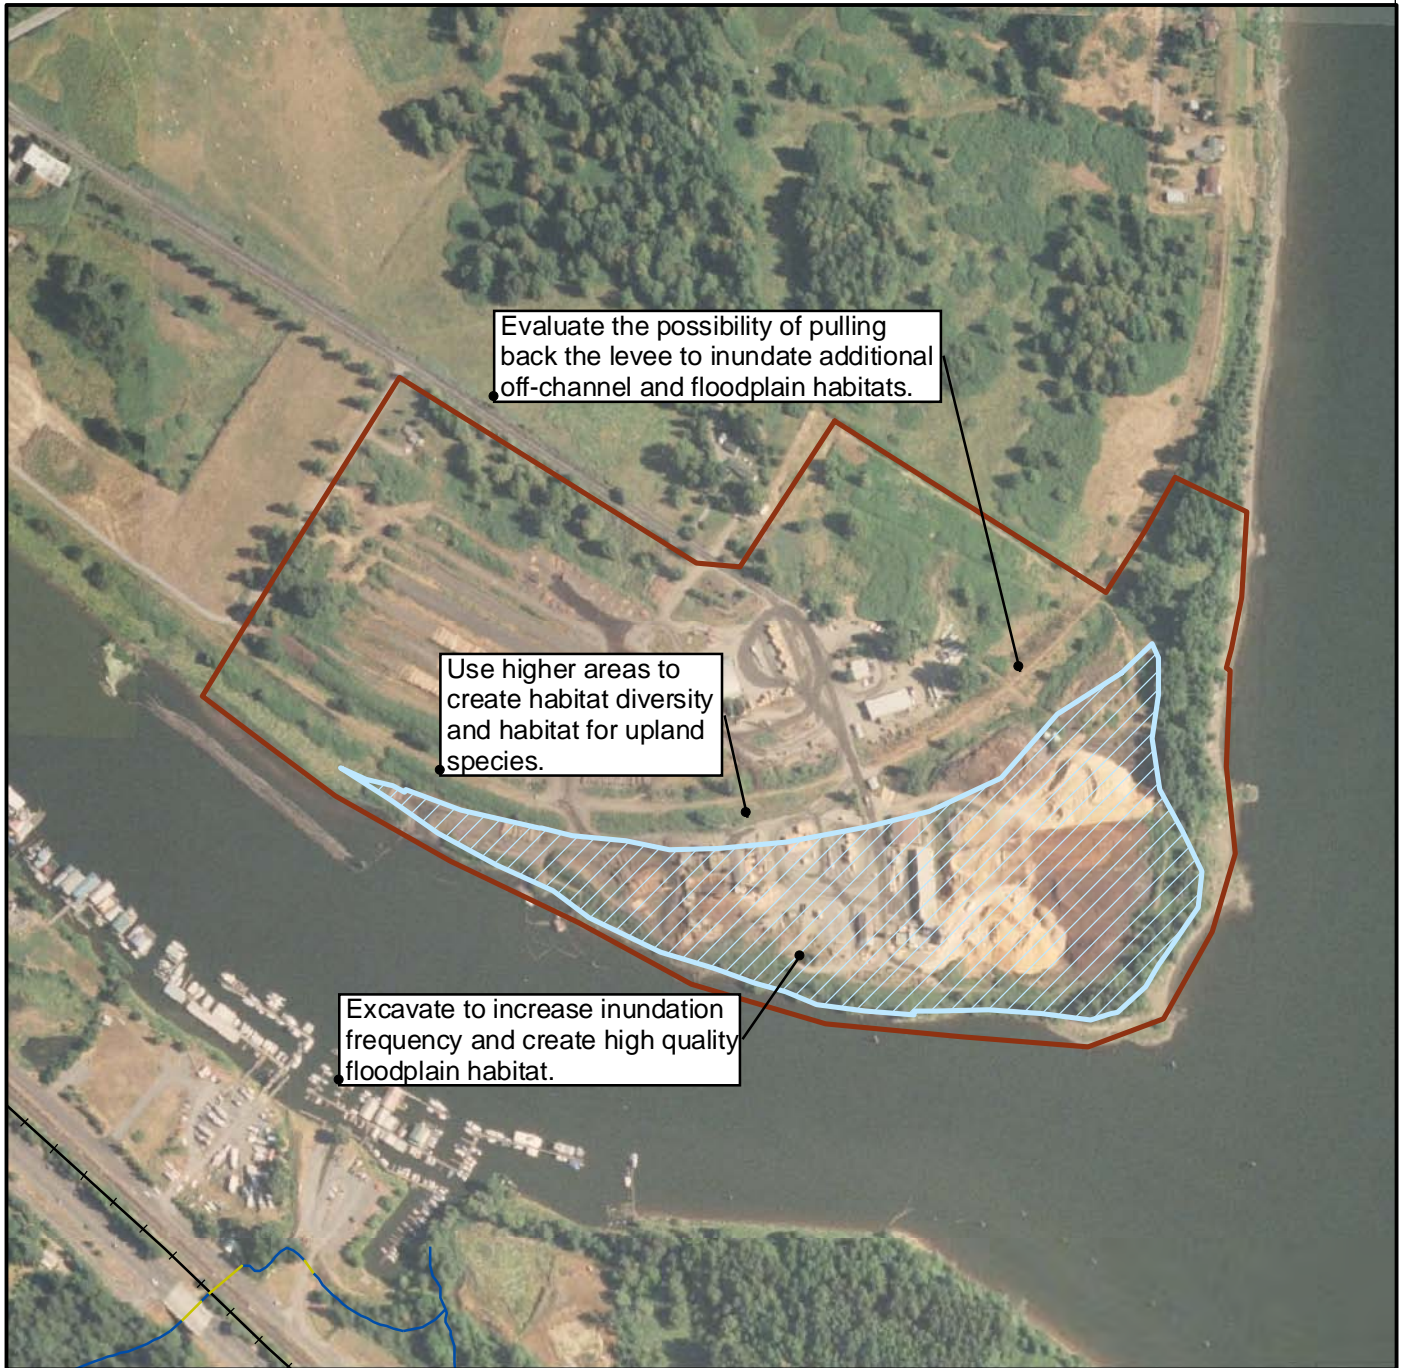
# Alder Point

This map represents conceptual fish and wildlife habitat restoration opportunities which have been screened against criteria developed by the Portland Harbor Natural Resource Trustees. Further analysis of this site will occur to determine the feasibility, cost, and habitat value of the restoration concepts on a finer scale. This map was prepared, in part, using geospatial databases provided by the City of Portland's Bureau of Environmental Services. (3/5/10)

**Site description:** The Alder Point property is a 51-acre site at the southern tip of Sauvie Island near river mile 3.0 and the confluence of the Willamette River with the Multnomah Channel. The property has been filled and partially developed for industrial uses. A levee divides the site into two sections. Some beach habitat with accumulated large wood habitat is present along the eastern end of the site riverward of the levee. A forested riparian area is present between the beach and the developed portions of the site. The remainder of the site has been cleared of vegetation and has historically been used for lumber processing and storage.

**Proposed restoration:** Restoration efforts at this site could include regrading the river banks to create a shallower slope, increasing interaction between the river and the floodplain. Restoration could also include adding native vegetation to floodplain and upland areas. Additional restoration options could also include removing portions of the private levee and restoring a diversity of riparian, marsh, mud flat and off-channel habitats across the site.

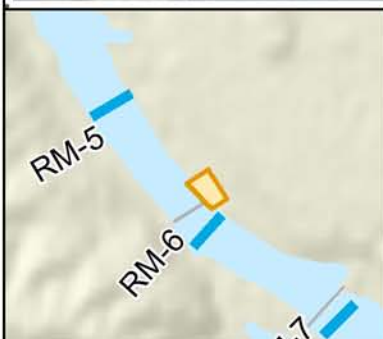
# Cathedral Park

- Outfall
- Restoration Site
- ~ Potential Bank Restoration
- ~ Stormwater Swales
- ▨ Off-Channel Habitat
- Riparian Shrubs and Trees

This map represents conceptual fish and wildlife habitat restoration opportunities which have been screened against criteria developed by the Portland Harbor Natural Resource Trustees. Further analysis of this site will occur to determine the feasibility, cost, and habitat value of the restoration concepts on a finer scale. This map was prepared using a geospatial database provided by the City of Portland's Bureau of Environmental Services.

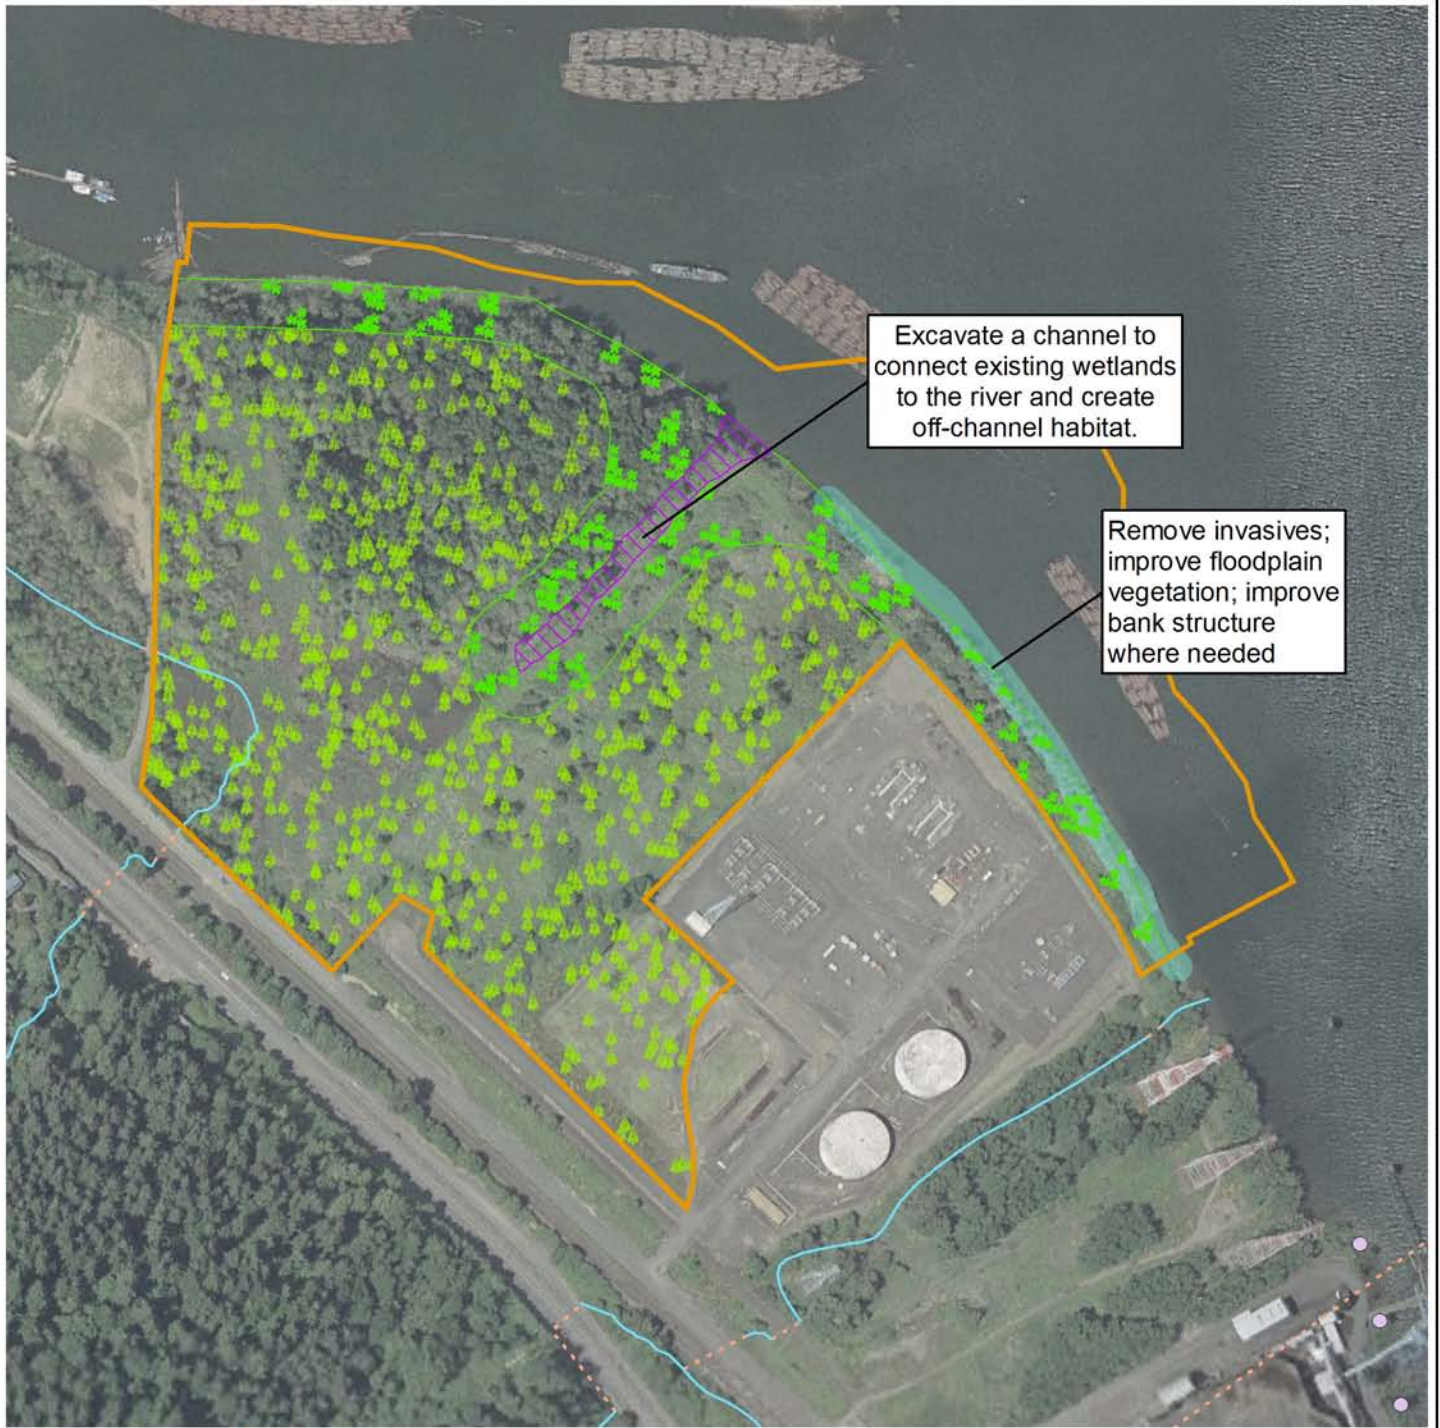
Excavate a channel to connect existing wetlands to the river and create off-channel habitat.

Remove invasives; improve floodplain vegetation; improve bank structure where needed

**Other constraints/considerations:** The PGE site is rare because it is an undeveloped site in good condition. Its location at the confluence of the Willamette River and Multnomah Channel is unique. There is no known imminent threat of the property being developed. Restoration at this site would need to be coordinated closely with restoration plans at the adjacent Miller Creek site.

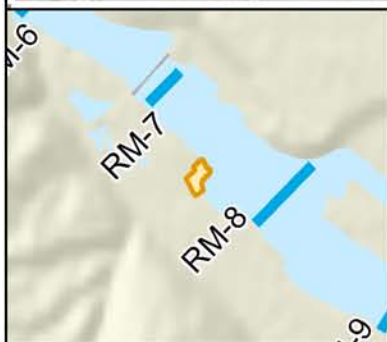
# Saltzman Creek

- Outfall
- Stream
- Piped Stream Segment
- Restoration Site
- Potential Bank Restoration
- Potential Channel Restoration
- Off-Channel Habitat
- Shallow Water Habitat
- Revegetation

This map represents conceptual fish and wildlife habitat restoration opportunities which have been screened against criteria developed by the Portland Harbor Natural Resource Trustees. Further analysis of this site will occur to determine the feasibility, cost, and habitat value of the restoration concepts on a finer scale. This map was prepared using a geospatial database provided by the City of Portland's Bureau of Environmental Services.

**Site description:** The Saltzman Creek site is located at river mile 7.5 on the edge of Willbridge Cove. Saltzman Creek itself runs in culverts through most of the site. There is a small amount of riparian vegetation currently on site, and 55.5% of the site is currently impervious. The shoreline contains beach and mudflat habitat and is in good condition. There appears to be very little shallow in-water habitat currently. The site contains some contaminated sediment, which is being at least partially remediated.

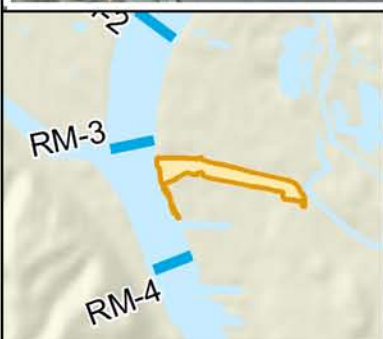
# South Rivergate Corridor

- Outfall
- Stream
- Piped Stream Segment
- Restoration Site
- Potential Bank Restoration
- Potential Channel Restoration
- Revegetation
- Wetland Enhancement
- Wildlife Corridor

This map represents conceptual fish and wildlife habitat restoration opportunities which have been screened against criteria developed by the Portland Harbor Natural Resource Trustees. Further analysis of this site will occur to determine the feasibility, cost, and habitat value of the restoration concepts on a finer scale. This map was prepared using a geospatial database provided by the City of Portland's Bureau of Environmental Services.

**Site description:** The South Rivergate Corridor site is located near river mile 3.3. It provides a vegetated corridor connecting the Willamette River, Multnomah Channel, Forest Park, the Lower Columbia Slough, and Smith and Bybee Lakes. The shoreline is designated as beach and accumulates large wood. Active dredging of the Willamette River causes a steep drop off from the shore, with little adjacent shallow in-water habitat. There is evidence of erosion and scour along the riverbank. In the upland portion of the site there are multiple seasonal and year-round wetlands and associated vegetation. The Portland General Electric (PGE) power line corridor runs along the site.

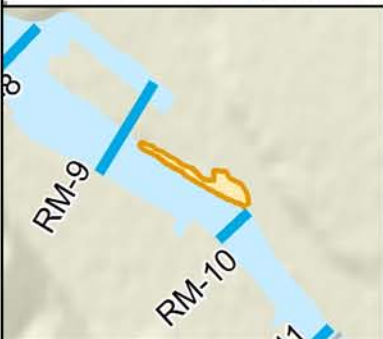
# Swan Island Beach

- Outfall
- Piped Stream Segment
- Restoration Site
- Potential Bank Restoration
- Potential Channel Restoration
- Riparian Shrubs and Trees

This map represents conceptual fish and wildlife habitat restoration opportunities which have been screened against criteria developed by the Portland Harbor Natural Resource Trustees. Further analysis of this site will occur to determine the feasibility, cost, and habitat value of the restoration concepts on a finer scale. This map was prepared using a geospatial database provided by the City of Portland's Bureau of Environmental Services.

**Site description:** The Swan Island Beach North site is located at river mile 9.5. Swan Island is a heavily developed and active industrial area. There are two segments of the site's shoreline classified as beach with adjacent shallow water habitat. These vegetated beaches appear to be in good condition and are known to accumulate large wood, an uncommon occurrence within Portland Harbor. These beach areas are interspersed among banks treated with vegetated rip rap. There is a strip of shrubs and trees separating the shoreline from the developed upland.

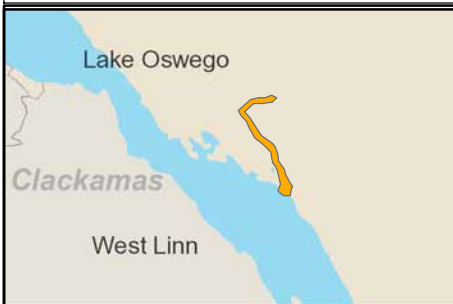
# Boardman Creek

-   Culvert area
-   Restoration Site
-   Channel Restoration
-   Confluence Enhancement

This map represents conceptual fish and wildlife restoration opportunities which have been screened against criteria developed by the Portland Harbor Natural Resource Trustees. Further analysis of the site will occur to determine the feasibility, cost, and habitat value of the restoration concept at a finer scale.

**Site Description:** Boardman Creek meets the Willamette River near River Mile 23 on the east side of the river. The 13,000 foot creek runs through a highly urbanized part of Clackamas County, including the towns of Jennings Lodge and Gladstone, Oregon. There are currently three deteriorating culverts at the downstream end of Boardman Creek, about 1000 feet from its confluence with the Willamette River. Two of the culverts are located at the same crossing under River Road and the third culvert is buried beneath Walta Vista Court. Salmon and steelhead have been documented just downstream of the undersized culverts, which form a complete fish passage barrier. The riparian areas between the culverts and down to the confluence area are degraded, further limiting the water quality and habitat within the stream.

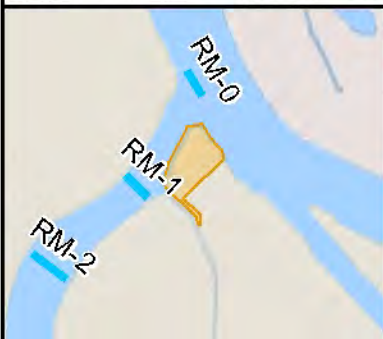
# Kelley Point Park

- Restoration Site
- Backwater Channel Creation
- Revegetation

This map represents conceptual fish and wildlife habitat restoration opportunities which have been screened against criteria developed by the Portland Harbor Natural Resource Trustees. Further analysis of this site will occur to determine the feasibility, cost, and habitat value of the restoration concepts on a finer scale.

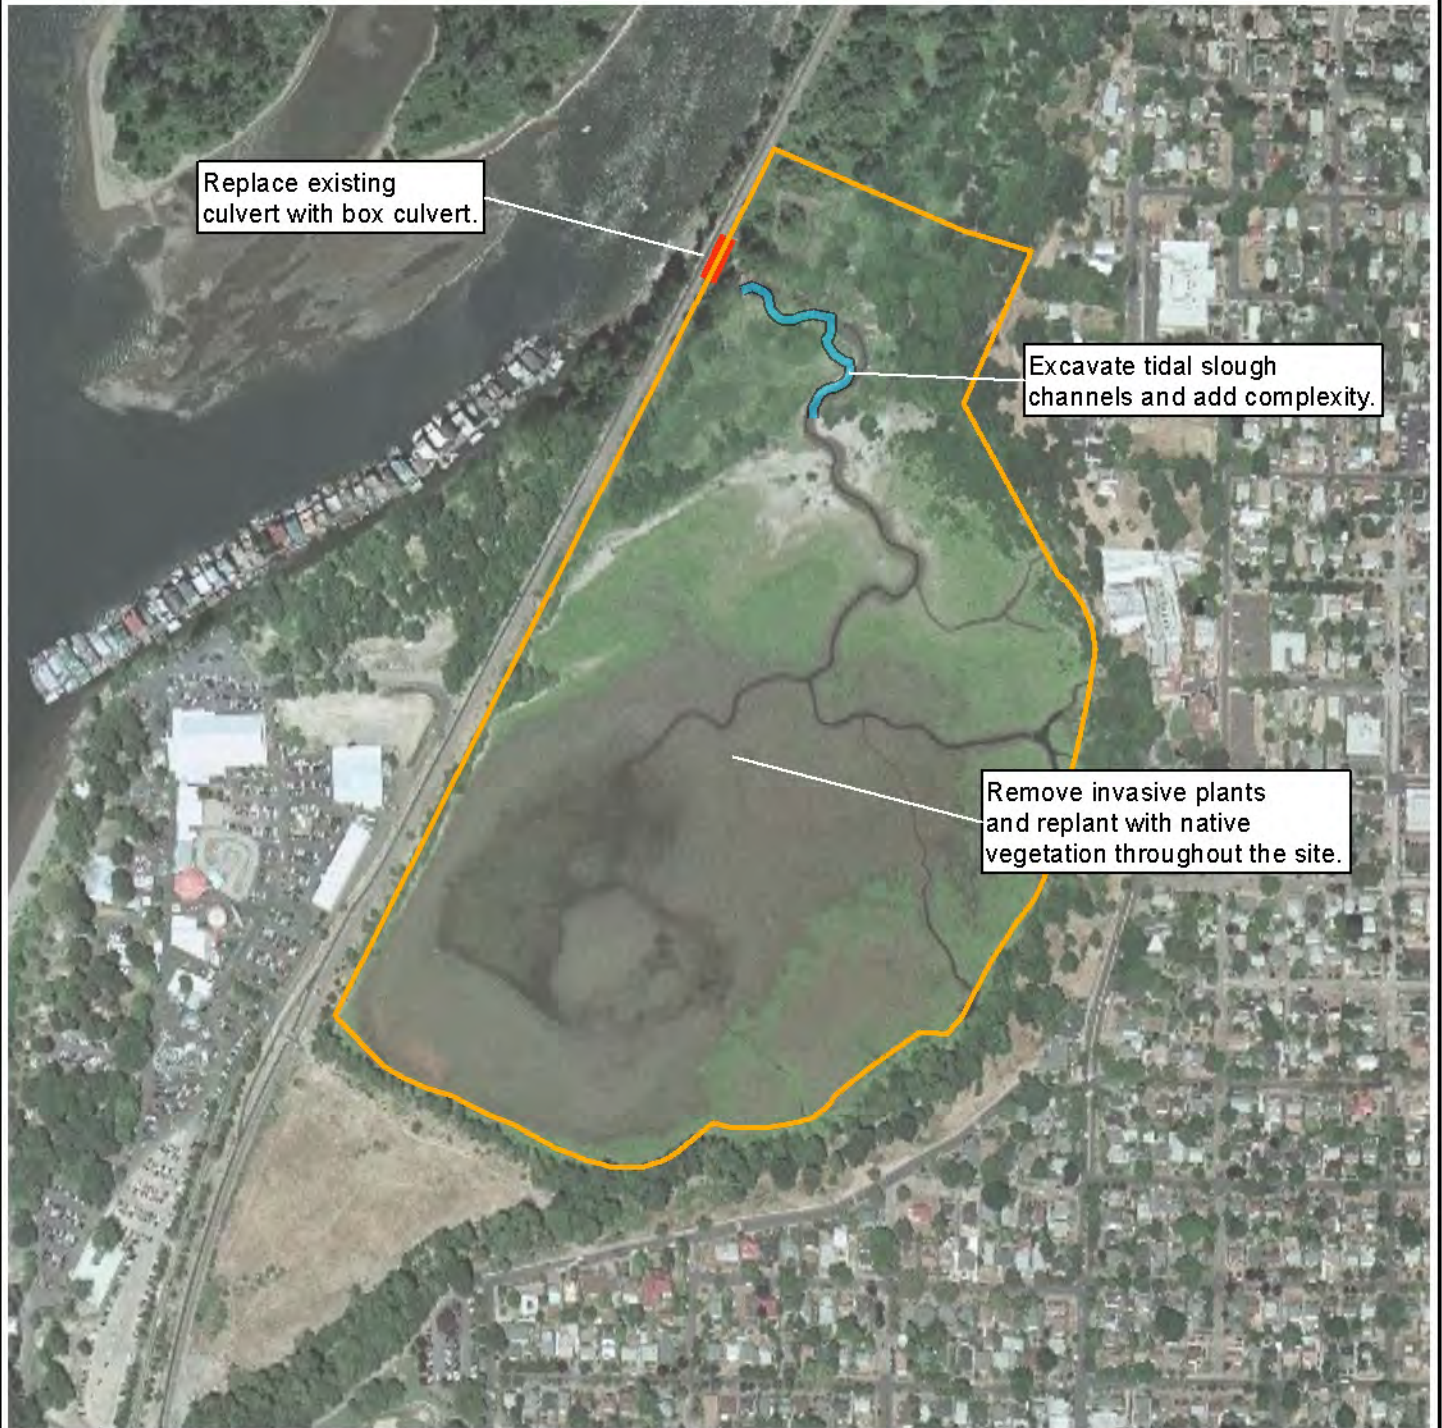
# Oaks Bottom Wildlife Refuge Habitat Enhancement

- Replacement culvert
- Potential Channel Restoration
- Restoration Site

This map represents conceptual fish and wildlife habitat restoration opportunities which have been screened against criteria developed by the Portland Harbor Natural Resource Trustees. Further analysis of this site will occur to determine the feasibility, cost, and habitat value of the restoration concepts on a finer scale.

**Site description:** Oaks Bottom Wildlife Refuge is a 170-acre city owned property comprised of meadows, wetlands and bottomland forest on the eastside of the Willamette River at river mile 15.5, just north of the Sellwood Bridge. The site presently provides habitat for a number of bird, amphibian, mammal and invertebrate species, but is largely disconnected from the river. Significant populations of invasive plant species, including purple loosestrife, currently inhabit the site. Nutria, an invasive mammal, is also present at the site.

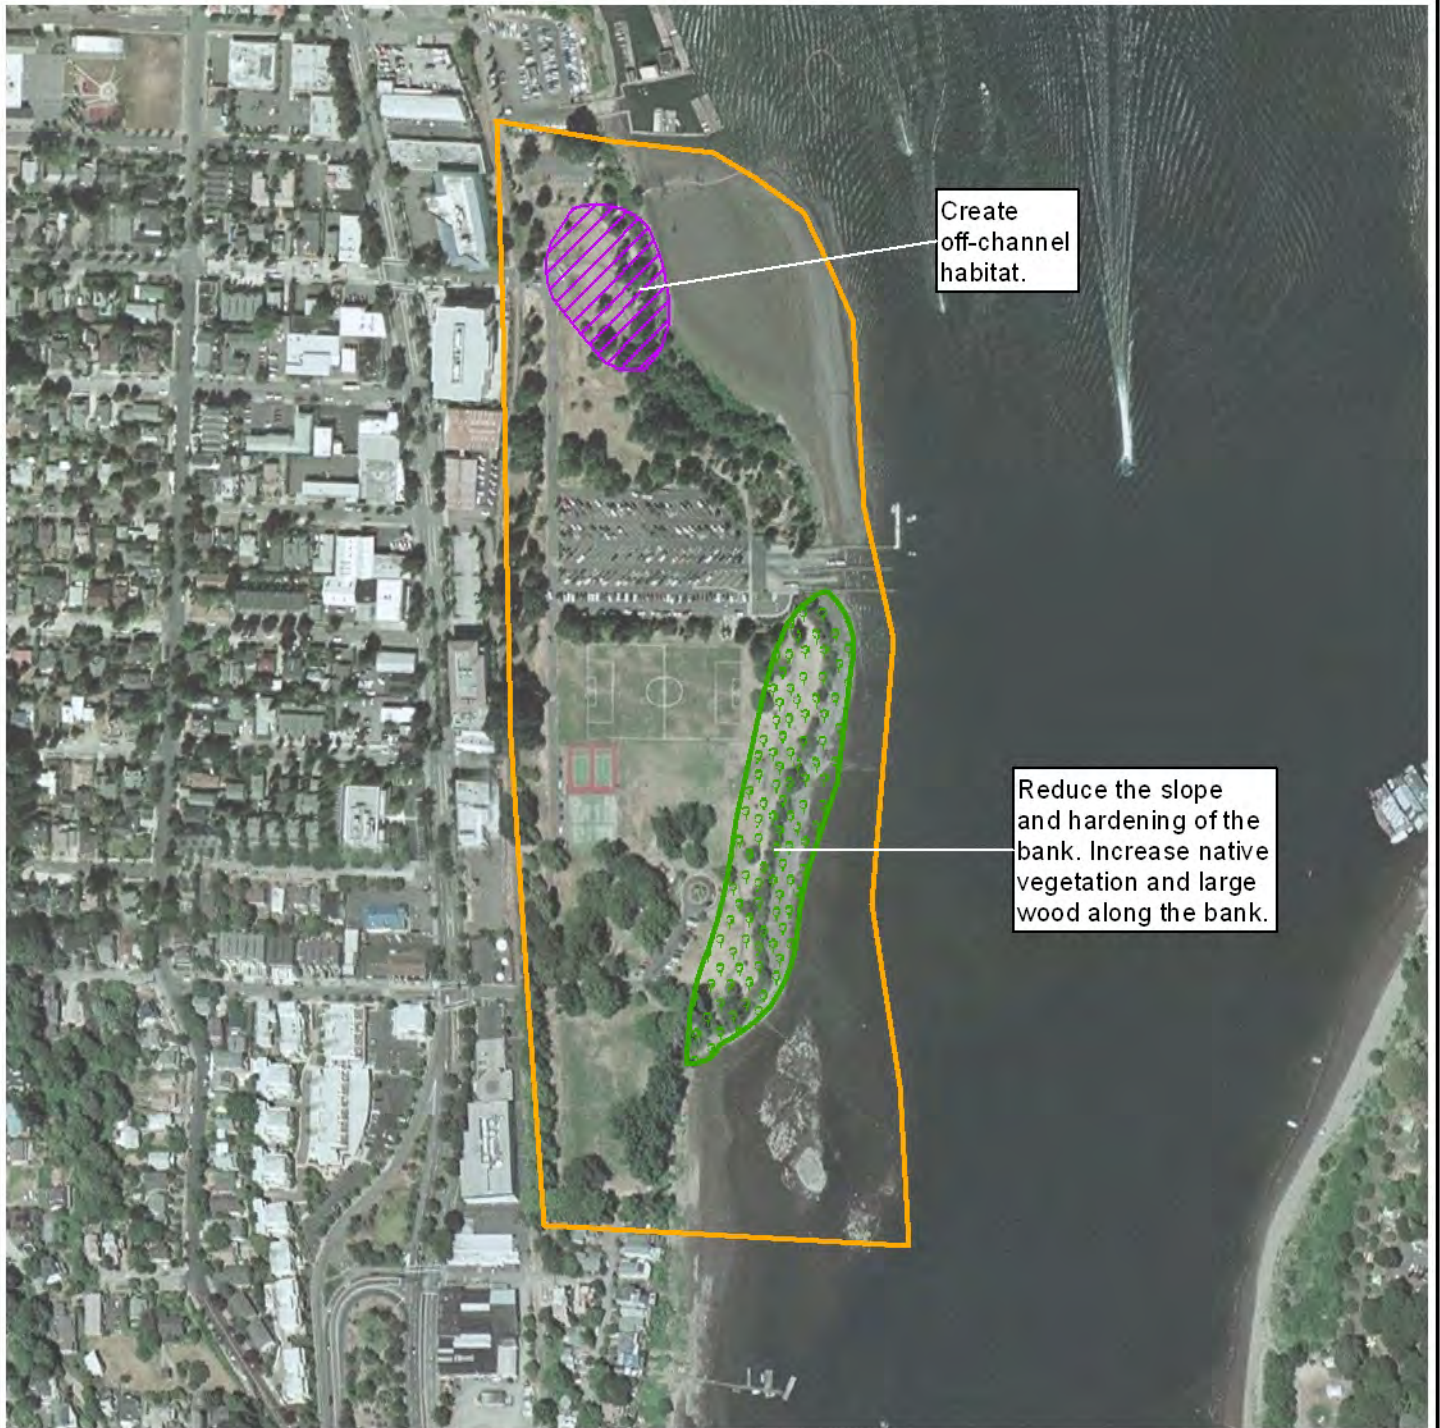
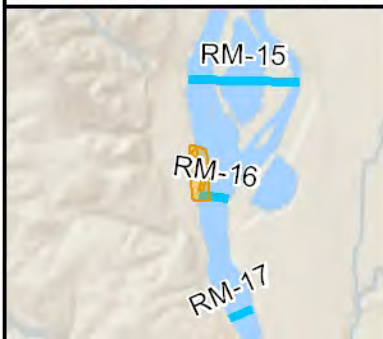
# Willamette Park

- Restoration Site
- Off-Channel Habitat
- Revegetation

This map represents conceptual fish and wildlife habitat restoration opportunities which have been screened against criteria developed by the Portland Harbor Natural Resource Trustees. Further analysis of this site will occur to determine the feasibility, cost, and habitat value of the restoration concepts on a finer scale.
