River Corridor Closure Project

Recovery Act Weekly Report

For the week ending April 1, 2011

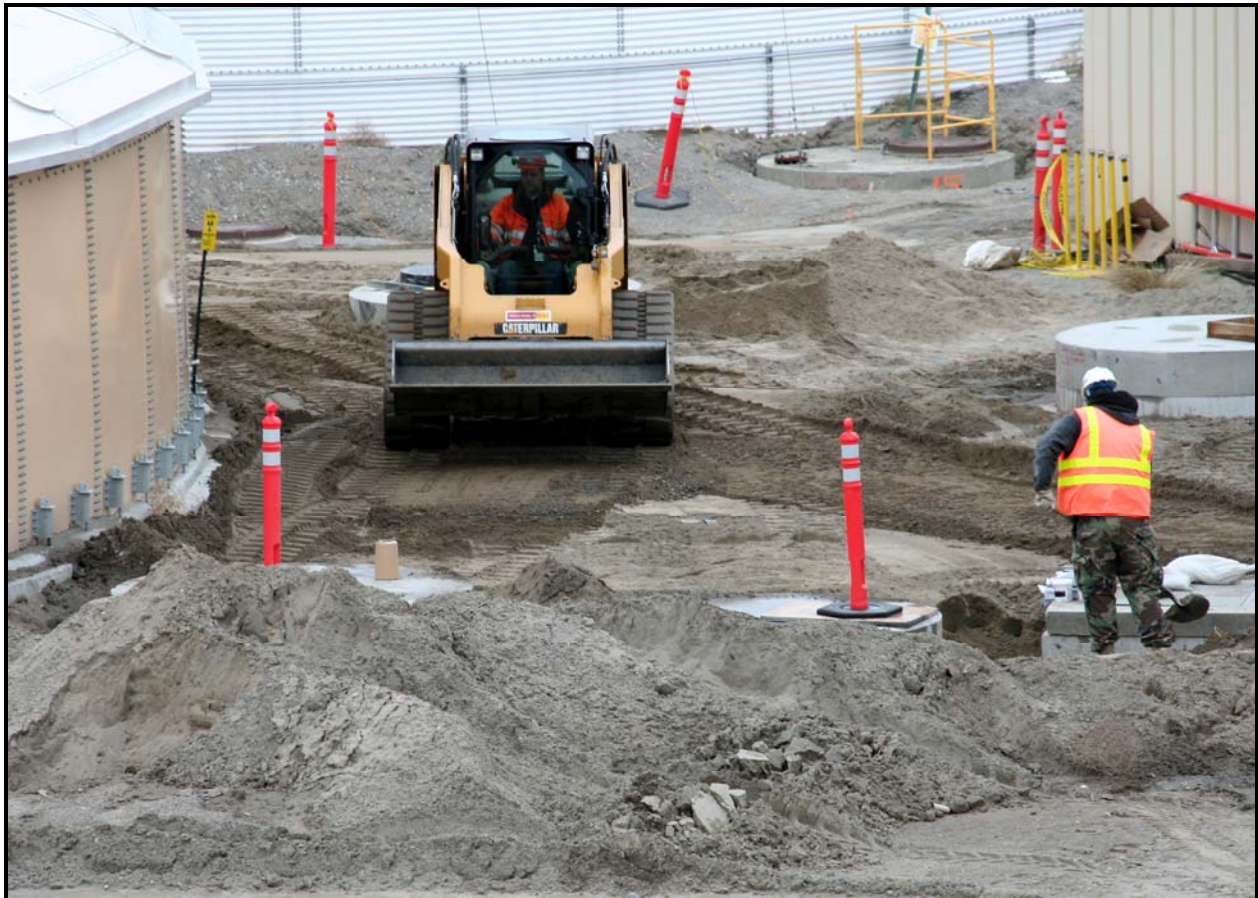
Washington Closure Hanford subcontractor DelHur Industries backfills around manholes associated with ERDF's two new leachate storage tanks. (Photo 1)

WCH continued modifying the leachate piping system and raising the manholes associated with the facility's two new leachate storage tanks (LST 3 and LST 4). LST 4 was placed into service earlier this month, and LST 3 is expected to be authorized for use next month. The new tanks measure 100 feet in diameter with a 425,000-gallon capacity.

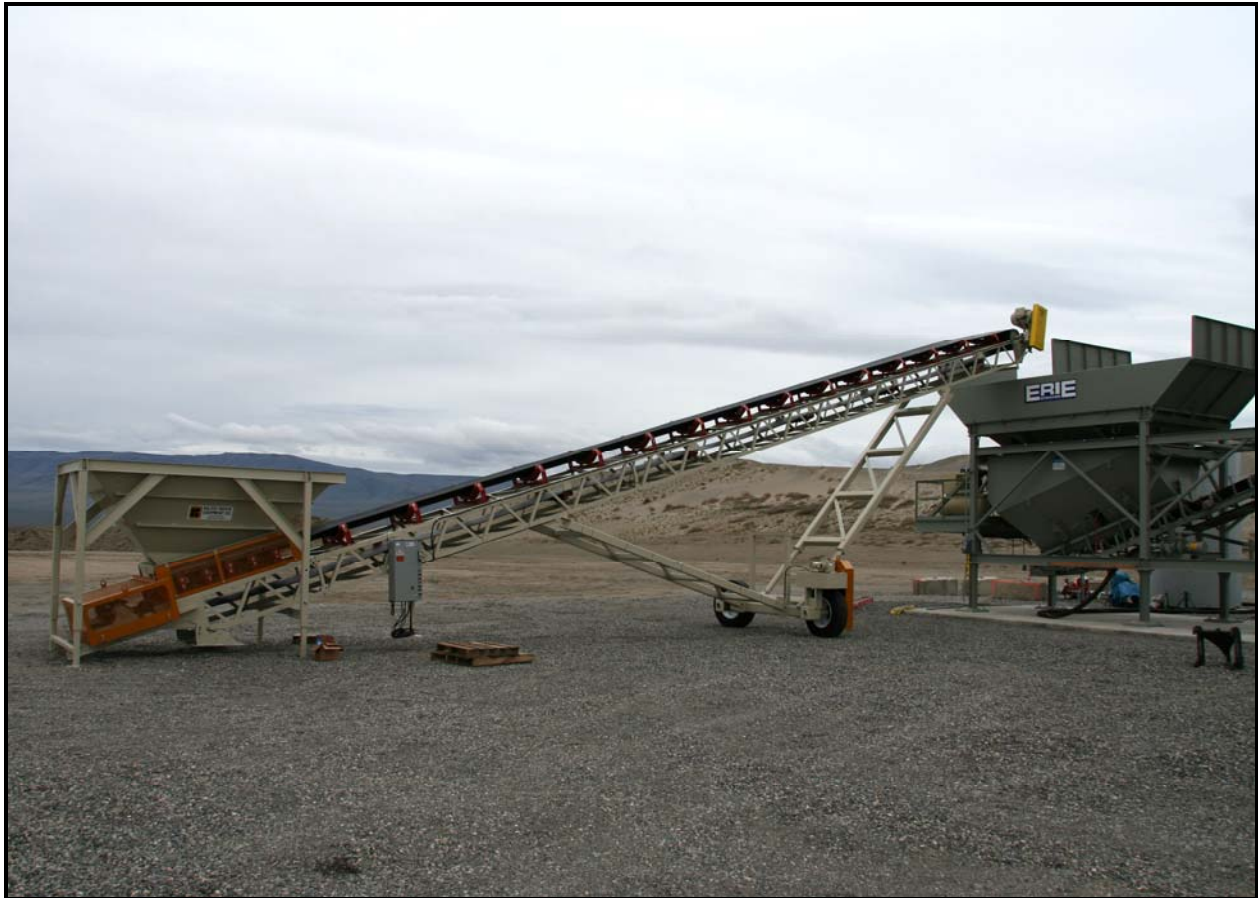
The conveyer and hopper for ERDF's new batch plant are being installed. (Photo 3)

WCH subcontractor DelHur Industries is installing the conveyer and hopper for ERDF's new batch plant. The batch plant will produce concrete used to mix with debris, ensuring no void space during disposal operations.

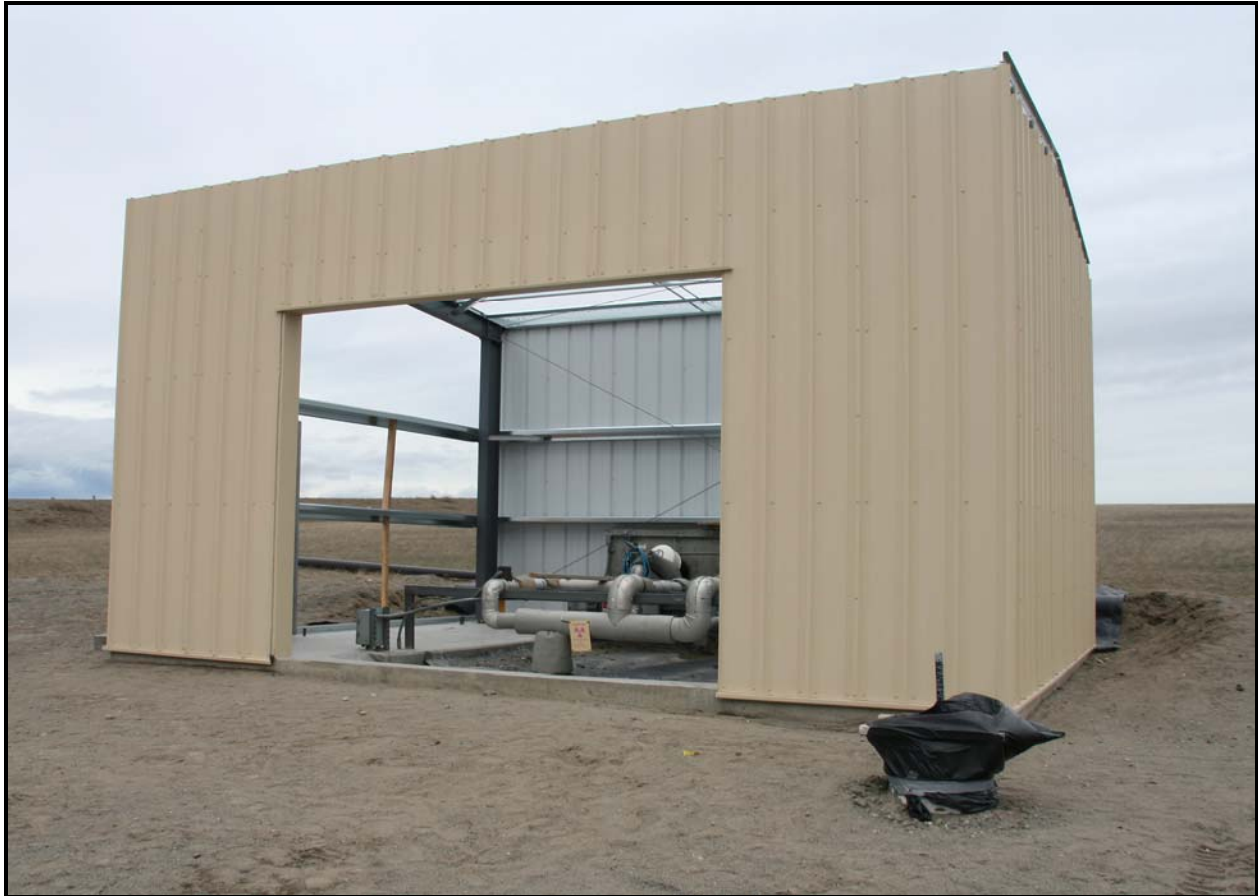
Washington Closure Hanford subcontractor TradeWind Services constructs the weather enclosure for the crest pad associated with cell 2. (Photo 4)

TradeWind Services continues to construct weather enclosures for the crest pads associated with cells 1 and 2. The enclosures were designed by Vista Engineering, a local company.

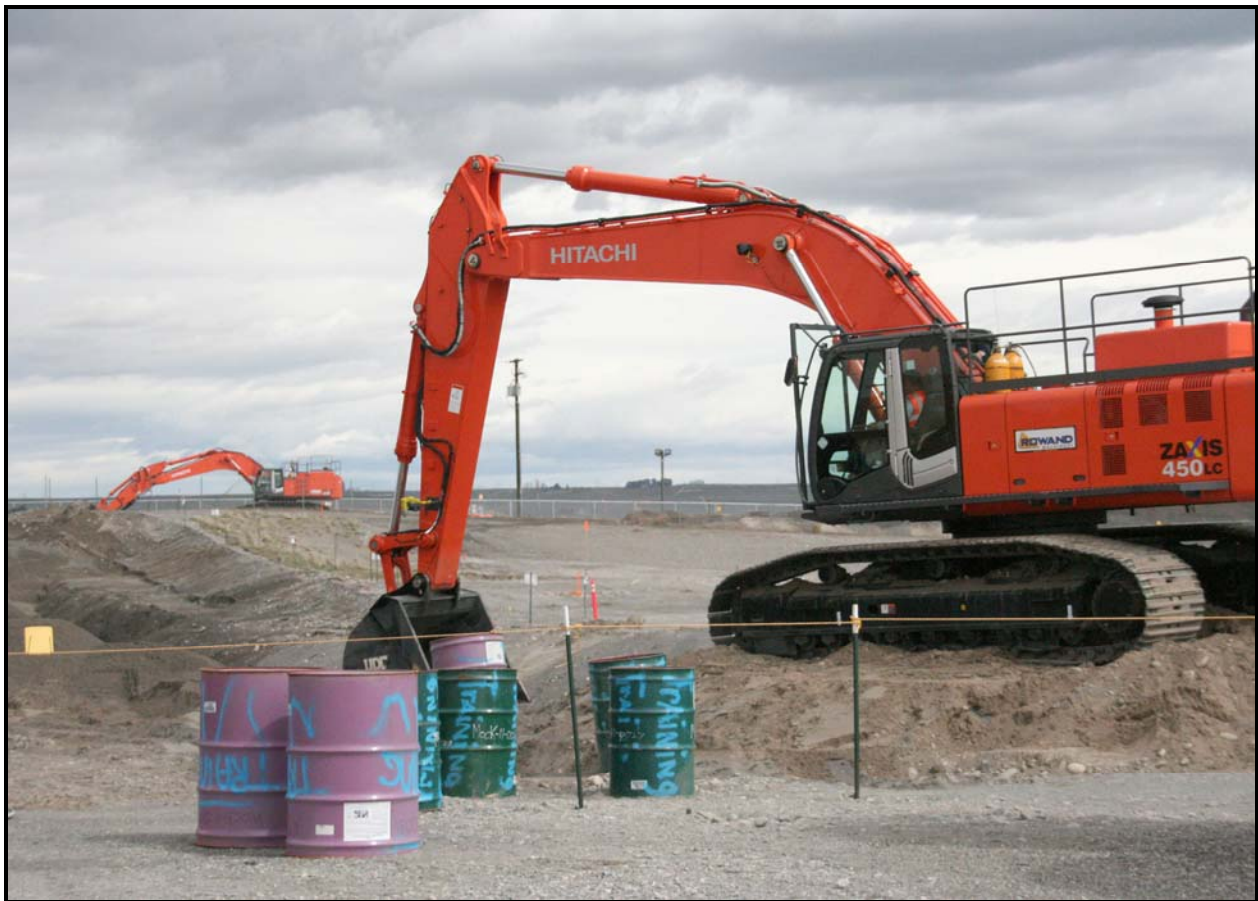
Washington Closure Hanford conducts mockups for trench remediation at the 618-10 Burial Ground. (Photo 5)

The project team continues to set up the drum processing area (instrument stations, drum storage area), continues training and mockup exercises, and is working to install wells and water tanks for fire control and dust suppression. It also continues to mobilize for remediation. Work to construct site roads and waste container transfer areas, and to install office trailers is complete.

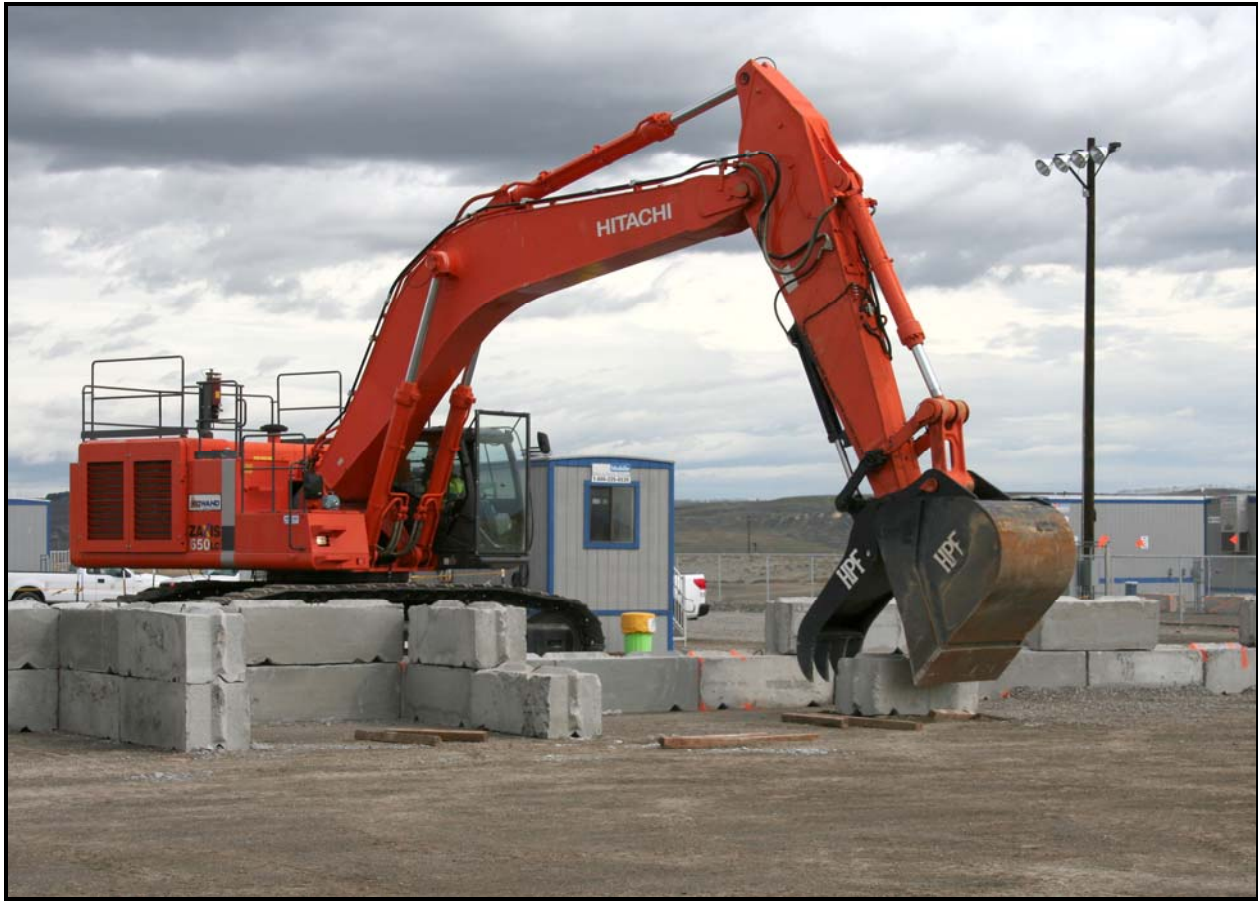
An excavator moves ecology blocks in the drum staging area during mockup exercises at the 618-10 Burial Ground. (Photo 6)
