HAZARD ALERT

ARC FLASH CREATES FIREBALL

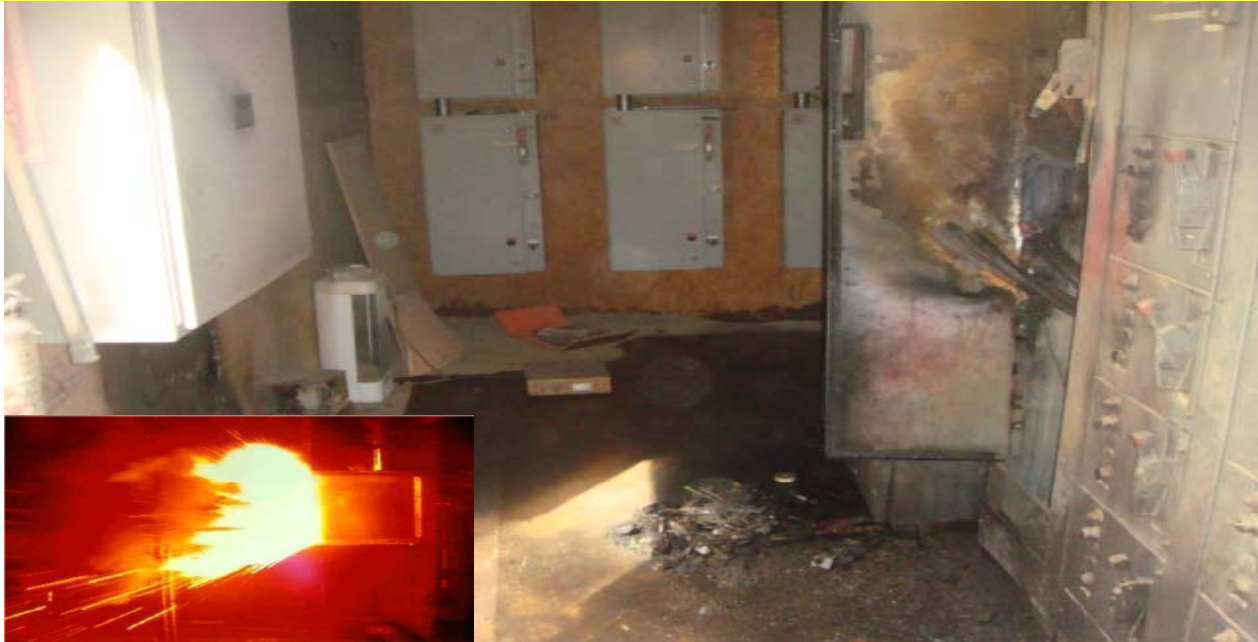
An electrical accident occurred on October 10, 2010, that caused the death of one contract electrician and seriously injured two coworkers. They were installing ground fault indicator lights in a circuit breaker enclosure when an arc flash occurred. They were not aware the circuit breaker enclosure contained a bottom feed circuit breaker and had locked out the wrong disconnect switch.

- After opening the correct load break switch, always ensure the correct visual disconnect is opened, locked, and suitably tagged prior to working on any portion of the electrical circuit.
- Always ensure there is no voltage inside an electrical enclosure prior to working on it.
- Properly label visual disconnecting devices to identify the circuit they protect.
- Place warning labels on the terminal covers of bottom feed circuit breakers stating that the “Bottom terminal lugs remain energized when the circuit breaker is open.”
- Wear appropriate personal protective equipment (PPE) as defined in NFPA 70E (Standard for Electrical Safety in the workplace) when doing any electrical work.
