AL WAHDA  
WATER TREATMENT PLANT  
BAGHDAD, IRAQ

**SIGIR PA-05-001**  
**MARCH 15, 2006**

## Al Wahda Water Treatment Plant in Baghdad, Iraq

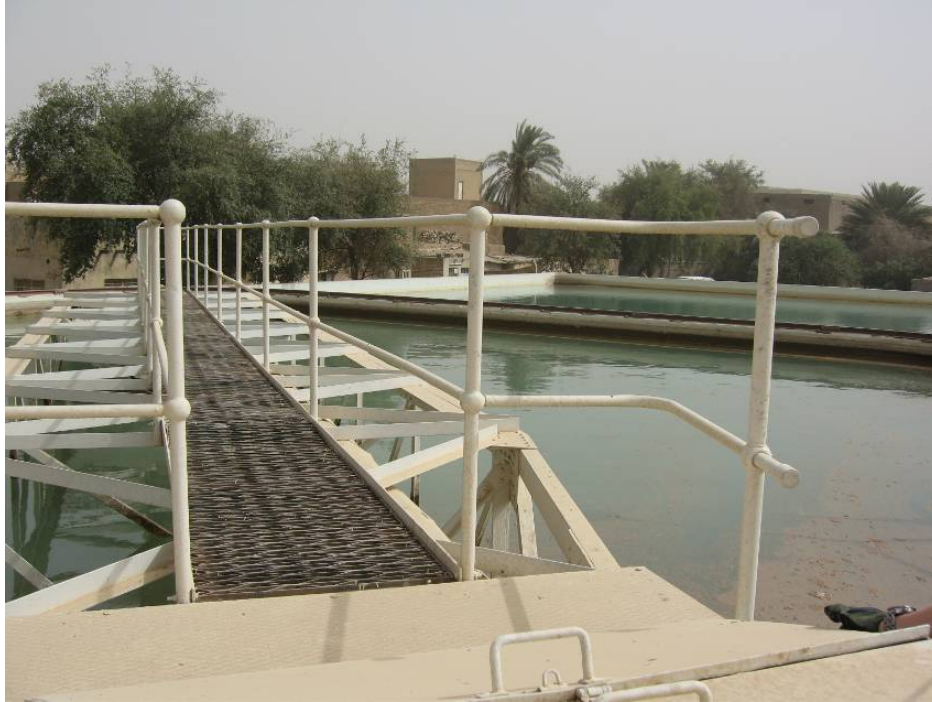
The original SOW required the clarifiers and settling tanks to be drained, cleaned, repaired, and painted. The quality assurance documentation disclosed, and the site assessment found, that the clarifiers and settling tanks (Site Photos 1 & 2) had been drained, cleaned, repaired and painted. The quality of work performed could not be determined because the tanks were filled with water and in operation. During the site assessment, the Iraqi Plant Manager said he was satisfied with the rehabilitation of the clarifiers and settling tanks.

**Site Photo 1: Clarifier tank**

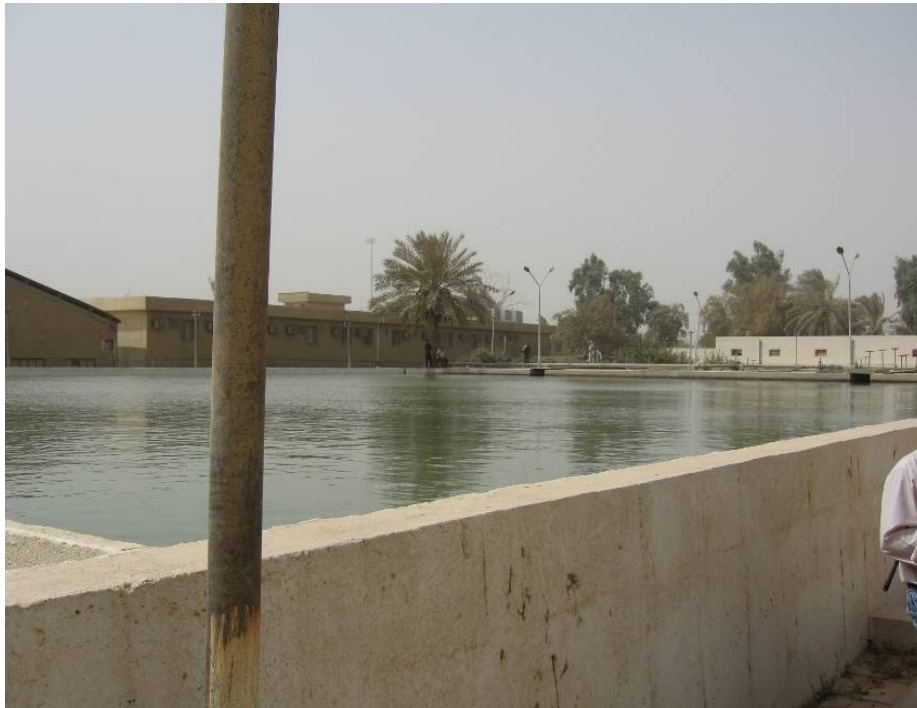
**Site Photo 2: Settling tank**

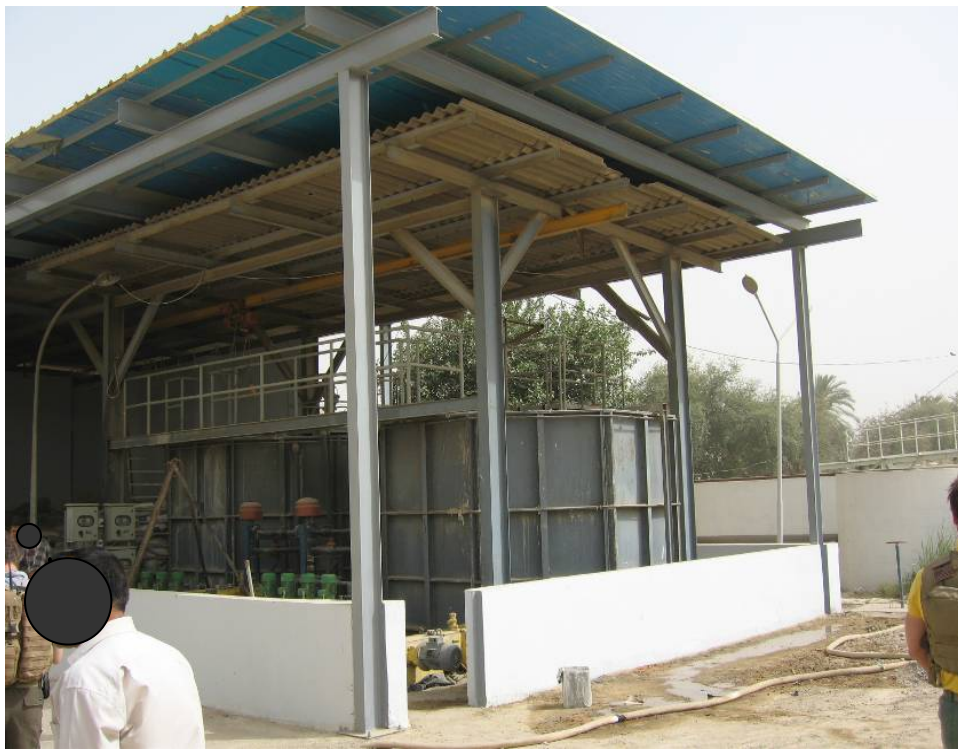
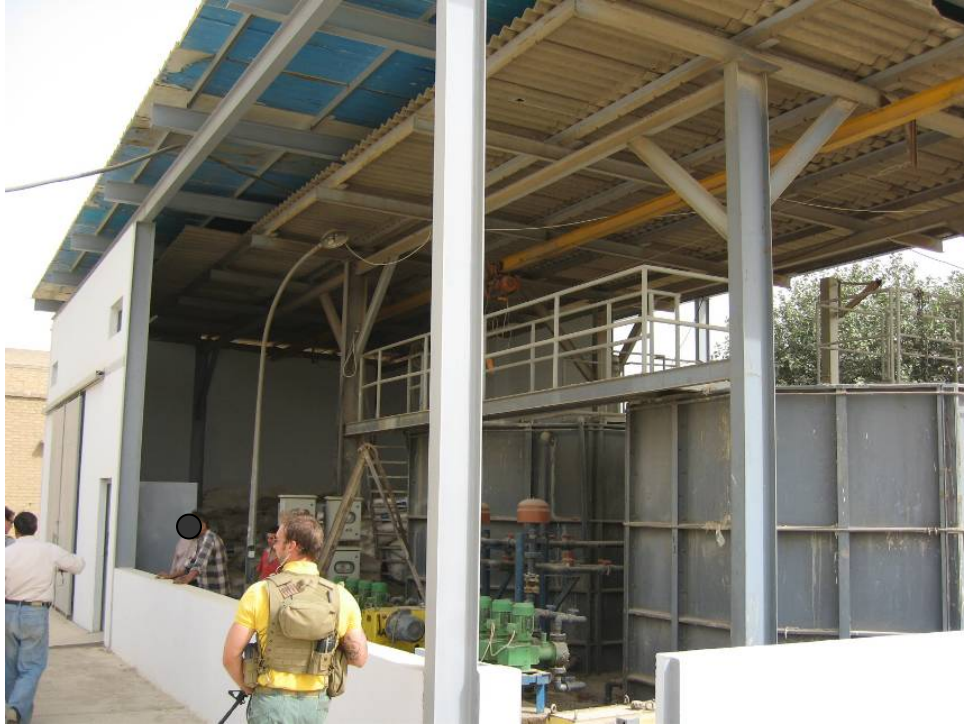
The site assessment found that the chemical building (Site Photos 3 & 4), had been completed. The existing alum feed system with roof structure had not been removed and the new building was built around it.

The cost of this new structure appeared to be extremely high compared to the cost of a comparable sized building of the same design that was constructed under the same task order at Al Wathba WTP. A FluorAMEC, LLC Progress Measurement Worksheet, dated 8 June 2005, showed the cost of both the chemical and administration buildings at Al Wathba WTP to be budgeted at \$141,032. But, the current project cost for just the chemical building at Al Wahda was \$180,307, at 85% completed, not including contractor overhead and fees. A breakdown of the specific charges was requested from the contractor, but had not been furnished at the time of the issuance of this report.

**Site Photo 3: New chemical building**

**Site Photo 4: New chemical building**

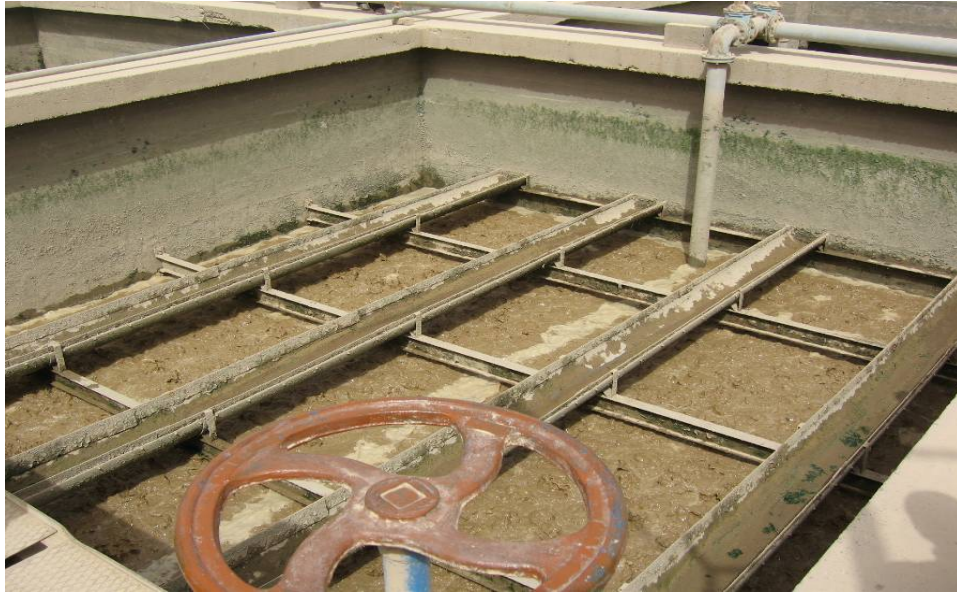
During the site assessment, the Iraqi Plant Manager stated that the rapid sand gravity filter system (Site Photos 5 & 6) needed substantial repair. During backwash

operations, backwash water should flow to the sludge pit; however, due to the poorly operating system and possible faulty valves, some of the backwash water (backwash effluent) gets into the clear well tanks. The clear well tanks are the final storage location of the treated water before chlorination and distribution. The Iraqi Plant Manager said customers have sand and sediment in their drinking water. The deteriorated state of the entire system was confirmed during the site assessment.

**Site Photo 5: Rapid sand gravity filter**

The FluorAMEC, LLC technical study and the original SOW identified the following actions as necessary for refurbishment of the rapid sand gravity filter system: drain and inspect each tank, repair tanks as needed, replace the under-drain system, and replace filter media. This refurbishment was, however, deleted from the SOW, according to the contractor.

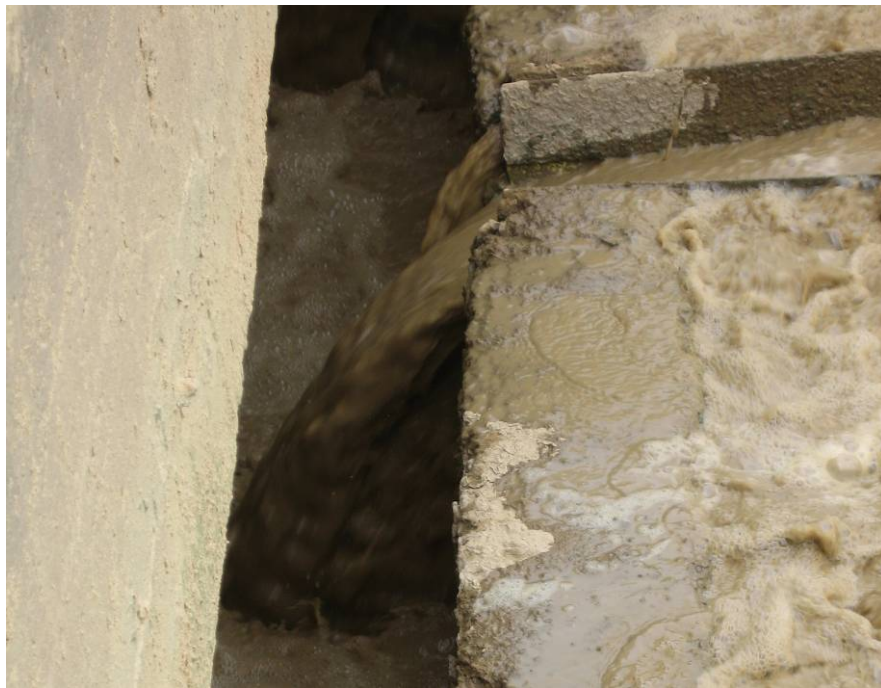
**Site Photo 6: Backwash effluent**

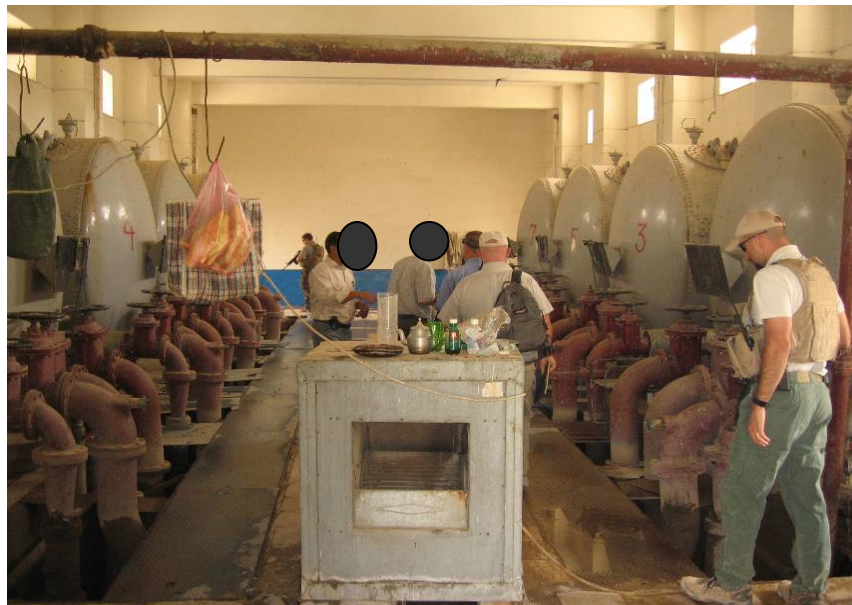
During the site assessment, the Iraqi Plant Manager said he did not think refurbishment was practical and a new system was warranted. He also said the turbidity (which is a measure of suspended solids in a liquid) of outflow from the filters was equal to that of the inflow, which means that the filter system was not functional.

The site assessment found that no rehabilitation work on the filters had been performed, only minor work was planned, and the system still required replacement as recommended in the technical study. (Site Photo 7).

**Site Photo 7: Pressure filters and piping**

The initial SOW required rehabilitation of the filters to proper working order, to include the evaluation and rehabilitation or replacement of the existing filters. The FluorAMEC, LLC technical study states, “Although the Task Order calls for rehabilitation of the existing filters, field investigation has determined that the filters are in poor condition. Refurbishment would be cost-prohibitive due to the extent of work required.” According to the contractor, only the inspection of the filters, installation of monitoring equipment, and minor repairs to the system pipe work are planned.

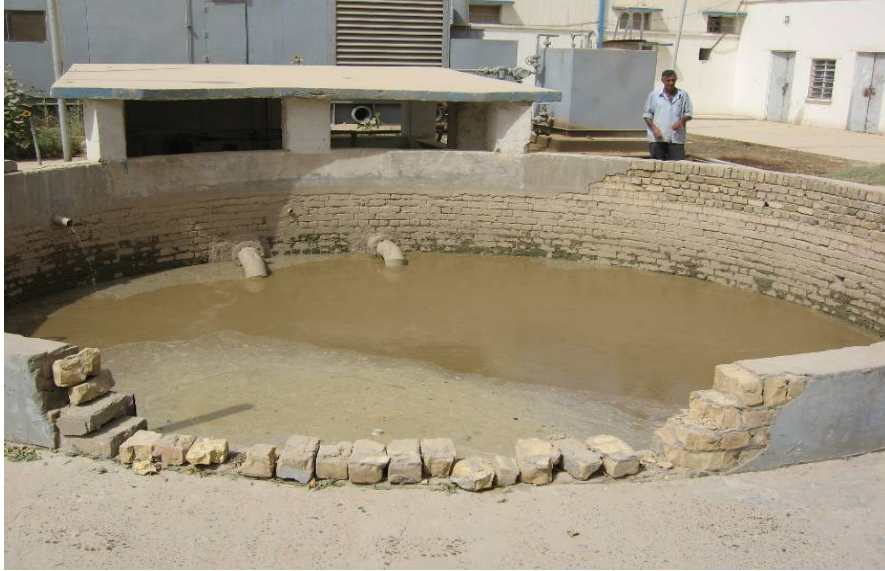
In addition to work listed above, the Iraqi Plant Manager demonstrated that the sludge tank and outflow pumps are undersized and cannot handle the effluent from the rapid sand gravity filter backwash operations (used to clean the filters). This negatively impacts the total time required and efficiency of the rapid sand gravity filter backwash operations. (Site Photo 8).

Site Photo 8: Sludge tank

The FluorAMEC, LLC technical study and SOW included the following repairs for the sludge tank: drain and inspect tank, sludge removal, minor crack and spalled concrete repair, seal tank with Thoroseal coating, earthwork to repair erosion around tank foundation, and a \$10,000 allowance for unforeseen repairs. All of this work, however, was removed from this project, according to the contractor.
