AMMUNITION SUPPLY POINT  
UMM QASR, IRAQ

**SIGIR-PA-05-025**  
**JANUARY 27, 2006**

SUBJECT: Report on Project Assessment of the Ammunition Supply Point, Umm Qasr,  
Iraq (Report Number SIGIR-PA-05-025)

## Project Assessment of the Ammunition Supply Point Umm Qasr, Iraq

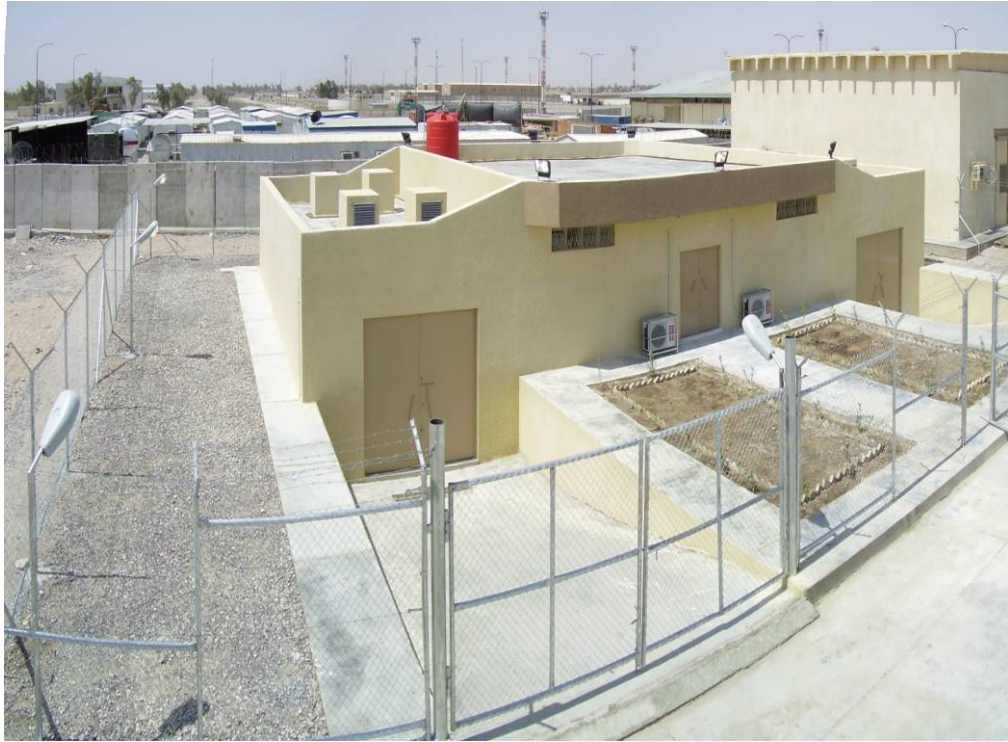
The SOW required security fencing around the ASP building. The fence was required to be chain link with a 2-inch diamond mesh. The top of the fence required general purpose tape obstacle barbed concertina wire or barbed wire outriggers. The assessment team observed the security fence (Site Photo 1) with barbed wire outriggers (Site Photo 2) which appeared to be consistent with design requirements. The fence and poles were anchored in the ground with concrete and appeared to be consistent with the design requirements (Site Photo 3). The chain link fence was 2-inch diamond mesh that appeared to be consistent with design requirements.

**Site Photo 1. View of Security Fence around the ASP (Photograph Courtesy of USACE Resident Engineer)**

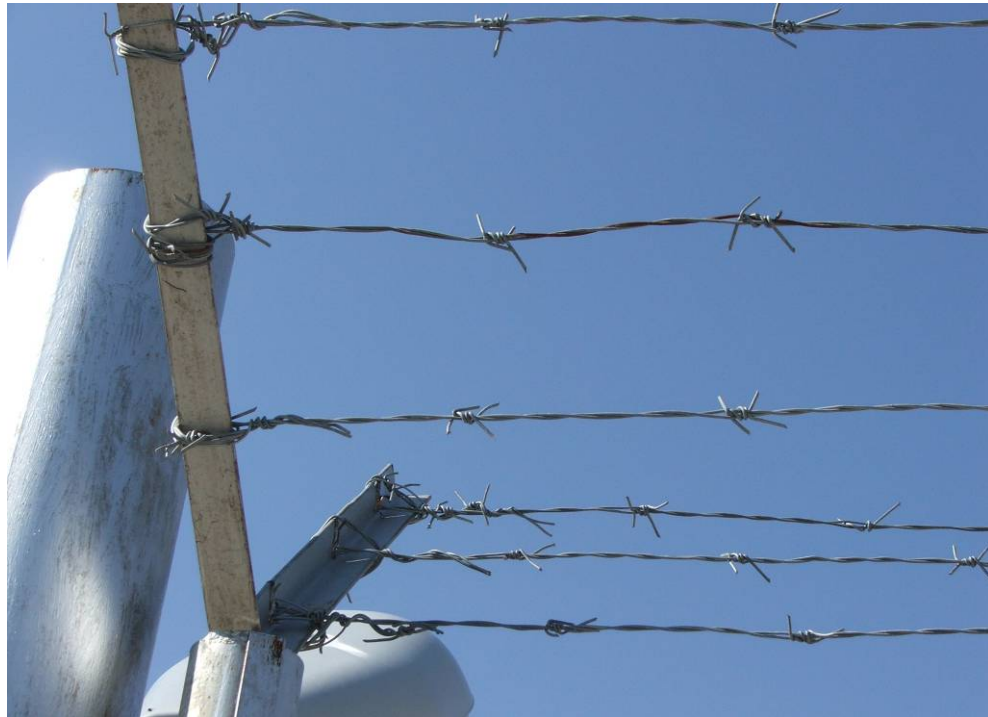
**Site Photo 2. Barbed Wire Outriggers on Security Fence**

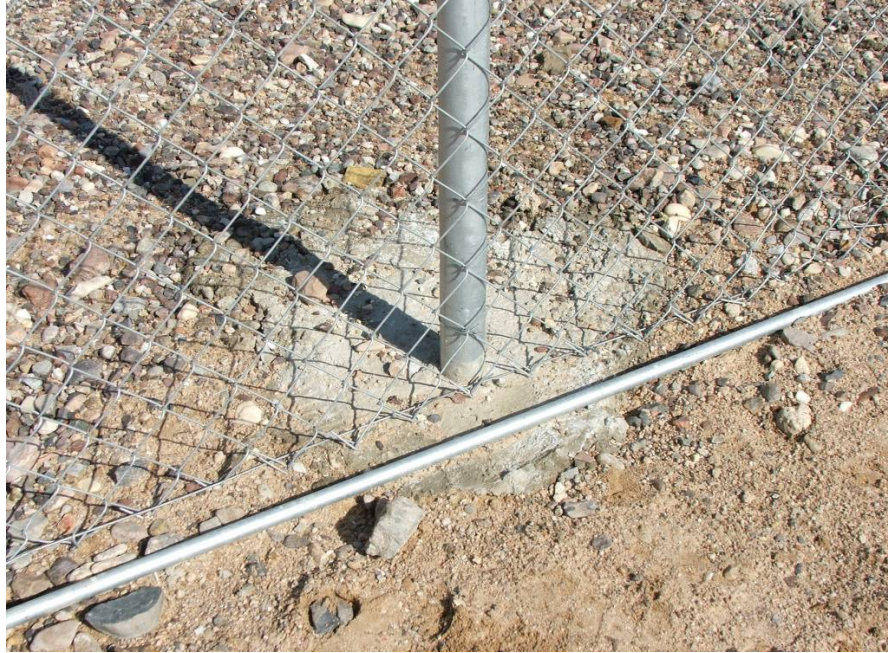
**Site Photo 3. Security Fence Pole Anchored into Ground with Concrete**

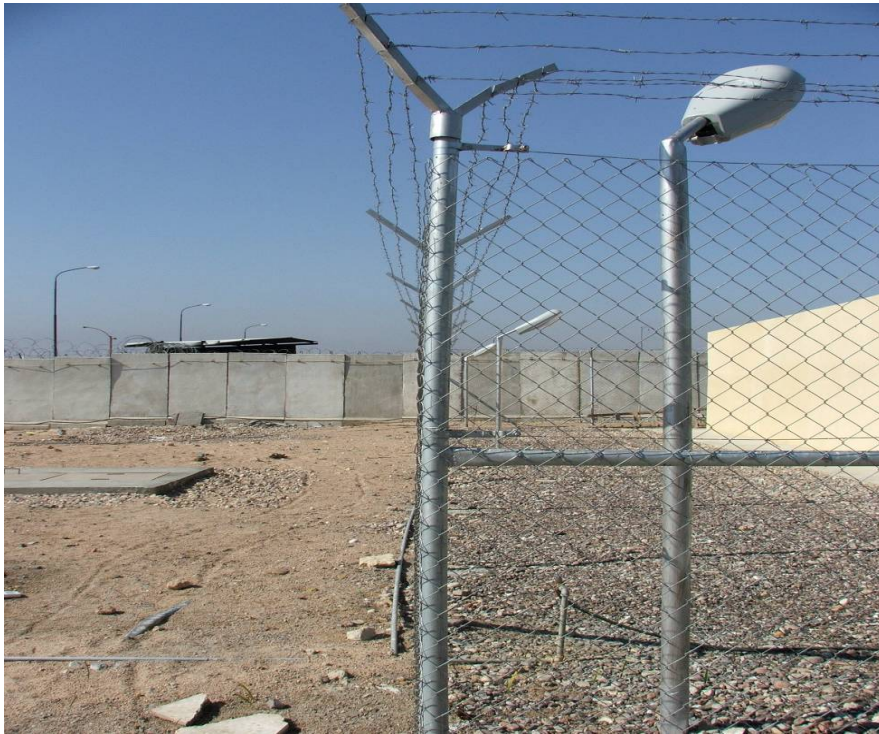
The SOW required pole mounted outdoor security lighting connected to the local power supply. Site Photos 4, 5, and 6 show pole mounted and roof mounted lights which appeared to meet the requirements of the contract.

**Site Photo 4. Three Pole Mounted Lights on Side of ASP**

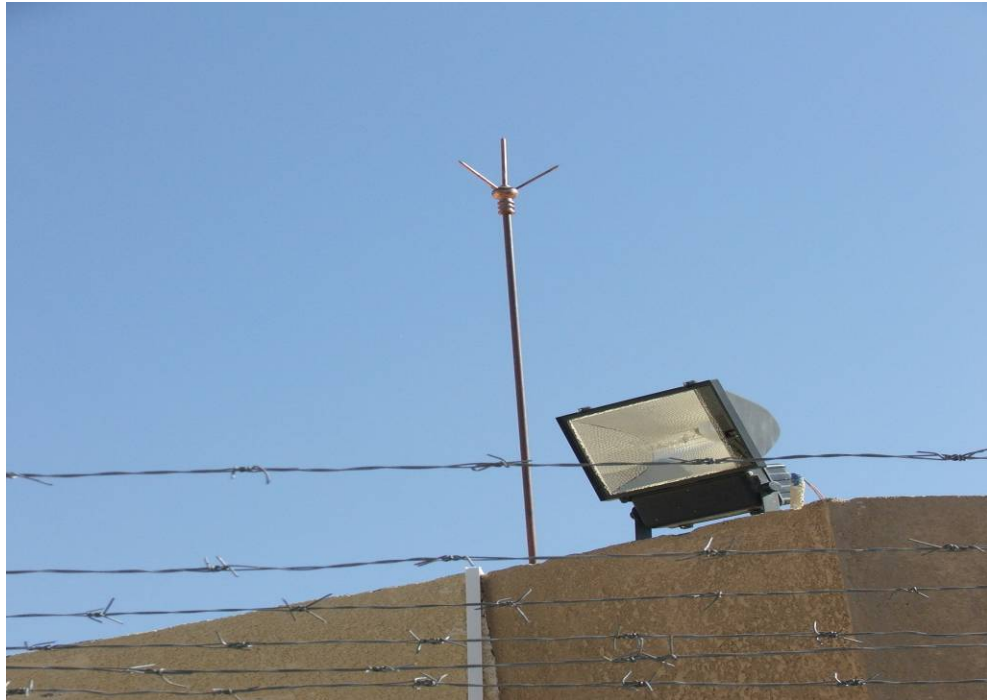
The SOW required the design and construction of a lightning arrestor system. The assessment team observed that a lightning arrestor system was in place on top toward the back side of the ASP. The lightning arrestor system is displayed in Site Photo 6.

**Site Photo 6. Lightning Arrestor and Roof Mounted Light**

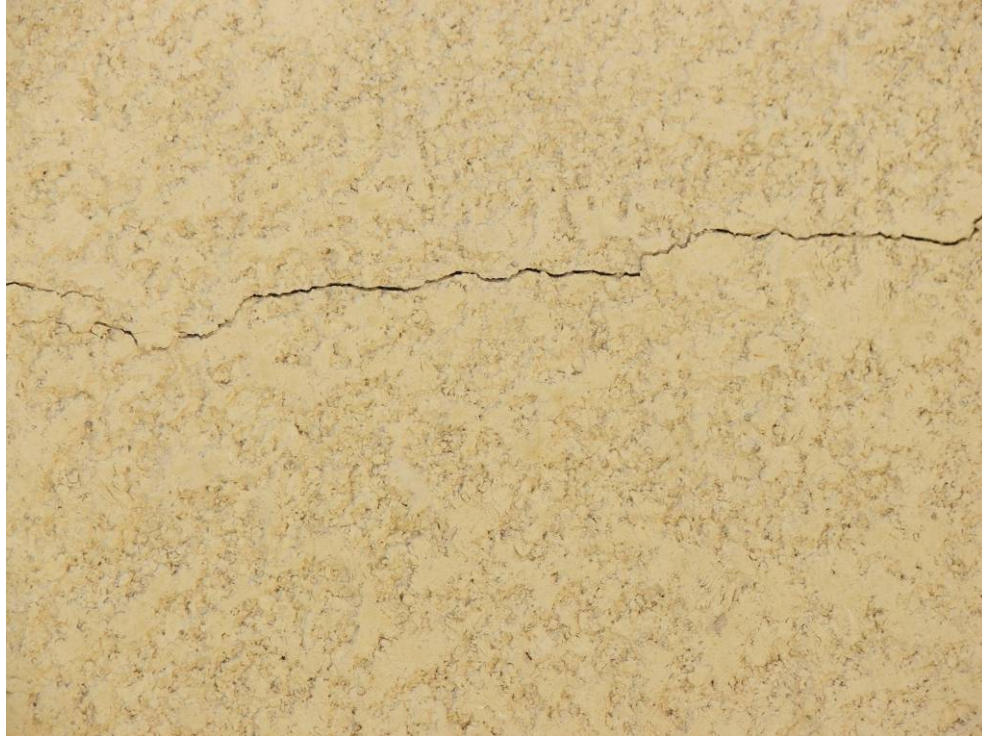
During our site visit, a large crack in a stucco wall outside the ASP was identified (Site Photo 7). The USACE Resident Engineer noted that 6 and 12 month reviews of completed projects are done to identify any corrective actions required by the contractor. During the warranty period, the customer is required to provide a list of defects in workmanship and equipment to the USACE representative for resolution. The USACE Resident Engineer stated this crack will be noted and addressed during the 6 month review.

Site Photo 7. Crack in Stucco Wall Outside the ASP

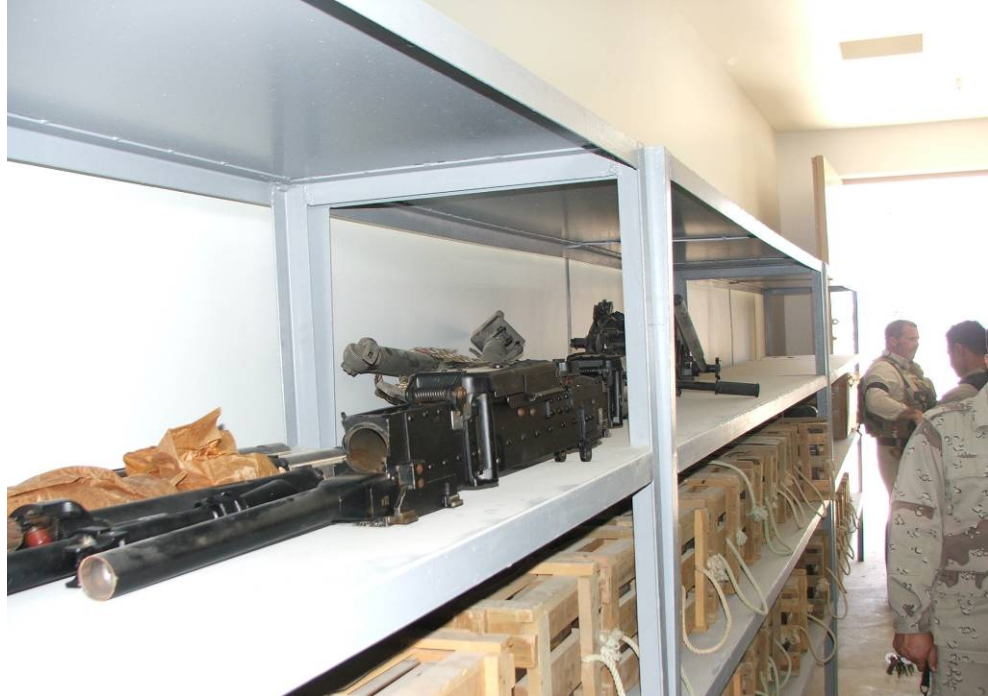
Operational effectiveness of this project was addressed in the contractor proposed design, quality oversight, and quality construction. Safety issues for storing explosive materials were addressed by using reinforced concrete and double concrete walls with a buffer to reduce the likelihood of a sympathetic detonation should there be an explosion. A lightning arrestor system was constructed to reduce the probability of an electrical accident. The USACE LN QAR was on-site during construction and monitored field activities. This project was conceived in close coordination with the Iraqi Navy. We interviewed an Iraqi Navy representative who stated that he was satisfied with the results of the project. At the request of the Iraqi Navy, the contractor added, at no cost, several additional pieces of equipment to improve the operability of the facility. This facility was being used by the Iraqi Navy to store ammunition and weapons at the time of the assessment ( Site Photos 8 and 9).

**Site Photo 8. Iraqi Navy Weapons Stored within the ASP**

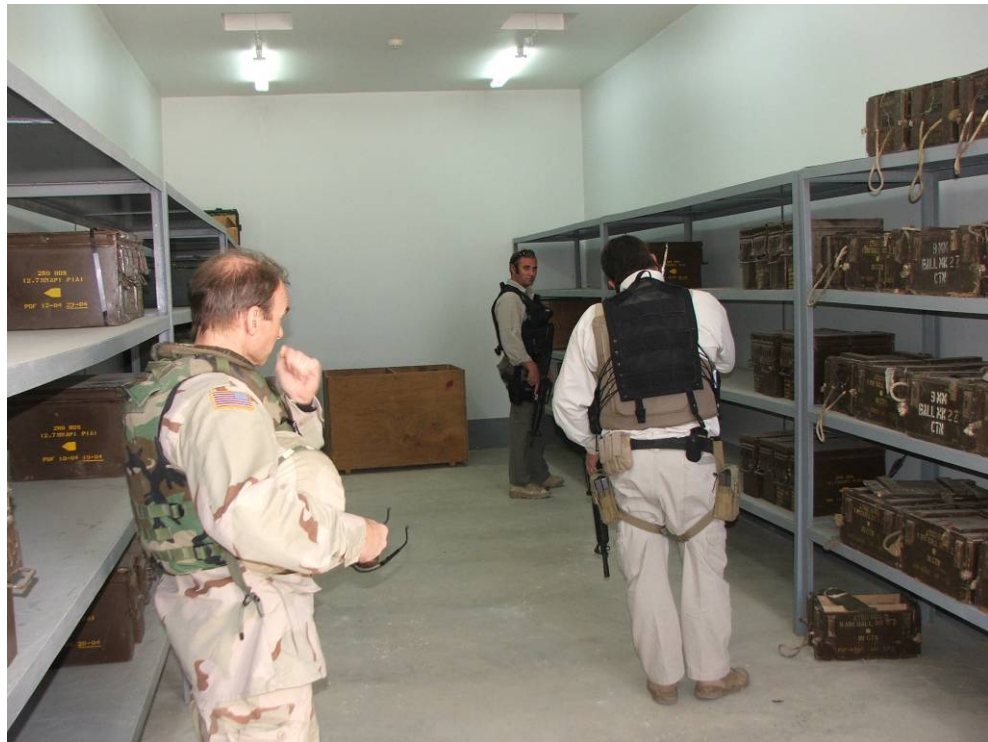
**Site Photo 9. Iraqi Navy Ammunition Stored within the ASP**
