NIST Technical Note 1552

**Measurements to Support Public Safety
Communications: Attenuation and
Variability of 750 MHz Radio Wave Signals
in Four Large Building Structures**

Electromagnetics Division
National Institute of Standards and Technology
325 Broadway
Boulder, CO 80305

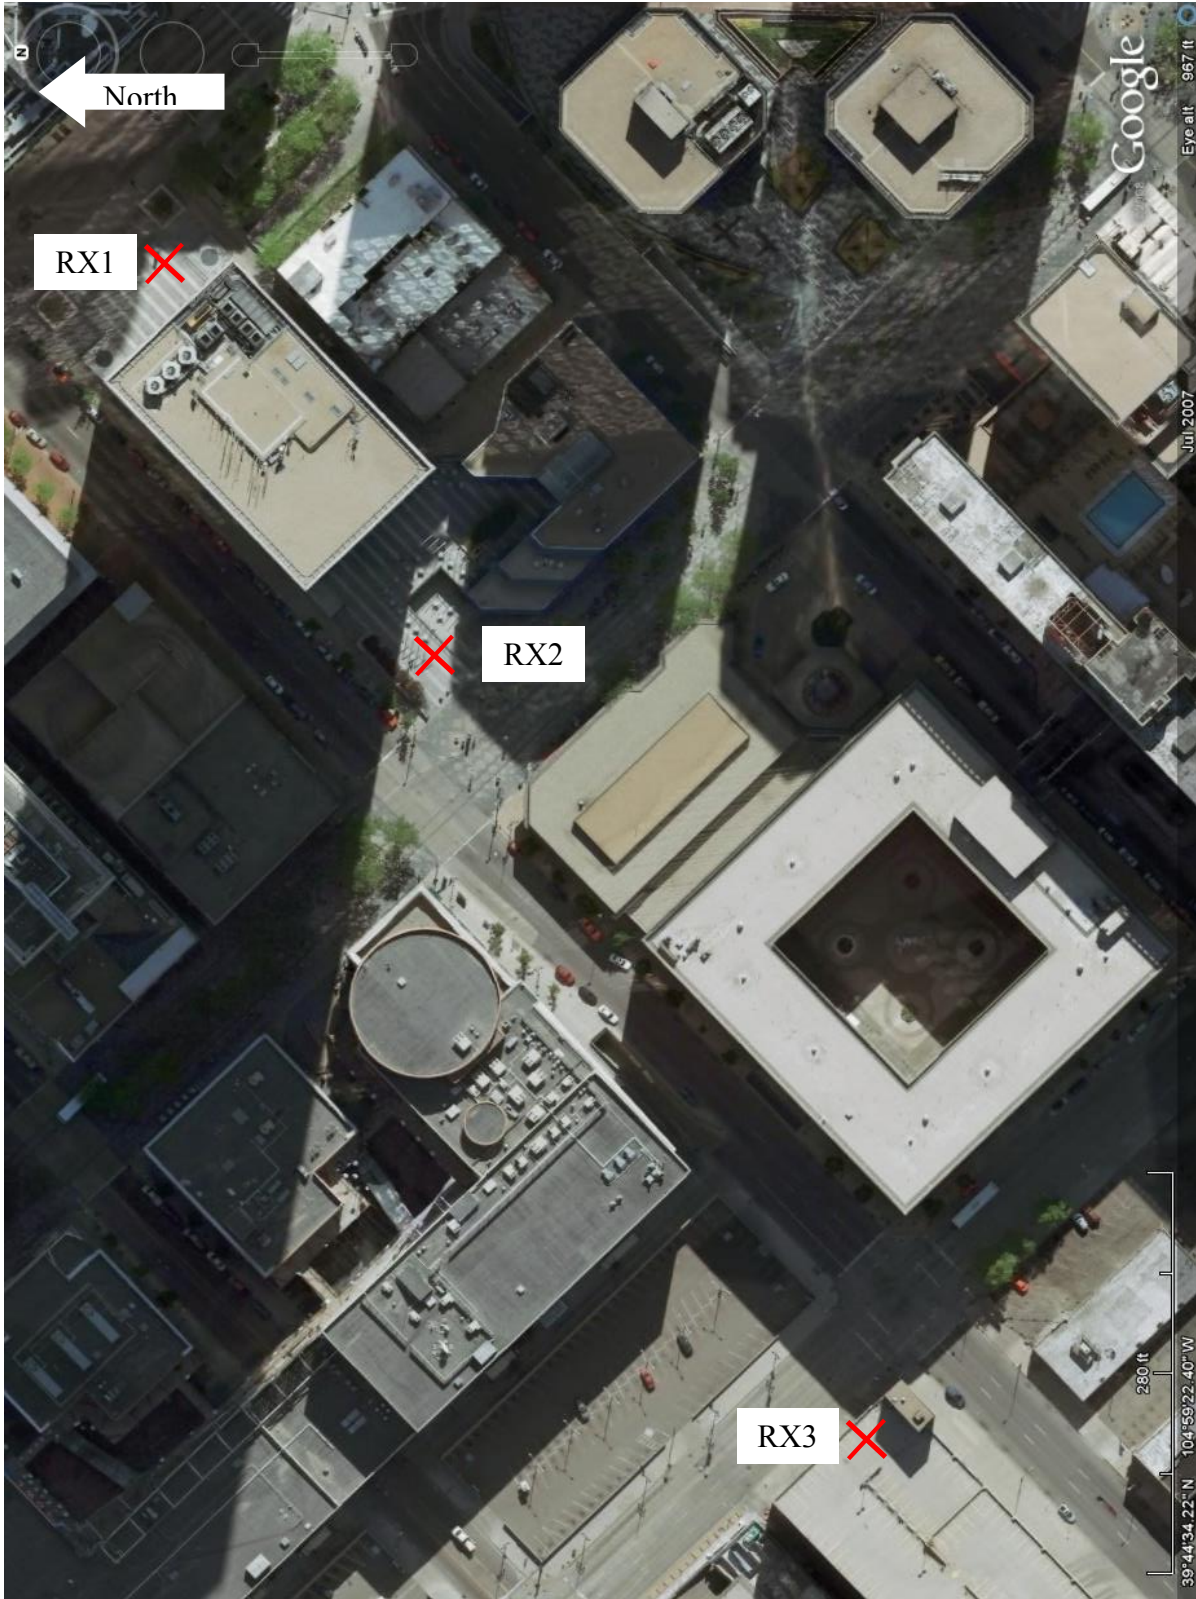
Figure 14. Location of receive sites at the Republic Plaza Building.

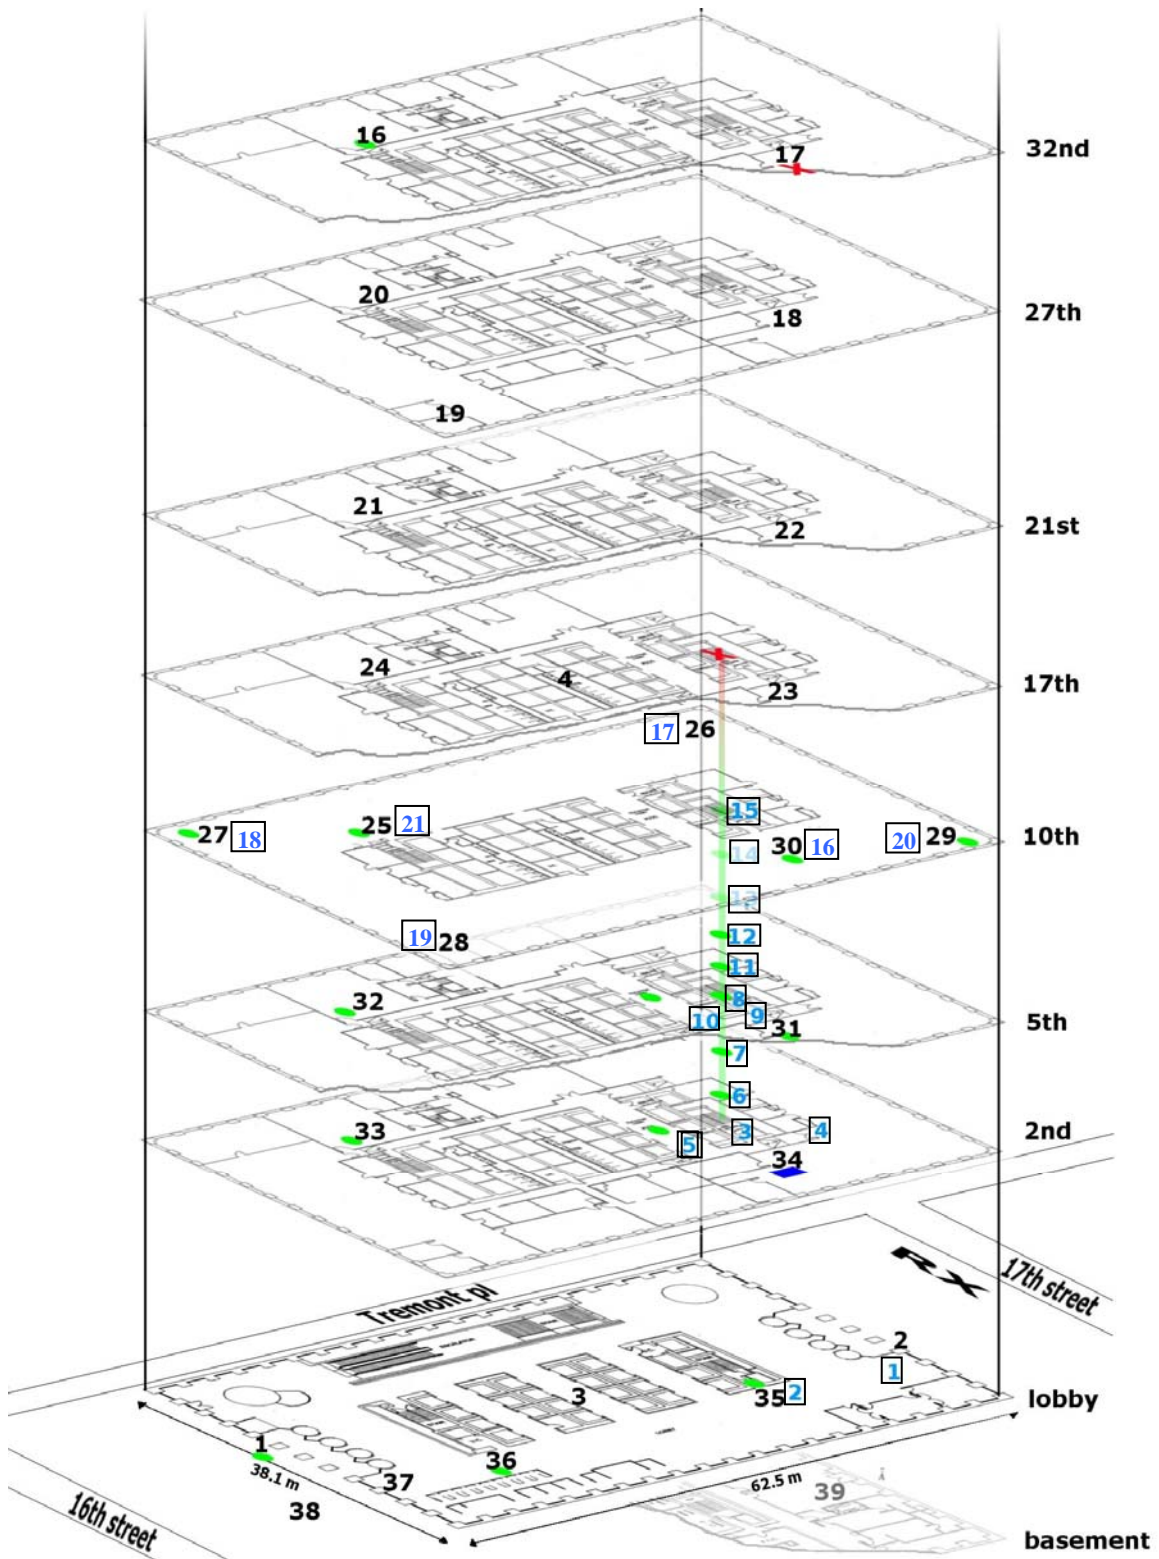
Figure 15. Synthetic pulse test points in Republic Plaza. The test locations are the blue numbers in the black boxes; the unboxed numbers are radio-mapping locations as in Figure 12.

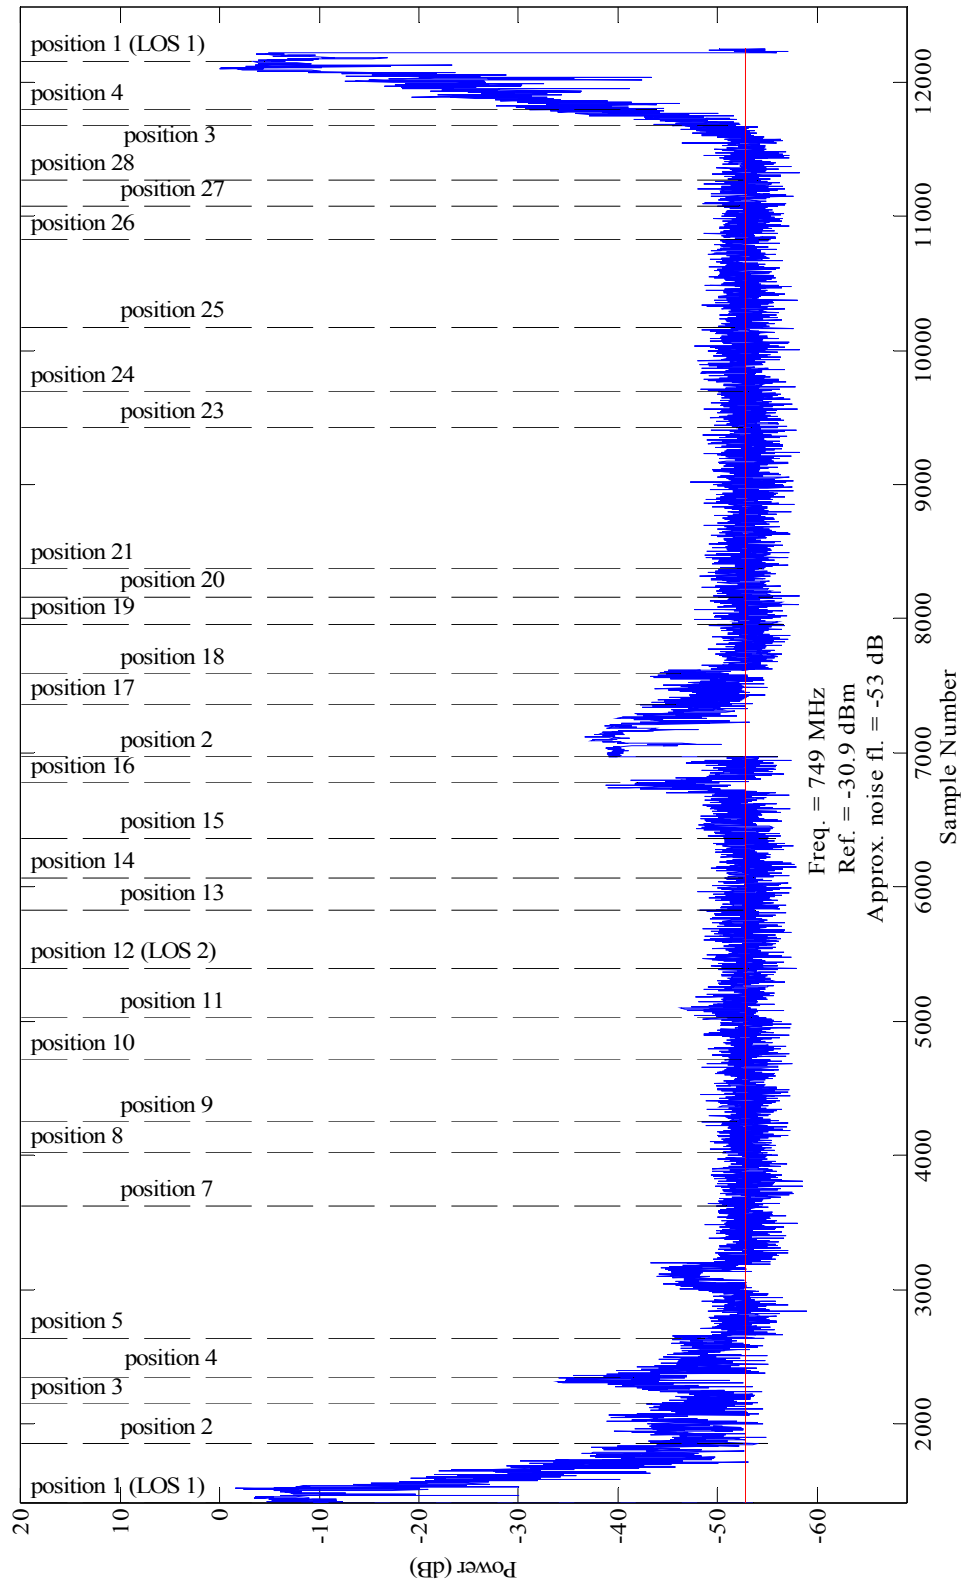
Figure 22. Colorado Convention Center, receive site 1. Normalized received-signal data from the spectrum analyzer as the 749 MHz transmitter is carried through the building.

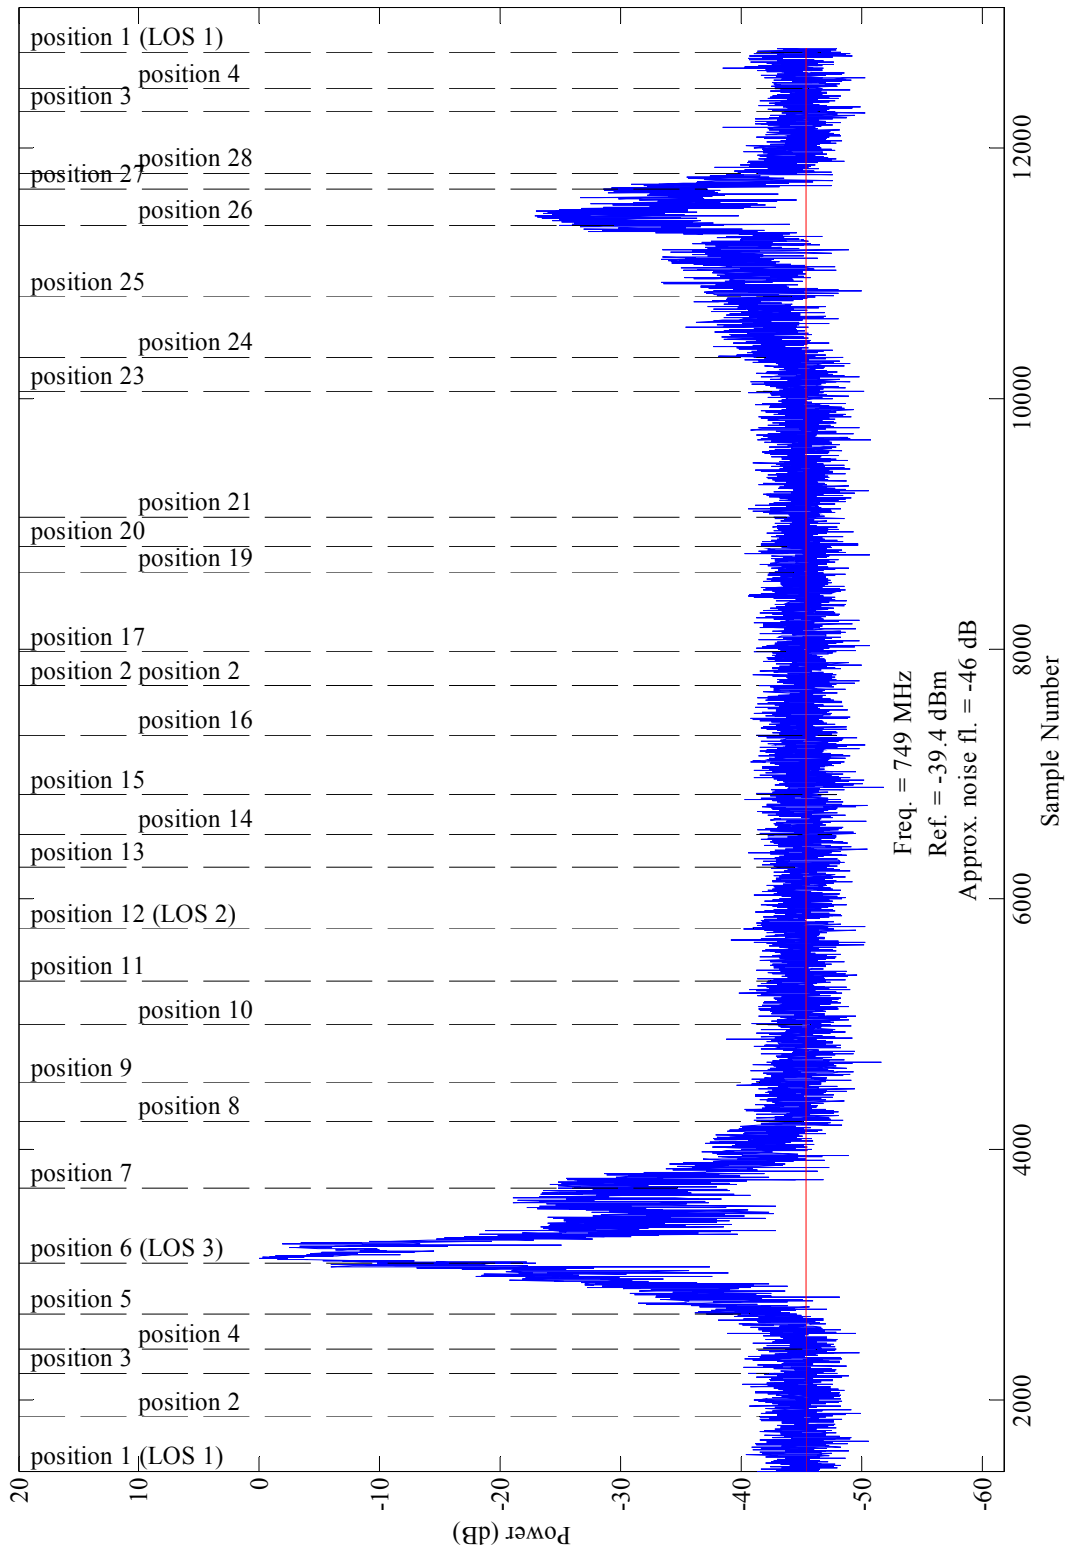
Figure 24. Colorado Convention Center, receive site 3. Normalized received-signal data from the spectrum analyzer as the 749 MHz transmitter is carried through the building.

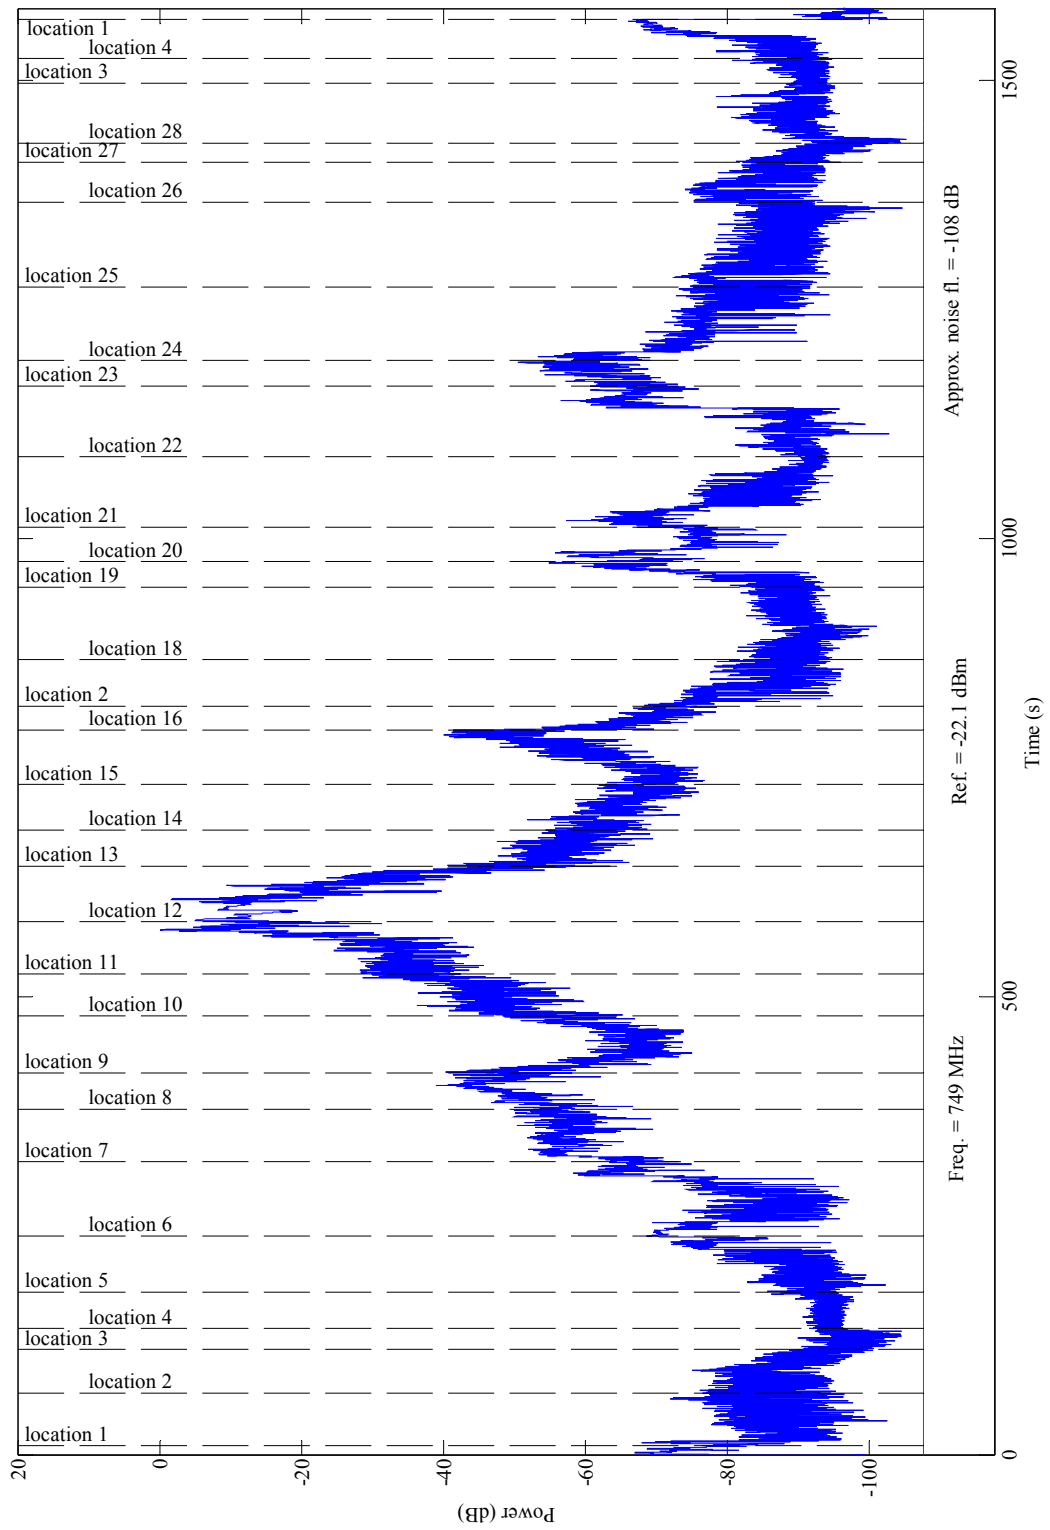
Figure 27. Colorado Convention Center narrowband receiver results for receive site 2.

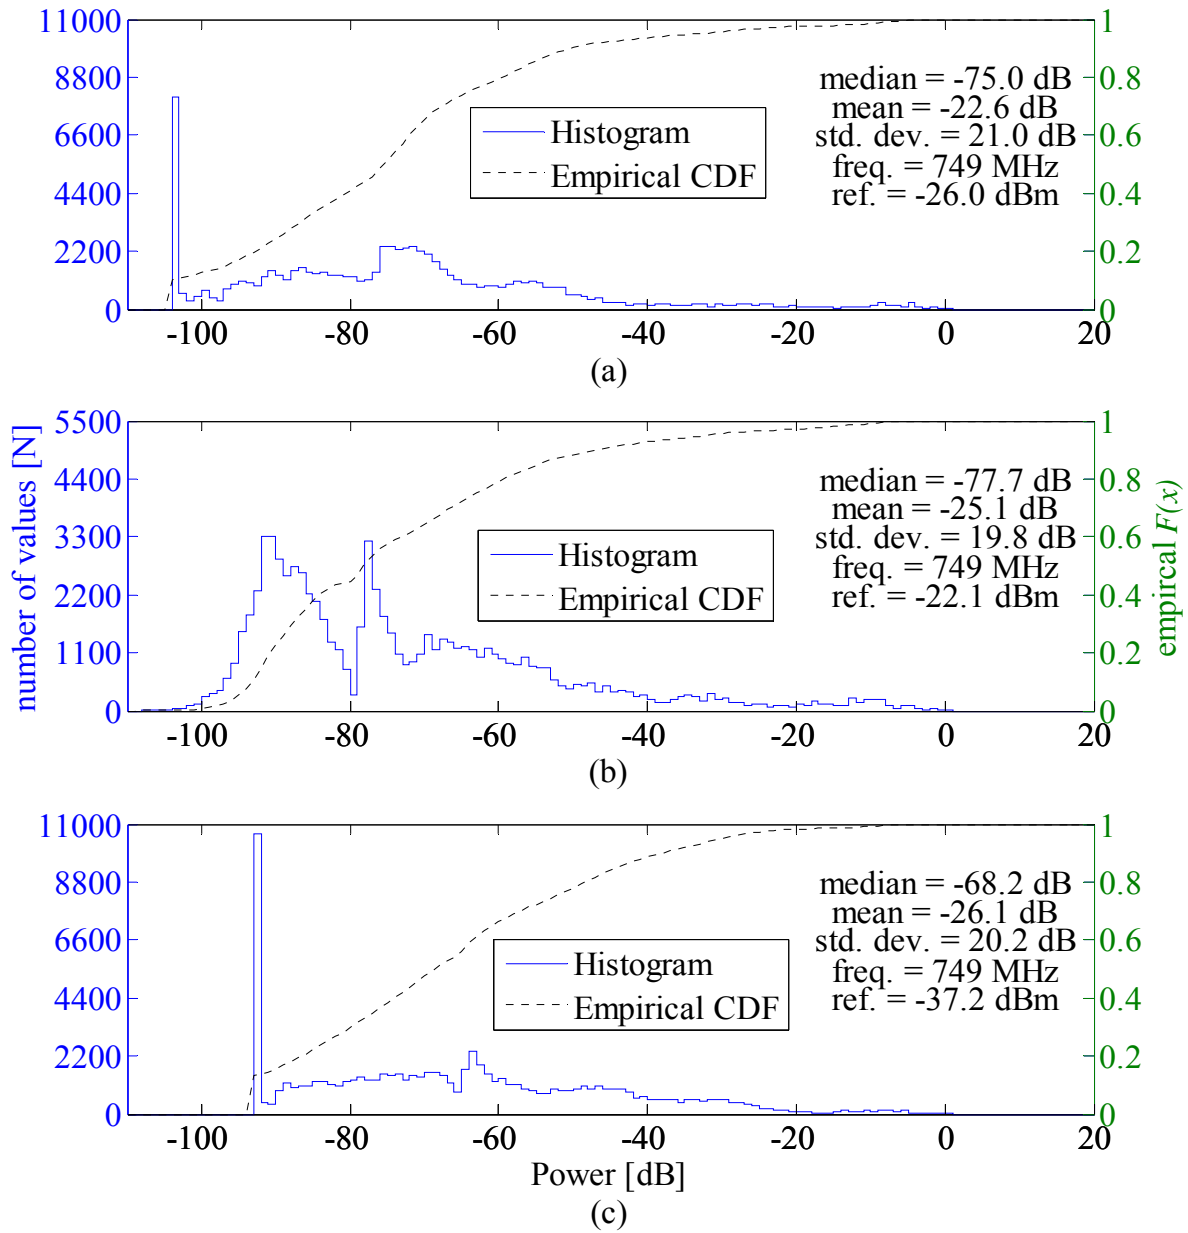
Figure 29. Histogram and empirical CDF of the narrowband receiver signal power at the Colorado Convention Center for (a) receive site one, (b) receive site two, and (c) receive site three. Note that histogram count scale is different for the receive site two, plot (b).

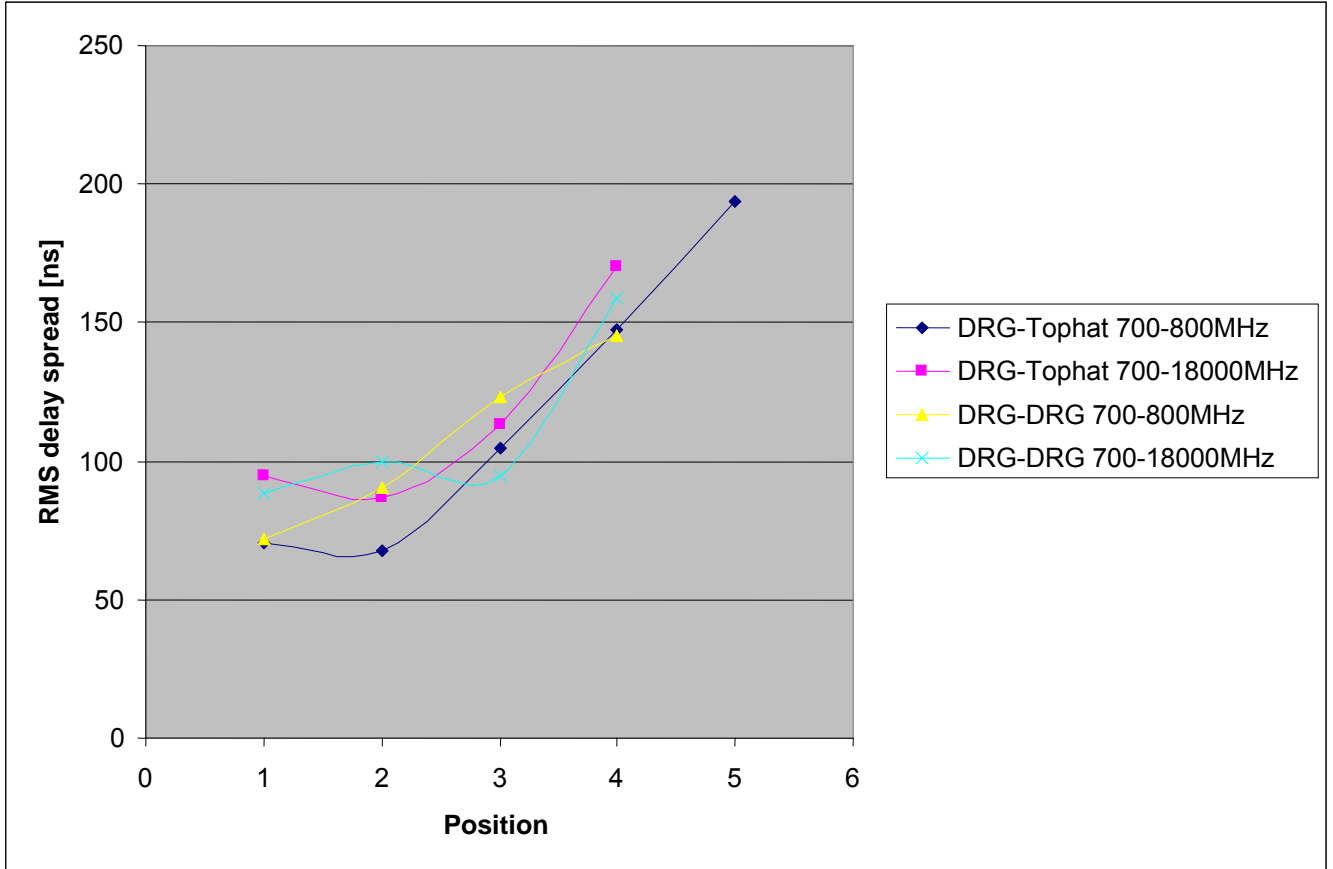
Figure 34. Colorado Convention Center RMS delay spread versus position for two antenna configurations and two different frequency bands. “DRG” refers to dual ridge guide horn, and is a directional antenna. “Tophat” refers to an omnidirectional receive antenna.

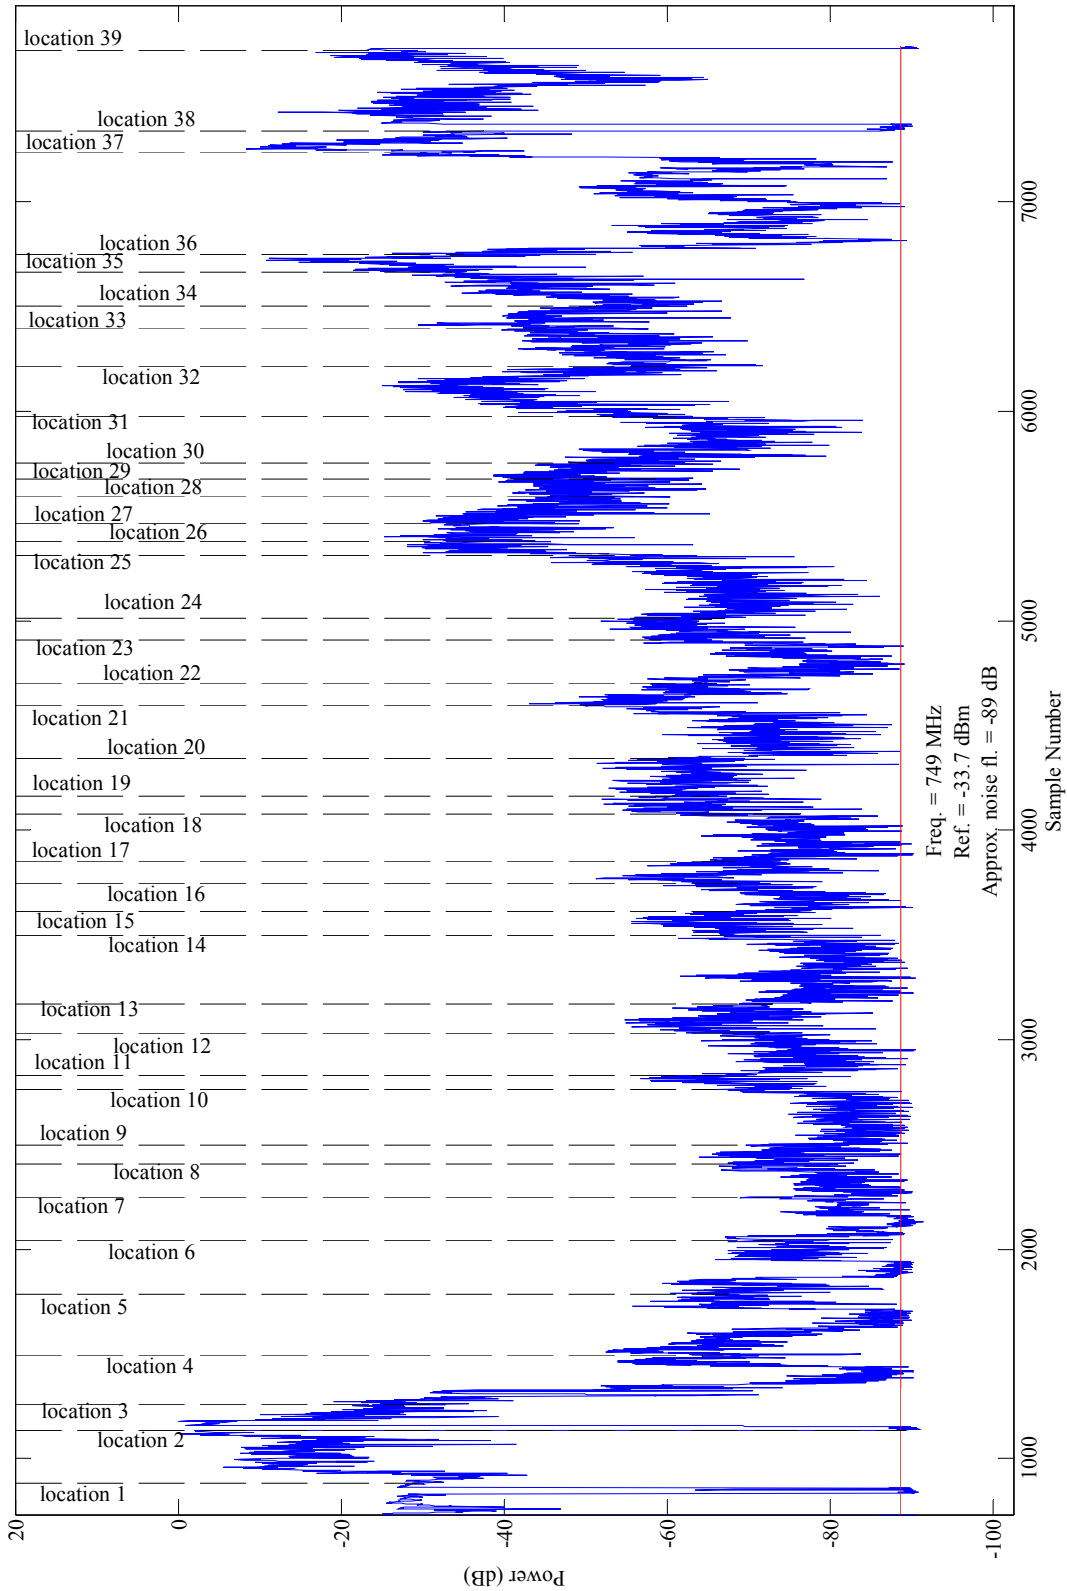
Figure 35. Republic Plaza, receive site 1. Normalized received signal power from the spectrum analyzer as the 749 MHz transmitter is carried through the building.

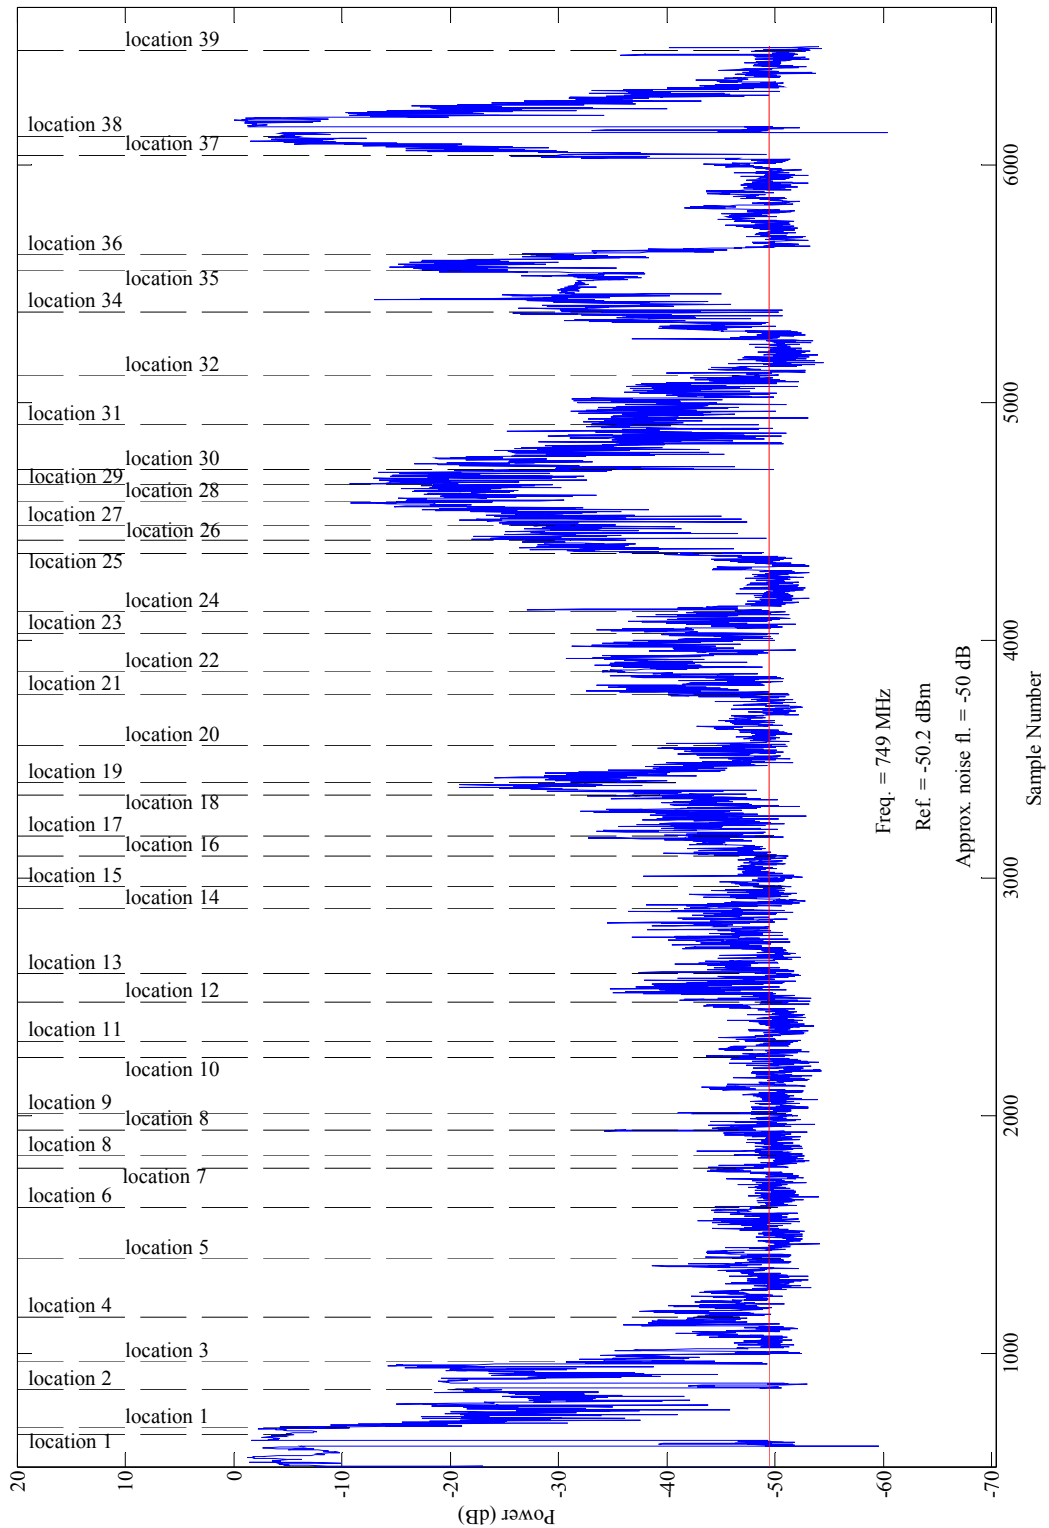
Figure 37. Republic Plaza, receive site 3. Normalized received signal power from the spectrum analyzer as the 749 MHz transmitter is carried through the building.

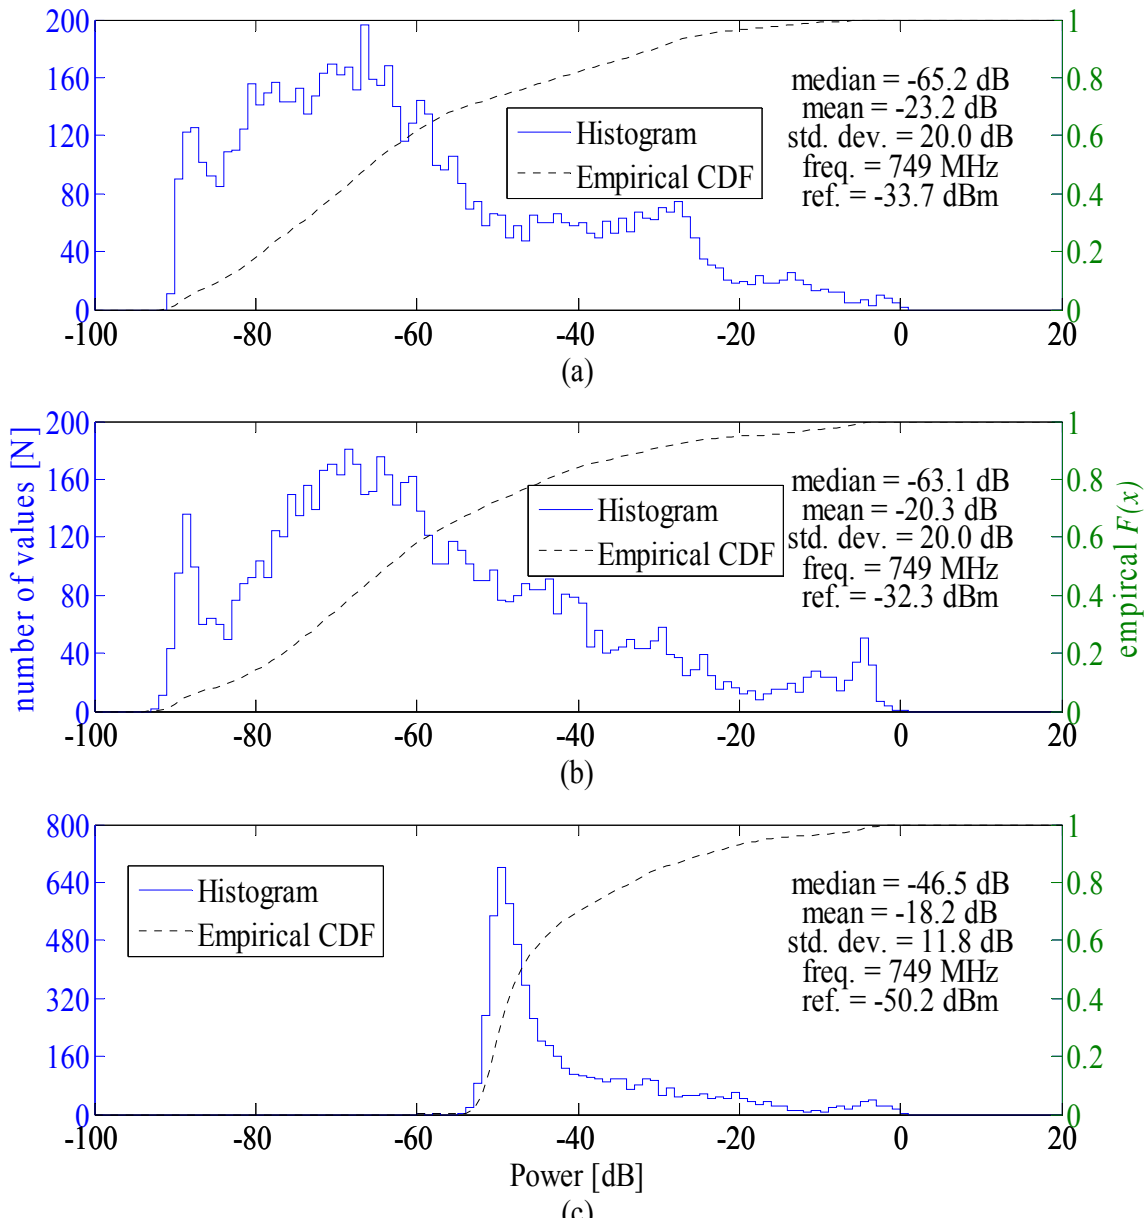
Figure 38. Histogram and empirical CDF of the received spectrum analyzer signal power at Republic Plaza for (a) receive site one, (b) receive site two, and (c) receive site three. Note that histogram count and the power scales are different for the receive site three, plot (c).

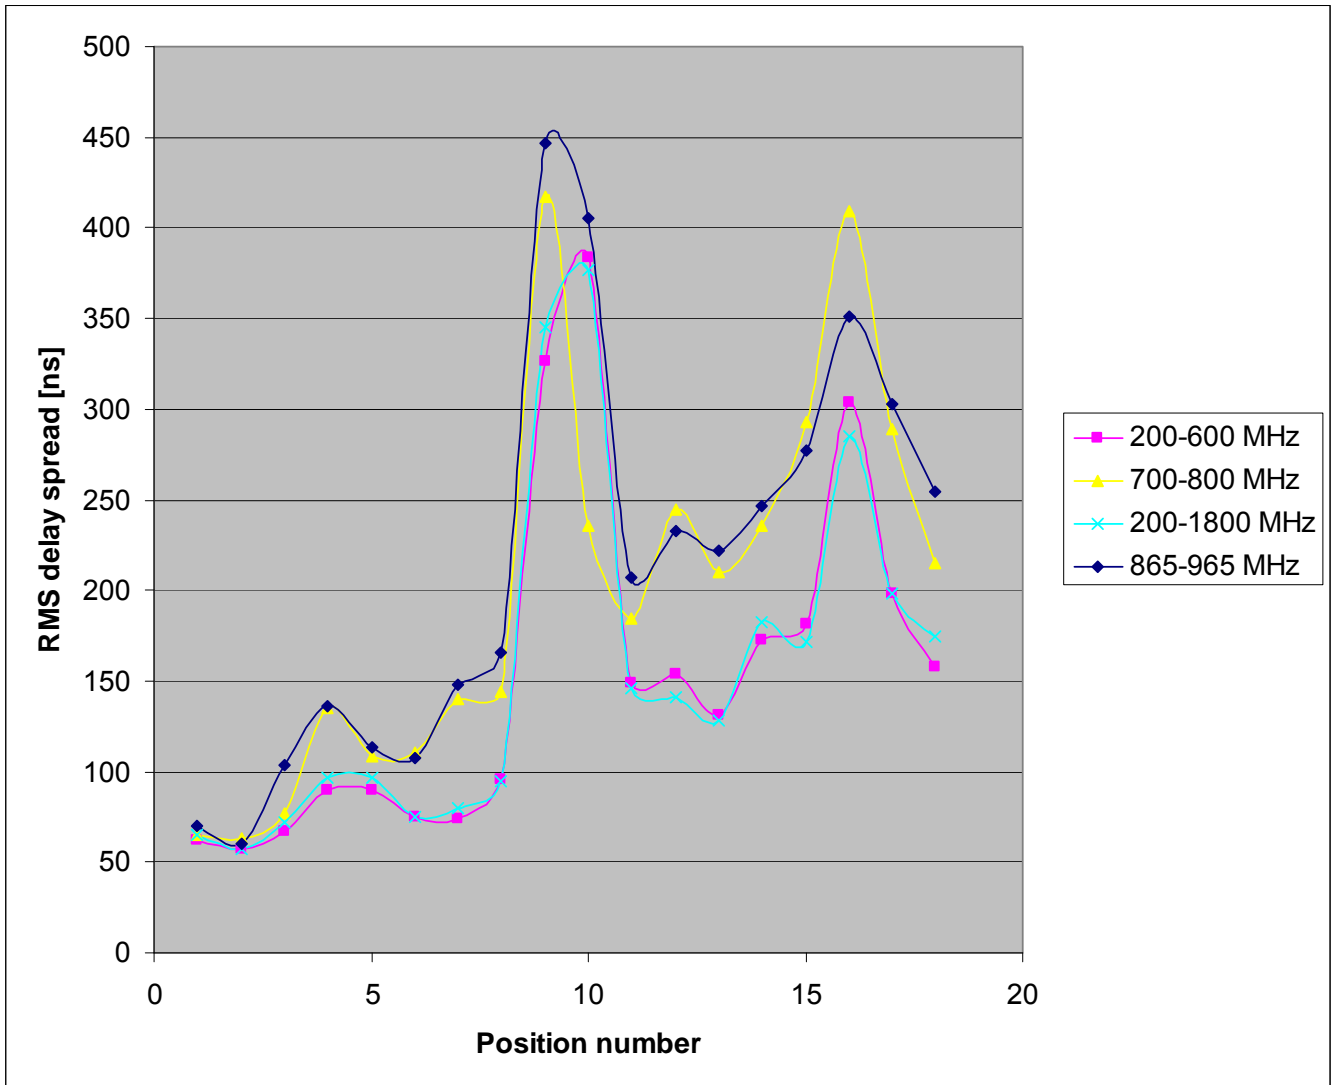
Figure 55. Republic Plaza RMS delay spread versus position based on four different frequency bands.

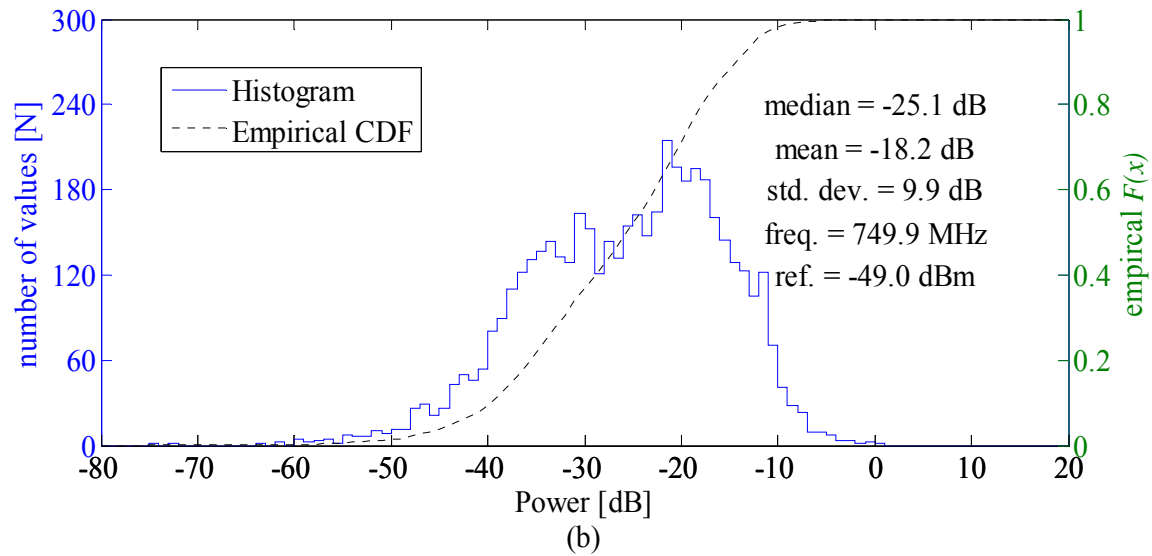
Figure 58. Histogram and empirical CDF of the received spectrum analyzer signal power at Horizon West for (a) receive site one and (b) receive site two.

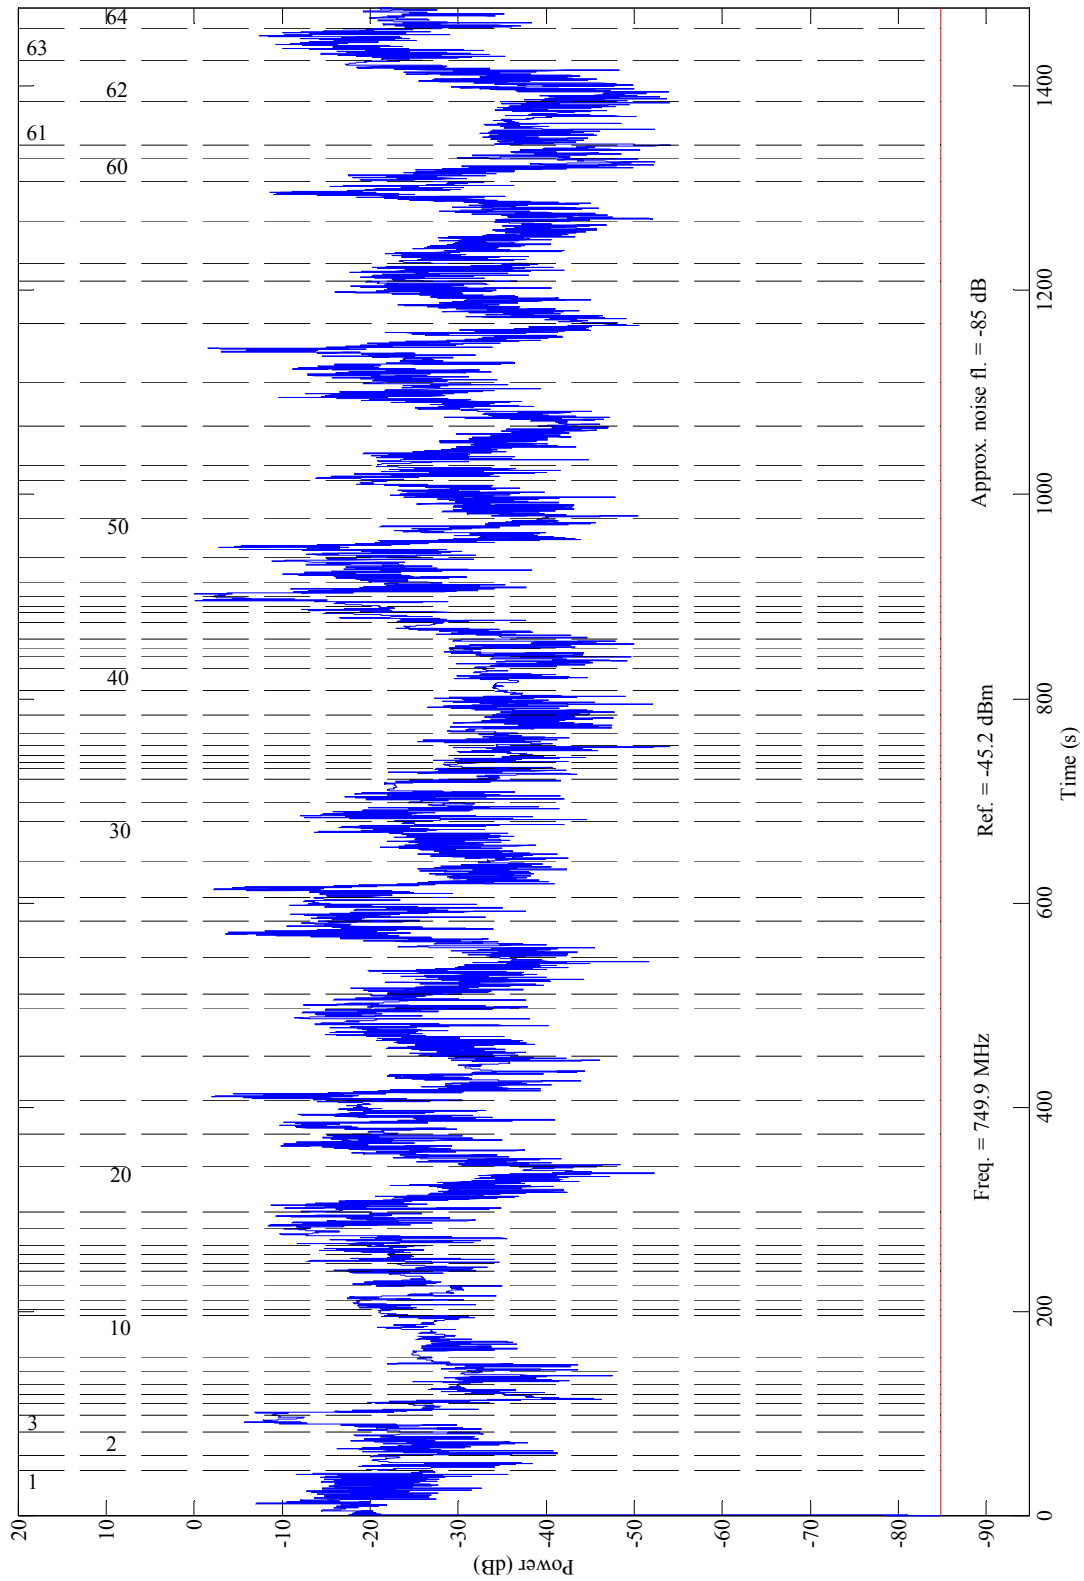
Figure 60. Horizon West, receive site 2. Normalized narrowband receiver signal power as the 750 MHz transmitter is carried through the building.

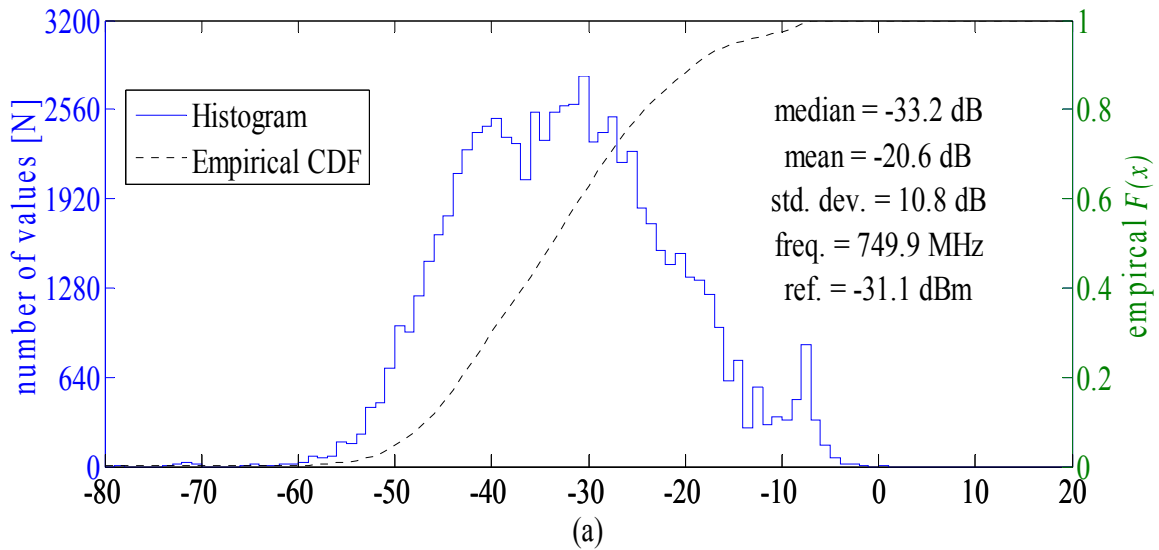
Figure 61. Histogram and empirical CDF of the narrowband receiver signal power at Horizon West for (a) receive site one and (b) receive site two.

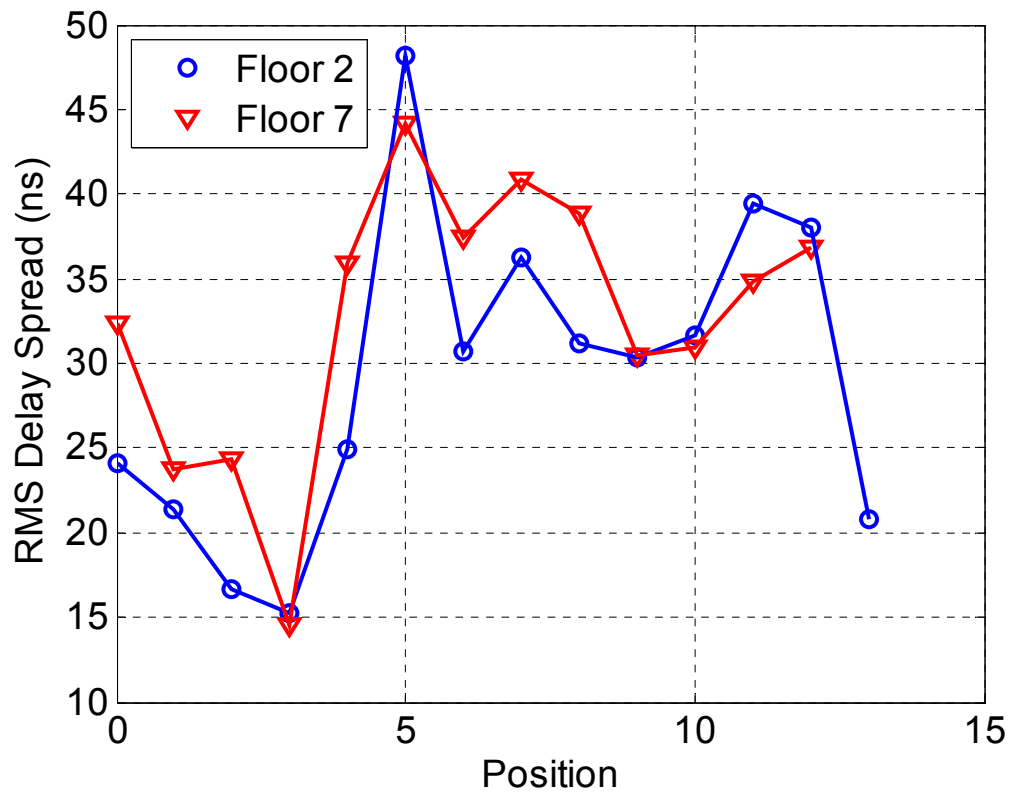
Figure 66. Summary of RMS delay spread values calculated at the Horizon West apartment building. Data were calculated using the frequency band from 1 GHz to 18 GHz.

Synthetic pulse measurements for this building were carried out previously, and the results, reproduced from TN 1546 [8], can be found in Figures 62 through 65. The RMS delay spread is summarized in Figure 66. While these results are not calculated specifically across the 700 MHz to 800 MHz band, as demonstrated by the earlier results, the expected behavior should be quite similar even when considering a much wider bandwidth, especially because the signal energy is greatly reduced at the higher frequencies.

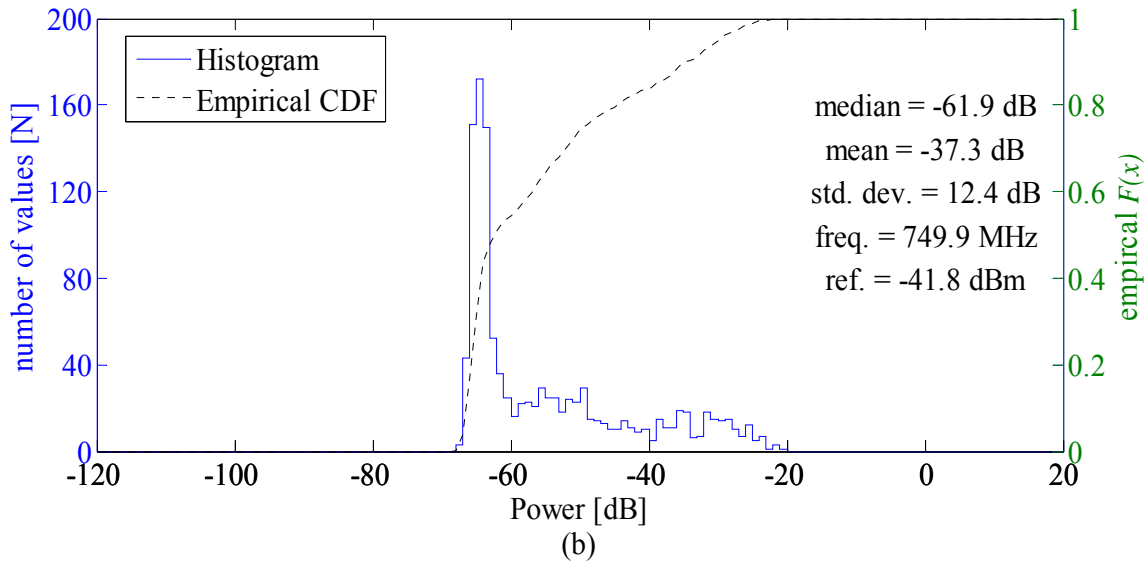
Figure 78. Histogram and empirical CDF of the spectrum analyzer signal power at NIST Boulder laboratory for (a) receive site one and (b) receive site two. Path II, walk 2.

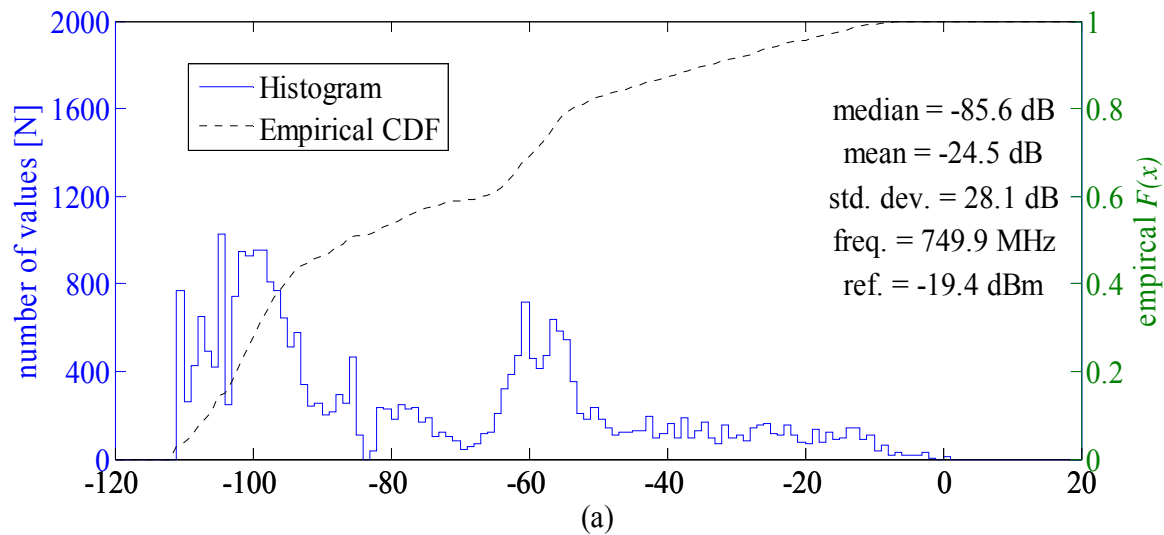
Figure 84. Histogram and empirical CDF of the narrowband receiver signal power at NIST Boulder laboratory for (a) receive site one and (b) receive site two. Path I, walk 2.
