NIST Technical Note 1552

**Measurements to Support Public Safety
Communications: Attenuation and
Variability of 750 MHz Radio Wave Signals
in Four Large Building Structures**

Electromagnetics Division
National Institute of Standards and Technology
325 Broadway
Boulder, CO 80305

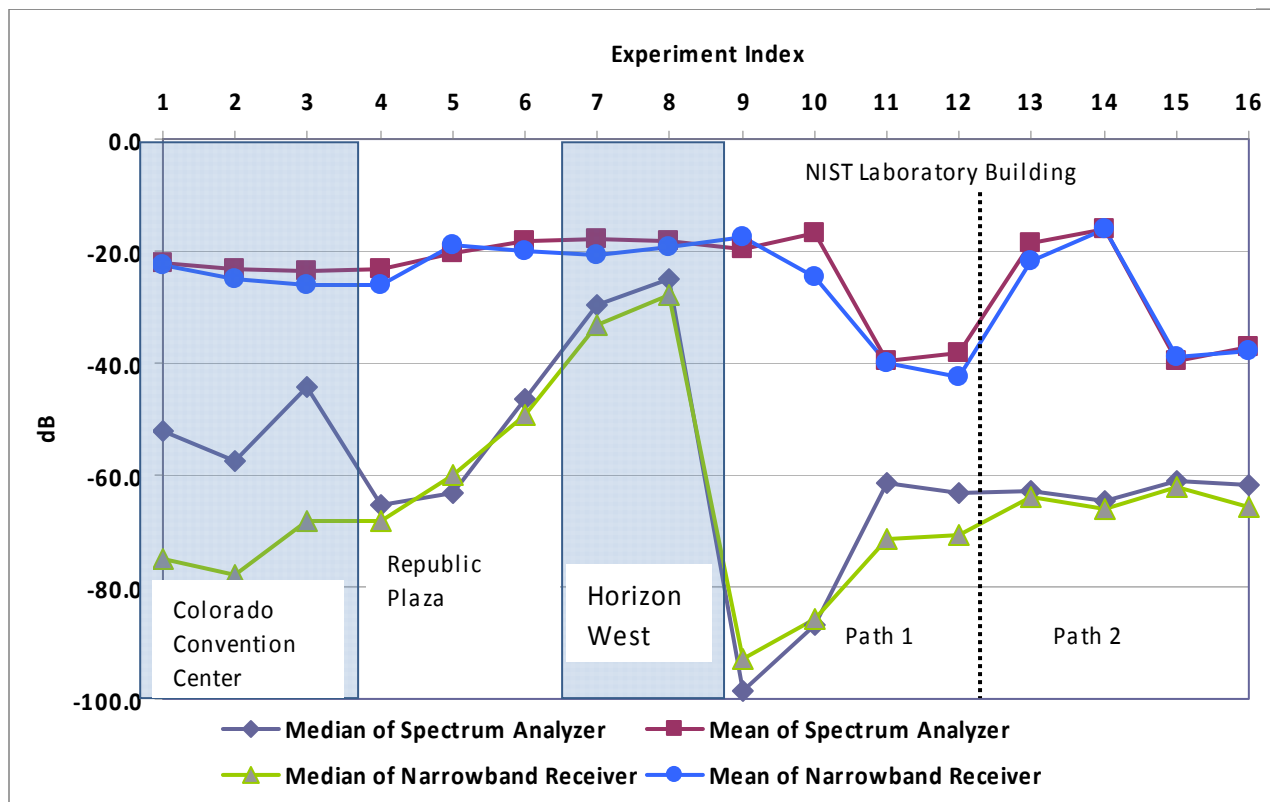
Figure 100. Comparison of median and mean values from the normalized spectrum analyzer and narrowband receiver data across all the test locations.

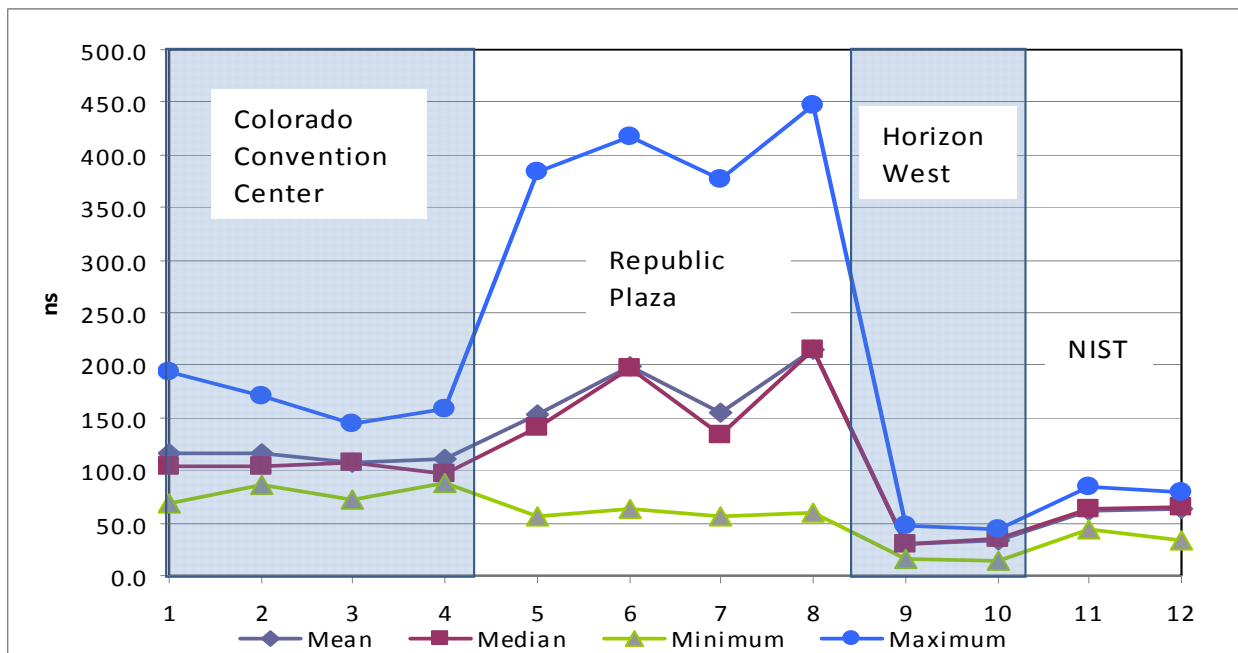
Figure 102. RMS delay spread statistics for the four buildings, indexed on the horizontal axis by the various frequency bands provided in Table 3.
