Automatic Sprinklers: Sprinkler Inspections

No. FP-2009-9 March 3, 2009

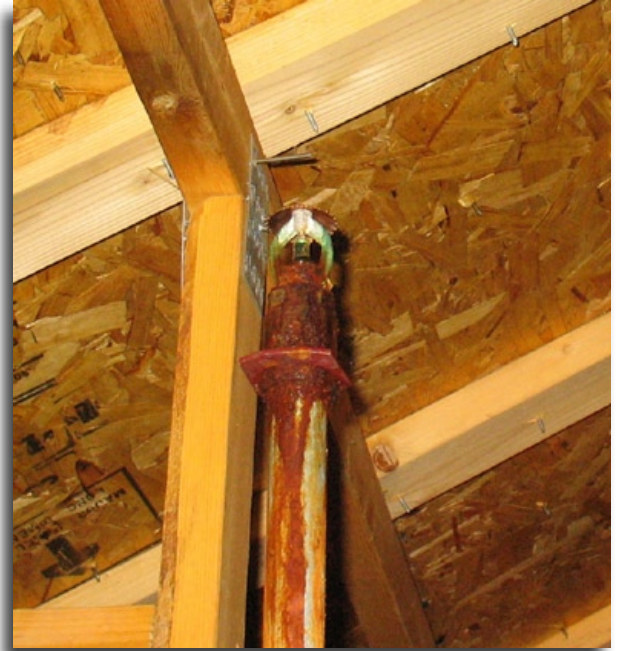
Today's illustration identifies two problems with this upright sprinkler in an attic on a 1-inch riser nipple (also known as a "sprig up"). This damage was discovered by another company on a service call after other portions of the sprinkler system froze and broke.

Photo courtesy of Freedom Fire Protection, Longmont, Colorado. This corroded sprinkler was one part of a larger system failure.

The corrosion resulted from a leak between the sprinkler and pipe. Why wasn't this identified as part of the annual inspection required by the National Fire Protection Association (NFPA)[®] 25, *Standard for the Inspection, Testing, and Maintenance of Water-Based Fire Protection Systems*? NFPA[®] 25 requires "Sprinklers shall be inspected from the floor level annually. . . . Sprinklers installed in concealed spaces such as above suspended ceilings shall not require inspection." The purpose of these inspections is to find and correct obvious deficiencies; in this case, the sprinkler above the ceiling could not have been observed from the floor.

The second problem probably should have been corrected during the initial inspections for the sprinkler system. According to NFPA[®] 13, *Standard for the Installation of Sprinkler Systems*, the sprinkler is too close to the web of the roof truss. Should the sprinkler operate in a fire, the web would create an obstruction preventing a complete circular water discharge pattern. (See Coffee Break Training 2008-38 for an explanation of the clearance rules from noncontinuous obstructions.)

NFPA[®] 25 provides the person conducting annual sprinkler inspections some guidance on what to do if these sorts of obstructions are found during periodic checks. In a section that describes what to do about "temporary" obstructions, such as storage too close to sprinklers, NFPA[®] 25 states "other obstruction rules are impractical to enforce under this standard. However, if obstructions that might cause a concern are present, the owner is advised to have an engineering evaluation performed."
